PITEAU ASSOCIATES
GEOTECHNICAL AND
HYDROGEOLOGICAL CONSULTANTS

Our file: 85-804B

November 9, 1991

Re: Geotechnical Review of Faro and Vangorda Pits

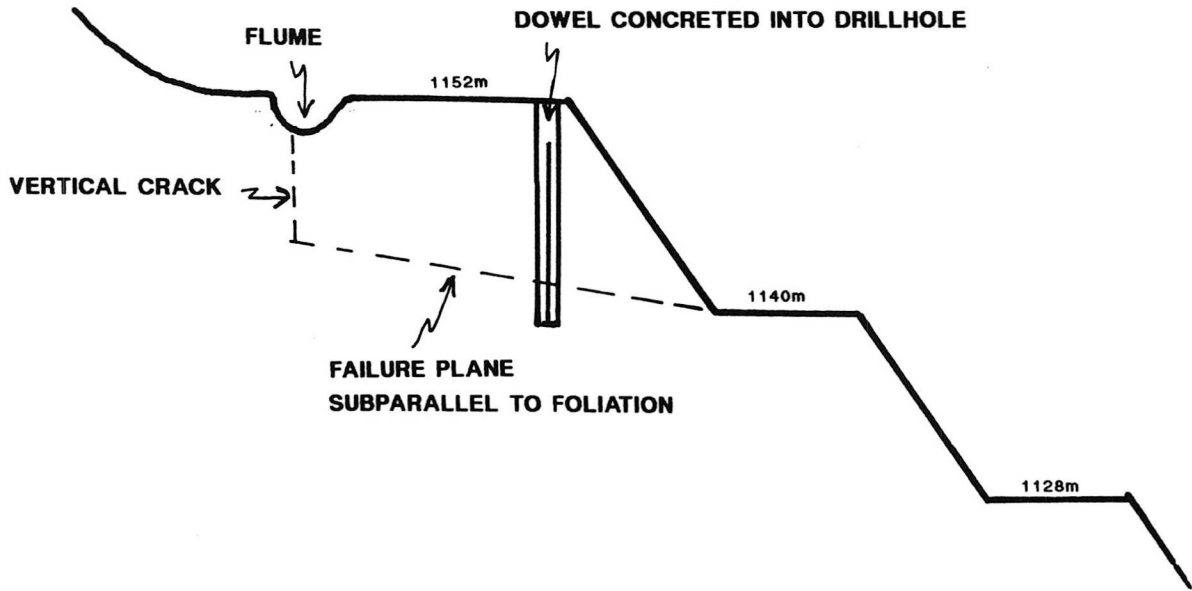
FIG. 1

For purposes of determining the lateral spacing of the dowels, it has been assumed that a failure plane could extend upward at a dip of 10° from the toe of the 12m bench below the flume (see Fig. 1). It is also assumed that a vertical crack could form the back scarp of the failure, and that this crack and the failure plane could be subject to water pressure due to leakage from the flume, and/or general groundwater seepage. Based on a lower bound estimate of shear strength equivalent to the dip of the failure plane, it is conservatively estimated that the lower bound factor of safety could be about 0.75. To increase the factor of safety to 1.5, additional shearing resistance equivalent to about 70 kips/ft of slope would be required.

While the specifications for the "95 lb" rails are unknown, it is assumed that the rails may have an ultimate shearing strength of about 80 kips/in² and a cross-sectional area of about 9 in². Assuming the concrete does not provide any shearing resistance, each dowel would have an ultimate capacity of about 720 kips of shearing resistance. Thus, the recommended lateral spacing between vertical rail dowels would be about 10 ft (i.e. 720 kips/70 kips per ft = 10.3 ft). Before beginning installation of the dowels, it is very important that the actual shearing strength and cross-sectional area of the dowels be determined. If they are different than the parameters assumed above, a revised dowel spacing must be calculated.

As it is apparent that some movement has taken place along the cracks in the area in question, and as further movement along these or other failure planes subparallel to foliation could jeopardize the integrity of the flume, it is recommended that remedial measures be taken to artificially support the bench on which the flume is located. Toward this end, it is recommended that the most practical method of artificially supporting the bench would be to concrete lengths of steel into vertical boreholes along the crest of the bench, such that they act as reinforcing dowels. It is understood that the mine can obtain 12m lengths of used "95 lb" railroad rails, and is able to concrete these rails into 10-5/8 inch diameter drillholes drilled by the blasthole drill. This drill rig is able to drill 15m deep holes.

With regard to installation of the row of dowels, it is recommended that they be installed within 2m of the crest of the slope. If possible, the bars should be approximately centred in the holes (possibly by spot welding two or three spacers on each end of the bar) before the concrete is poured into the hole. The dowels should be installed prior to blasting and excavating the rock from the bench below.
