July 13, 1987

RE: Mt. Skukum Gold Mine
Inspection of Tailings Ponds

This letter-report summarizes observations made during the June 15, 1987 site visit of the above mine. The purpose of the site visit was to examine the tailings facilities in detail for surface features which may be indicative of the probable future performance of these structures.

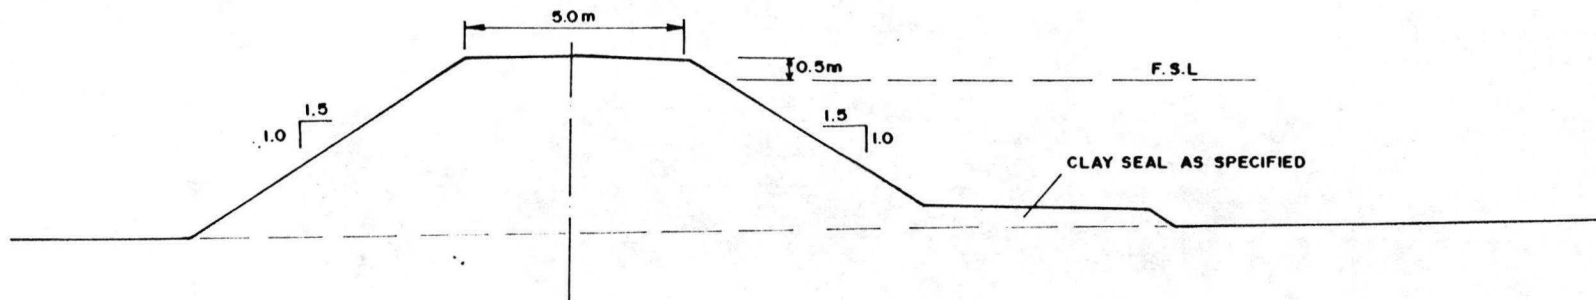
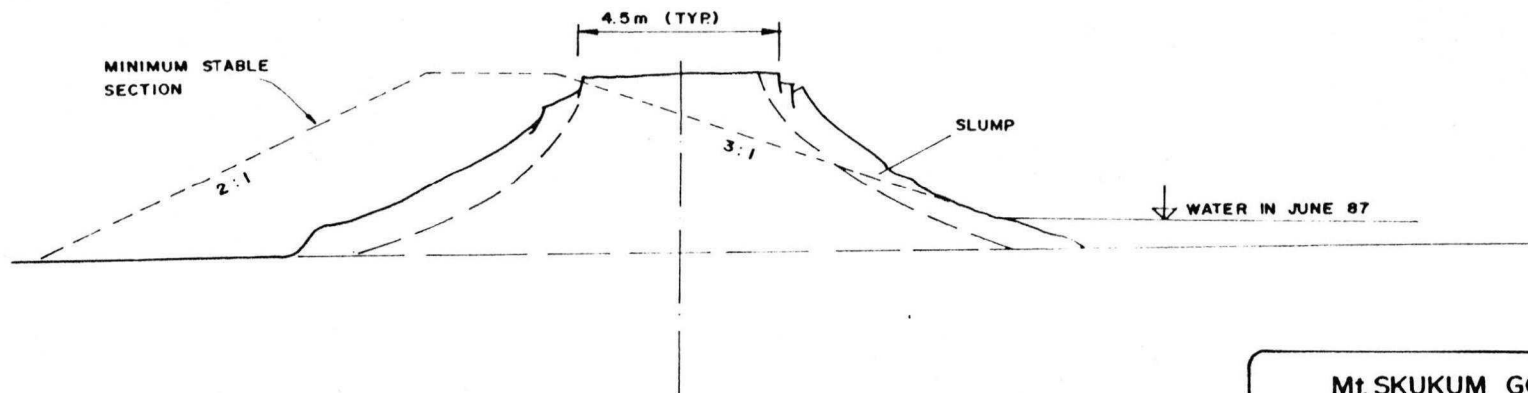
FIG. 1

- ° Dyke No. 1 (Figure 1) is approximately 300 m long and up to 5 m high. It will eventually impound tailings to elevation 989.5 m. The dyke crest is 5 m wide, the freeboard is 0.5 m and the dyke slopes were designed 1.5:1 (H:V).
- ° Dyke No. 3, approximately 100 m long and only 2 m high, is blocking a terrain depression at the northeast corner of the designated tailings pond area. The crest is 3 m wide and slopes are 1.5:1.

A schematic sketch of current dyke deformations is shown also on Figure 1 together with a dyke configuration which would meet the above guidelines.

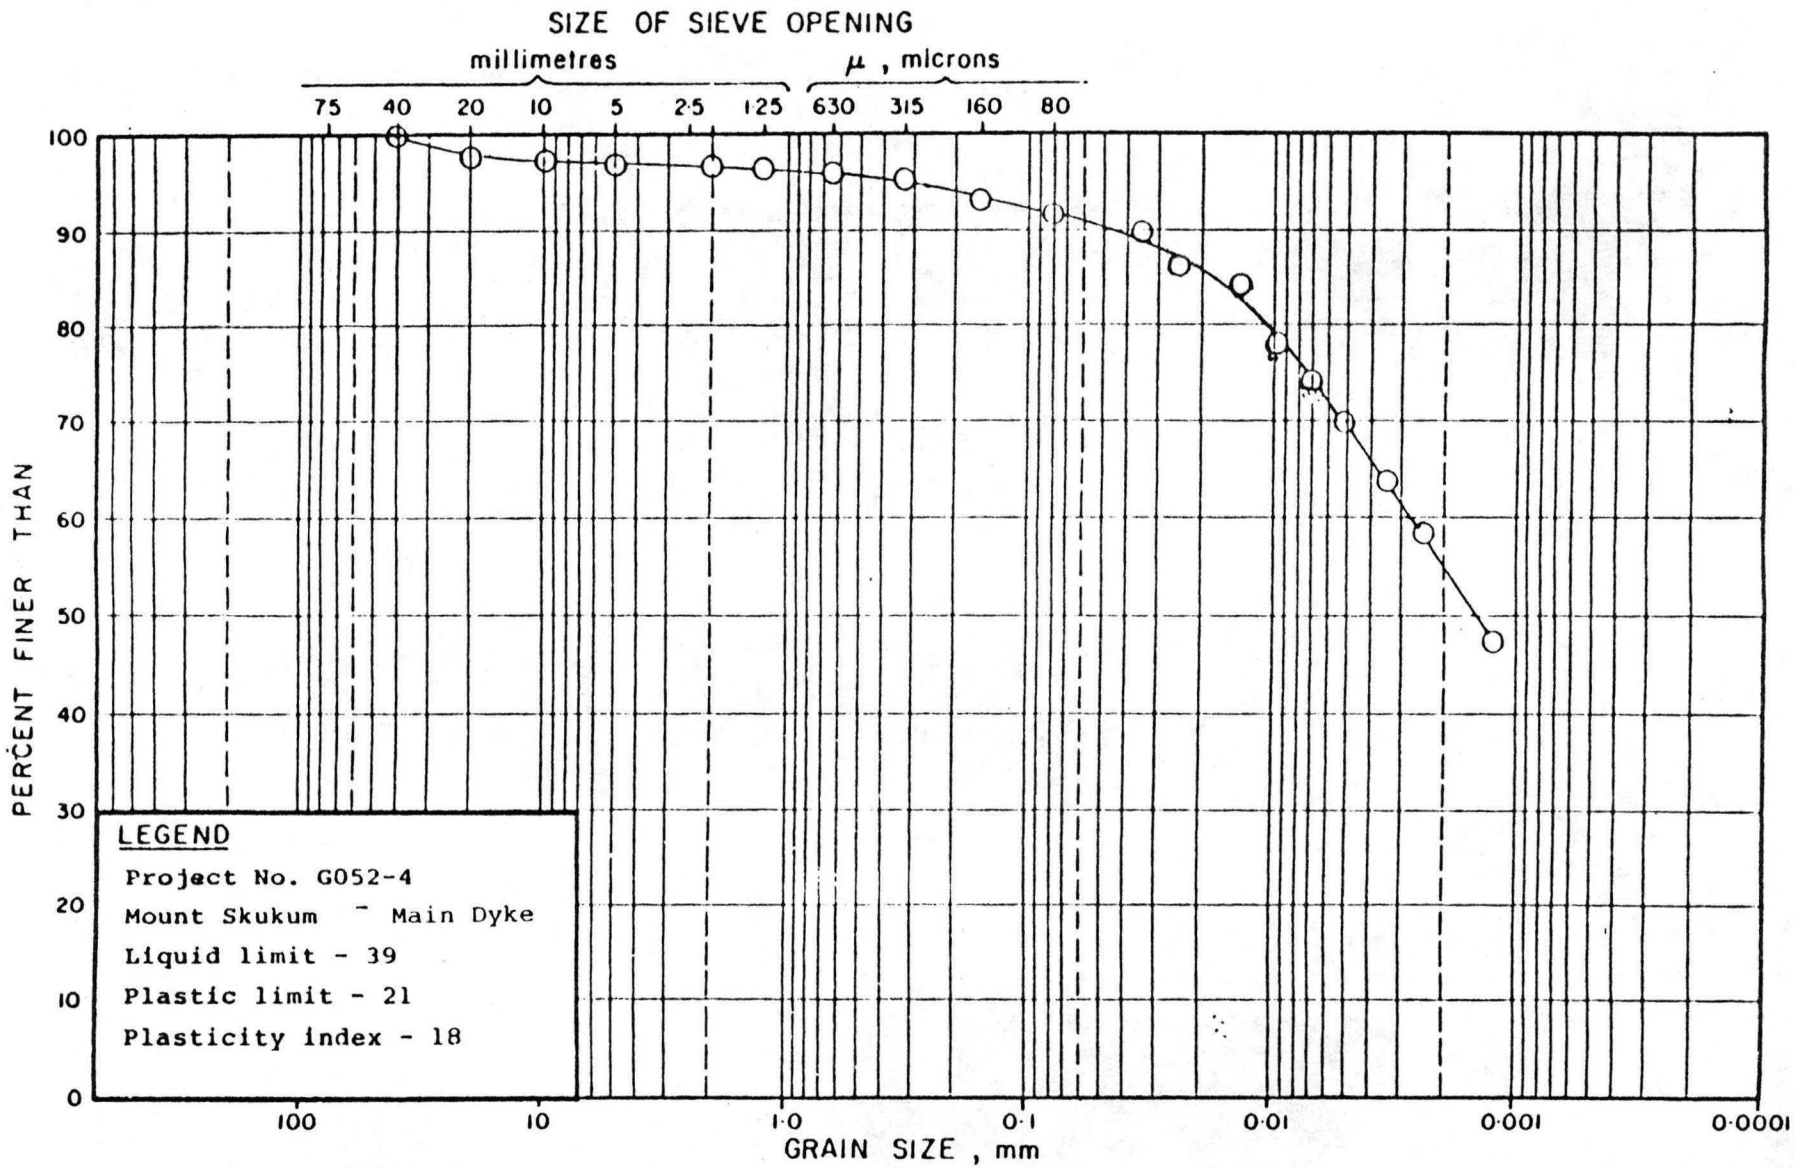
Figure 2

Visual examination of the dykes indicates that they were constructed using local lacustrine deposits, i.e. silts and clays. While silty clay may represent the dominant embankment material, pockets of powdery silt were identified as well. A typical sample obtained from the main dyke was analyzed and the results are shown (together with Atterberg Limits) on Figure 2. As a result, embankment fill is classified as "ML-CI", i.e. ranging from clayey silt of slight plasticity to silty clays of medium plasticity.

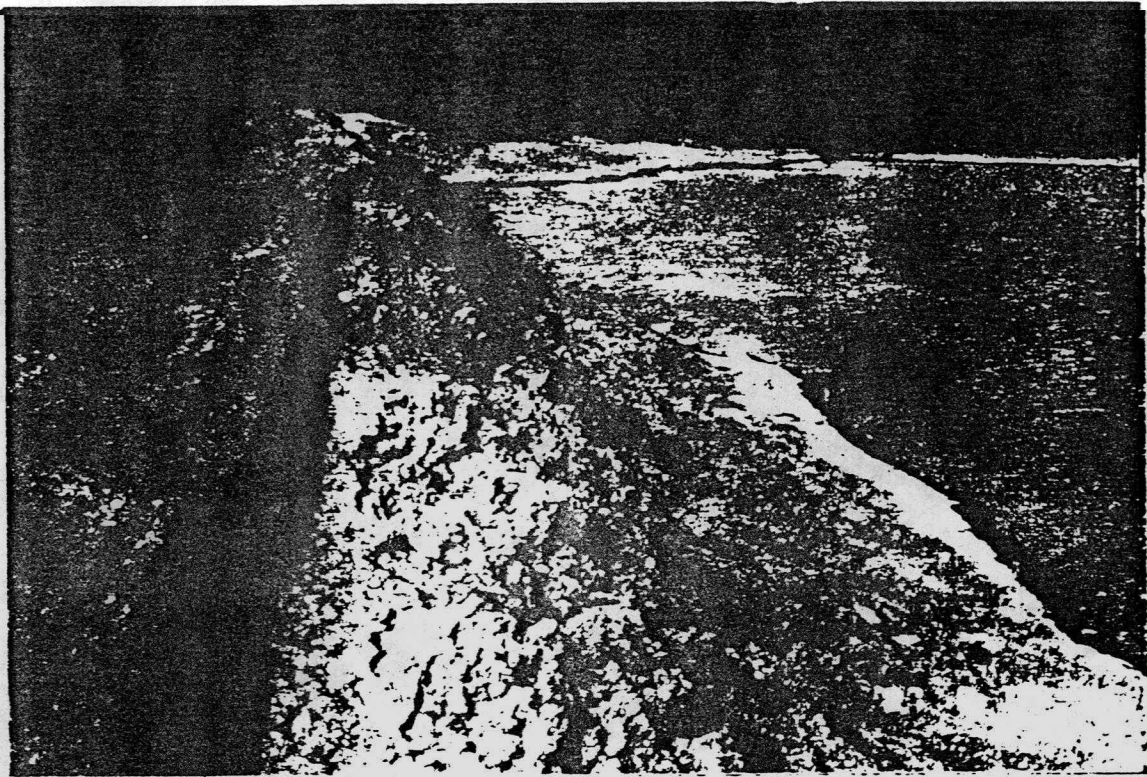
Fissures and cracks exist on the crest as well as on both dyke faces. Sloughing of saturated material affects the entire upstream side of the

dyke. The downstream toe is locally cracked and bulged, indicating slope and/or foundation failure (Photo Nos. 1 and 2).

It is therefore concluded that the dam Factor of Safety against sloughing is likely in the order of unity.

Photo 1: Main dyke, looking west. The instability of the upstream face is manifested by bulging toe and cracks at the crest.

- placement of additional fill on the downstream side of the dyke to compensate for the poor quality of the embankment fill and achieve a stable downstream slope;
- grading of the upstream dyke faces to achieve a more stable slope;
- placement of additional fill and grading of the dyke crests to achieve the designed grade;
- construction of properly armoured spillways;
- initiation of a regular monitoring program.

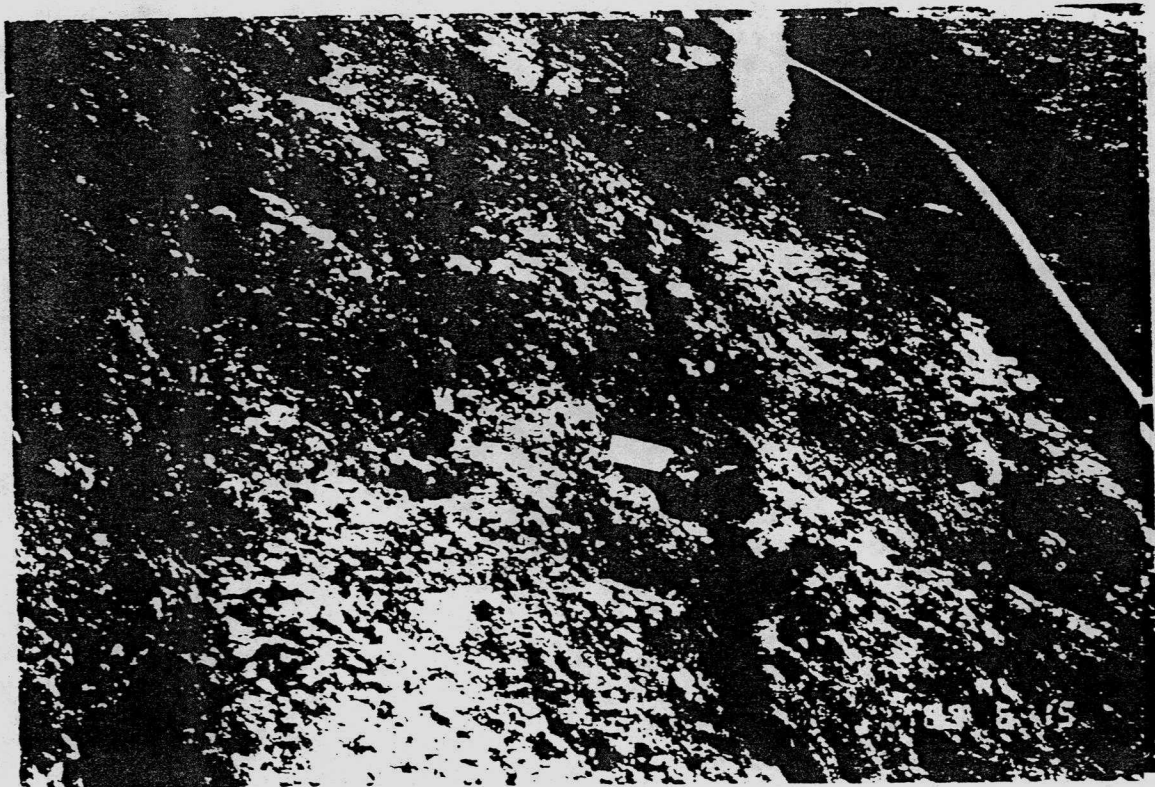
Photo 2: Cracks in the downstream face of the main dyke.

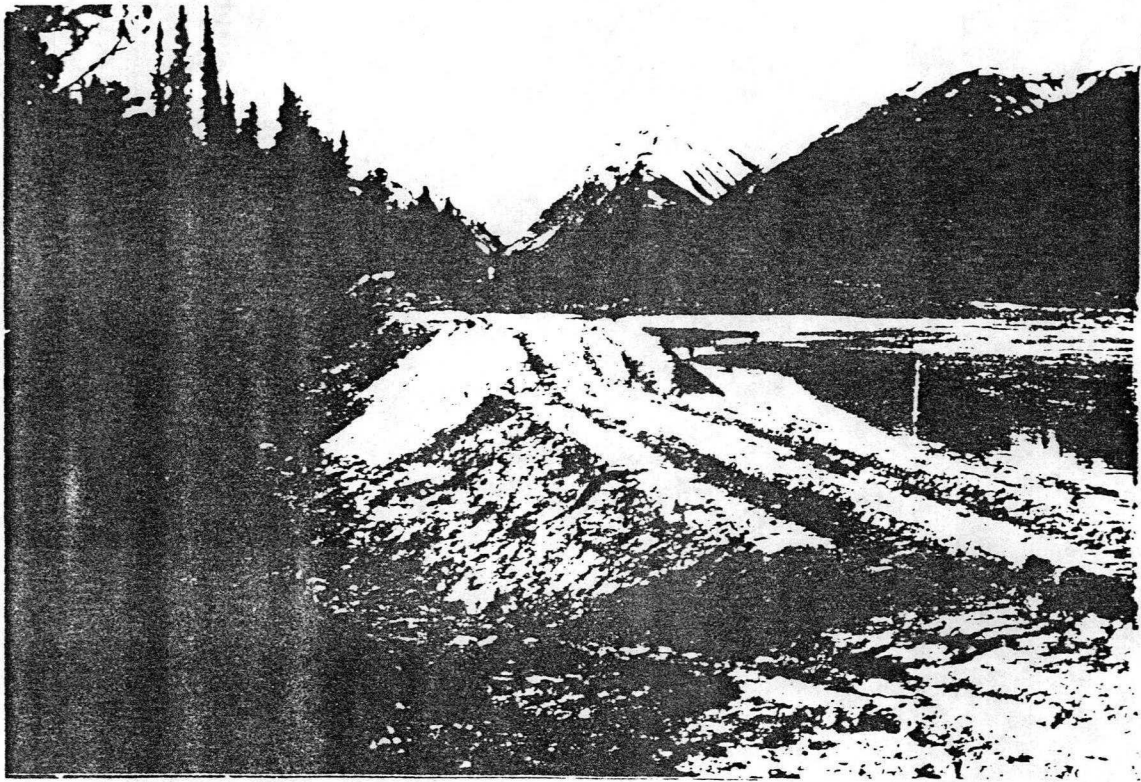
The dyke (Photo 3) was overtopped in 1986 and is currently under reconstruction. A powdery, dry, non-cohesive silt is used for the dyke without compaction (Photo 4). This type of fill should not be used because powdery silt is very difficult to compact and would readily pipe. The dyke slopes are 35 to 37 degrees steep, i.e. in excess of one safe slope gradient for this material.

Photo 3: Dyke No. 3 - looking south. Current construction procedure involves pushing and spreading of the fill material (comprising powdery silt) with dozer.

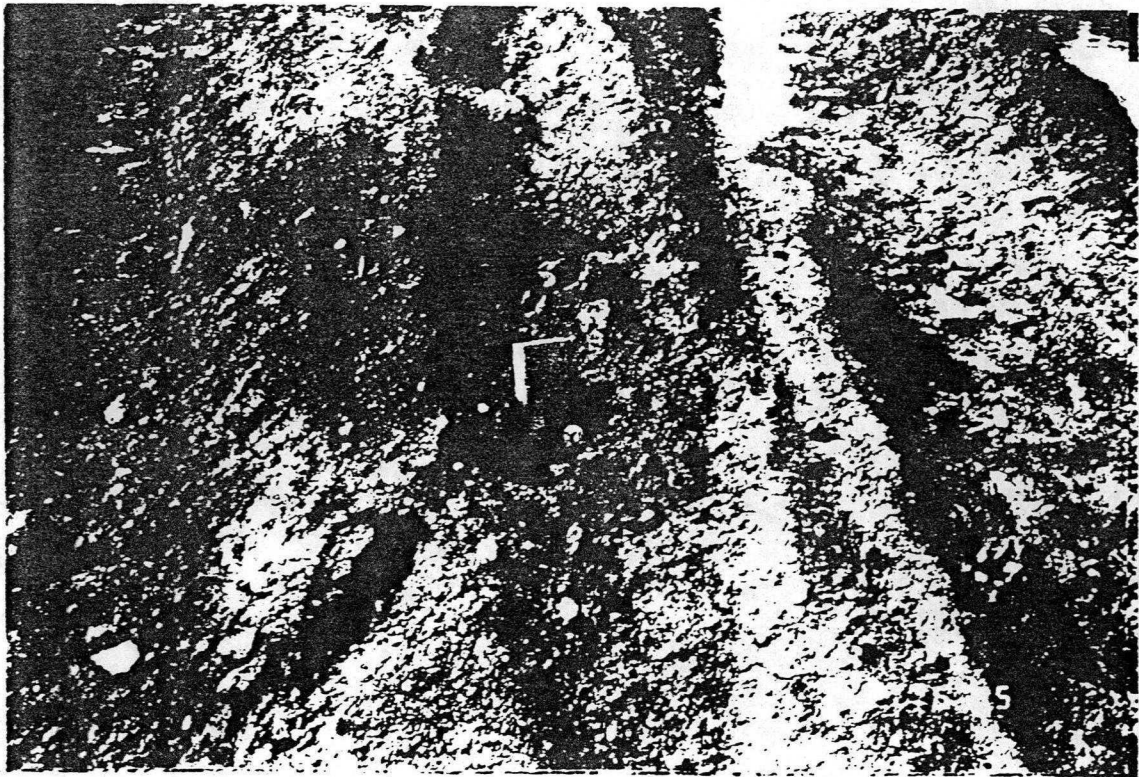
All dykes have been constructed as homogeneous embankments. While placement of material in compacted lifts was specified, the actual degree of compaction applied could not be established. In some areas, such as Dyke No. 3, the material was apparently dozed in without any benefit from compaction (Photo 4).

Photo 4: Uncompacted or poorly compacted silt is inherently unstable.

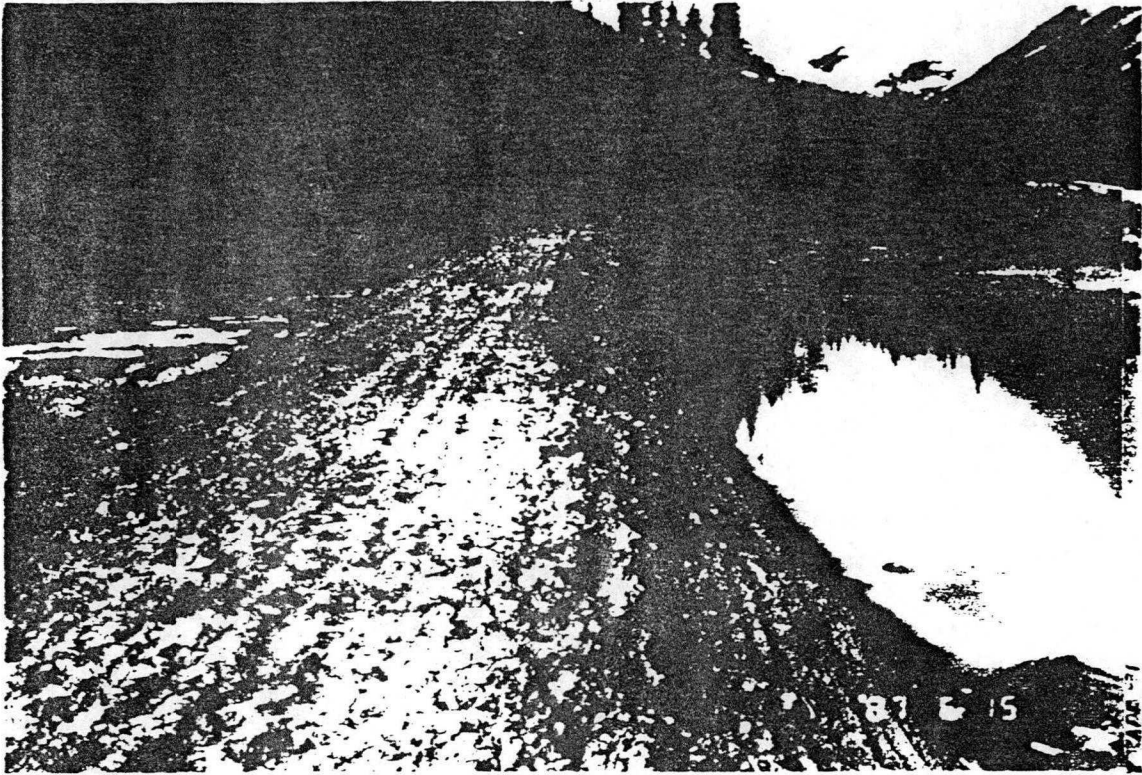
The dyke is comprised of clayey silt, similar to the material used for the main dyke. Its sideslopes are steep, approximately 1.5:1 (H:V), fissured and cracked. The overall stability of the dyke is marginal (Photo Nos. 5 and 6) and localized dyke sections are currently unstable.

Photo 5: Dyke No. 2 - looking west. Cracks at the crest are caused by the unstable upstream dam slope.

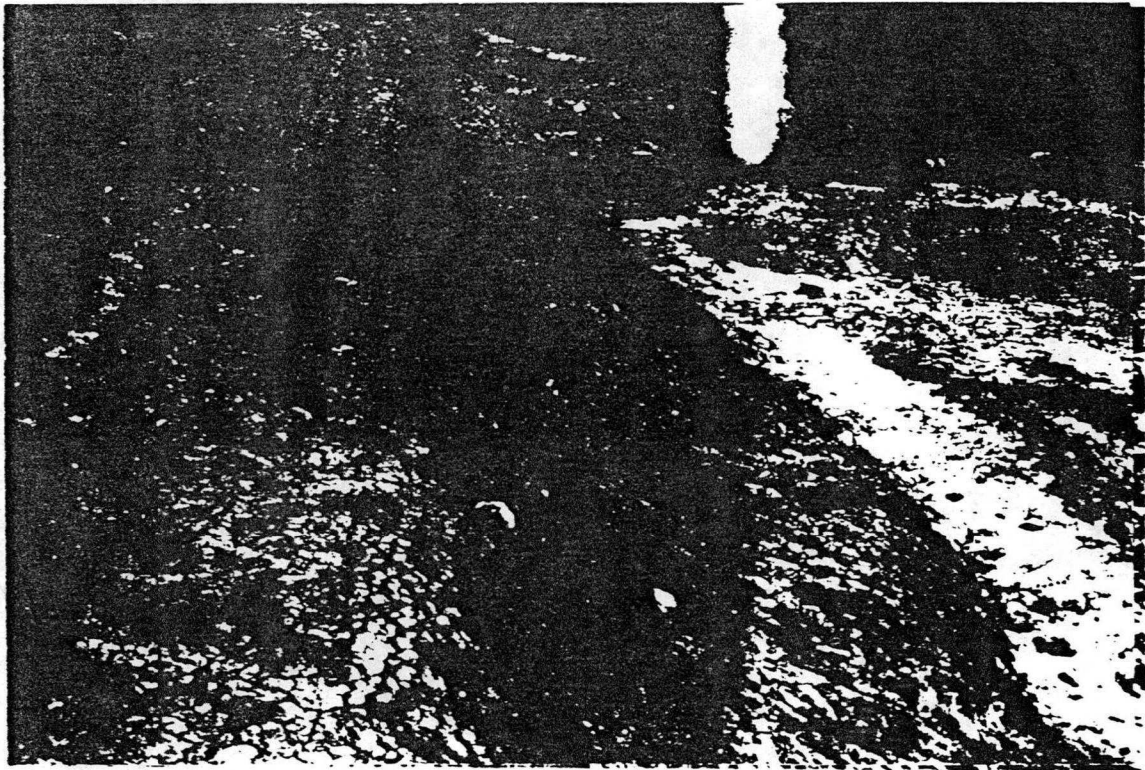
Photo 6: Slide on the downstream face of the auxillary pond dyke. White patches along the toe may be indicative of seepage.
