TAILINGS OXIDATION
PROJECT

SUBJECT
OBJET Tailings Oxidation Project

SECURITY - CLASSIFICATION - DE SÉCURITÉ
OUR FILE - N/RÉFÉRENCE
YOUR FILE - V/RÉFÉRENCE
DATE August 26, 1975

THE POTENTIAL FOR ACIDIC DRAINAGE IN ROSE CREEK
AS A RESULT OF THE BREAK OF THE ANVIL TAILING DAM

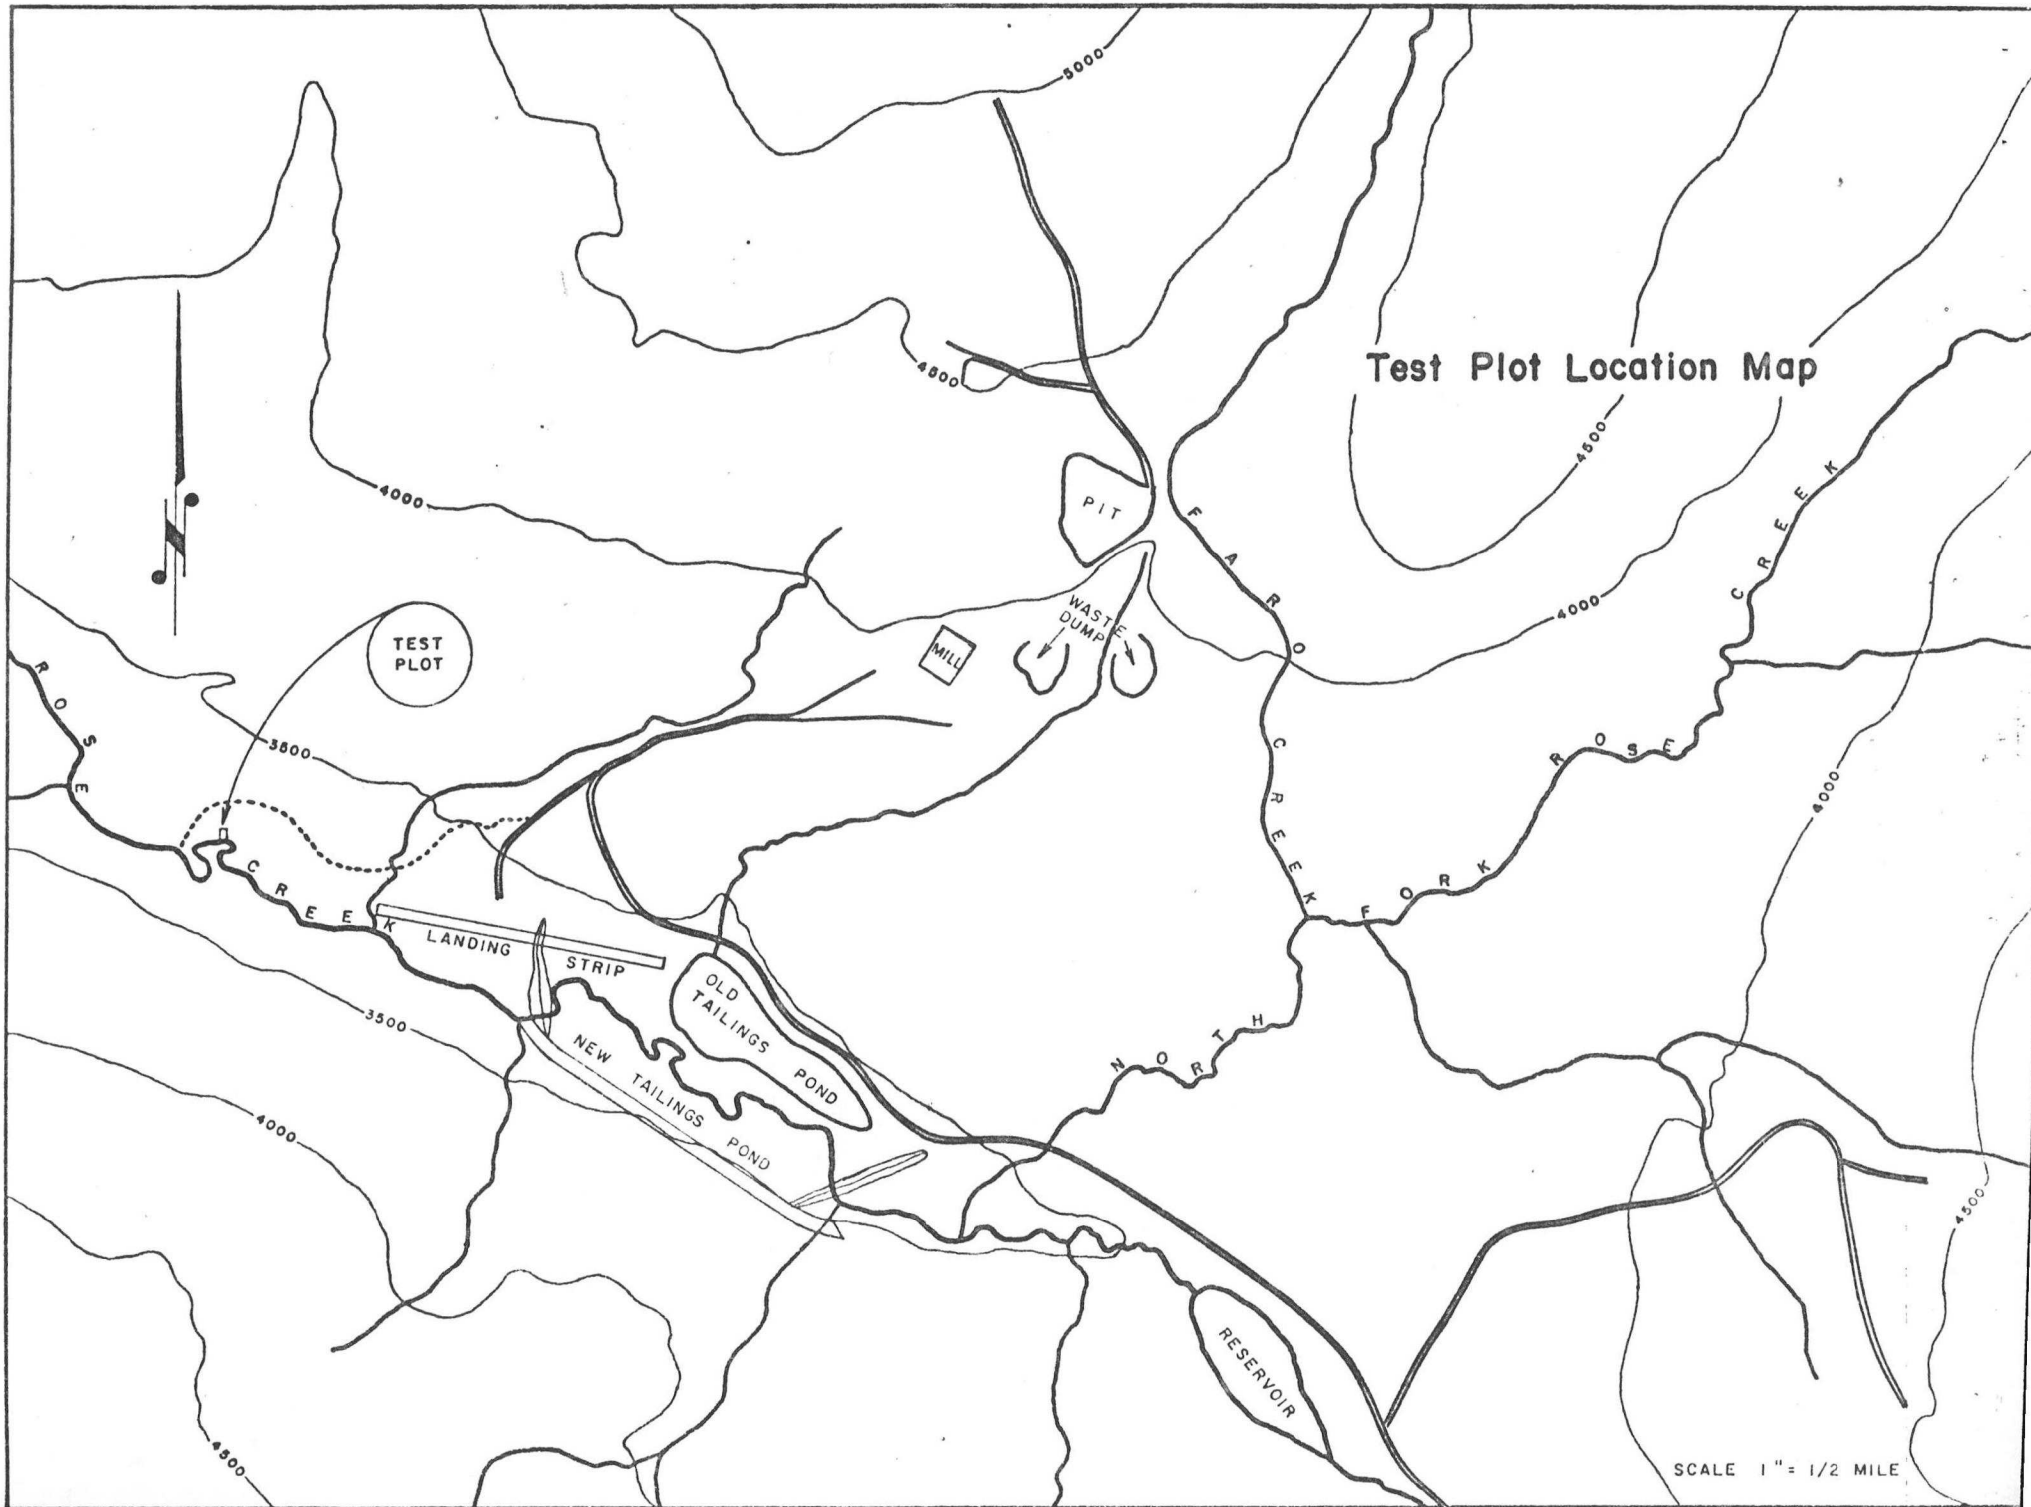
Test Plot Location Map

On August 5, 1975 a sampling grid of 100 feet by 140 feet was established approximately two miles below the dam break (fig.1). The grid was sampled at 20 foot intervals, a sample of tailings was taken and the depth of tailings measured. The pH of the tailings was determined using the 1:1 soil to water method for the determination of soil pH as described in the Standard Methods of Chemical Analysis.(2)

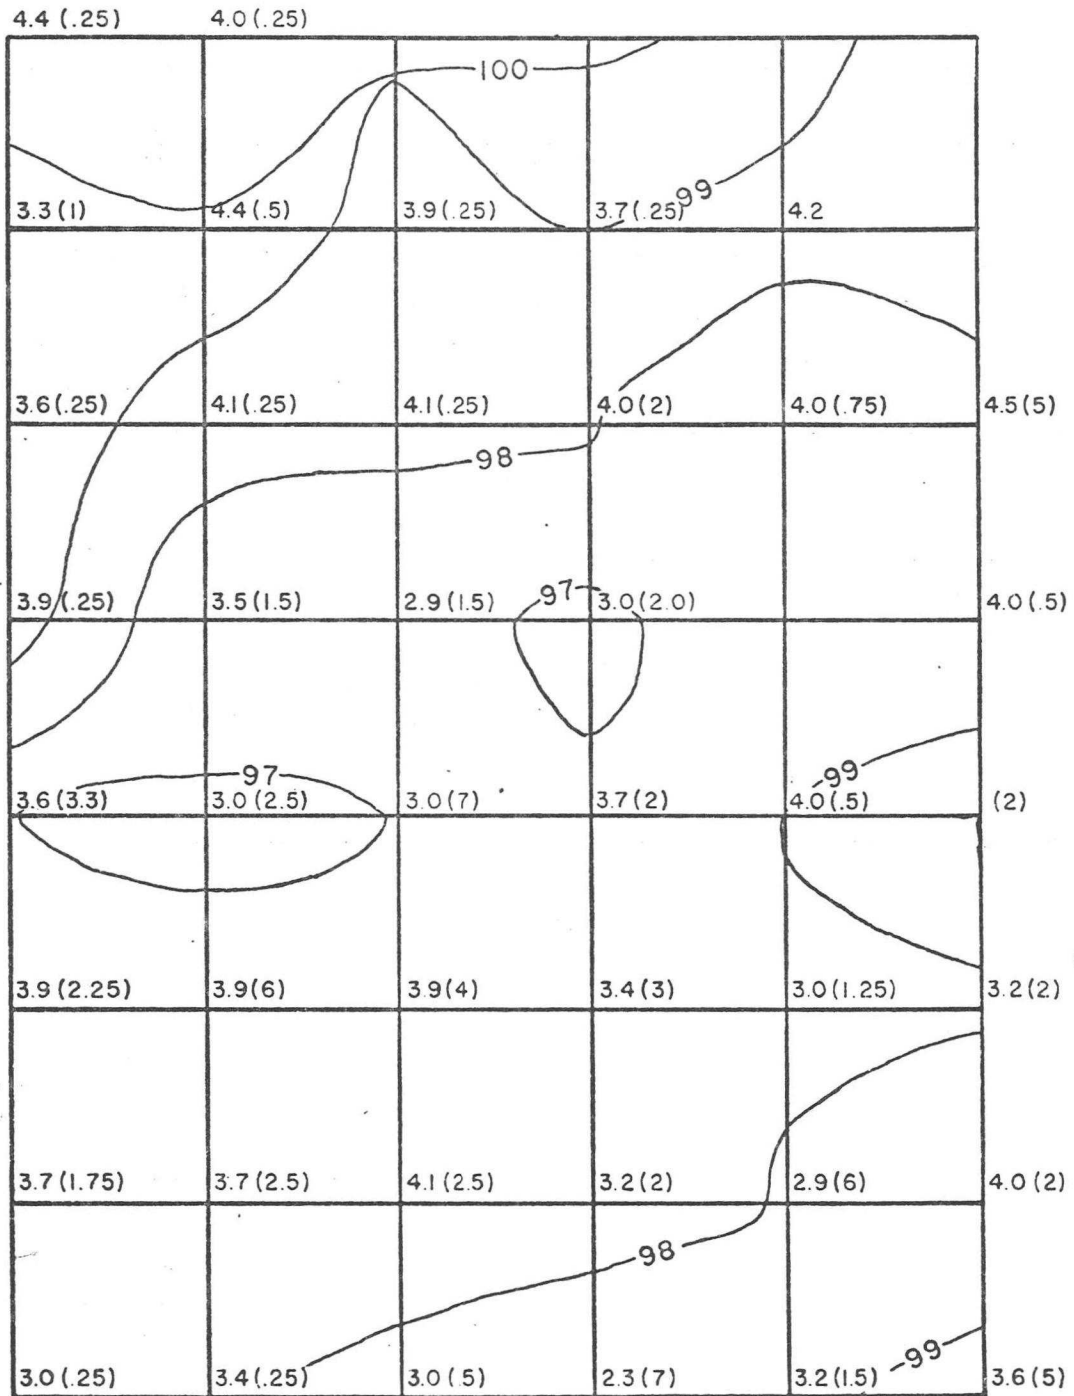
Average Depth of Tailings and Average PH

The average depth of tailings was 1.74 inches over the site ranging from trace to seven inches thick (figs 2 & 3). The average pH of the tailings was 3.64 with a low of 2.9 and a high of 4.5. There was no correlation between the depth of tailings and pH.
