**AQUIFER AND WELLHEAD PROTECTION PLAN
KLUANE FIRST NATION COMMUNITY WELLS**

BURWASH LANDING, YT

W23101003

June 2007

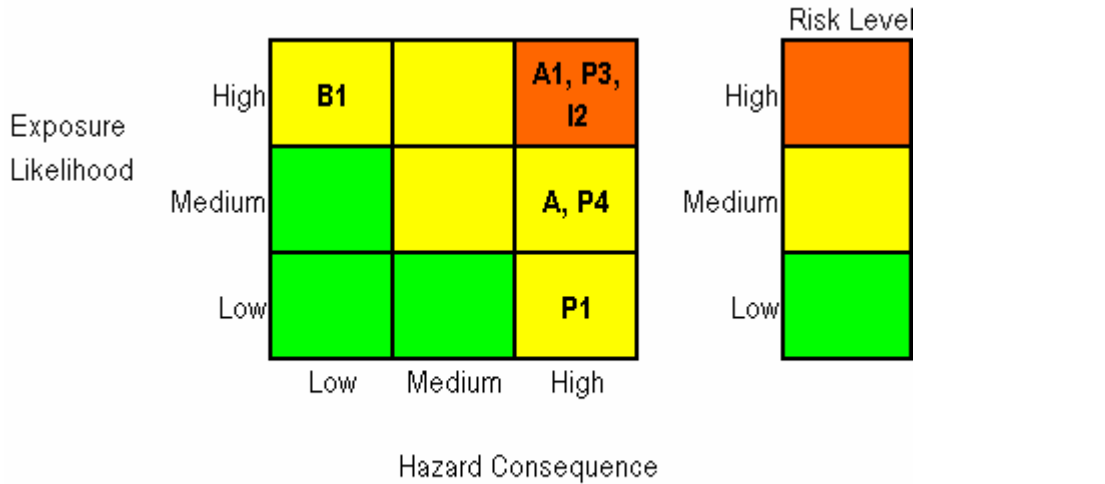
Figure 5a: Risk Matrix for KFN-F

The hazard scenarios identified in Table 2, attached, have been assessed using the above Risk Matrix. Figure 5, below, shows the risk posed by each potential hazard that is located within the Capture zones for each of the Community Wells and the two potential locations for the proposed Back-up Well. Based on the hazard location on the risk matrix, an overall risk of “low”, “medium”, “high”, or “very high” has been assigned to each hazard scenario.

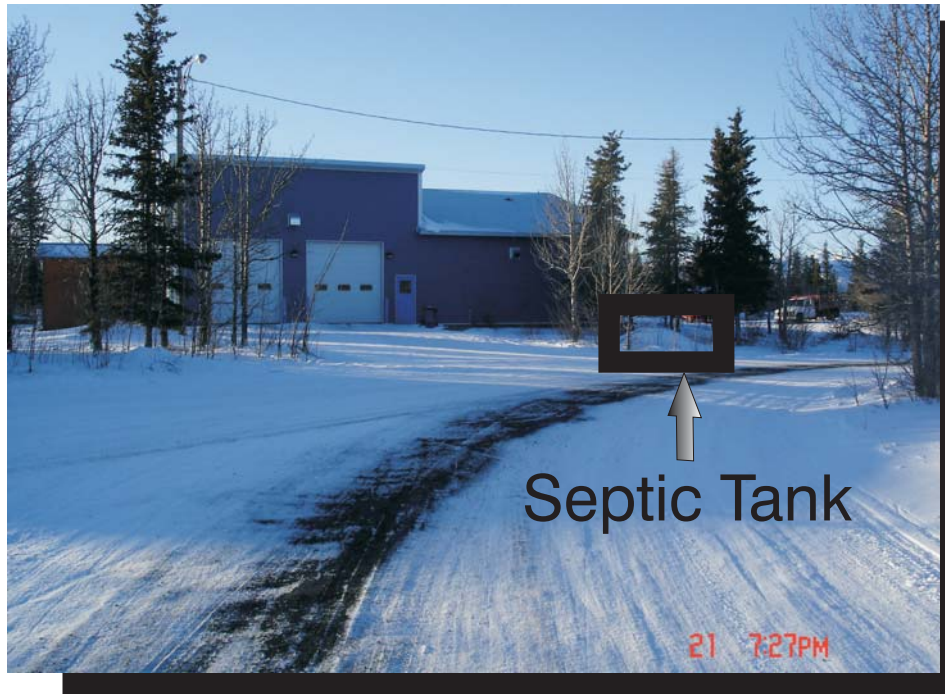
Photograph 1
Water Truck Garage; Septic tank located in front of Garage (March 21, 2007)

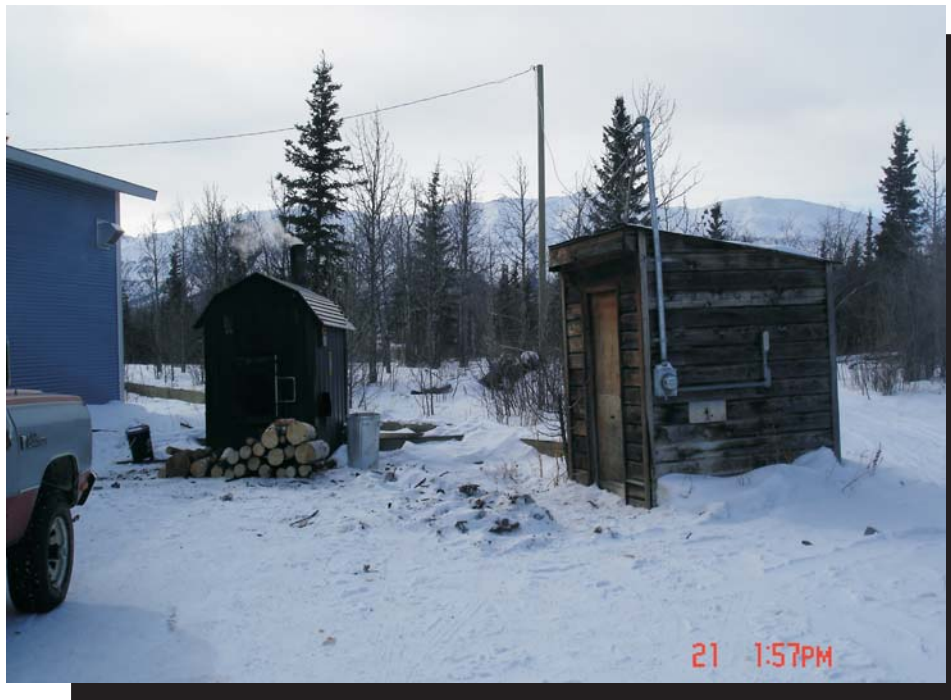
Photograph 2
Community Well KFN-F well enclosure (right) (March 21, 2007)

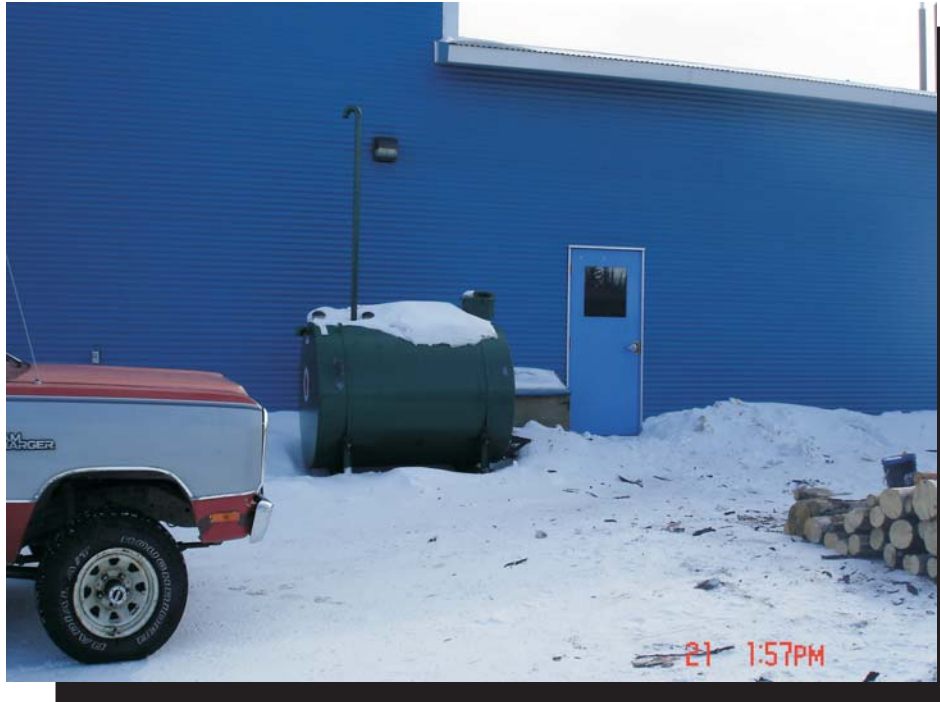
- The highest risks to the Community Well KFN-F and potential Back-up Well location MV-A were potential releases and spills from, or while filling or servicing the AST and the wood fired boiler systems near the Water Truck Garage;

Photograph 3
AST adjacent to Water Truck Garage and KFN-F (March 21, 2007)

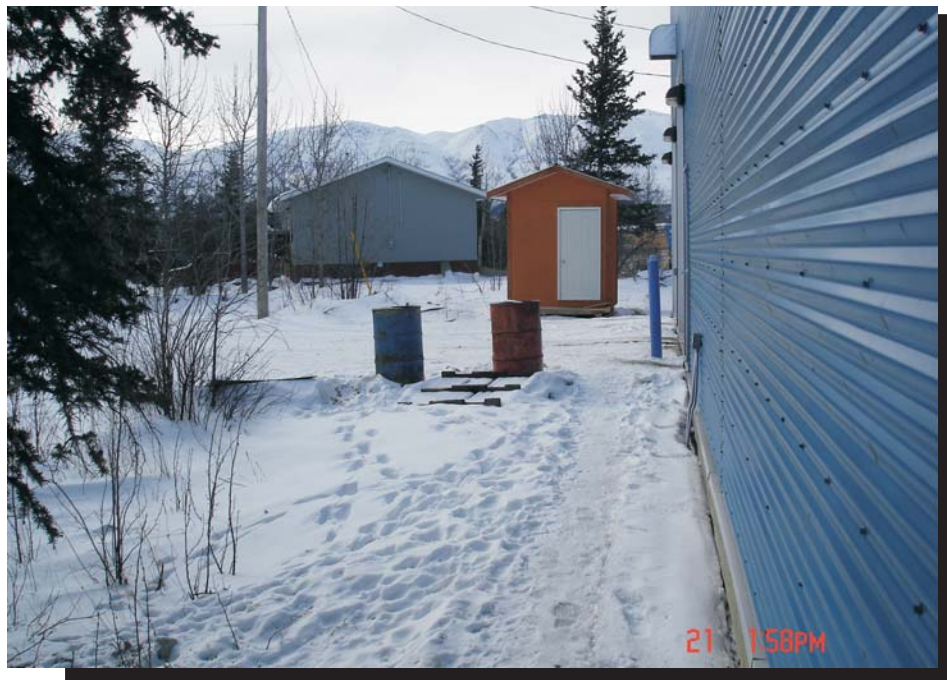
Photograph 4
200 L fuel drums adjacent to the west die of the Water Truck Garage; no secondary containment. (March 21, 2007)

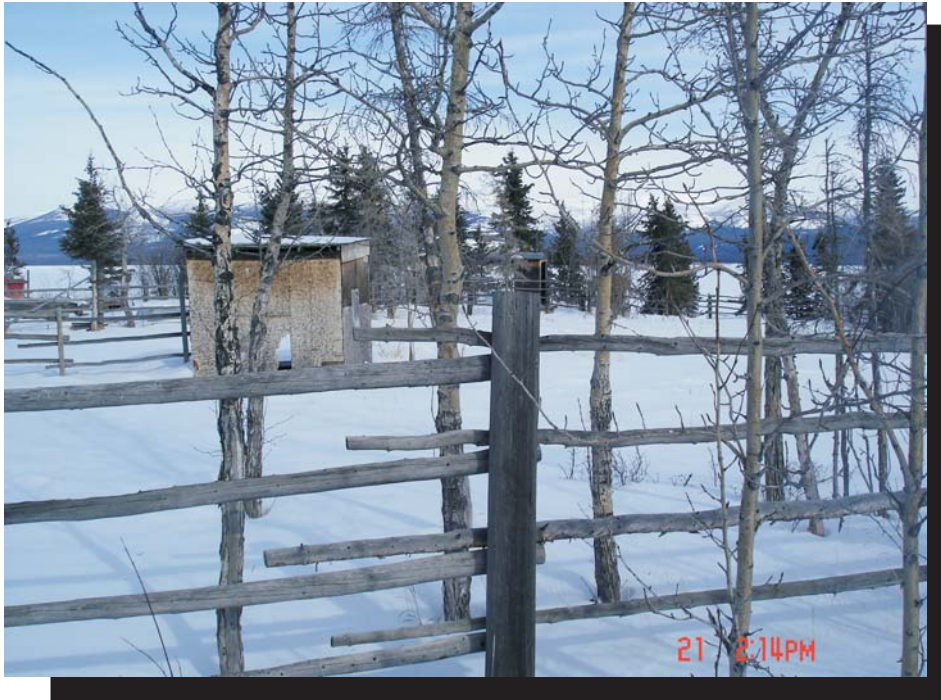
Photograph 5

The potential location for the Back-up Well MV-B should be considered carefully based on the proximity of the livestock pen. The livestock pen is considered a high hazard due to the storage of animal manure piles located within zone 1 and 2 of this potential well. Leachate from manure piles contains pathogens and viruses that can be dangerous to human health. If site MV-B is to be considered a potential area for the Back-up Well, it is recommended that the livestock pen be re-located.

Livestock pen located to the west and within the capture zone of MV-B (March 21, 2007)

- Endorse and promote hazardous waste minimization and collection programs;
- Relocate the Livestock Pen if a Back-up Well is considered for location MV-B;

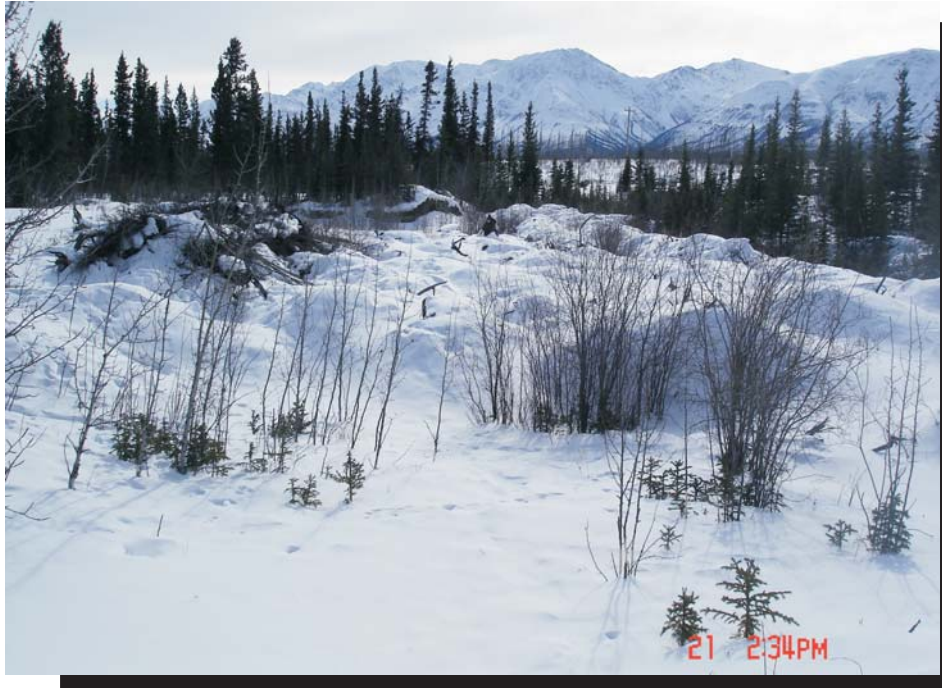
Photograph 6

It is important to note that although no solid waste sites were observed within the capture zones of the Community Wells and Proposed New Wells, numerous solid waste sites were identified in previous reports and from anecdotal information obtained during the site meeting. It was reported by KFN that in the past, it was common practice to dig a pit in the vicinity of a dwelling and deposit the refuse from that dwelling into the pit¹. The locations of such pits are unknown and do present a potential source of contamination.

Former solid waste dump located on the west end of Burwash Landing (March 21, 2007)

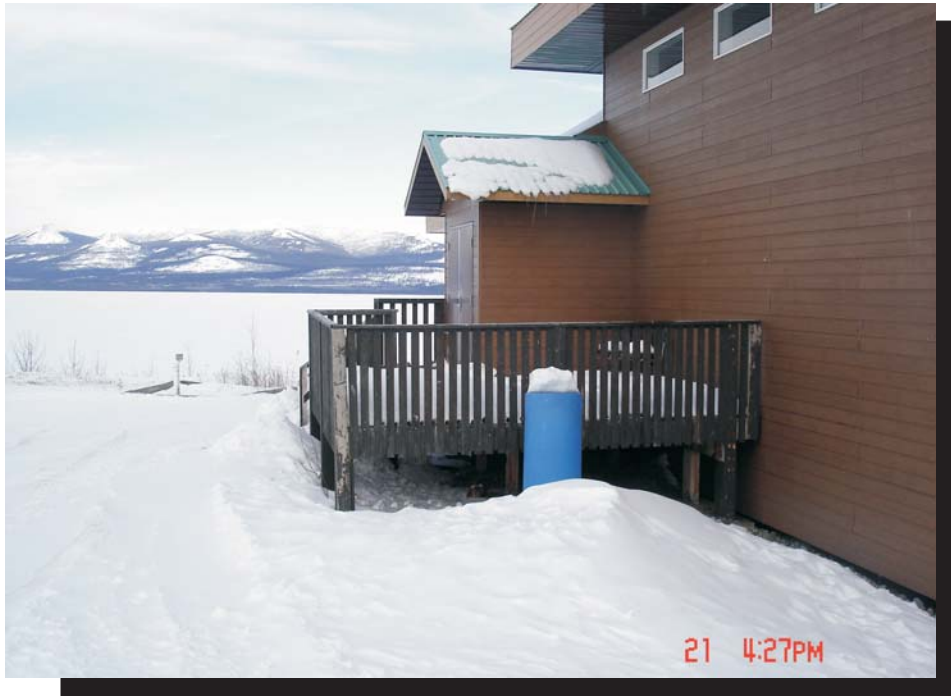
Photograph 7
Community Well KFN-C (March 21, 2007)

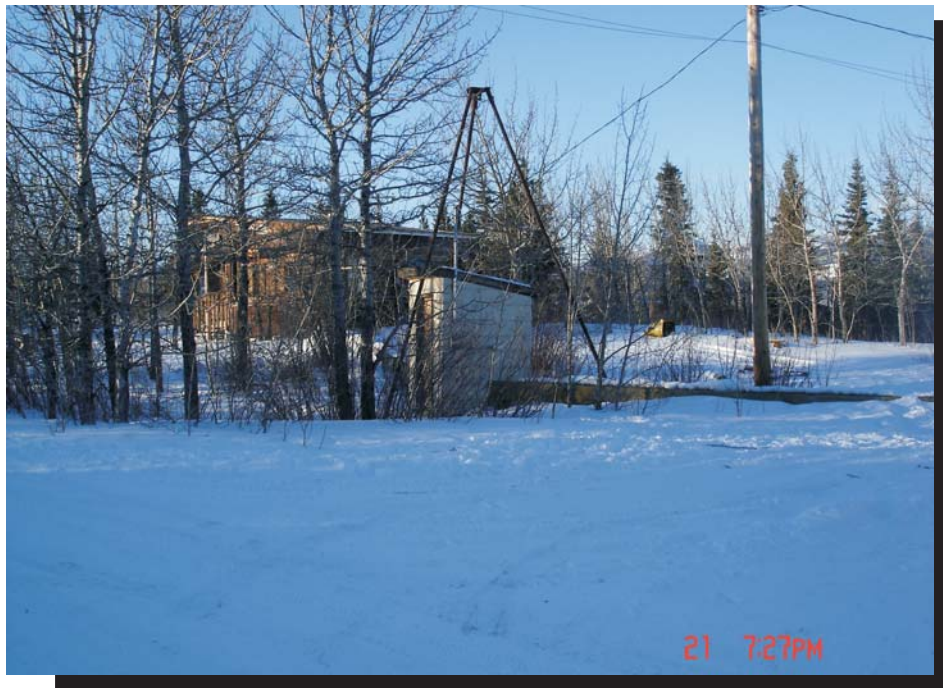
Photograph 8
Community Well KFN-G (March 21, 2007)

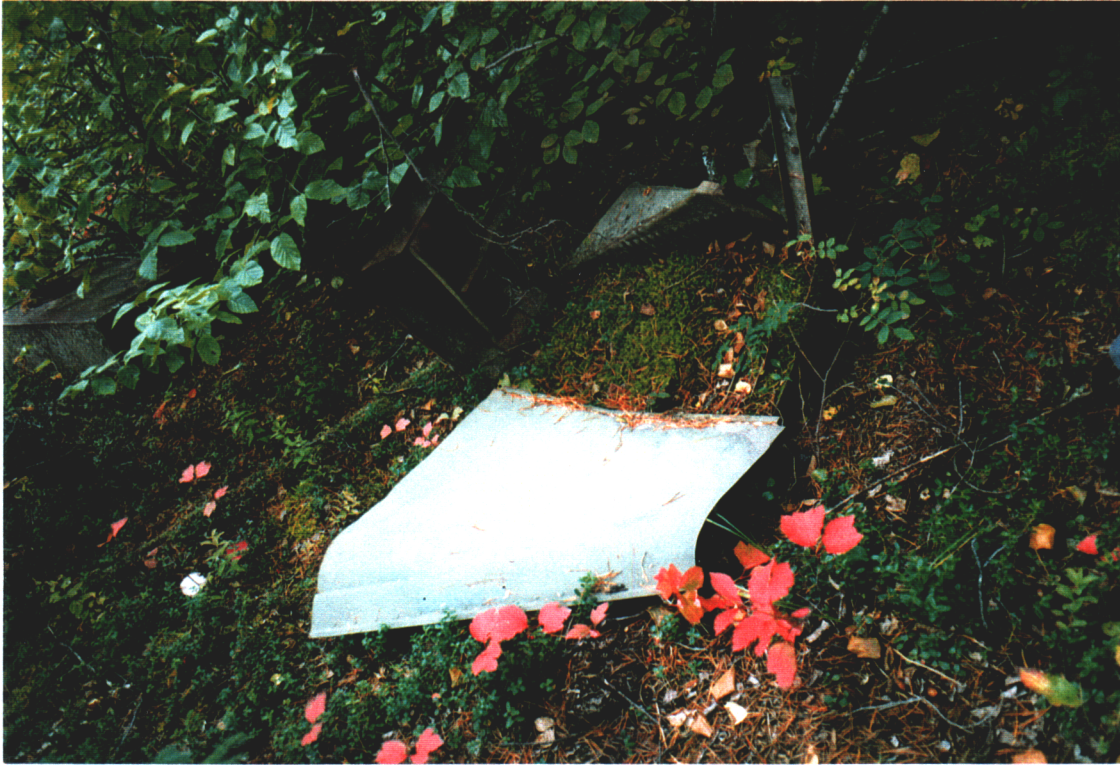
PLATE I1- WWII garbage dump, over embankment along east side of pond.

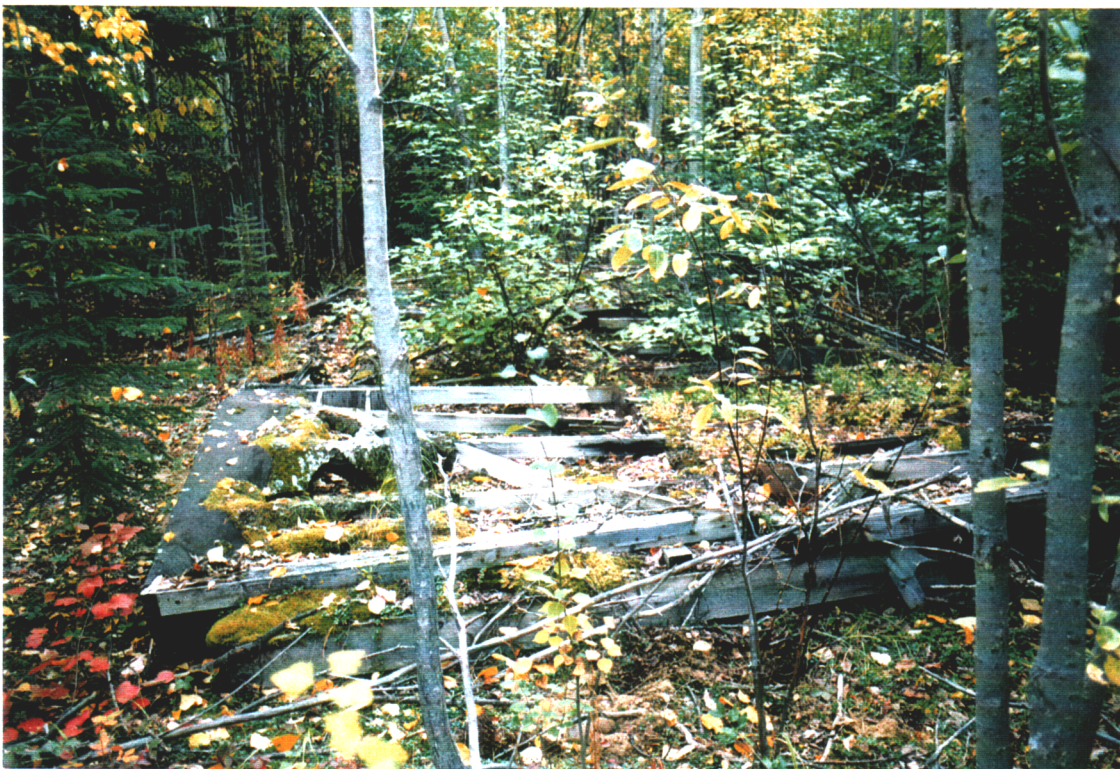
PLATE I2 - One of only two remaining collapsed army construction site buildings.

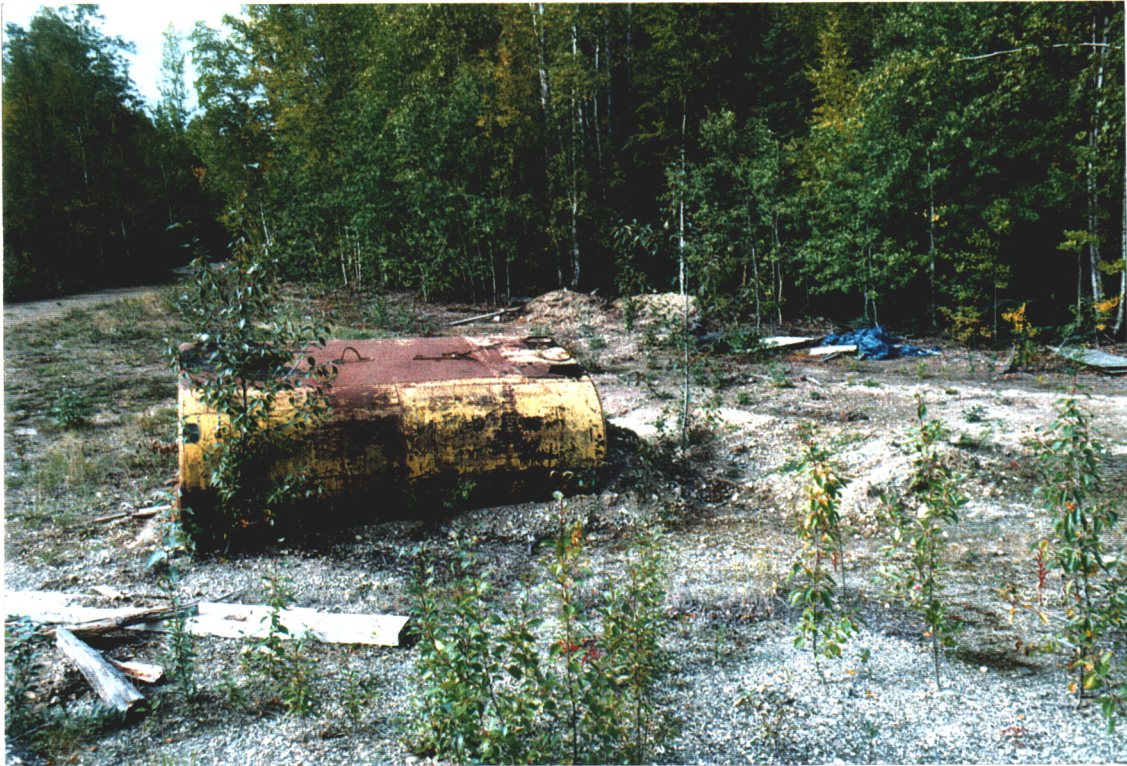
PLATE I3 - Tar tank disposed in clearing south of camp. Typical of junked equipment in the cleared area.

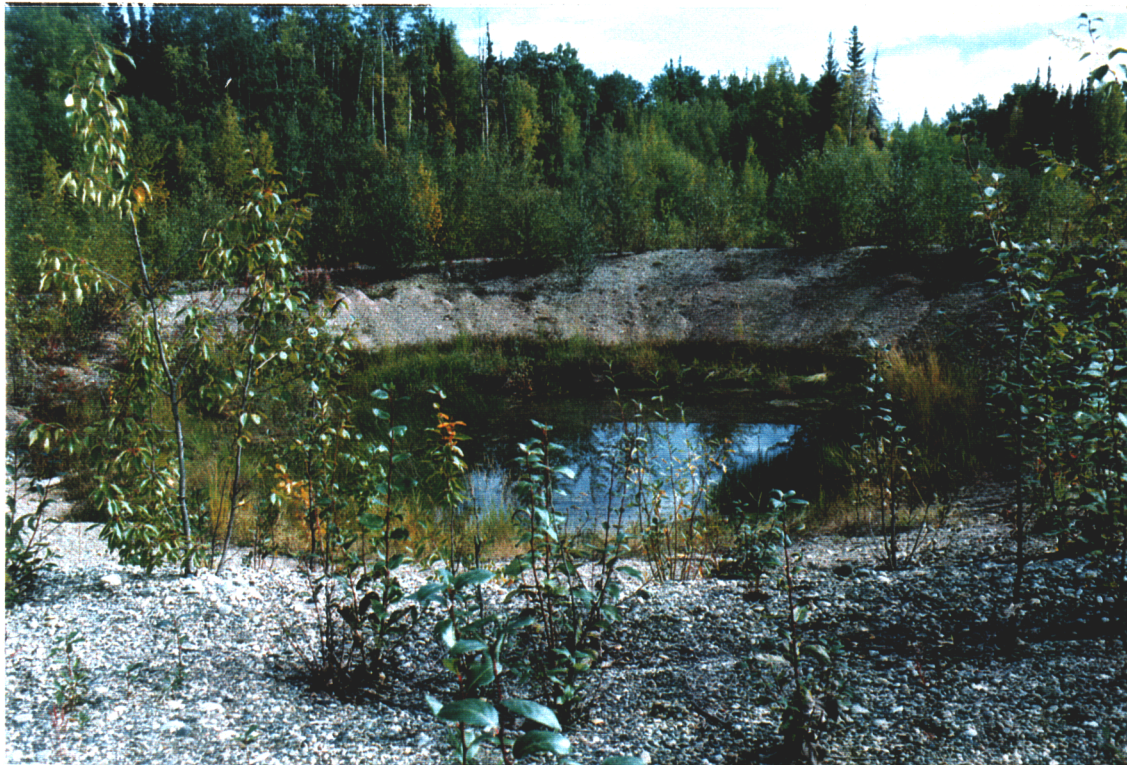
PLATE I4 - Unused sewage disposal pit in clearing south of camp. According to local residents, the pit was never used.

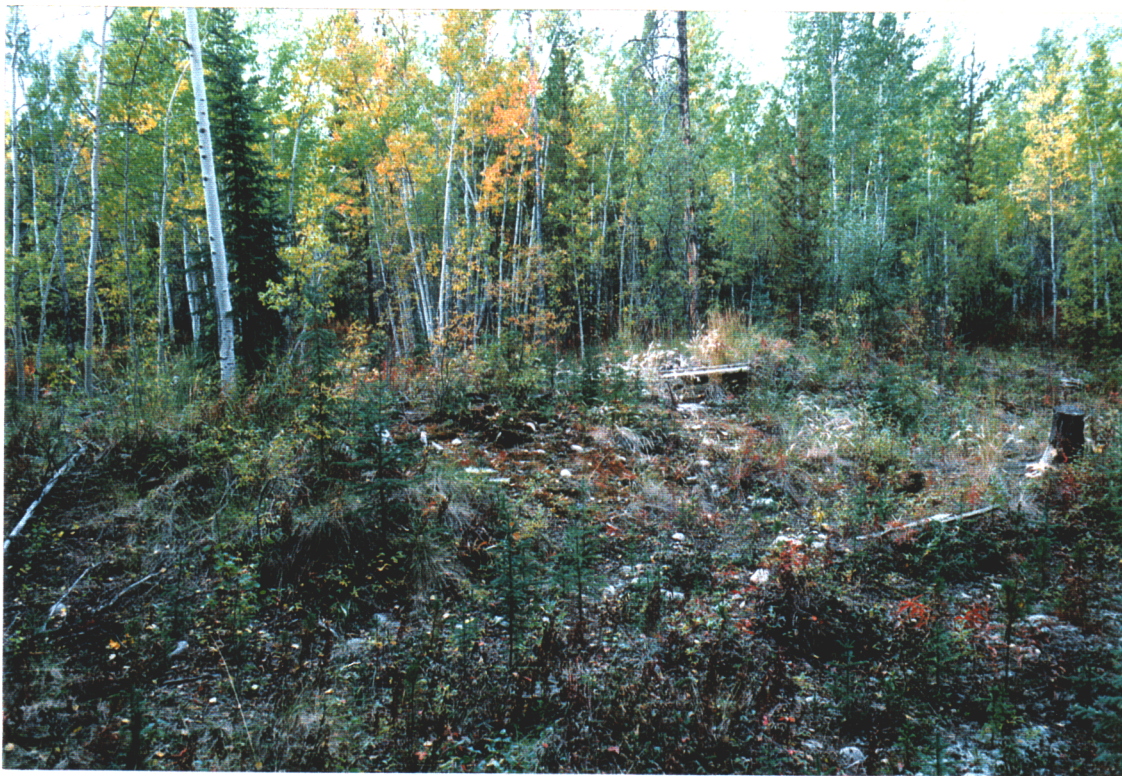
PLATE R2 - Power house site. Hydrocarbons detected in backfill material.

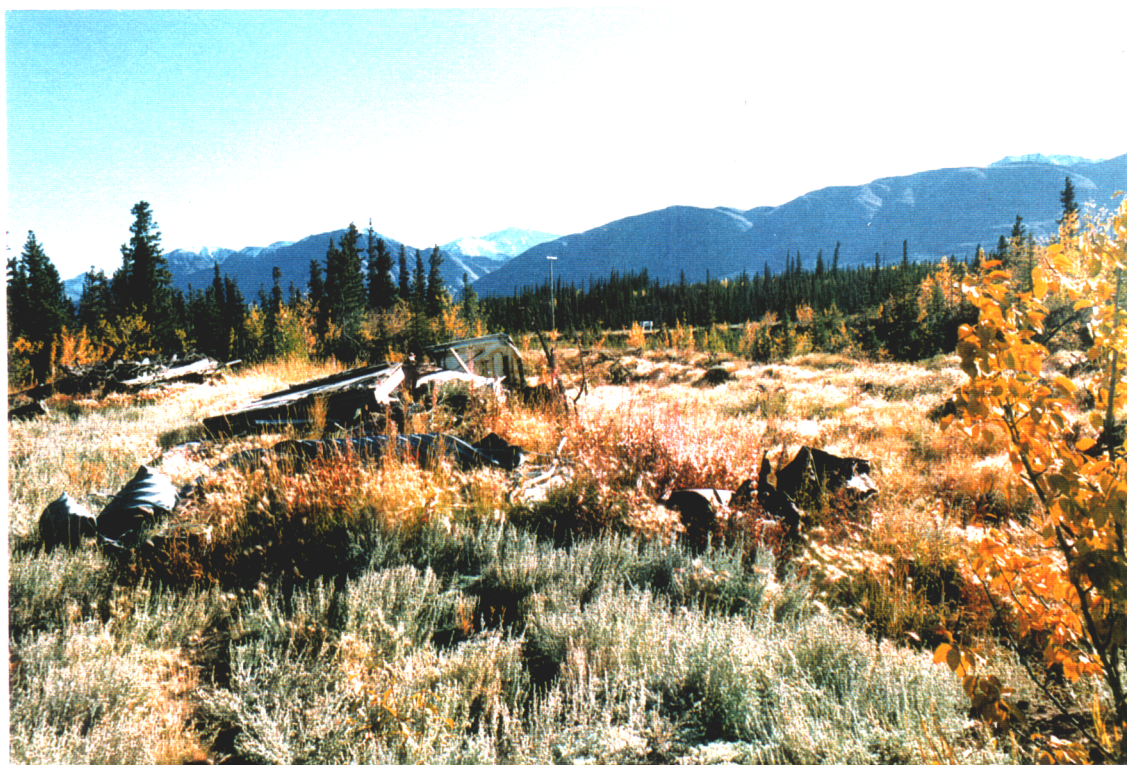
PLATE B2 - Looking south along edge of old dump at remaining metal waste.

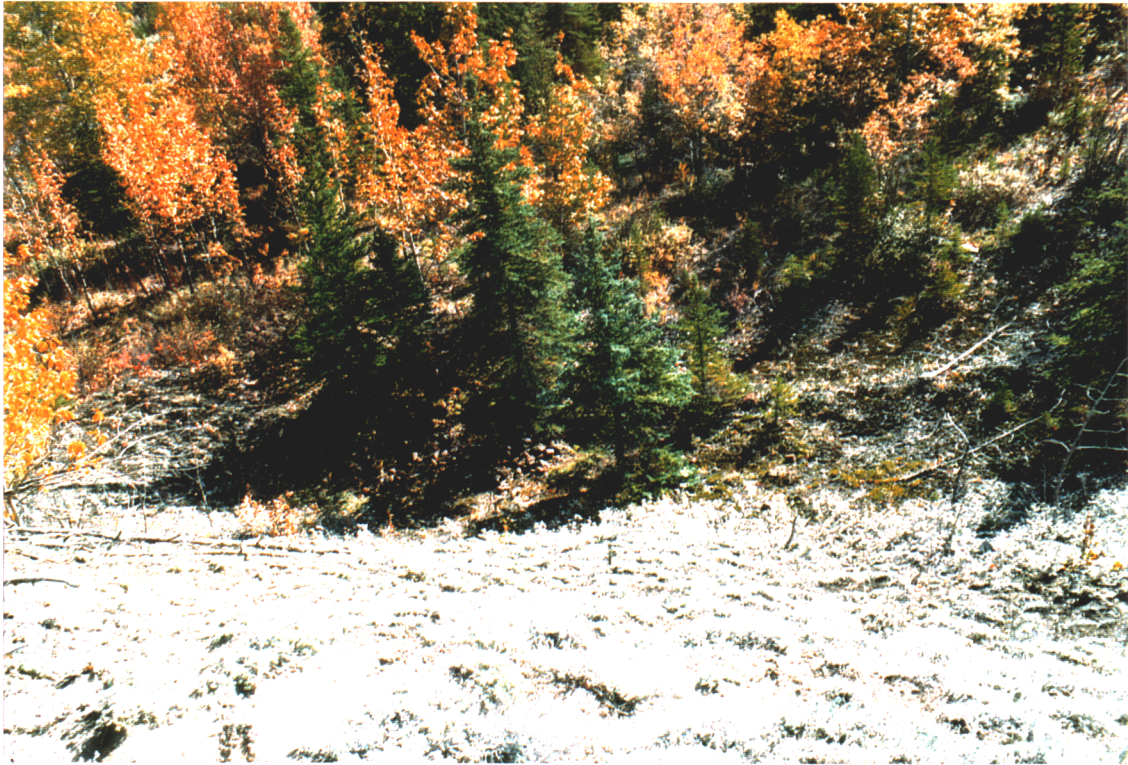
PLATE S1 - Looking down on casual garbage dating to road construction.

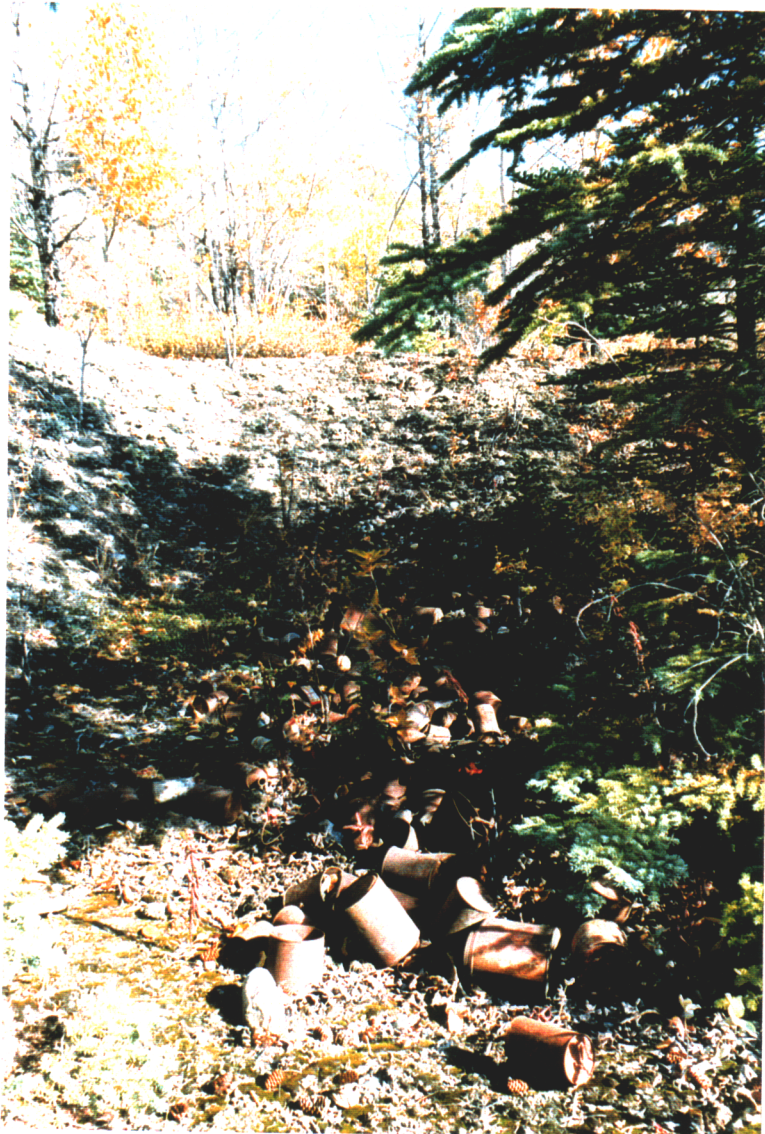
PLATE S2 - Typical of old construction era dumps along road embankment.

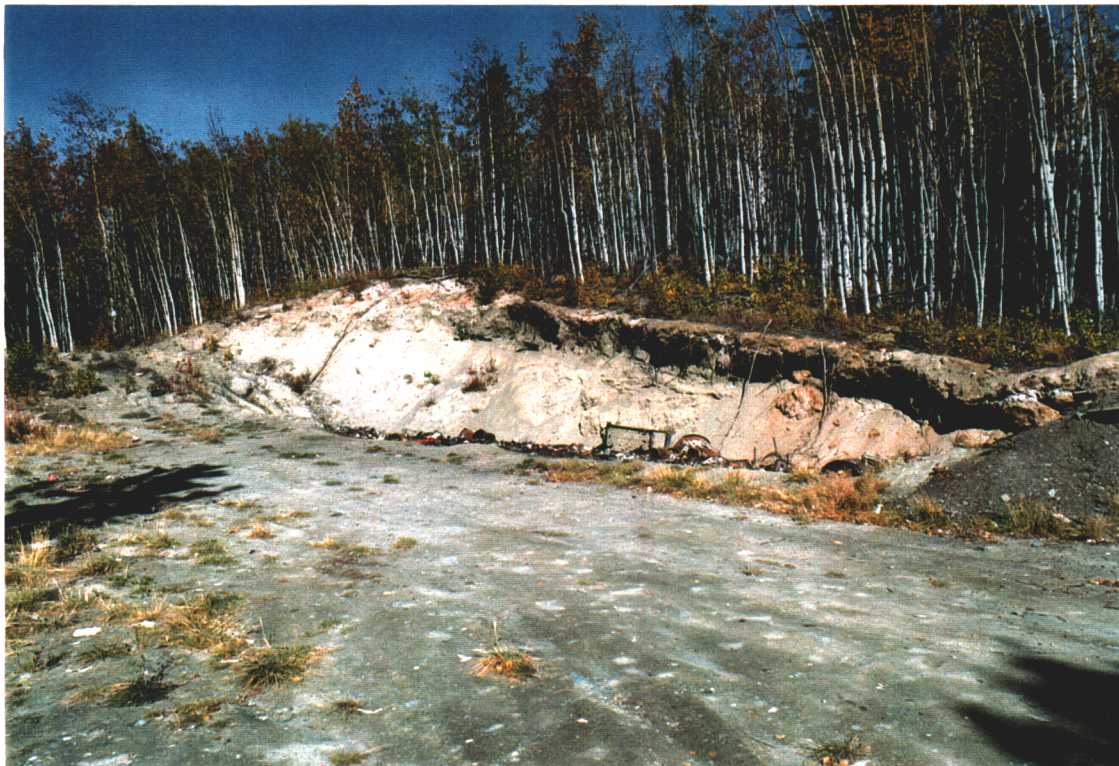
PLATE S5- Garbage dump currently in use.

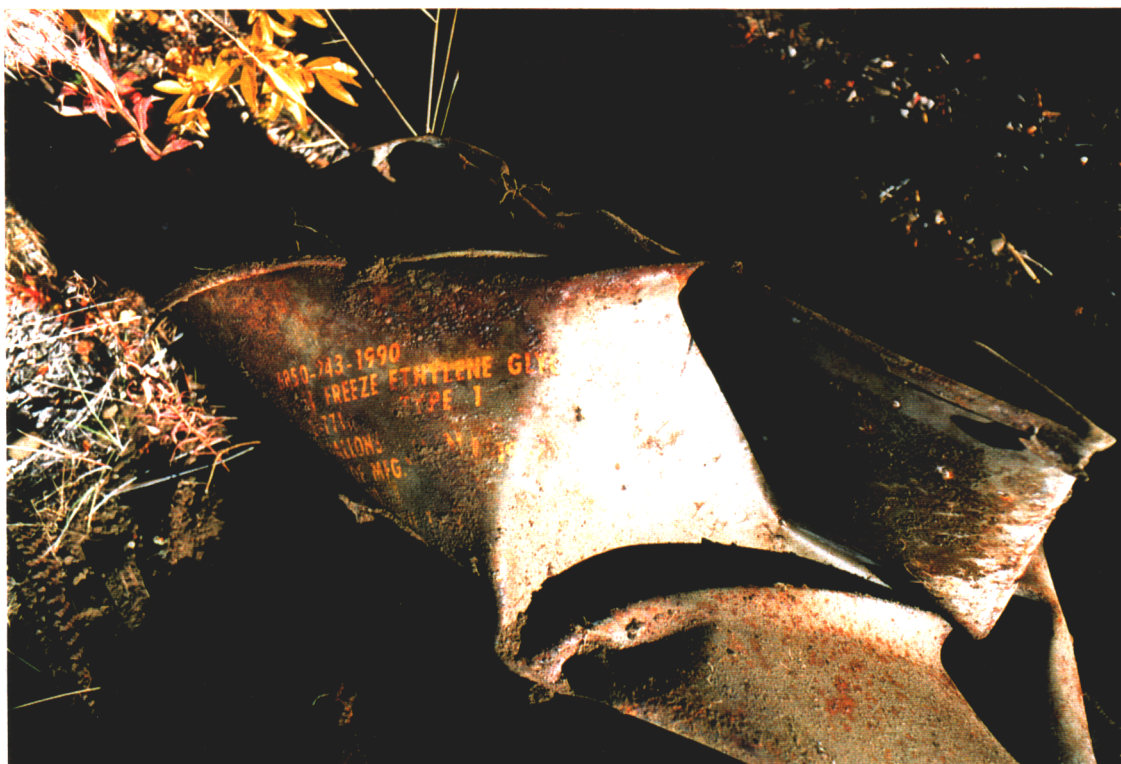
PLATE S6 - U.S. Military container dated 1957, near surface in TPS-2.
