AIRPHOTO INTERPRETATION OF  
GRANULAR MATERIAL SOURCES FROM  
MP 1150 to 1220 (KP 1850 to 1963 approx)  
ALASKA HIGHWAY  
FEBRUARY 16, 1988

GR-01-030

Re: Airphoto Interpretation of Granular Material Sources  
MP 1150 - 1220 (KP 1850 - 1963 approx.)  
Alaska Highway

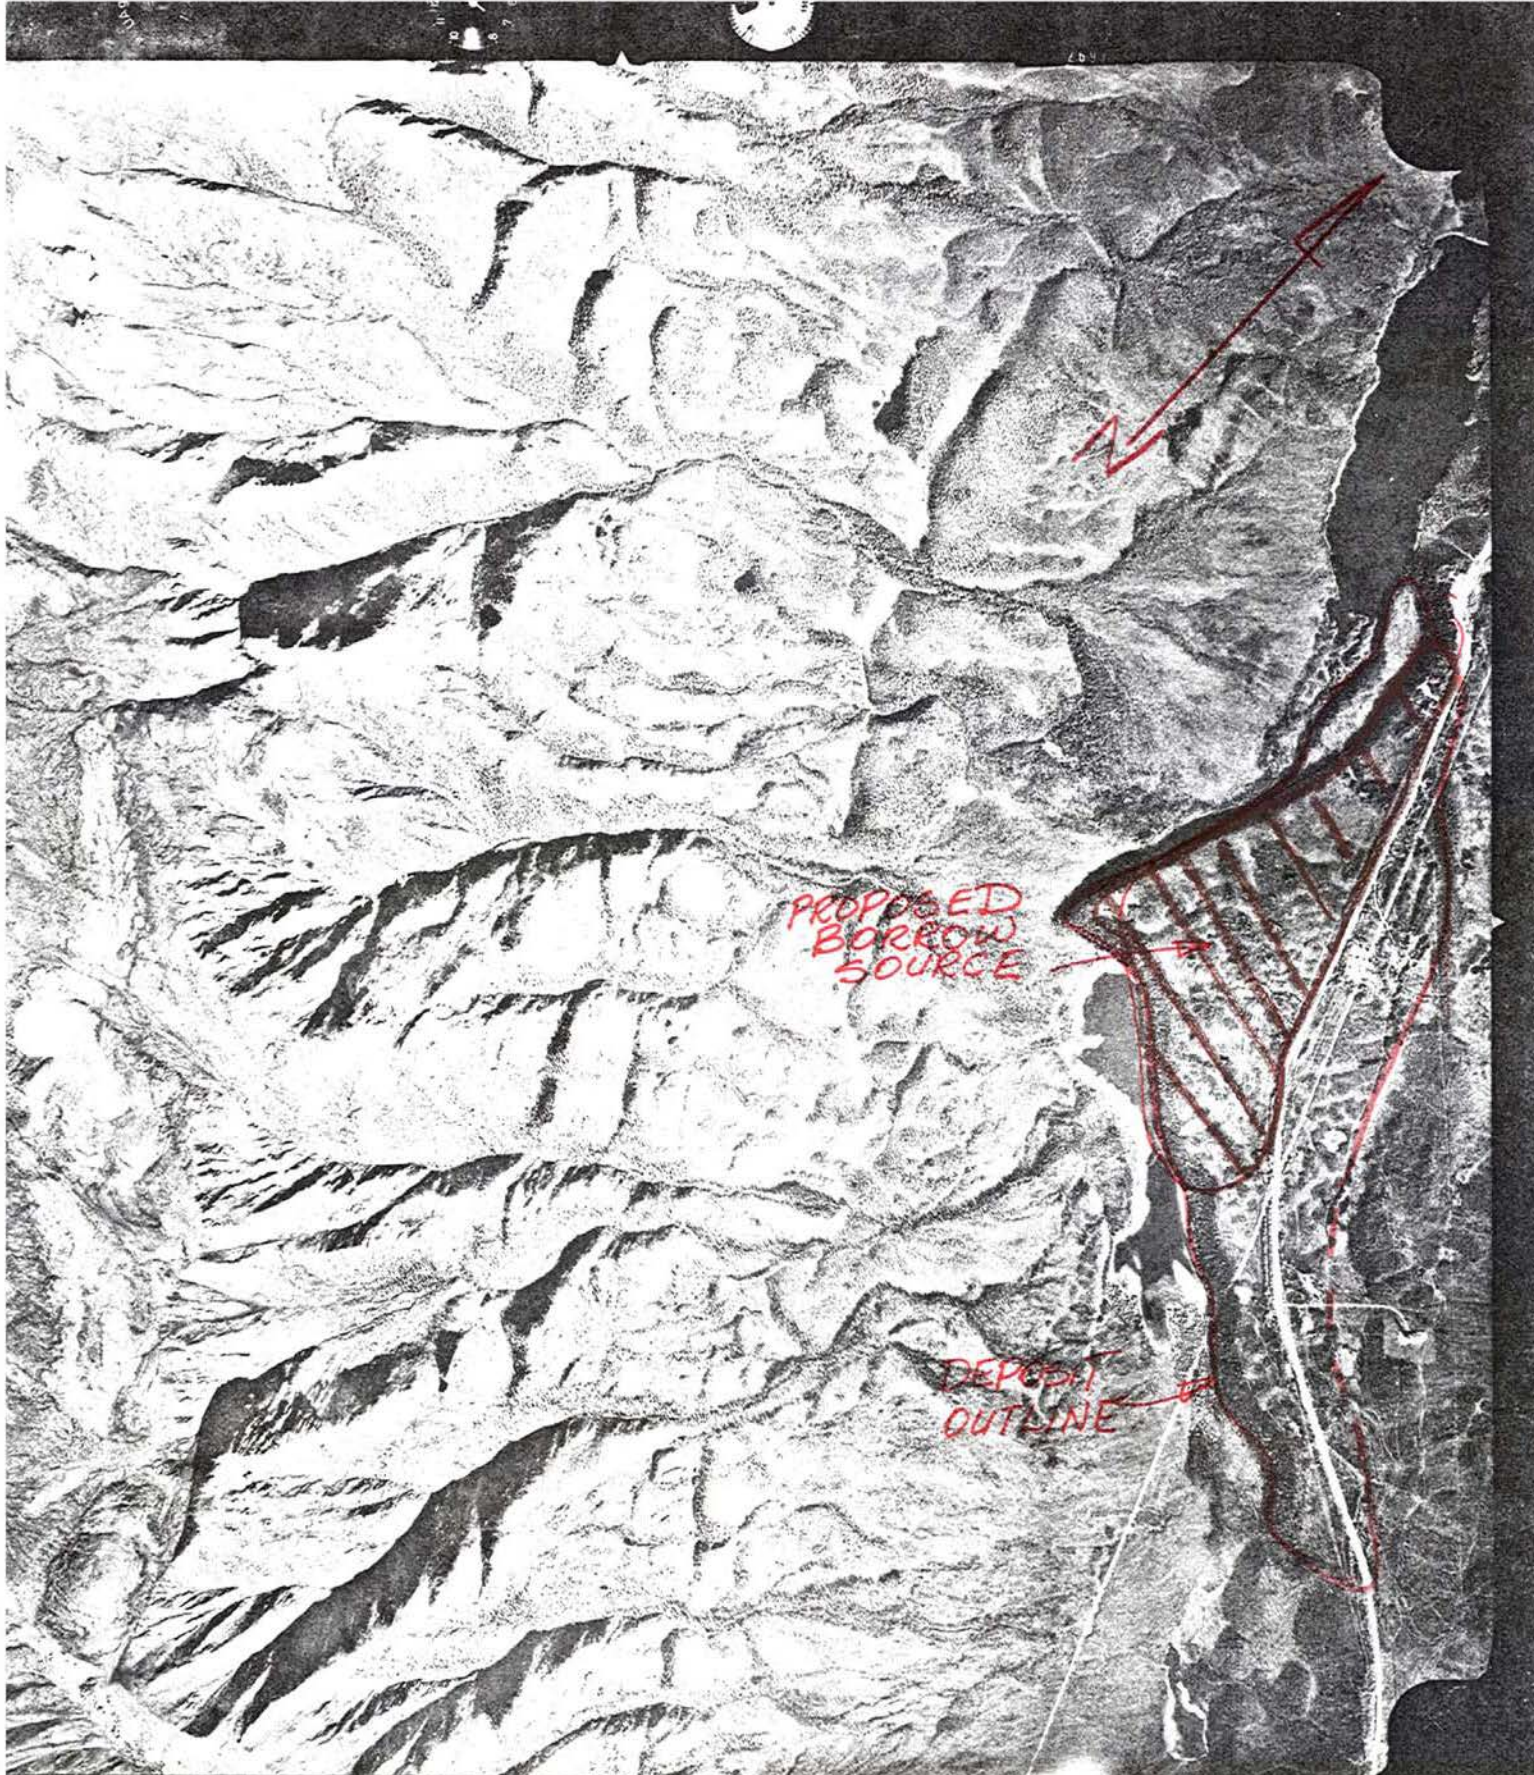
SITE NO. 1  
MP. 1175  
(KP 1890, approx.)

- flat to very gently sloping plain, pitted surface; steep frontal scarp descending to stream and small lakes
- covered with grass, sedge and stunted trees

- stratified, silty to well graded gravel and sand
- mostly frozen, occasional unfrozen zones
- ice contents typically 5 to 10%
- overburden depth 0.5 to 2 m of organic topsoil and clay
- deposit depth greater than 10 m

- material haul across flat grades to highway
- pit(s) could be concealed with tree screen by providing generous setbacks from highway
- clearing and stripping required
- quarry would be developed as a pit
- consider advance stripping of borrow area to allow material to thaw

- this is a proposed compressor station site (CS - 11A) for Foothills Pipelines (south Yukon) Ltd. and may have an existing reserve on it
- potentially very good borrow site with large quantities of granular material available
- some existing drill hole data from Foothills is available.

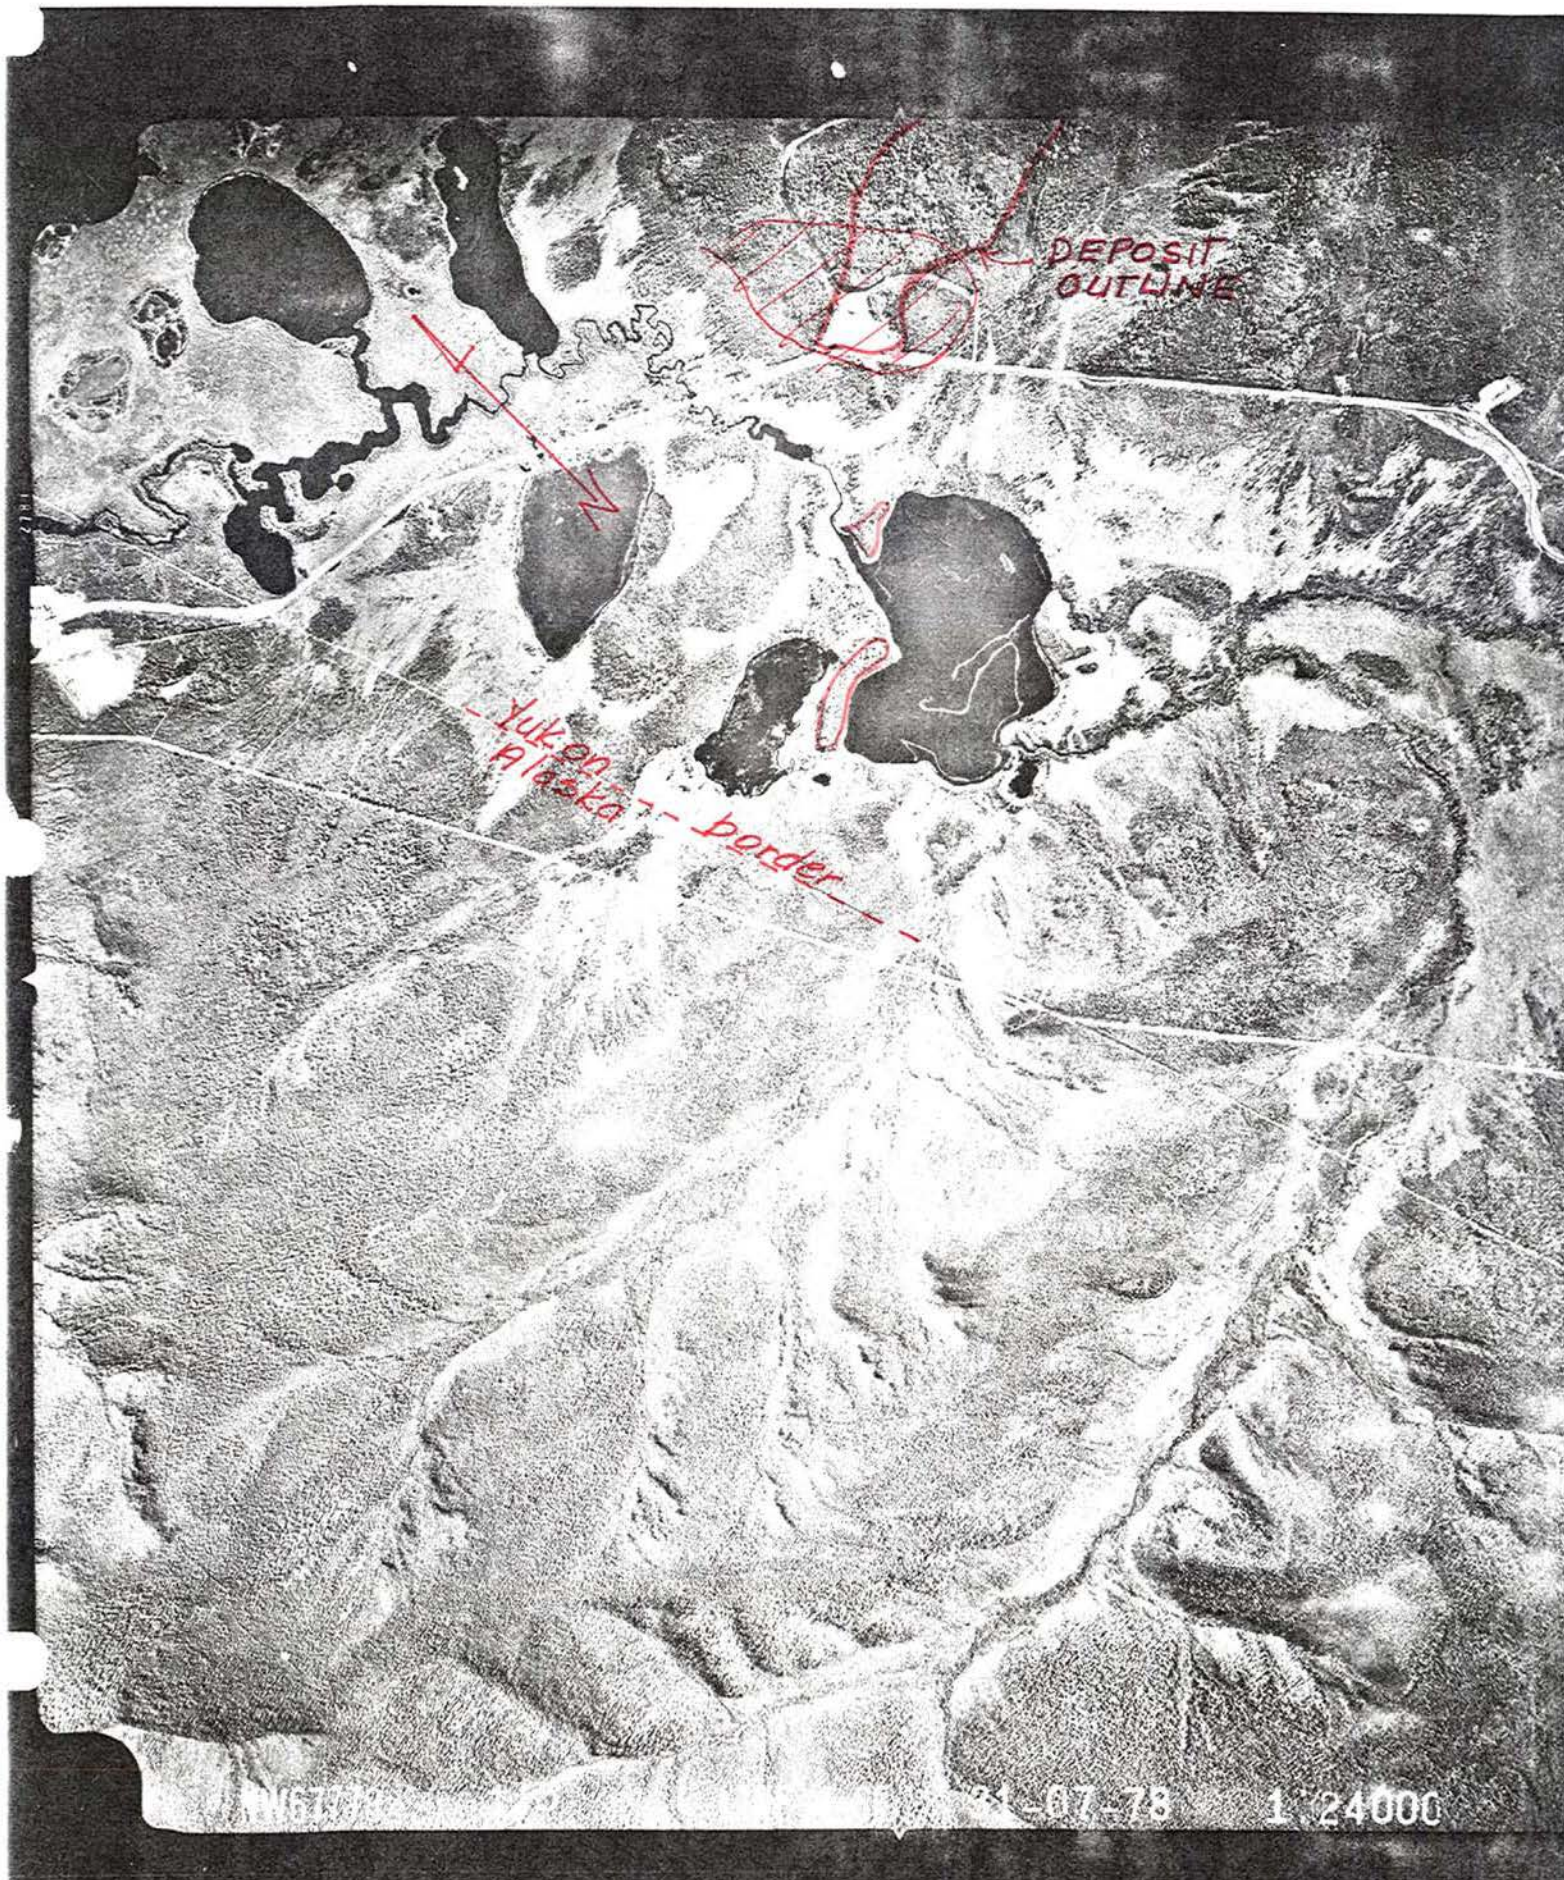
SITE NO. 2  
MP 1220  
(KP 1963 approx.)

- moderate to steep southwest-facing slope above highway
- covered with brush and small trees
- well drained

- decomposed shale, overlain by sandy clay to silty gravel surface layer
- this shale has been crushed and used for surfacing by PWC , in other pits nearby
- PWC records for pit in same terrain unit at MO 1215.5:
  - 0 - 3.5 m sand and silt, over shale
  - 20 - 25% fines in pit-run
  - average liquid limit (LL) = 29 %
  - average plasticity index (PI) = 5 %
- thin deposit, expect shallow bedrock

- adjacent to highway; easy access
- pit clearing is completely visible from highway; pit expansion would make even larger clearing visible from highway
- clearing, some stripping probably required
- face-type quarry working upslope and across slope
- consider ripping weathered rock to increase available quantities

- poor to fair quality borrow site
- test pits and laboratory tests are recommended if borrow area is to be expanded

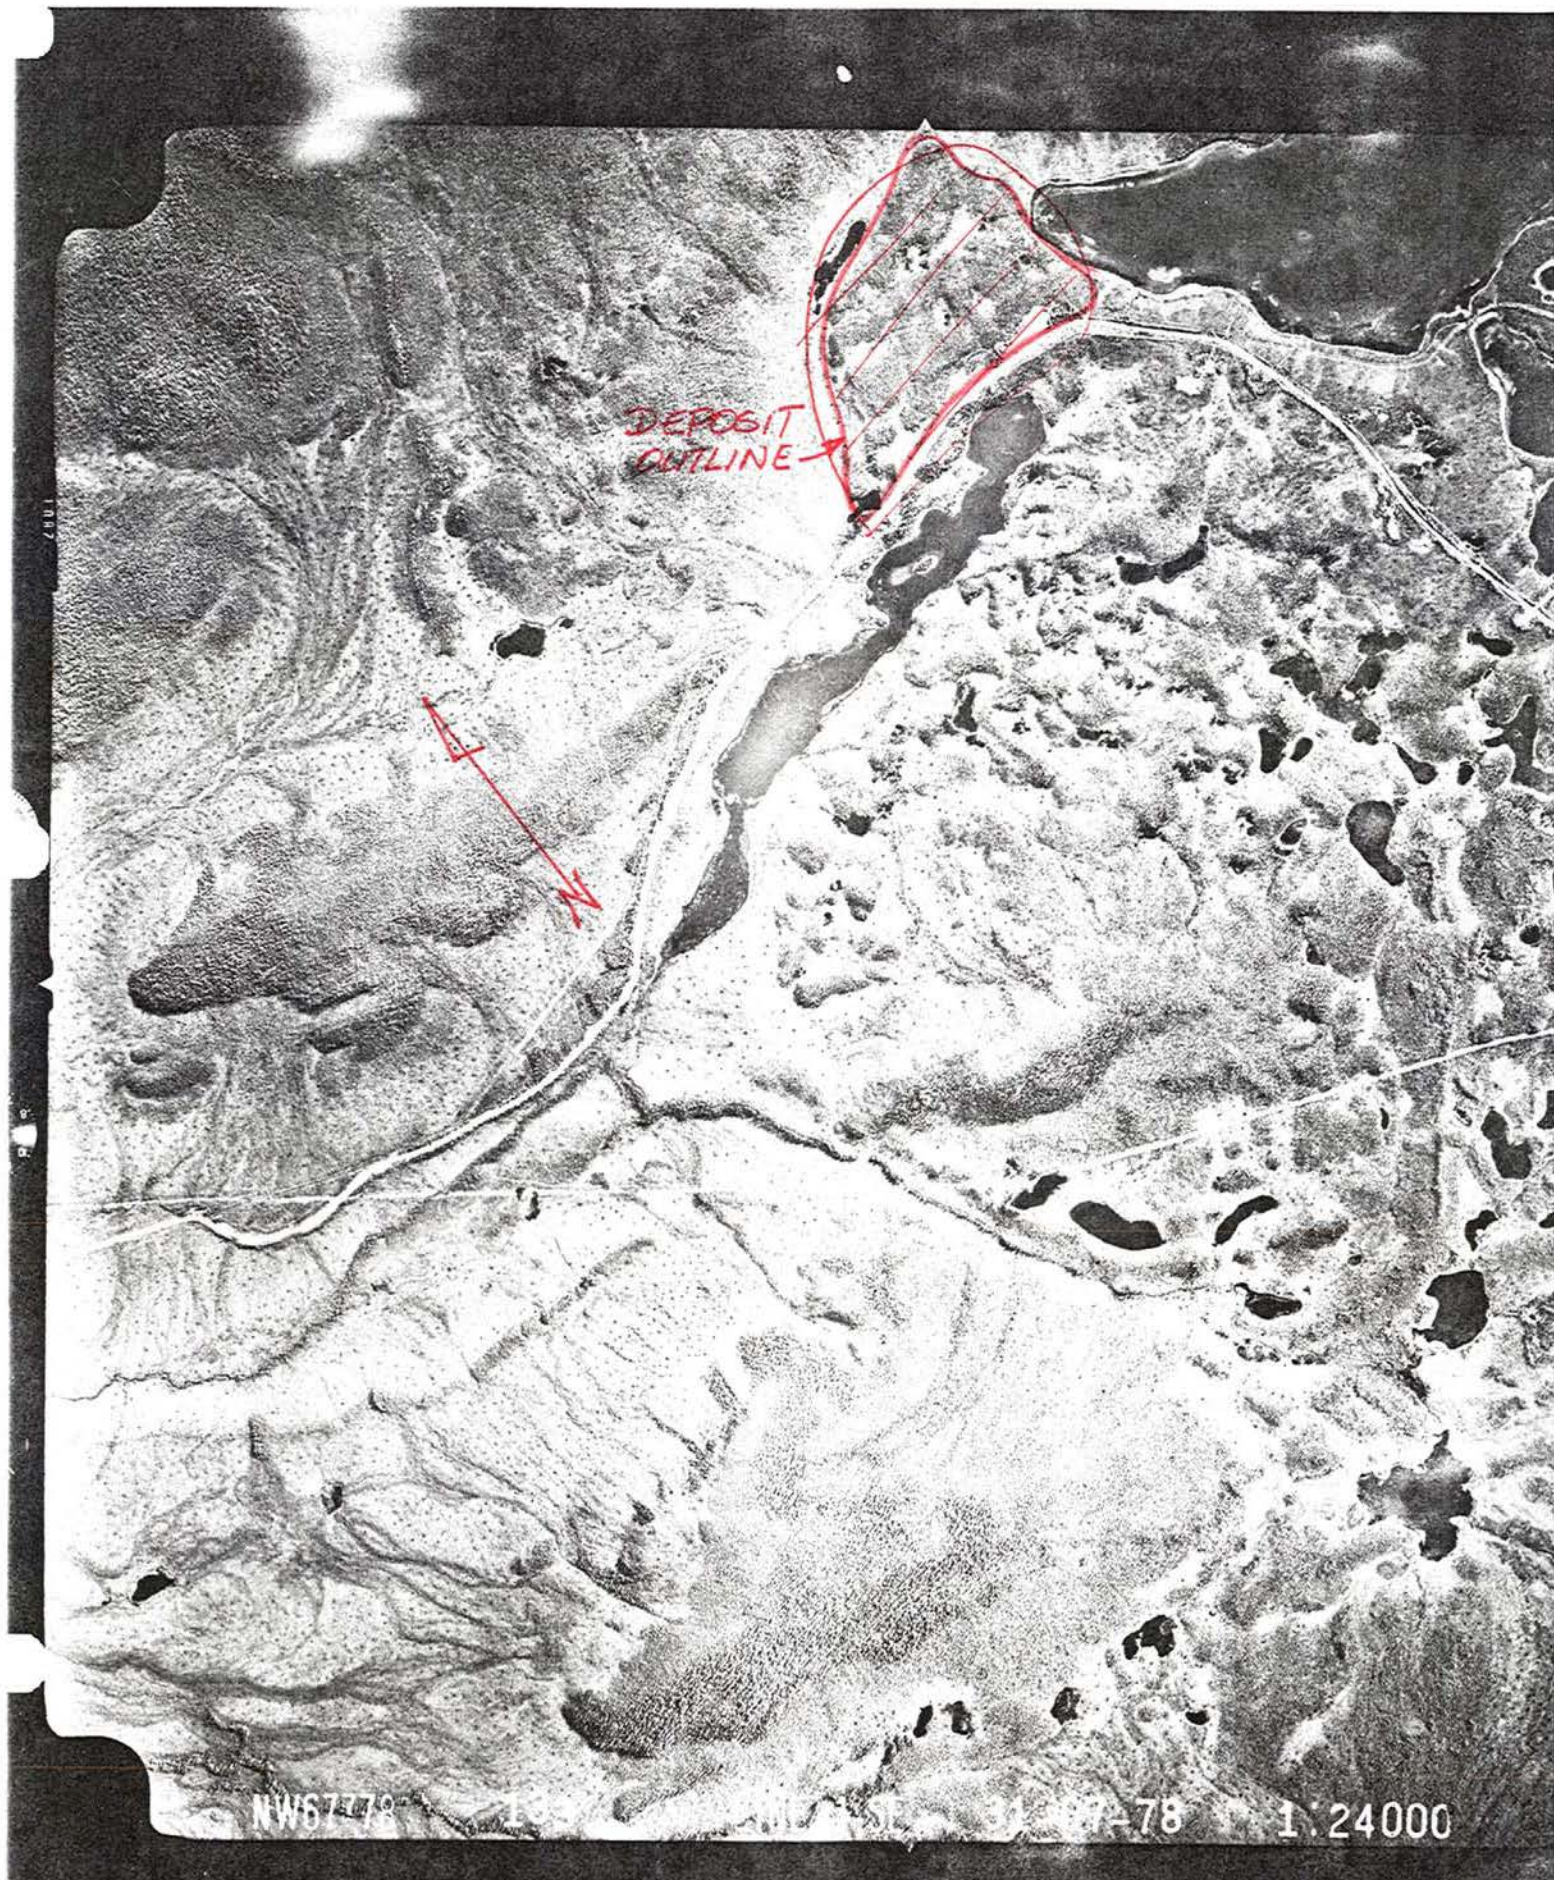
SITE NO. 3  
MP 1191  
(KP 1916 approx.)

- hummocky, irregular topography
- tops of knolls are moderately well drained, depressions are poorly drained
- covered with shrubs, stunted trees

- sandy clay to clayey gravel and silty gravel (gravelly till)
- HIGHLY VARIABLE
- frozen; some areas of high ice content
- overburden depth typically 1 - 2 m (from Foothills logs in same terrain unit nearby)
- PWC pit at M. 1191:
  - gravel with 2 - 15 % fines in pit-run
  - rock fragments: 80 % shale, 15 % granitic

- relatively good grades for access to highway
- clearing and stripping for expansion of existing pit or development of new pit
- may need advance stripping and predrainage to allow materials to thaw and drain
- depressions and low areas will be wet; pit layout should include drainage considerations

- deposit is highly variable; detailed test pit/drilling program needed to delineate most suitable quarry area
- Foothills has also identified this as a possible borrow source
- check for existing reserves
- check for possible encroachment on YTG campground at Snag Lake

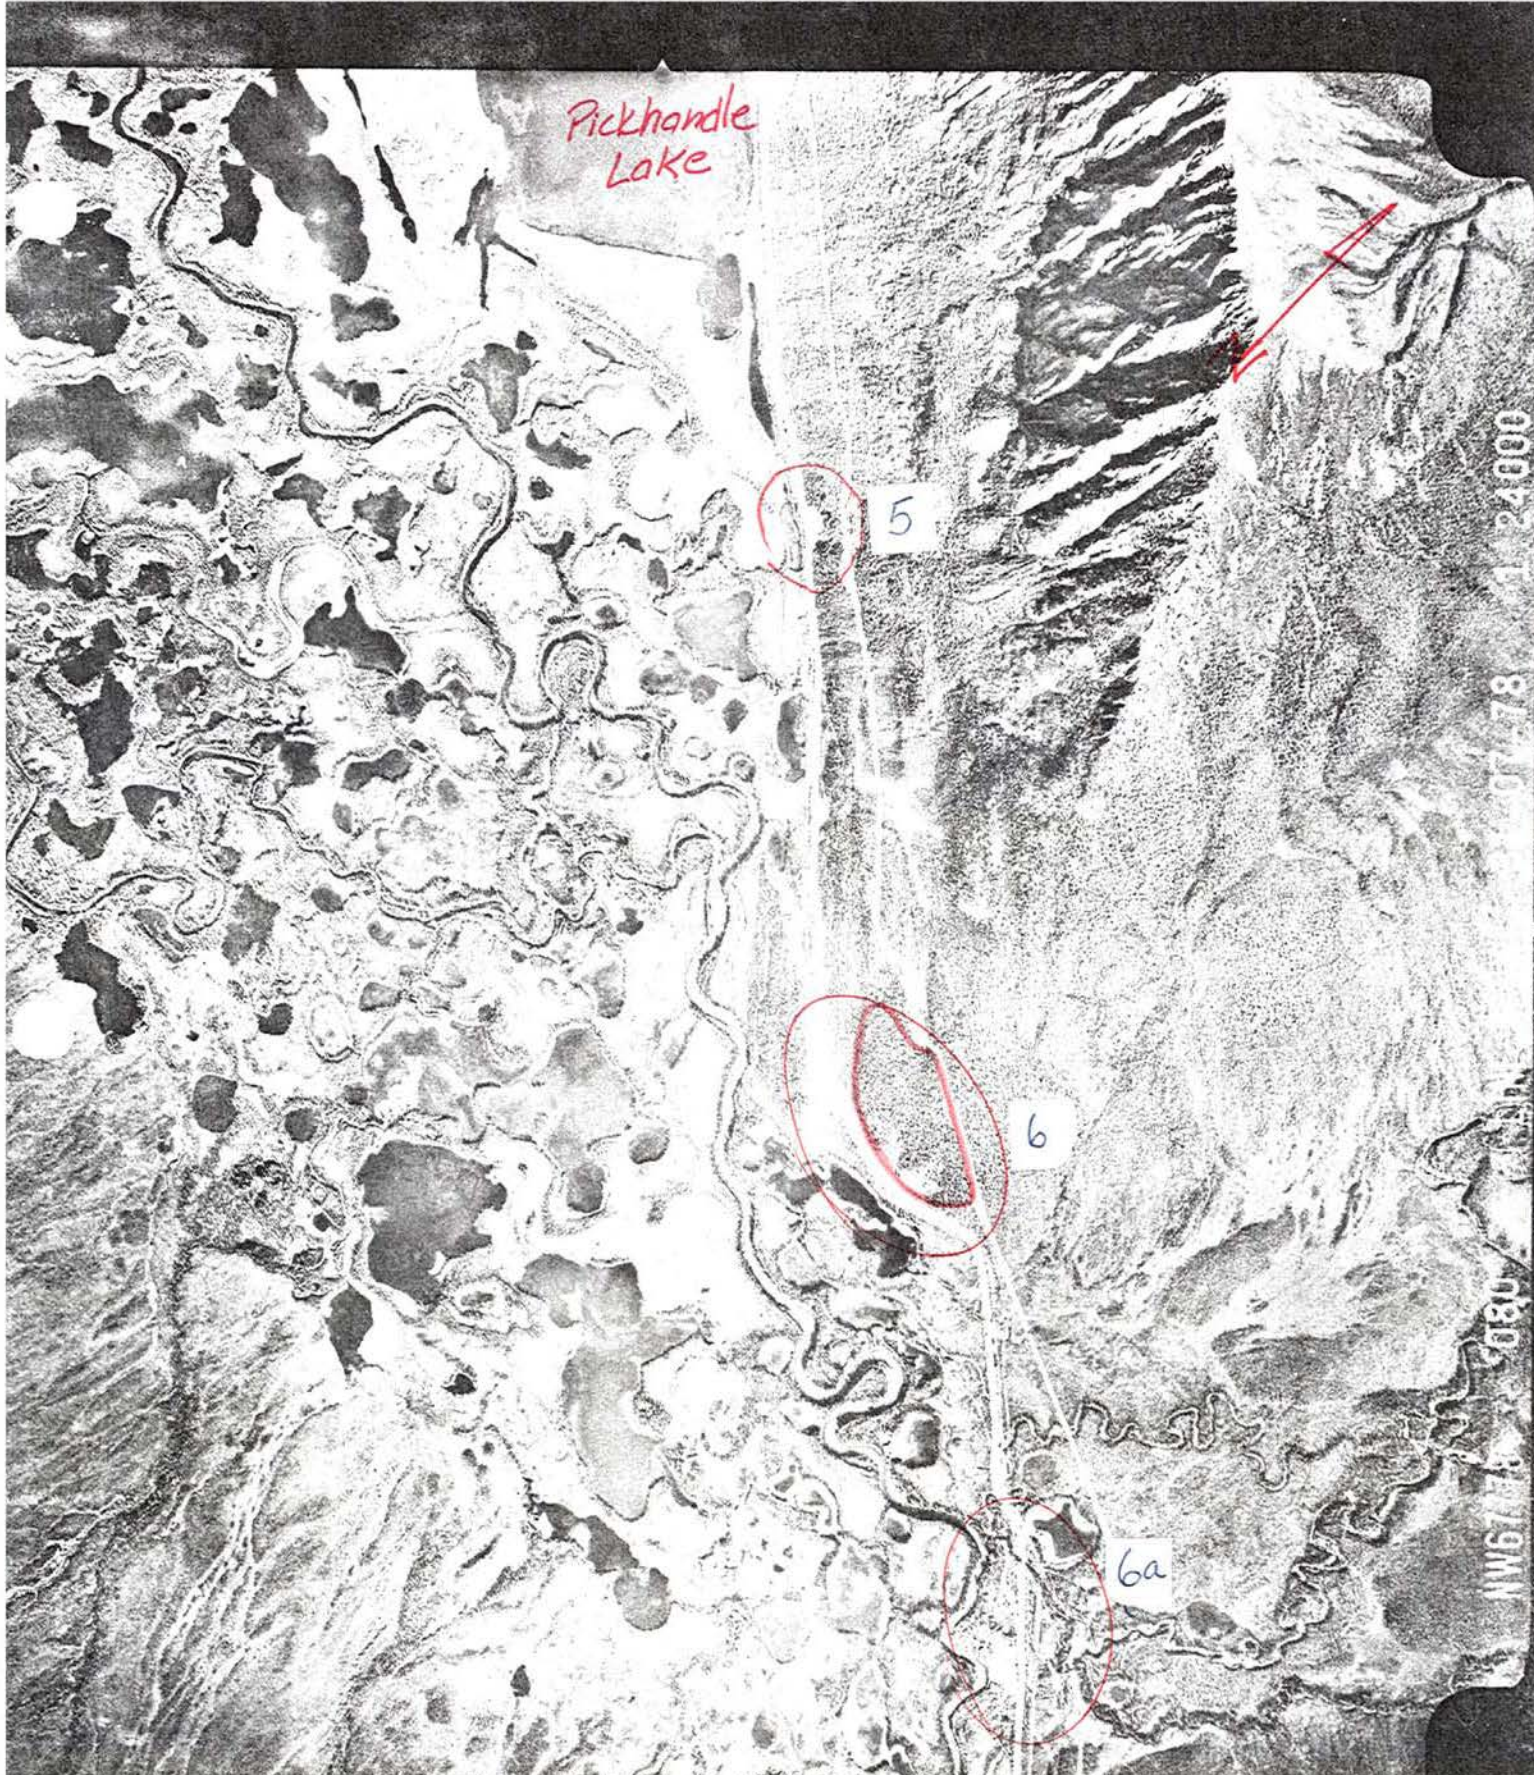
SITE NO.'s 5, 6 & 6a  
MP 1155 ± (KP 1858 approx)  
near Pickhandle Lake

- sites 5 and 6 are on moderate, south-facing, well-drained slopes just above the highway.
- site 5 is in a narrow band between the Haines-Fairbanks pipeline and the Alaska Highway
- site 6a is a relatively flat, poorly drained area in the vicinity of an old camp site

- sites 5 and 6: gravelly silt till to bouldery gravel over shallow bedrock (at 2 - 3 m depth according to Foothills data)
- PWC data for site 6 (MP 1155) shows:
  - silty sand and gravelly till over bedrock frozen at 0.5 m depth
  - rock particles: 60% quartzite, 10% granitic, 15% schist, 15% other
  - 12 - 47% fines in laboratory crush samples
- site 6 has been used as a crusher site
- site 6a: Foothills has a number of drill holes in this area showing layered, predominantly fine-grained alluvial deposits: silt, sand, peat, volcanic ash, and occasional thin seams of gravel
- material is frozen

- sites 5, 6 and 6a are all readily accessible to the highway
- site 5 is limited to the distance development can take place upslope by the existing pipeline, which may not be a constraint over the long term
- sites 5 and 6 are well-drained. Expansion of these pits would be highly visible from the highway. Expect shallow bedrock.
- developing a quarry at site 6 could facilitate a favorable highway realignment
- site 6a is not suitable for development. Existing drill hole data shows an absence of gravel.
- Foothills has identified this site as a possible stockpile site during construction.

- Site 5 is a poor to fair borrow site of limited areal extent
- site 6 is a fair borrow/quarry site
- site 6a is not suitable for development

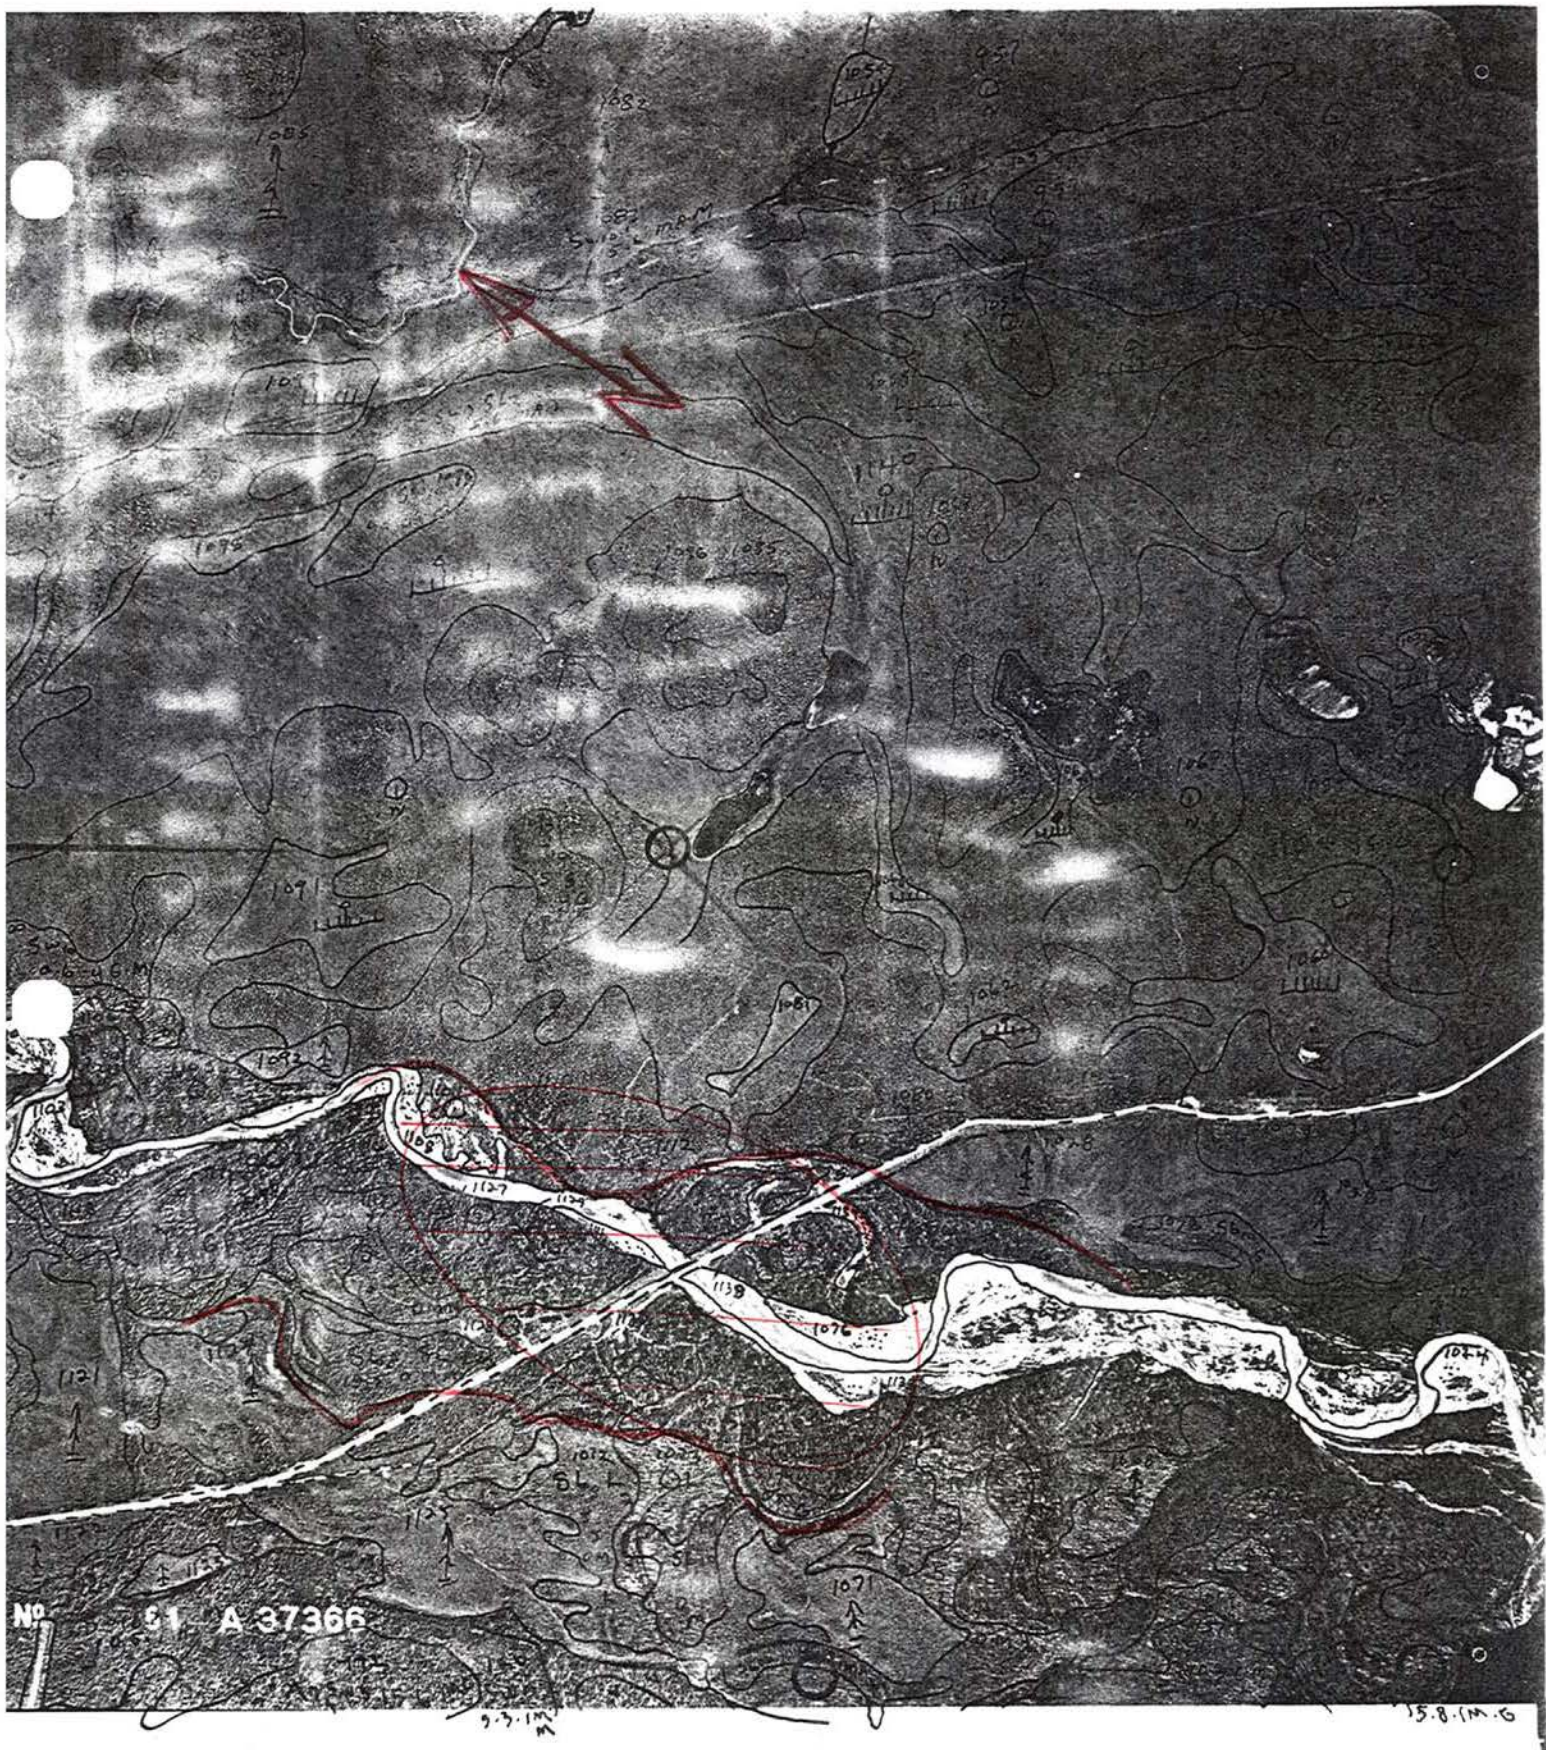
SITE NO. 7  
MP 1201  
(KP 1932 approx.)  
adjacent to  
Beaver Creek bridge

- flat to gently sloping, poorly drained, terraced and channelled surface
- thick brush and trees

- these alluvial deposits consist of stratified sands, silts and gravels and are highly variable
- without test hole data it is difficult to predict whether or not the gravel layers are sufficiently thick to be mined in a quarry  
(NB if there are drill hole logs for the bridge these may give some indication)
- expect a high water table
- expect frozen zones

- assuming that significant gravel zones exist, development of this site would involve a pit-type quarry
- pit development should consider drainage measures
- the highest terraces should be examined first

- a test pit program within the proposed borrow area is needed to confirm the material types and groundwater levels, etc.
- Note: there are very extensive gravel deposits in the glaciofluvial plain in the vicinity of the airport at Beaver Creek
