FILE: 2147-27-0

PROPOSED RIPRAP SOURCES
BLACKSTONE RIVER AREA
Km 139-145

DEMPSTER HIGHWAY

MAY 1989

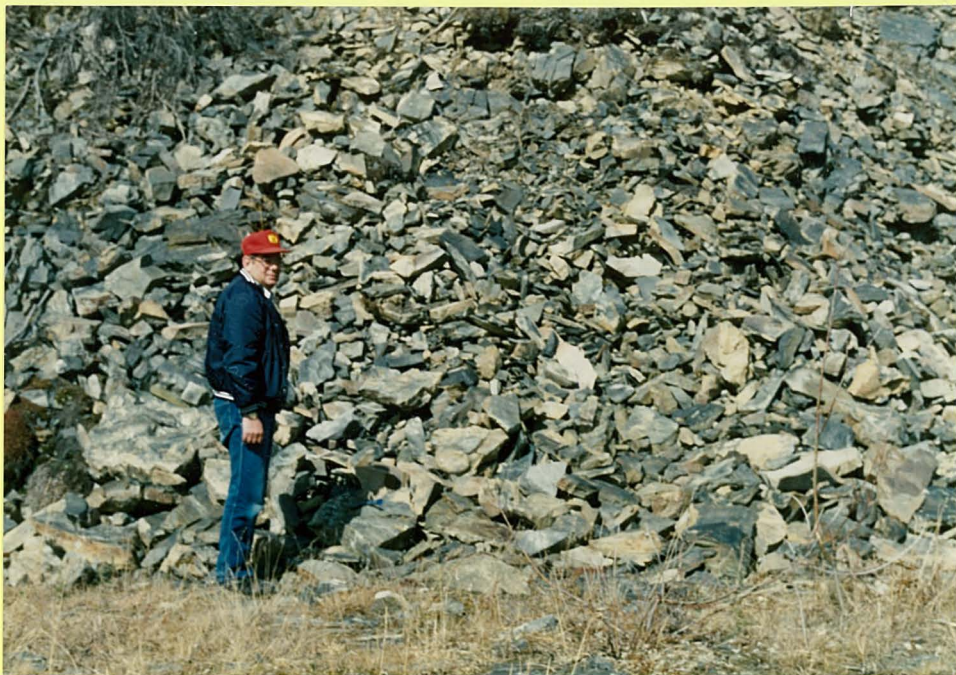
PHOTO 89-01-01
Dempster Highway
Km 134.5
Looking west at
proposed riprap
source (talus slope).

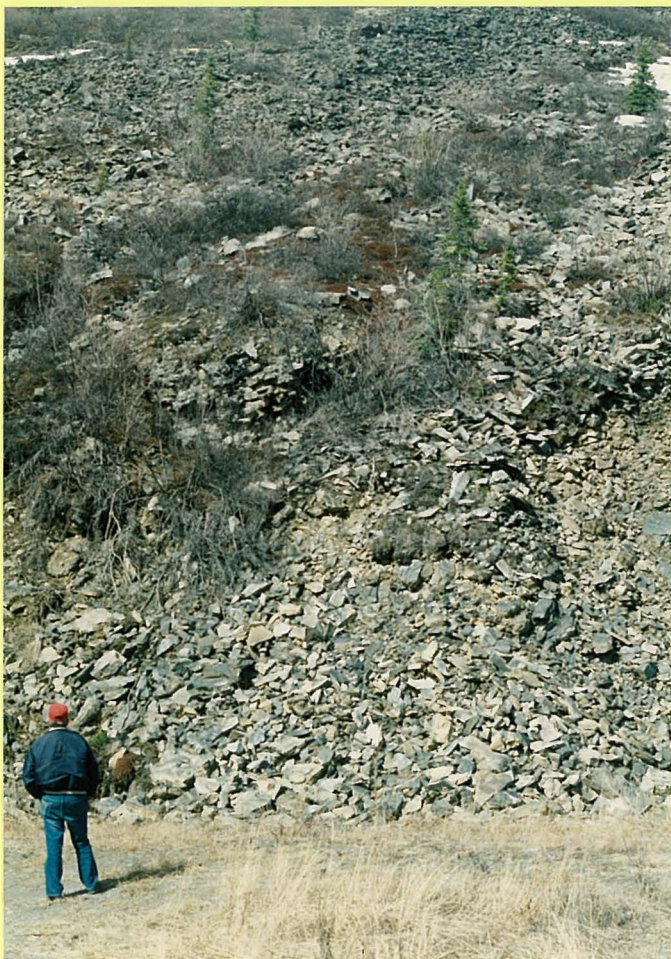
PHOTO 89-01-02
Dempster Highway
Km 134.5

Looking west at talus
slope.

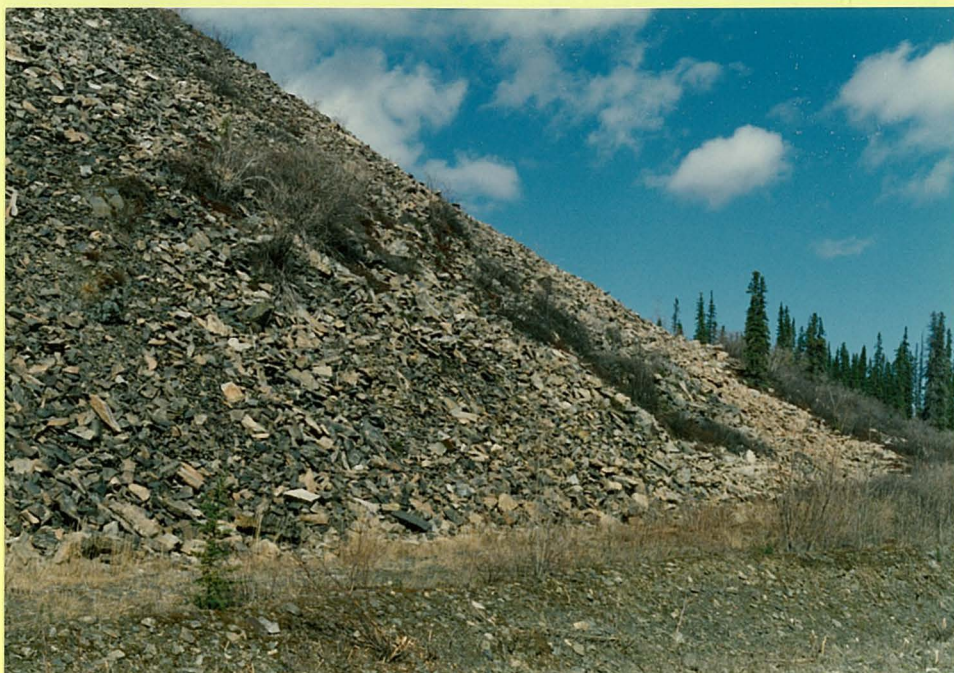
PHOTO 89-01-03
Dempster Highway
km 134.5
Looking northwest
along talus slope.

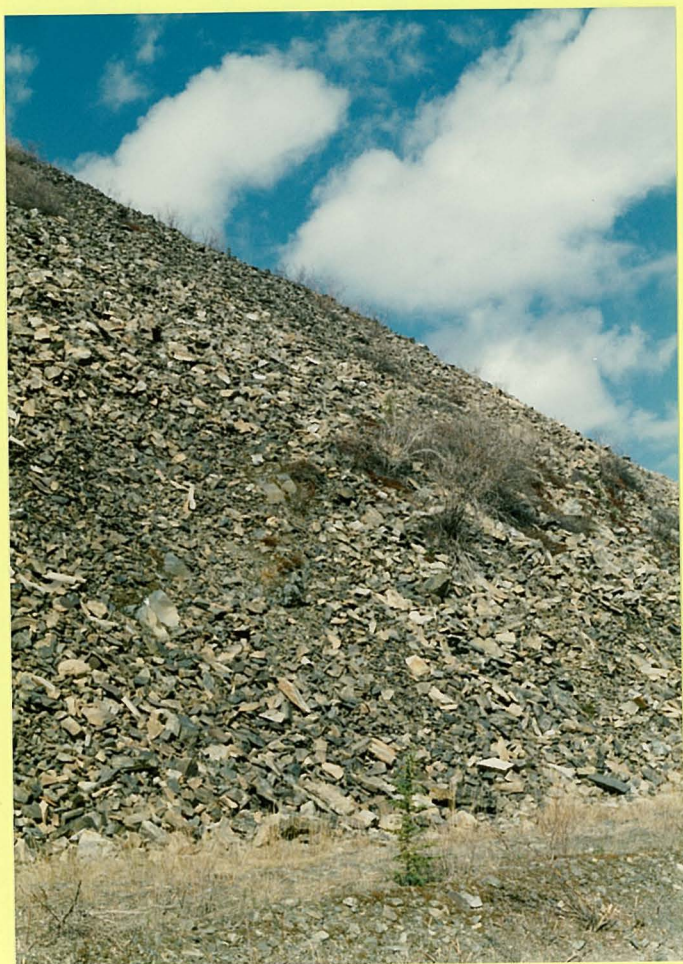
PHOTO 89-01-04
Dempster Highway
km 134.5

Looking northwest at
talus slope.

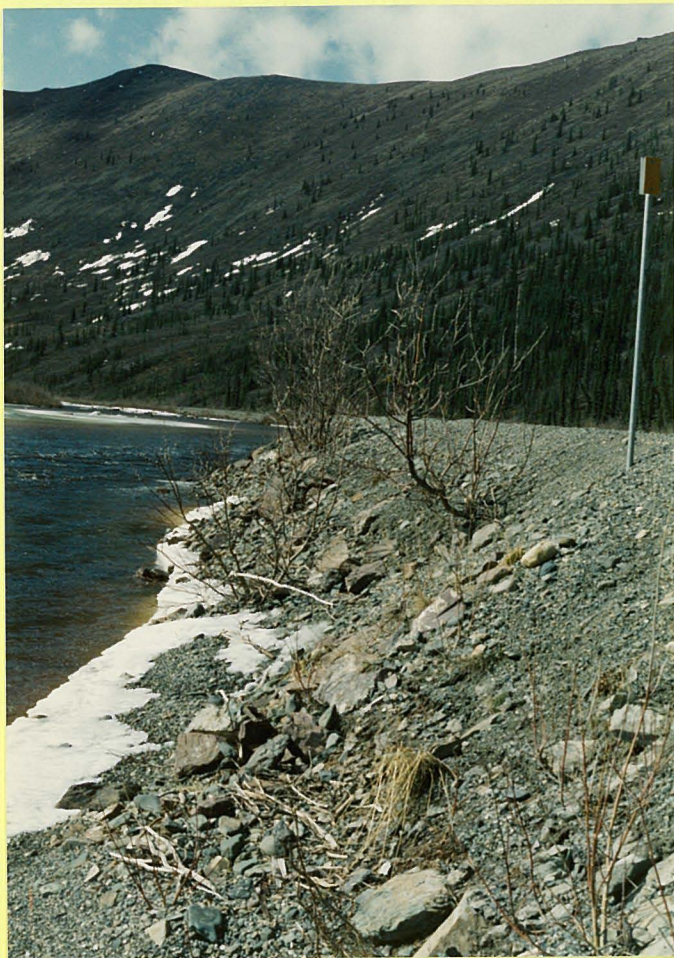
PHOTO 89-01-05
Dempster Highway
Km 144

Looking south along
river bank at edge of road.

Riprap placed by Hwys.
Maintenance forces visible
on bank.

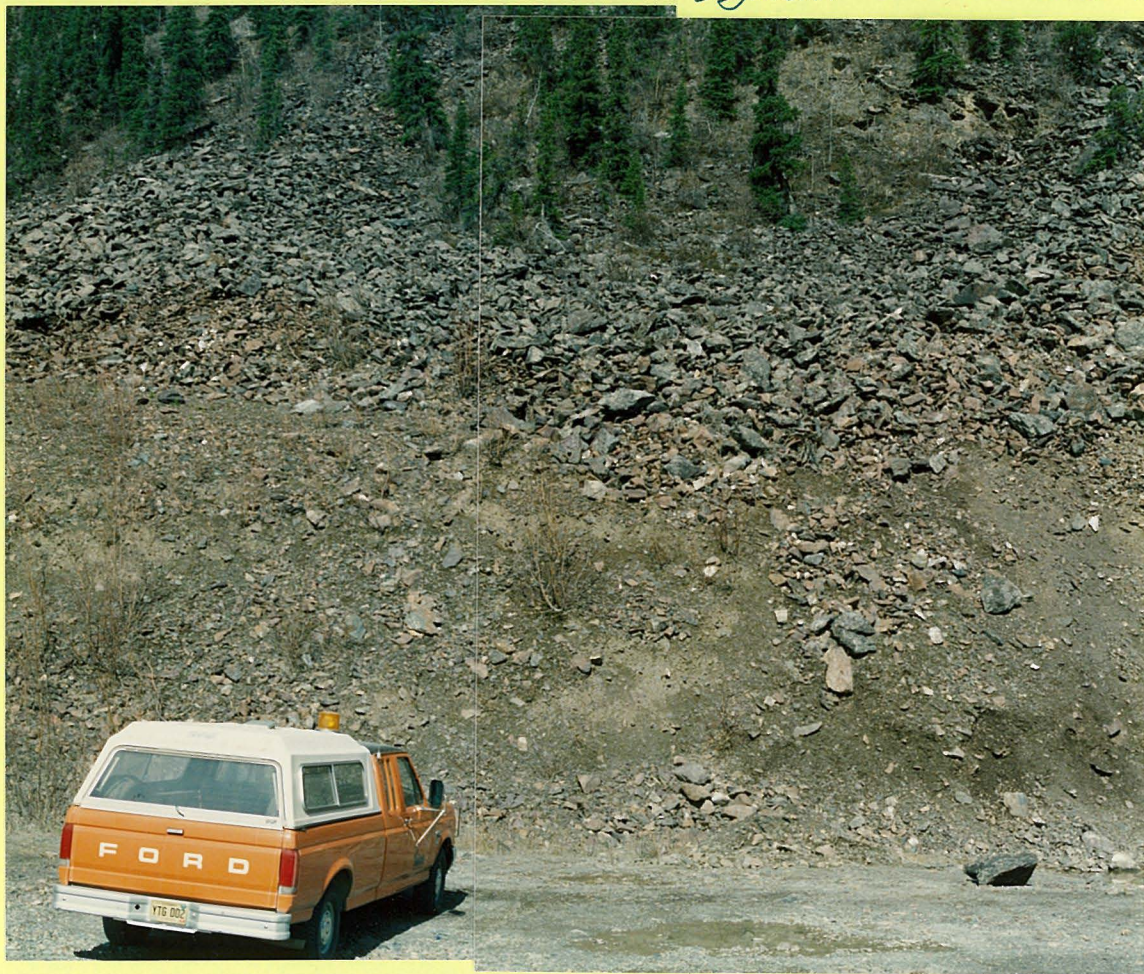
PHOTOS 89-01-06 & 07
Dempster Highway km 144.
Looking west at talus slope
by road. Lower part of slope has
been scalped by Hwys. Maintenance
forces for use as riprap along
adjacent Blackstone River.

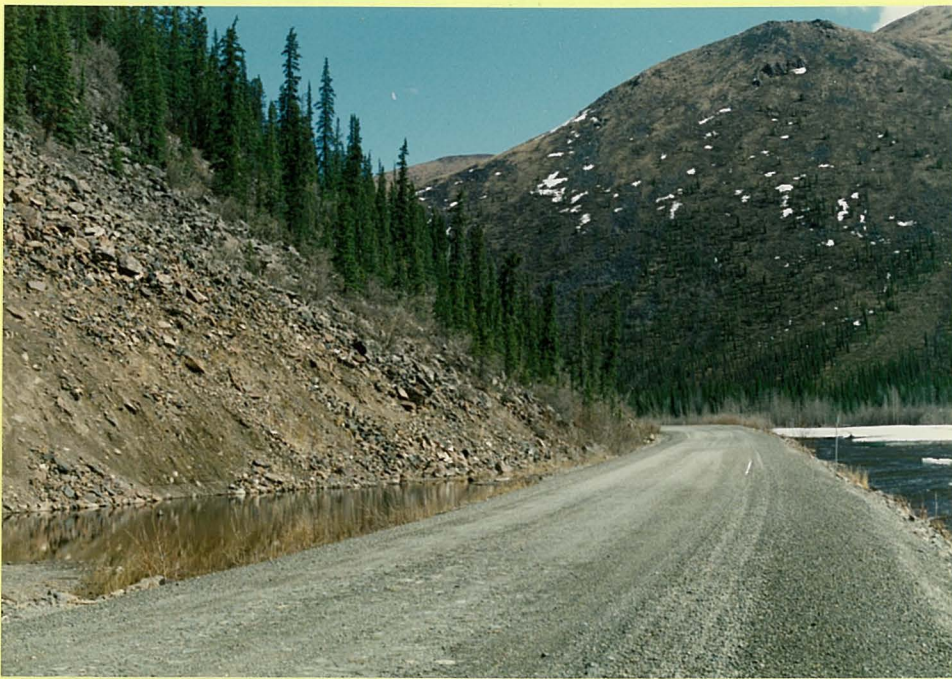
PHOTO 89-01-08
Dempster Highway
Km 144
Looking north along
highway. Talus slope
to left, Blackstone
River to right.

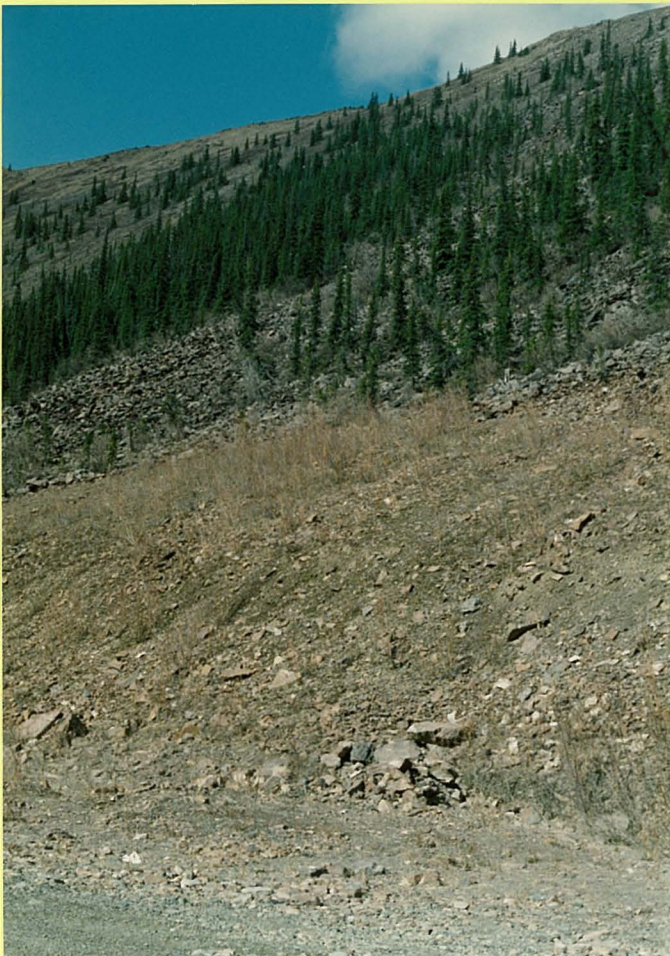
PHOTO 89-01-09
Dempster Highway Km 144
Looking southwest at
talus slope.
Lower part of slope has
been scalded by Highway's
Maintenance forces; natural
revegetation of grasses
and brush is occurring.

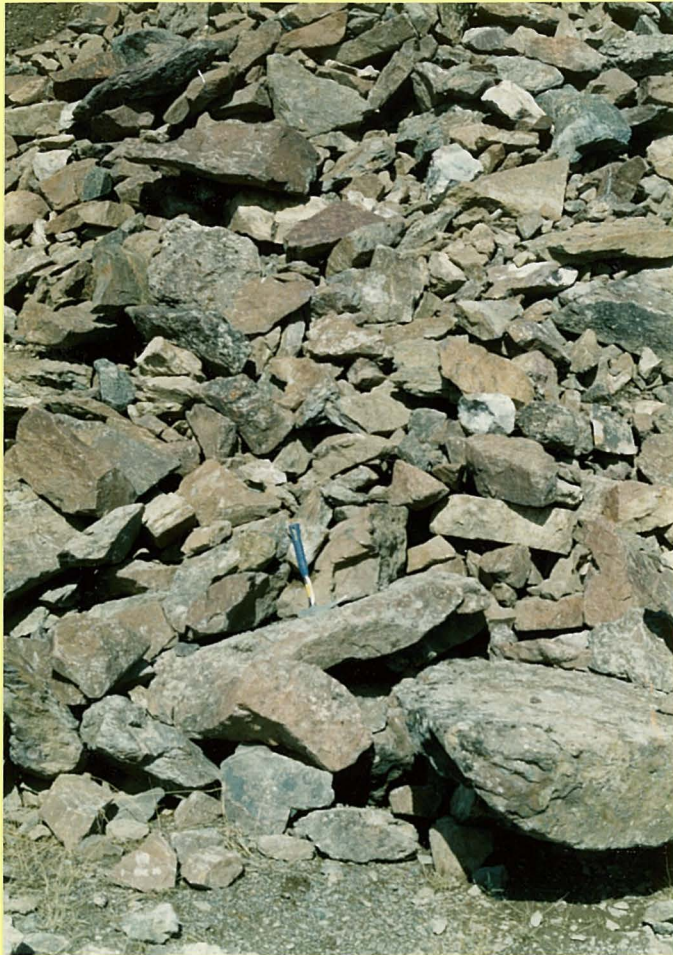
This material is very hard, pinkish-brown quartzite. The largest sizes noted were about 800 mm equivalent diameter. See Photos 89-01-06 to 10 in Appendix A. The largest rock sizes tend to be slabby, although in general the particle shape is acceptable for riprap.

PHOTO 89-01-10
Dempster Highway Km 144
Proposed riprap source.
close-up of talus materials.
89/05/05
GH
