## DRILL HOLE RESULTS

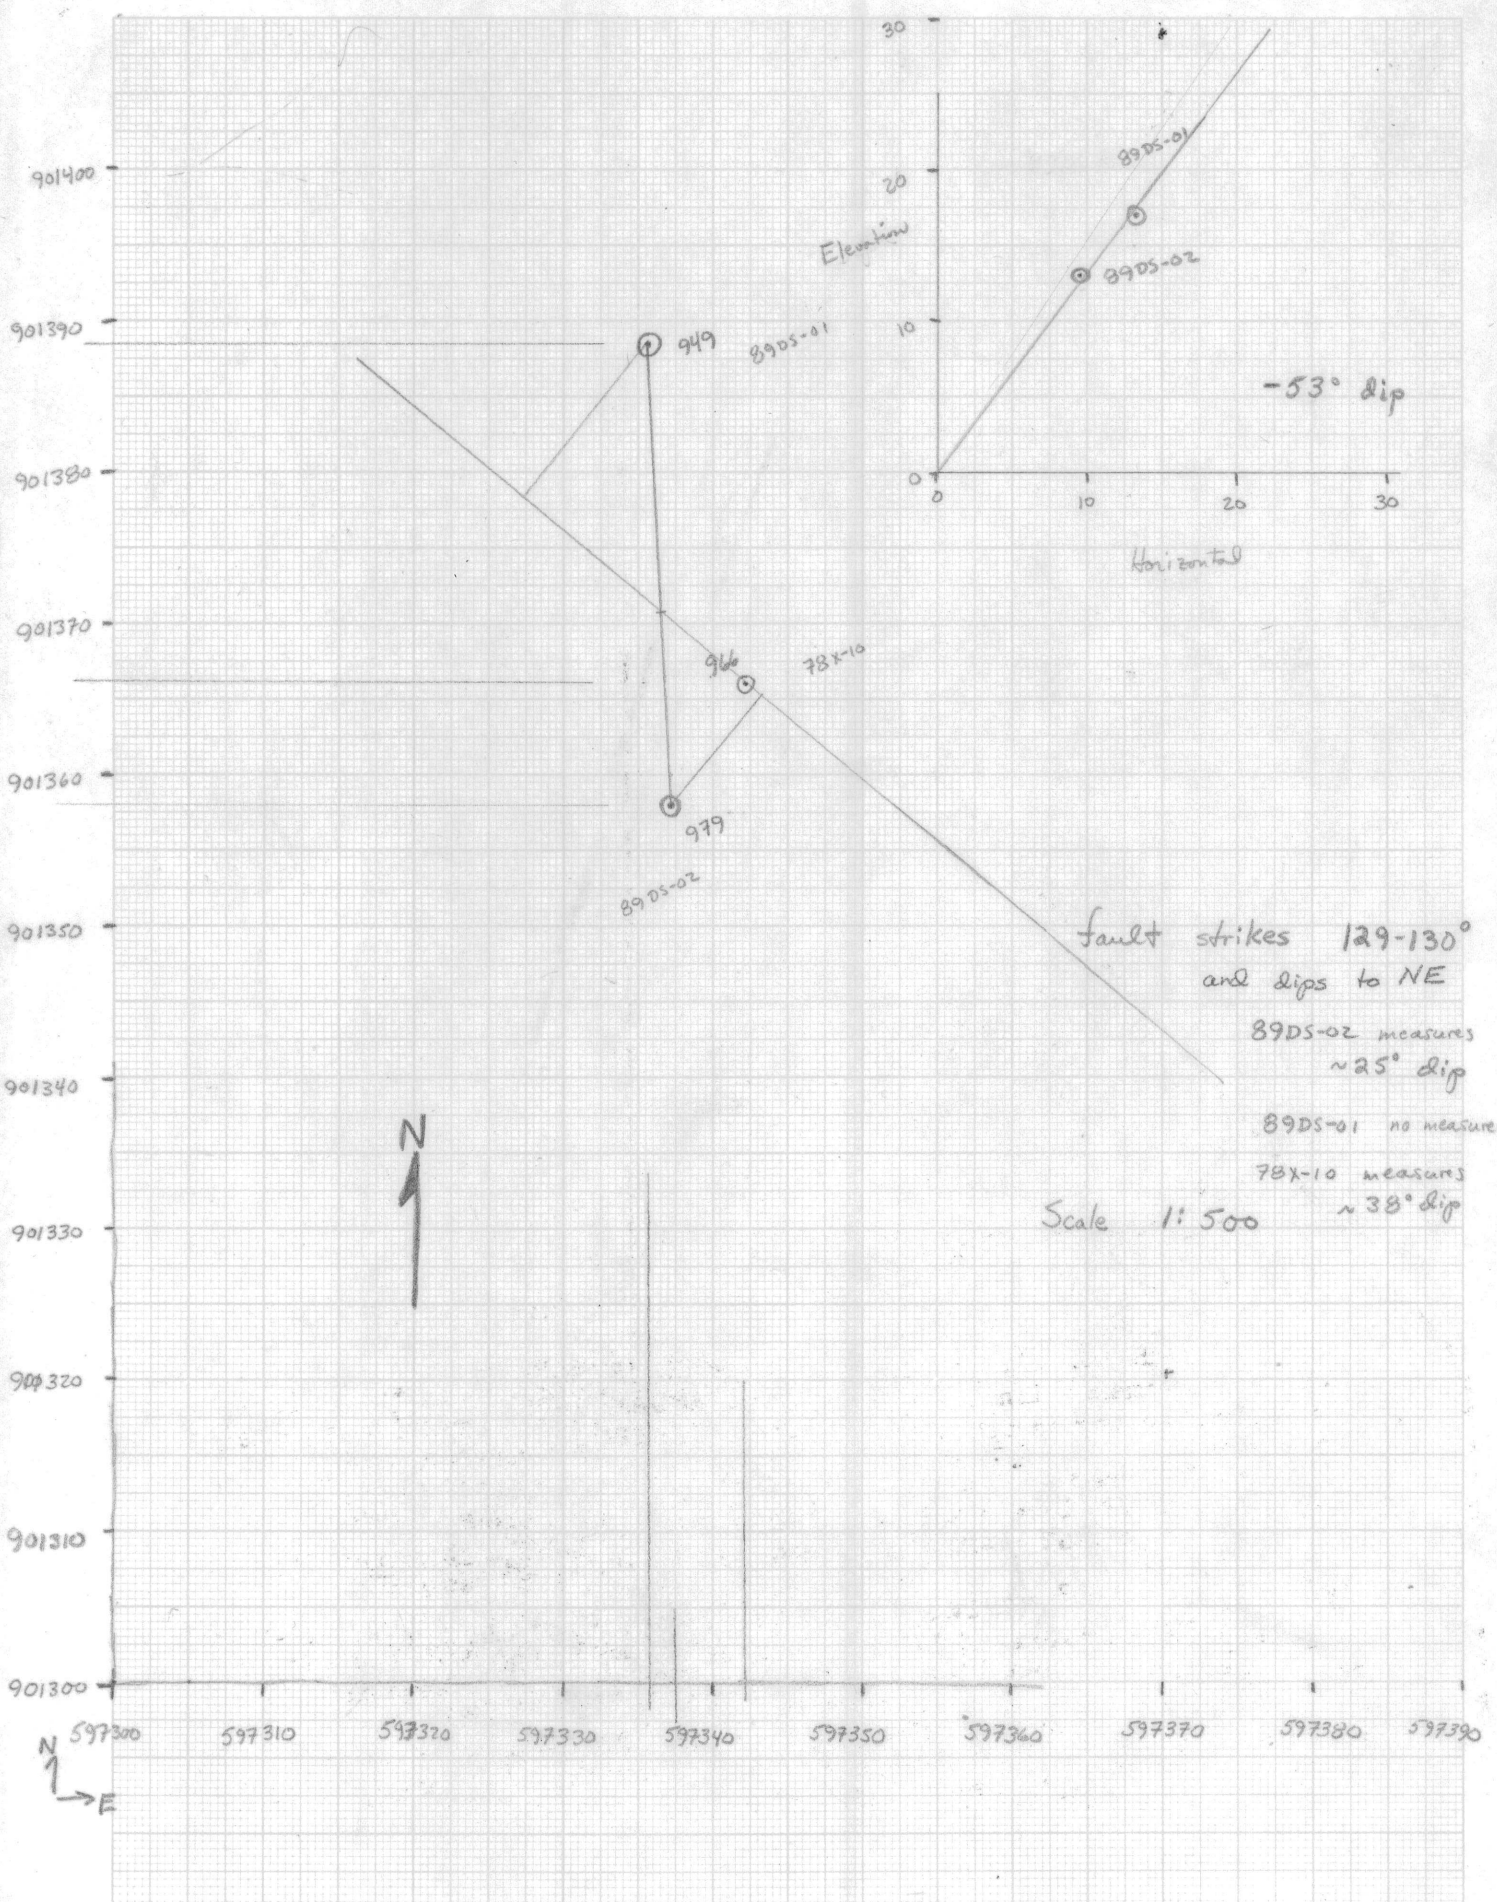
Problems were encountered in DDH 89DS-02 with a fault extending over the interval 128.1 - 130.5 m. Looking at cross-section 15+00, this fault interval correlates well with a logged fault zone in DDH 78X-10 at depth 138.4 - 141.4 m. With this correlation the most reasonable "same fault" in DDH 89DS-01 occurs in the interval 146.6 - 166.1 m.

The orientation of the plane containing these points was then calculated graphically as a three point problem. The resulting fault orientation is 130 / 53 NE. With this dip the core axis angle for the fault margins ideally would be 37° (assuming a vertical DDH). Measured angles from the drill logs are 38° (lower contact - 78X-10), 25° (upper contact - 89DS-02), and 40° (lower contact 89DS-02).

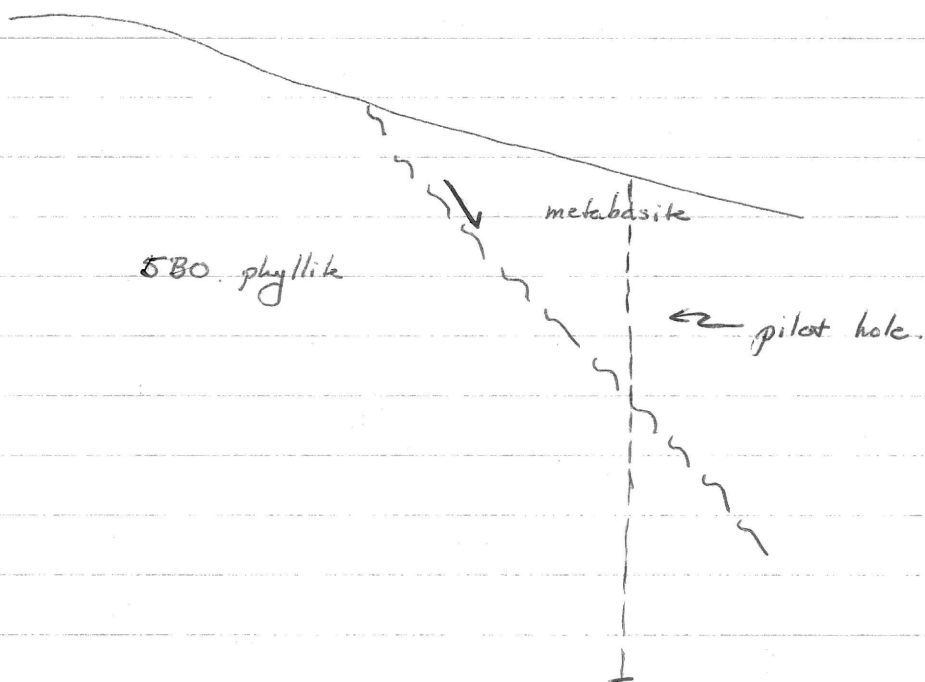
On section 15+00 the pilot drilling shows that the southwest metabasite - metasediment contact dips steeply to the northeast. This contact is crudely parallel to the projected trace of the problem fault. The contact is strongly discordant with the general compositional banding and the overall distribution (dip) of the ~~ore~~ horizons.

From the cross sections, the fault trace would "daylight" (i.e. come to the surface) along the approximate ~~contact~~ southwest contact between the metabasite sequence and the phyllite sequence. Because the calculated fault trend and the metabasite margin trend are similar, the fault trace would be parallel to the mapped contact.

The cross-section interpretation of this relationship is as shown below:

If this fault orientation is correct, the fault cannot be avoided by moving the pilot hole only a short distance. Placing the pilot hole in the footwall would probably result in the drill hole intersecting ~~the~~ mineralization at depth.

The suggested orientation should be checked by drilling a hole collared on section 15+00 slightly southwest of the current pilot hole 89 DS-02. The hole should be inclined to the southwest. The depth to the fault could be estimated once the collar location was known more exactly.

A second hole should also be collared in the flat area close to section 13+50. This hole would also start in the metabasite and attempt to drill through the ~~metabasite into~~ fault zone and into the phyllites. This hole would also be inclined to the southwest.
