MOUNT NANSEN MINES LIMITED

Property Examination - Head of Nansen Creek

June 13/68

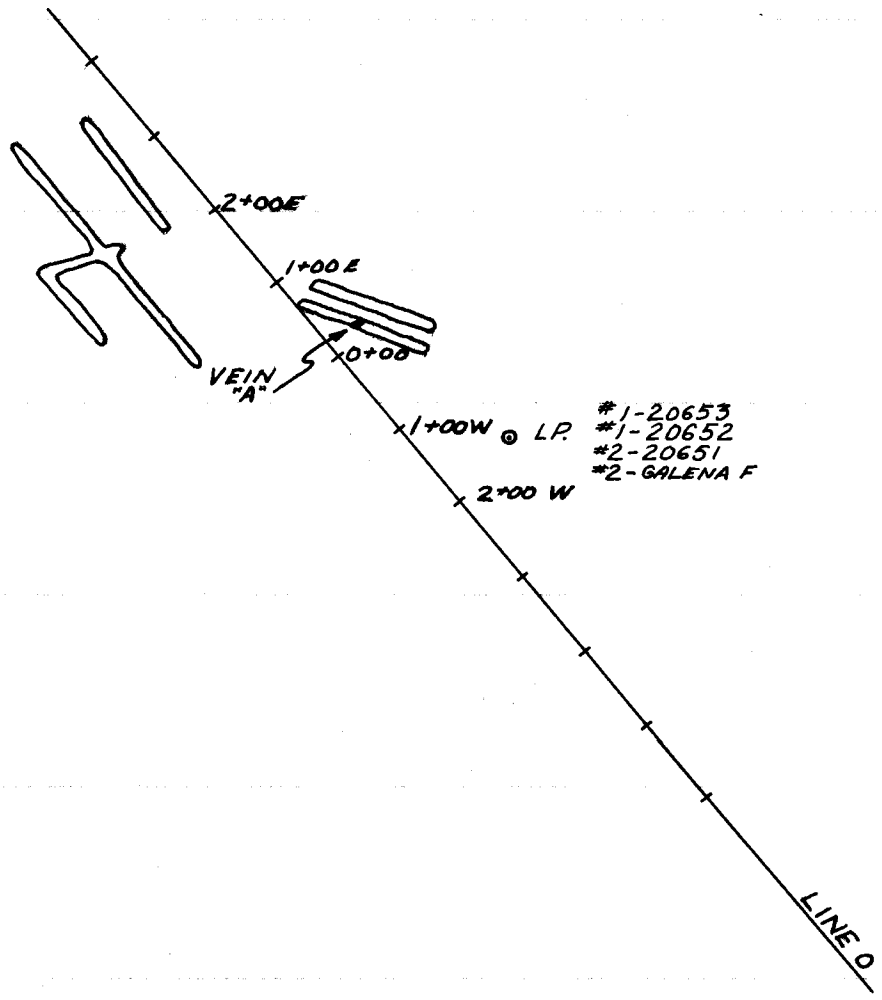
SCALE : 1 inch = 200 feet

Remarks: Considerable new trenching has been done here (see attached sketch-map; several more shallow, old trenches were seen. :

- : new trenches were from 4' to 8' deep, and most were water-filled
- : one (possibly several) veins were visible in the trenches, but all exposures were almost totally oxidized or decomposed, so it was impossible to establish vein widths, strikes or dips. However, there appeared to be very strong alteration zones about 12 feet wide, and I suspect the vein (veins) will be about 3' - 4' wide.
- : grab samples were taken which I feel should represent significant vein widths (2 feet or more), and these indicate a very promising ore-grade vein:

Location A:

Au	Ag	(oz/ton)
# 1a - barren quartz	0.22	3.7	
# 1b - 95% oxidized vein	0.64	4.1	
# 2 - yellow clay gouge from 3' wide zone	0.32	1.8	
# 3 - granular quartz, pyrite and clay	0.04	0.9

Location B: Silicified, weathered wall rock 0.04, 0.9
