Yukon Placer Mining Industry

2010 to 2014

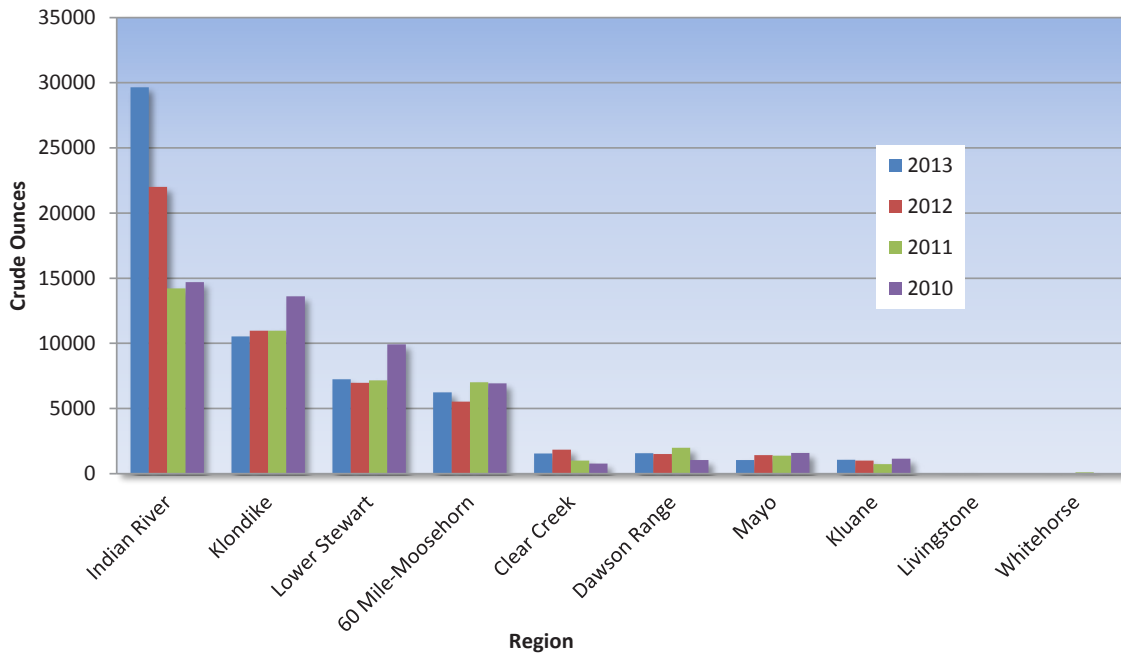
Figure 9. Regional gold production 2010-2013.

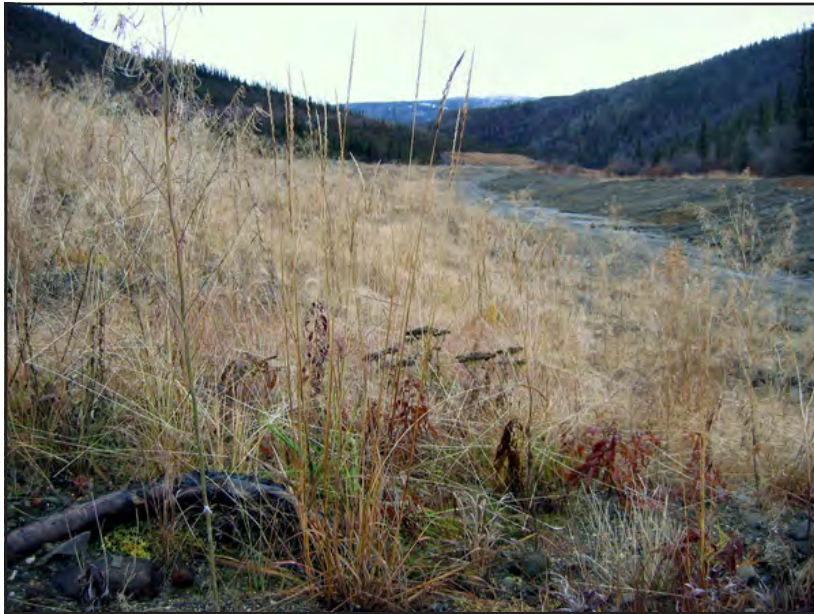
2013 award presented to Ben Warnsby and Alex Seely

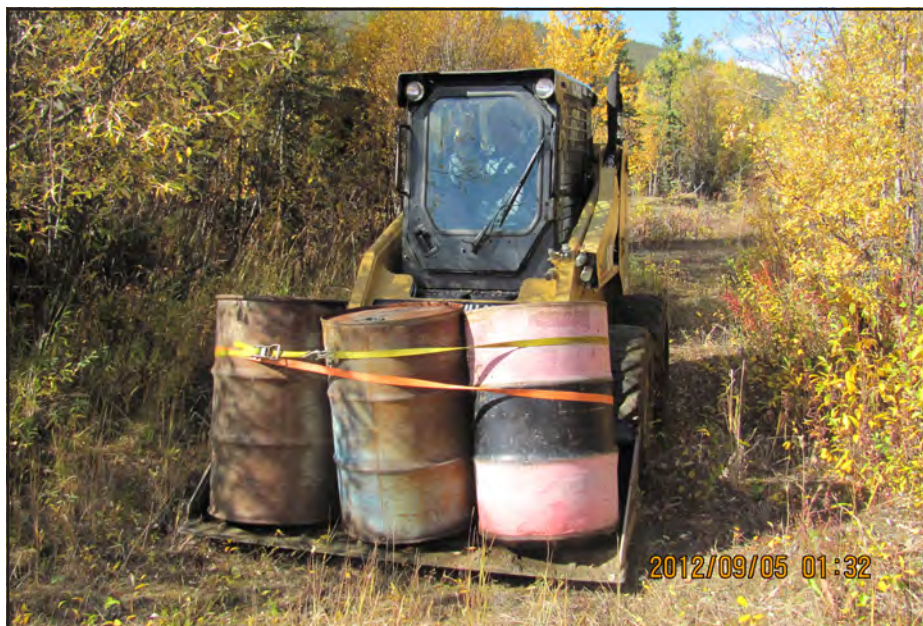
This dedication to site reclamation exceeds expectations and demonstrates exemplary environmental stewardship, benefitting the environment and setting an example for others to follow.

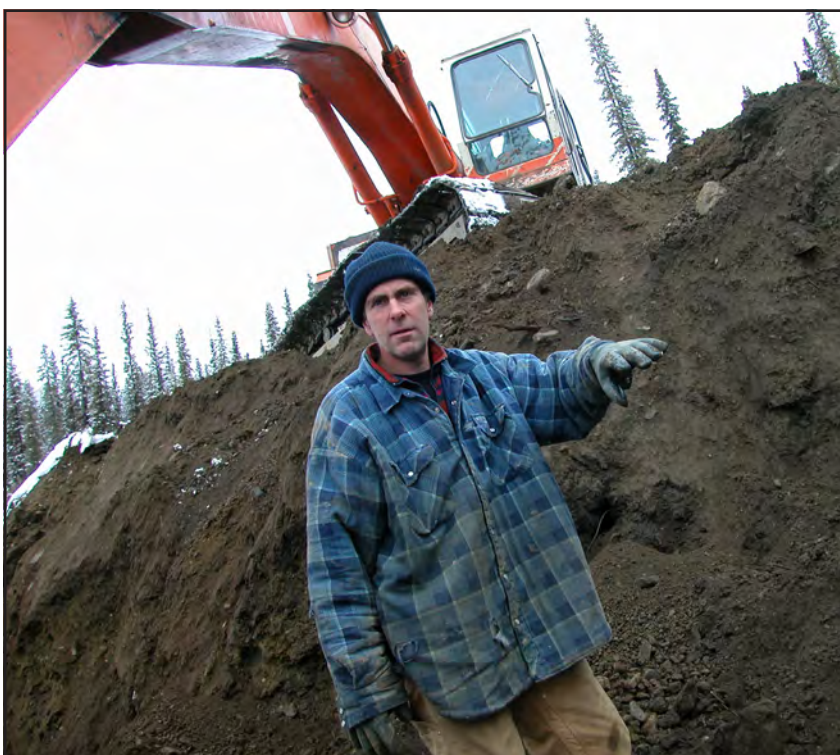
Kim explaining his theory on the trajectory of the pay unit in Davidson Creek.

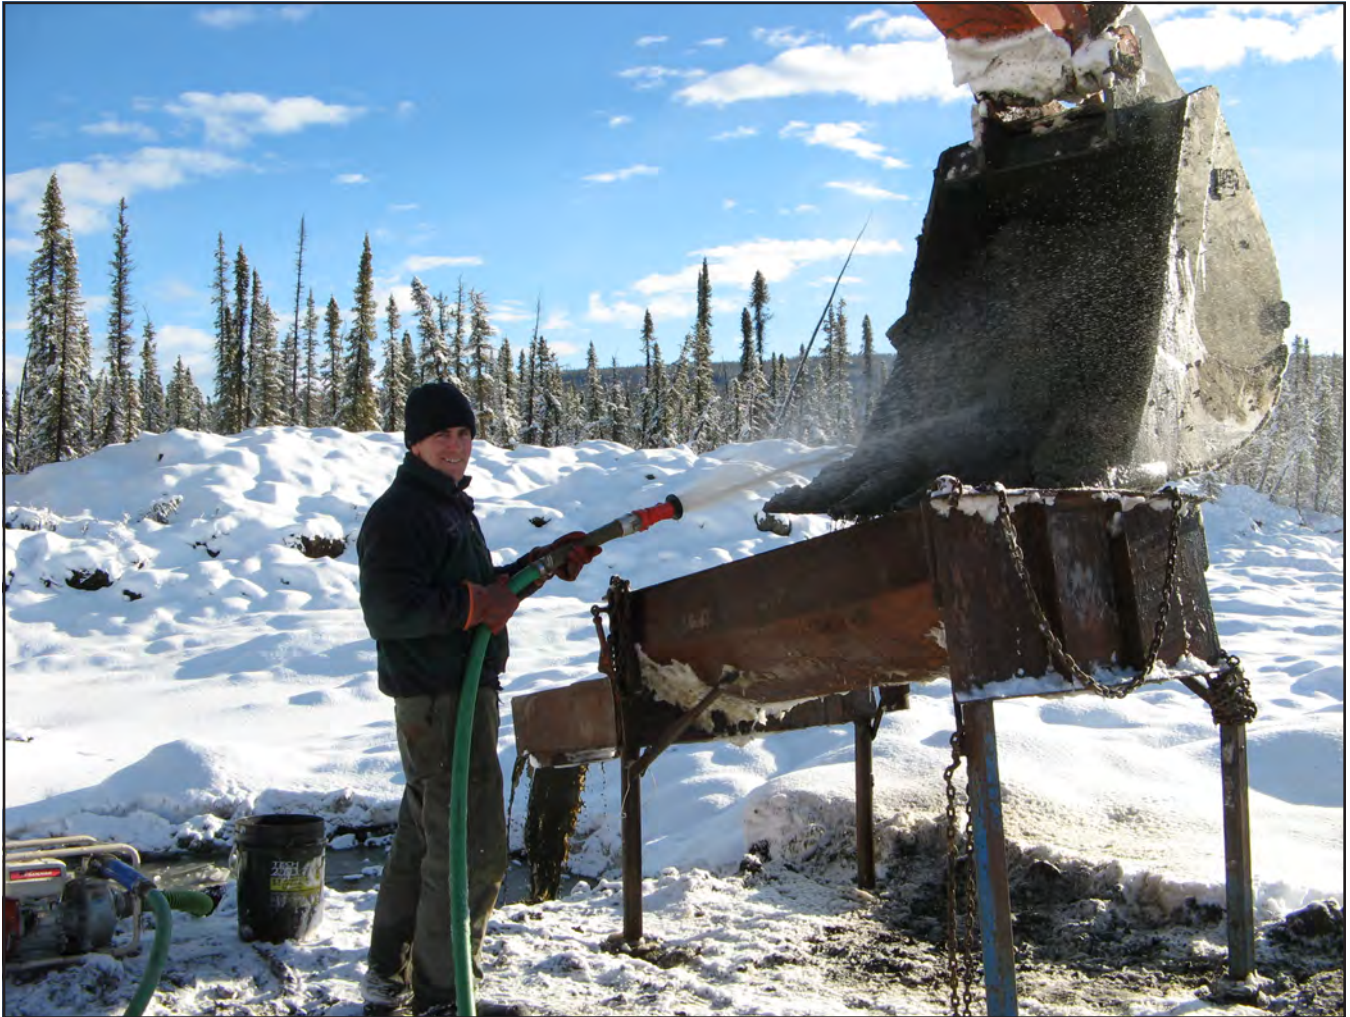
Working hard late into the season, Kim washes a test sample near the McQuesten River valley.

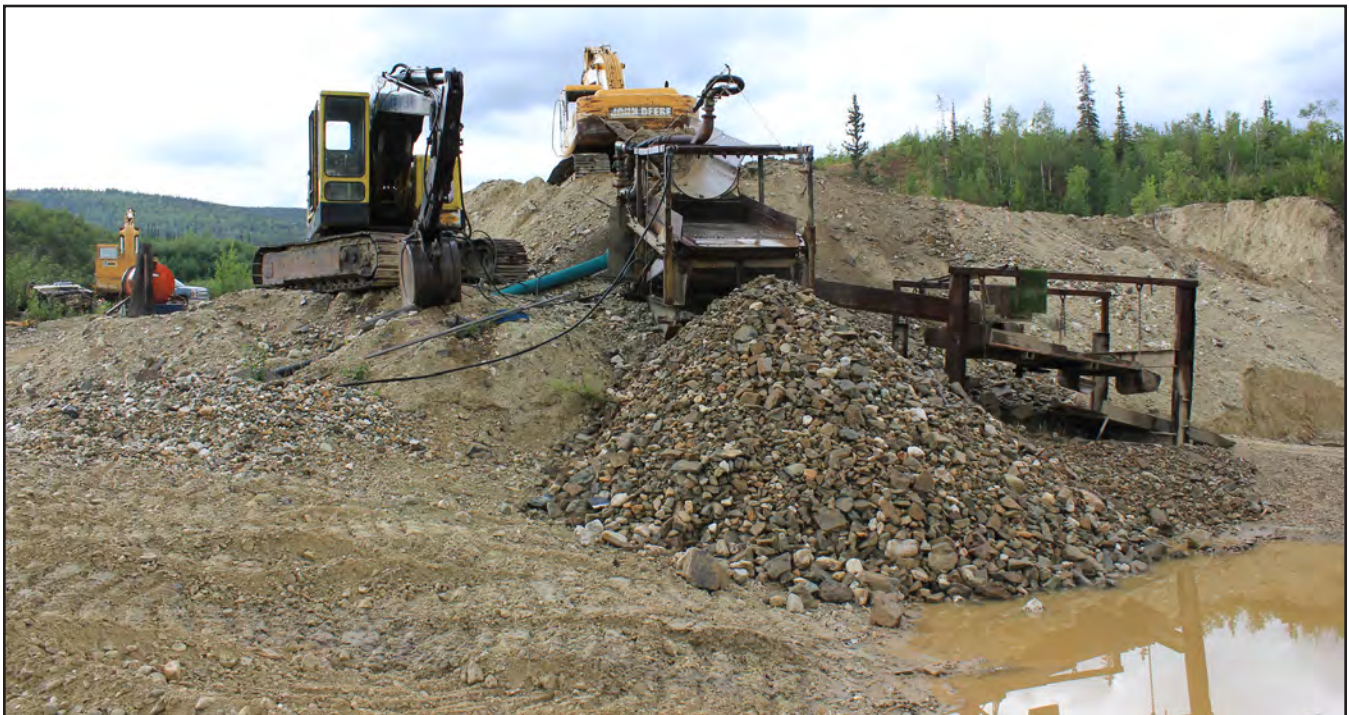
Mr. Van Bibber's wash plant beside the Bonanza Creek road in 2014.

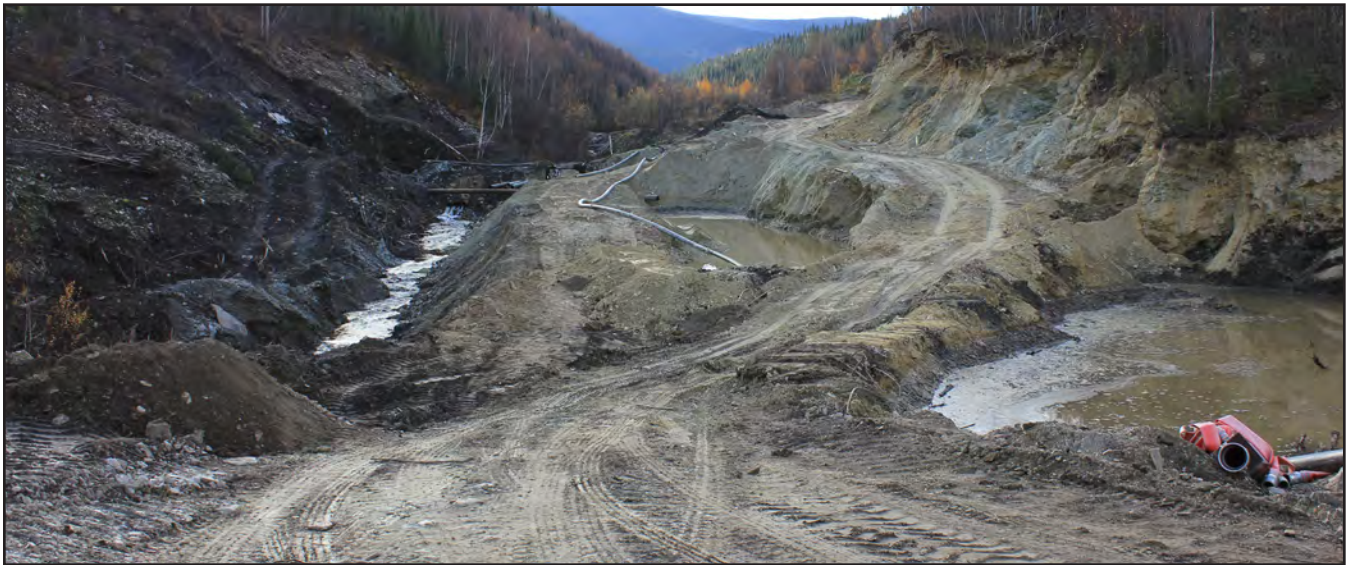
Upstream view in 2014 of the Gardiner's operation on Adams Creek.

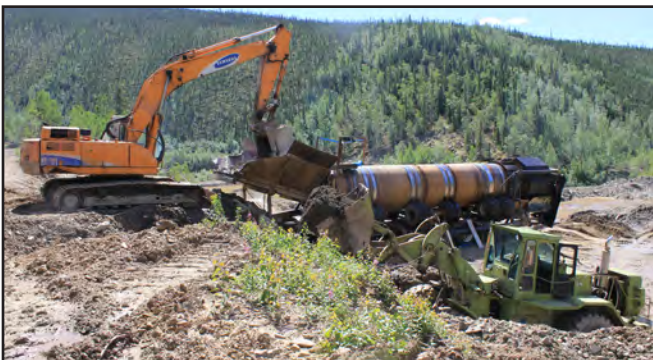
Mr. Arkininstall's trommel on upper Bonanza Creek in 2014.

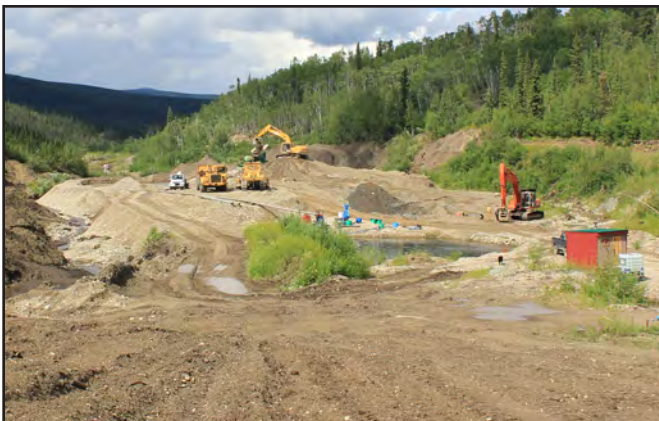
Downstream view in 2014 of the Rodal Placers operation on Eldorado Creek.

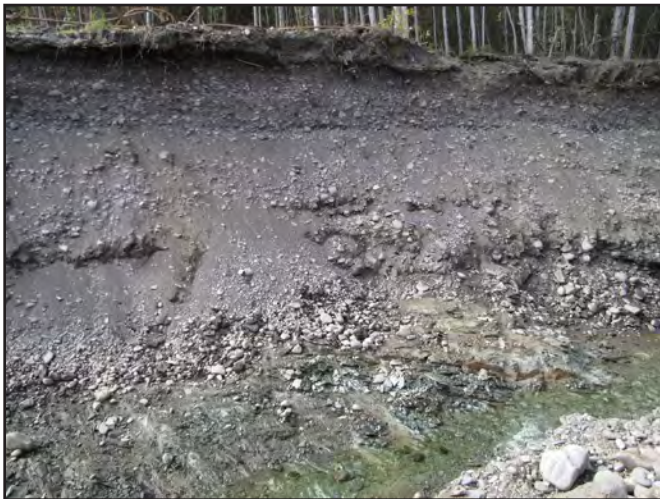
A view of Mr. Brown's left limit Klondike River exposure below Bear Creek. Virgin Klondike River gravel is preserved in this area due to the high bedrock (relatively thin gravel), which was problematic for the dredge to mine. Bedrock is exposed in the base of the cut. This section is 4.5 m (15 ft) in height.

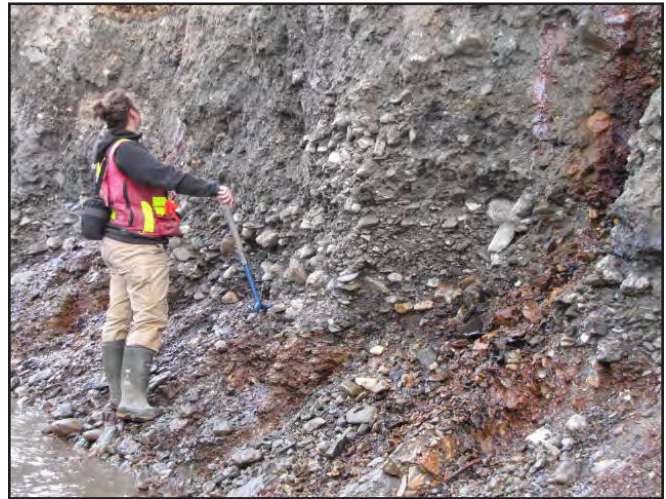
View of the left limit fluvial geology on Hunker Creek at Henry Gulch Explorations Ltd.'s cut in 2014. The pay gravel is overlain by 5 m (16.4 ft) of diamicton, gravel, and tailings overburden. The rusty brown bedrock exposed at the base of the cut is schist.

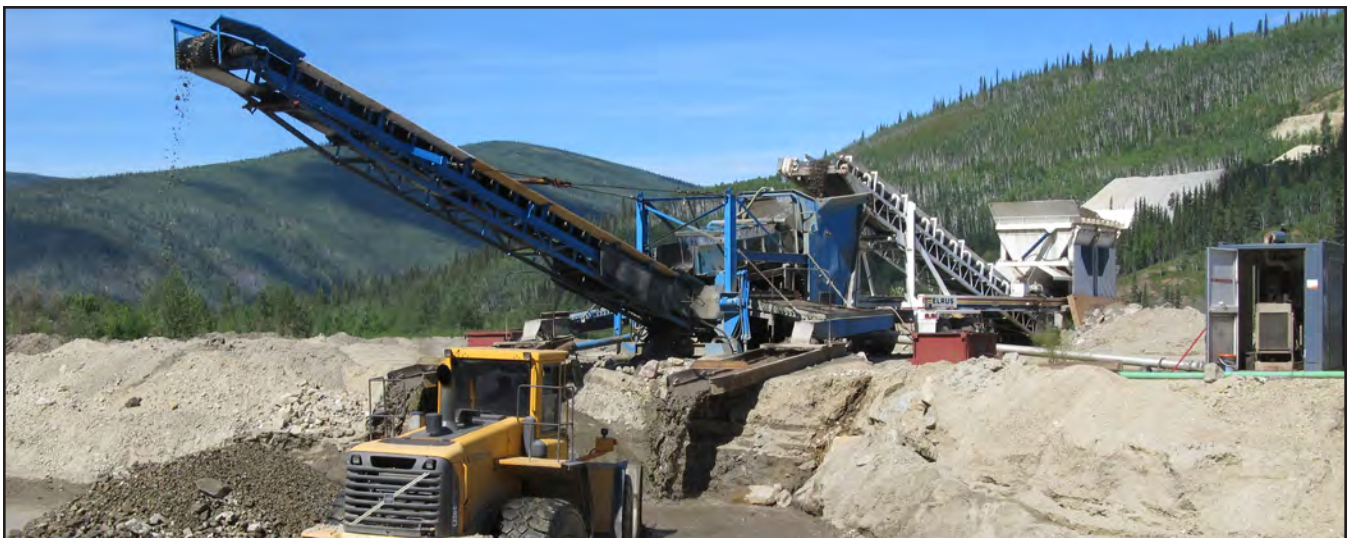
Active mining by Henry Gulch Explorations Ltd. in 2013 (Photo credit: Jim Leary).

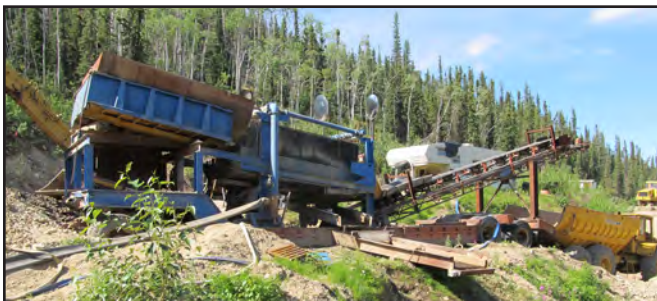
The sluice plant of Mr. Gillespie's mining operation on Henry Gulch in 2013 (Photo credit: Jim Leary).

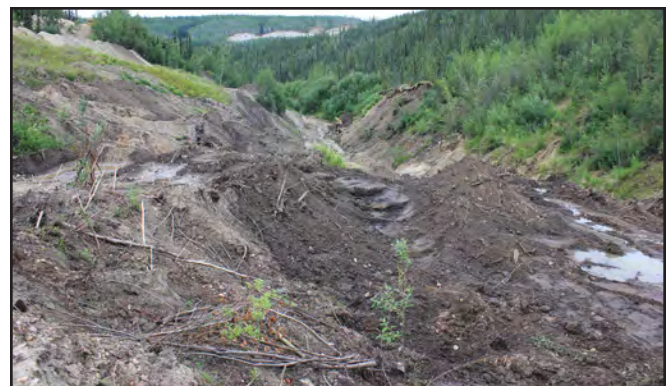
Downstream view of Mr. Gillespie's operation in 2014.

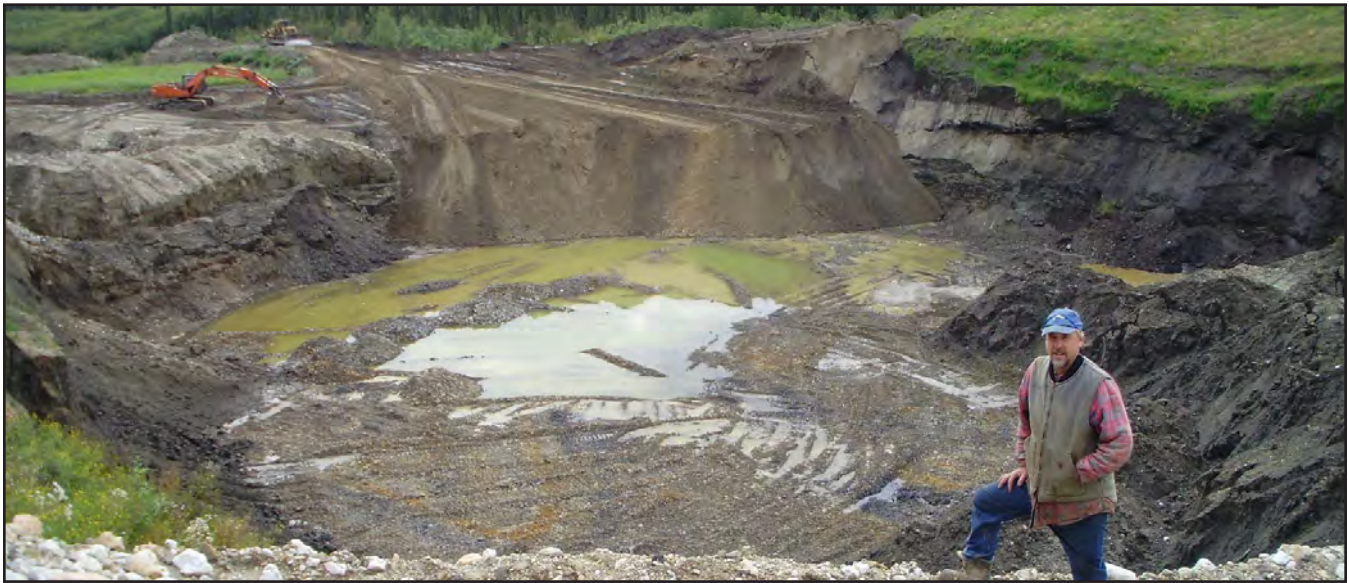
Mr. Olynyk at his cut in 2011 (Photo credit: Lee Olynyk).

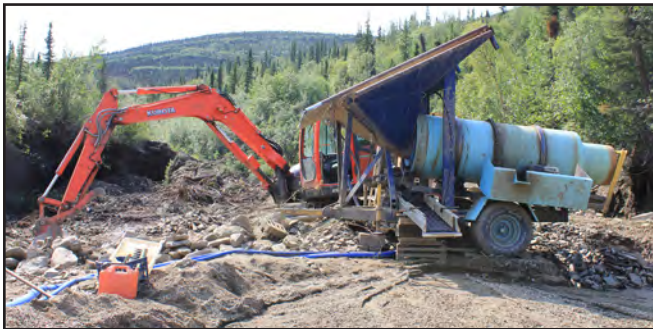
Mr. Brong and Ms. Dotzler's operation in 2014 at the upper right fork of Hunker Creek (Photo credit: Jim Leary).

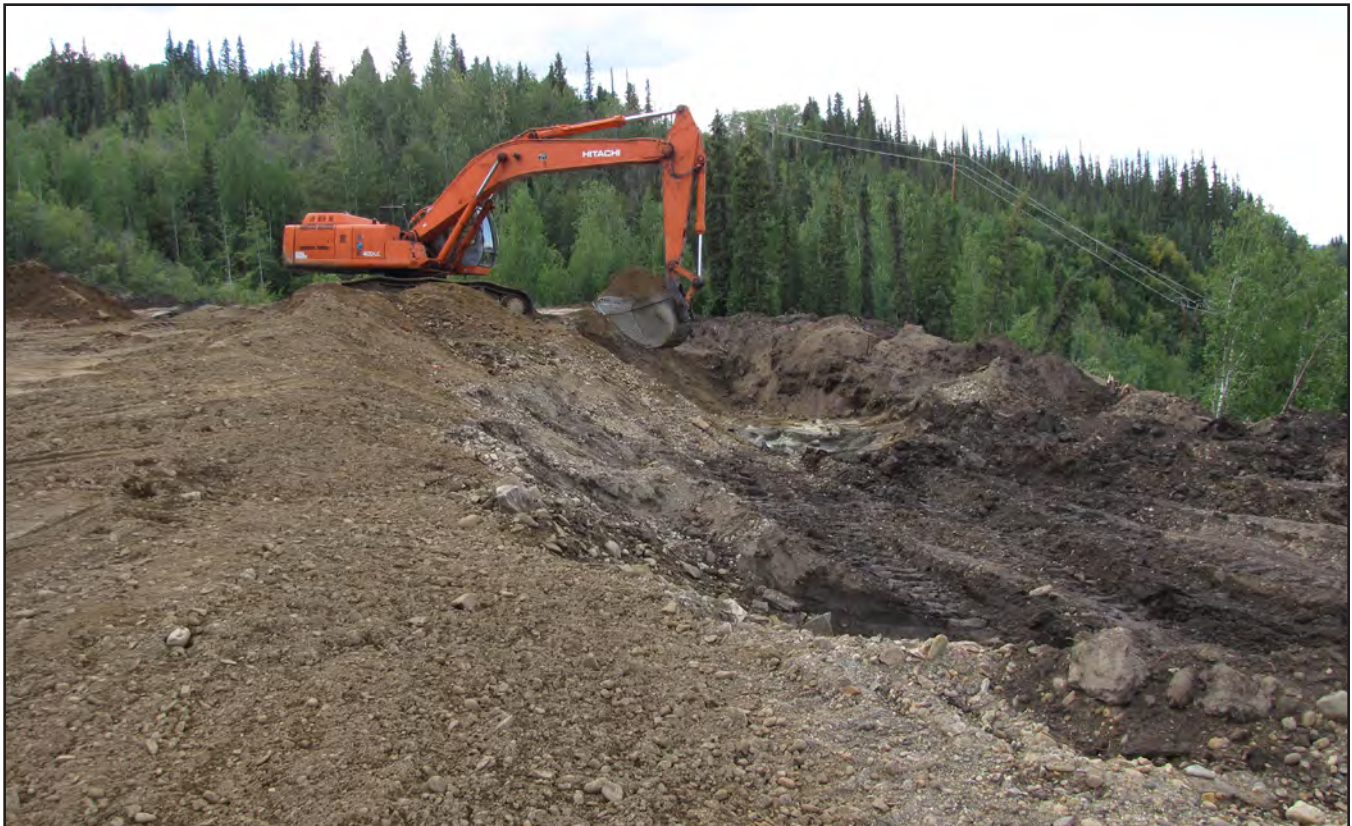
Henry Gulch Explorations active cut in 2013 on the upper left limit bench of Klondike River.

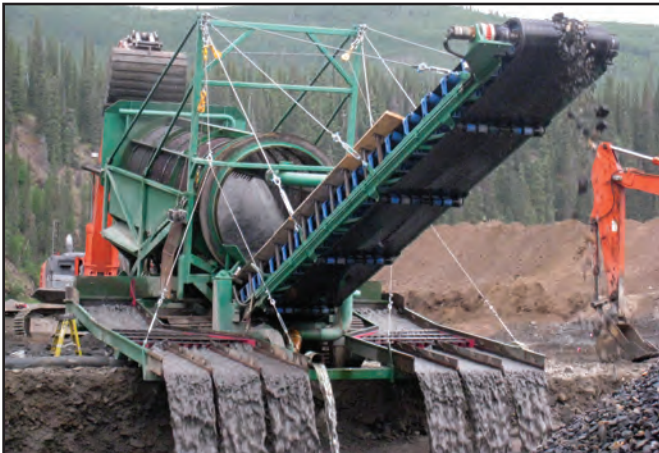
Trommel plant that M2 Gold Mines Ltd. fabricated and used in 2013 (Photo credit: Michael Cawood).

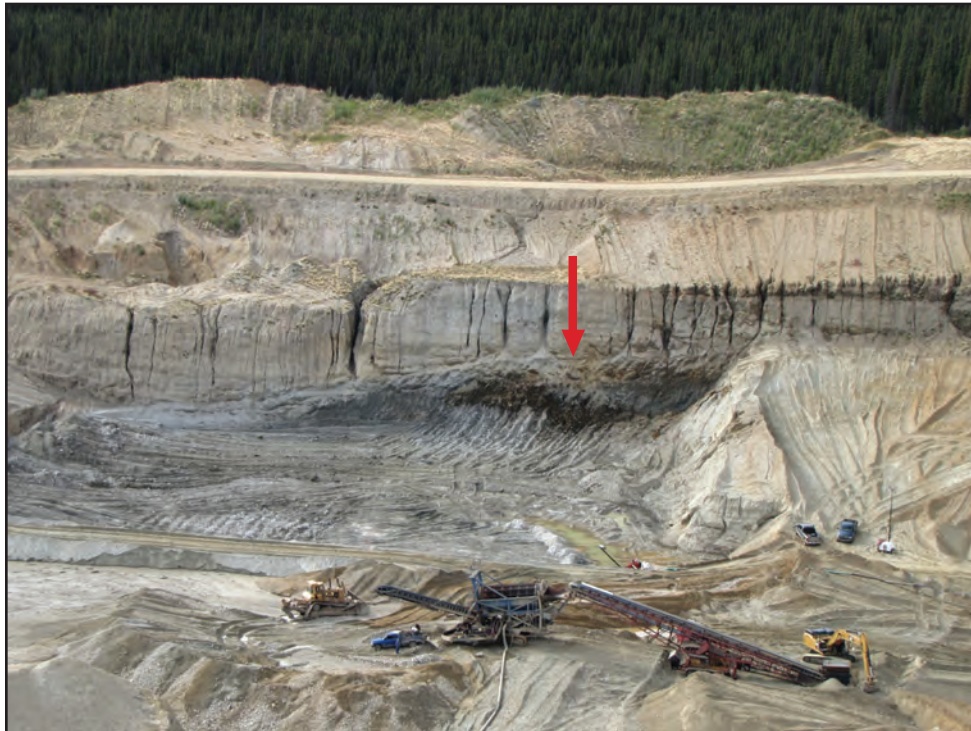
An aerial photograph from 2014 with a view to the west of Schmidt Mining's Quartz Creek bench. The mafic dike is visible in the lower White Channel gravel behind the wash plant (see arrow). Prolific old timer workings were present in this area.

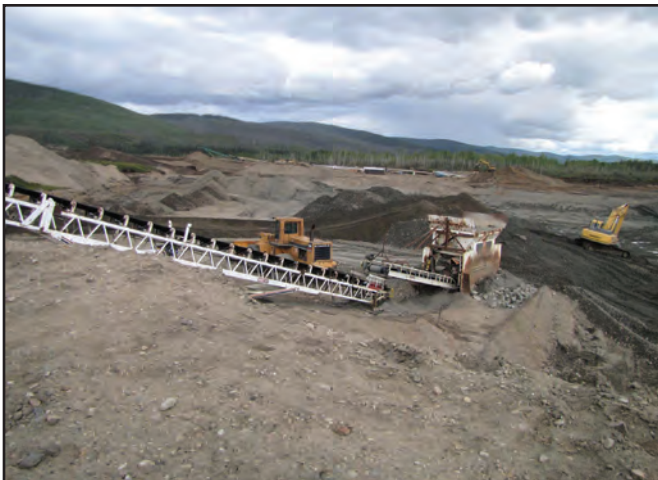
Active cut at Gimlex Enterprises Ltd. in 2011.

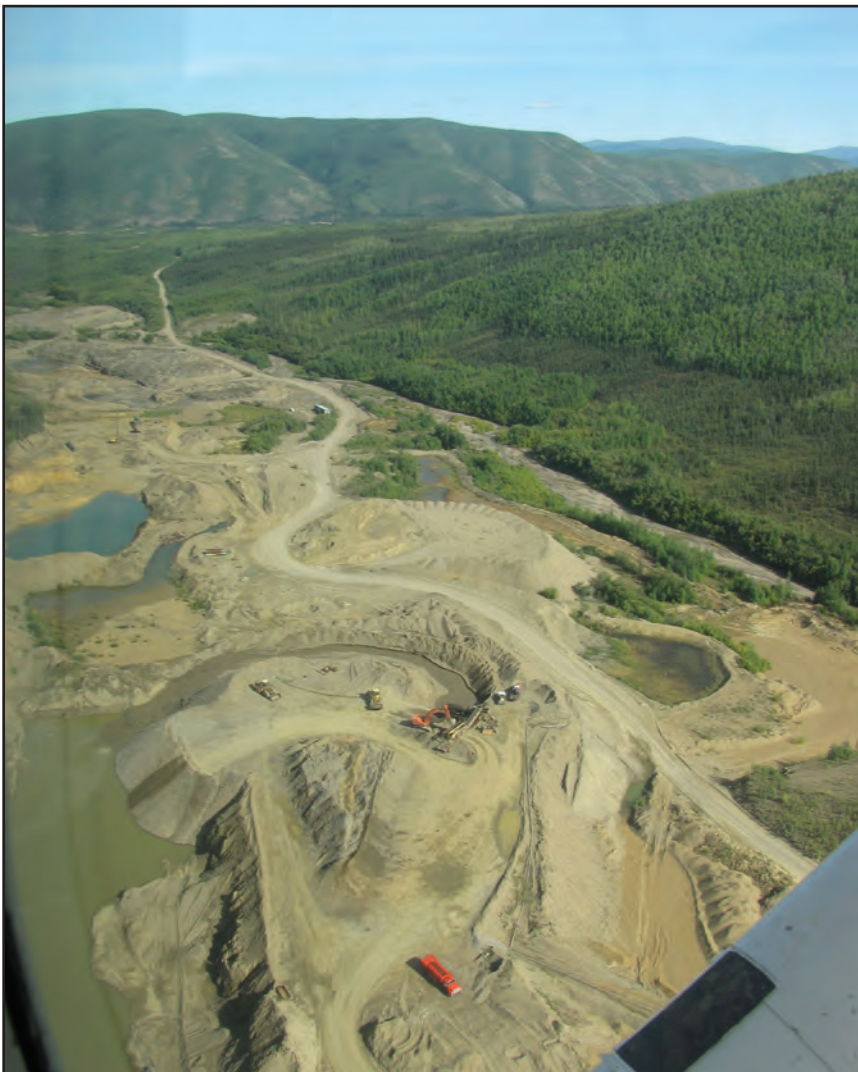
Downstream view of activity on Eureka Creek in 2013.

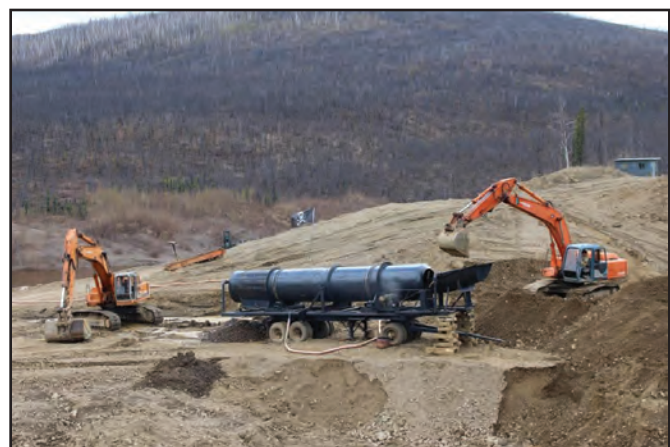
Them R Gold Ltd. wash plant on Eureka Creek (Photo credit: Marie Charbonneau).

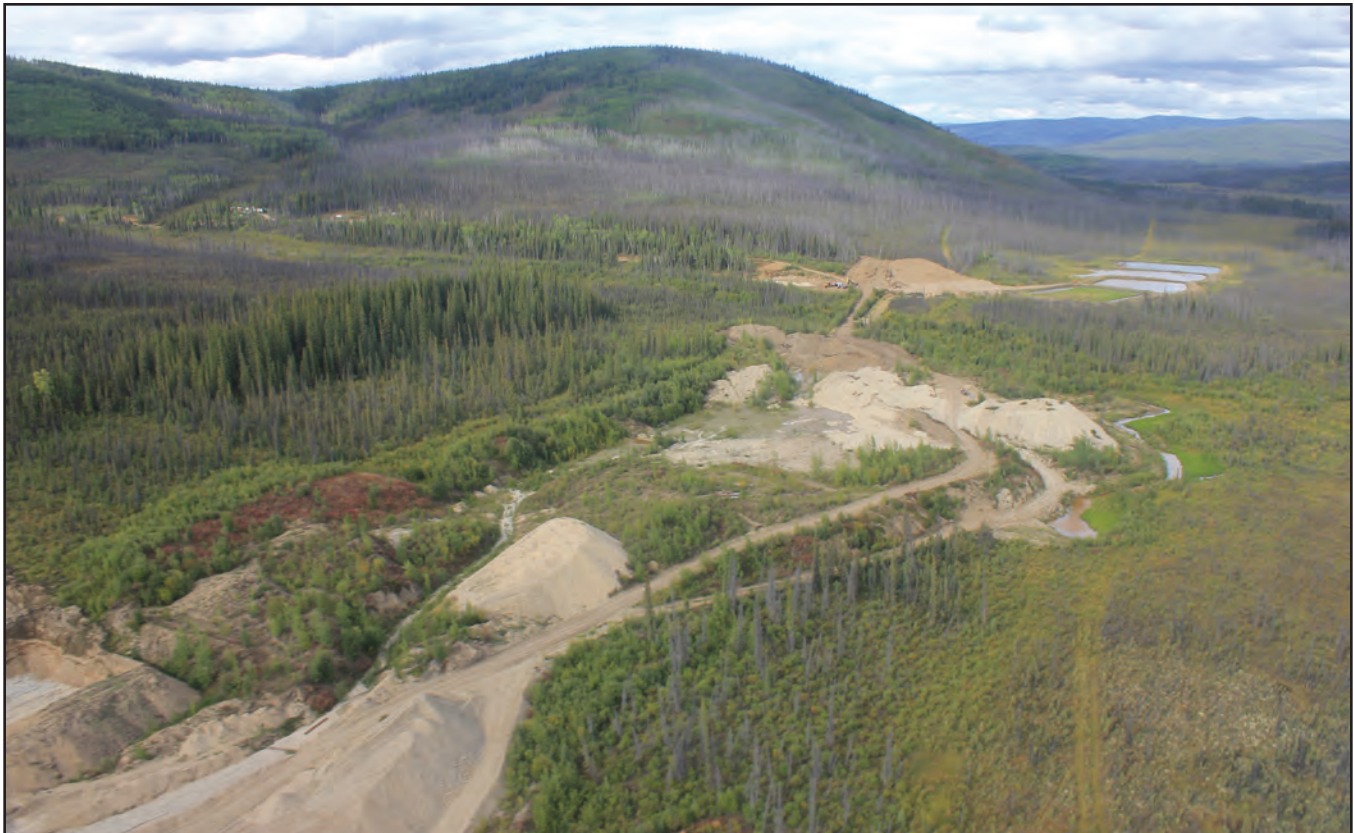
2014 downstream view of cuts on Montana Creek and mouth of Stowe Creek on the left limit.

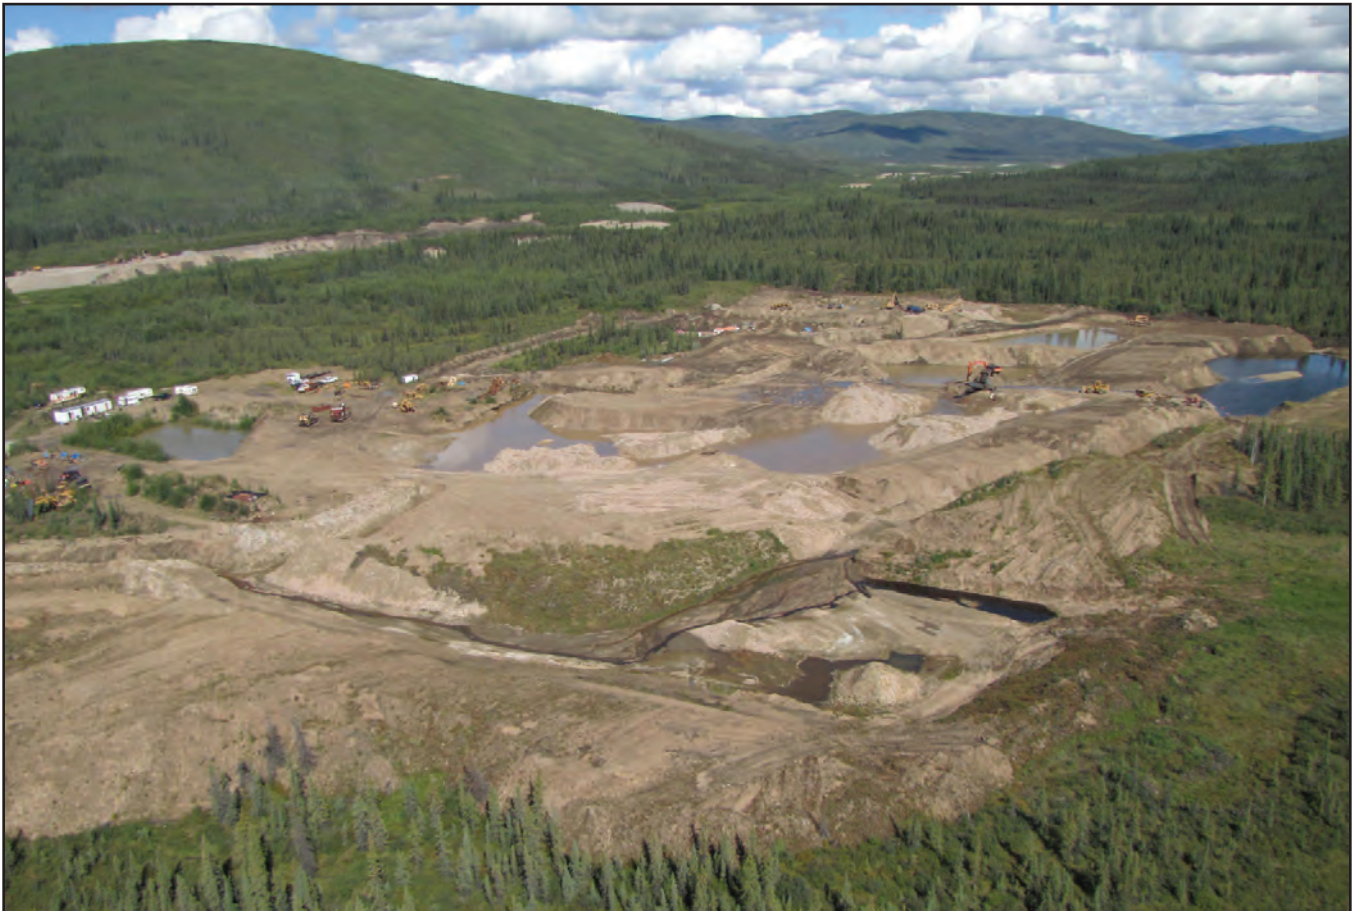
View to the northeast over Mr. Abermeth's mine at the confluence of Wounded Moose and Australia creeks. Dominion Creek valley is visible in the distance.

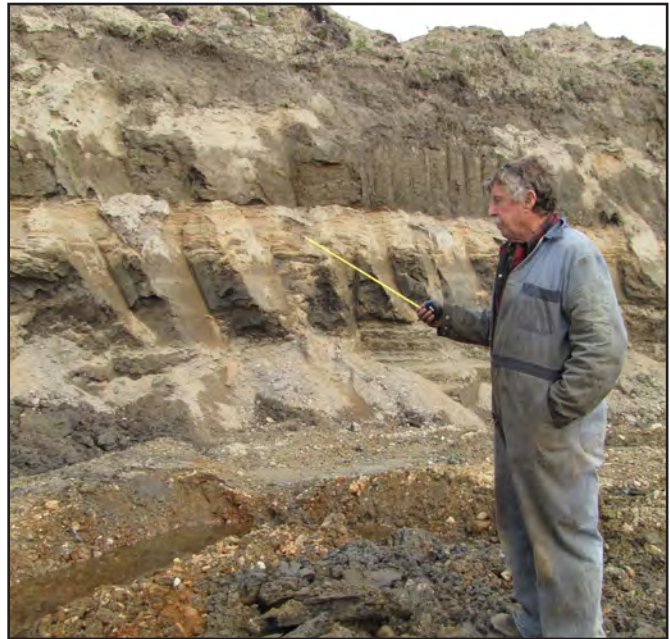
A view of the left limit overburden geology on Dominion Creek. Mr. Hollis is standing on the paleo-Dominion Creek pay gravel.

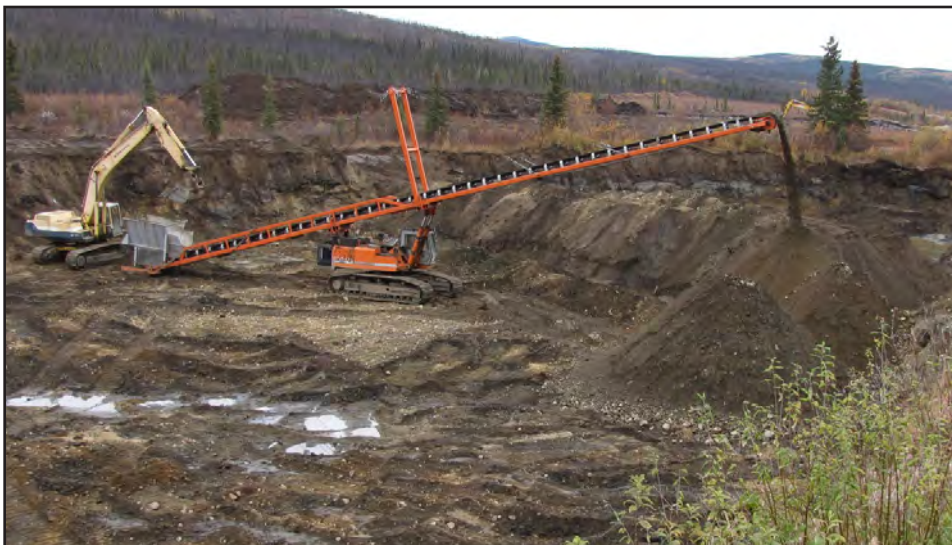
Mr. Hollis' operation on Dominion Creek in 2013, showing his custom-built track mounted conveyor.

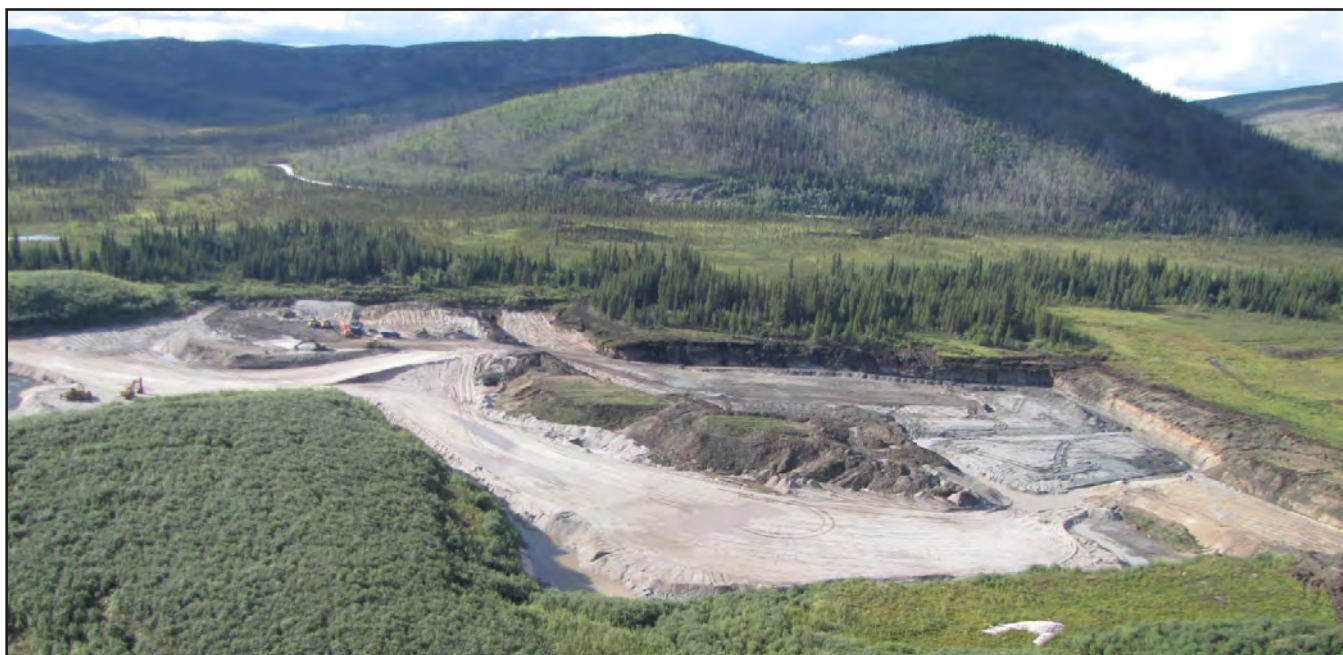
Dominion Gold Resources operation on Dominion Creek at the mouth of Eagle Creek.

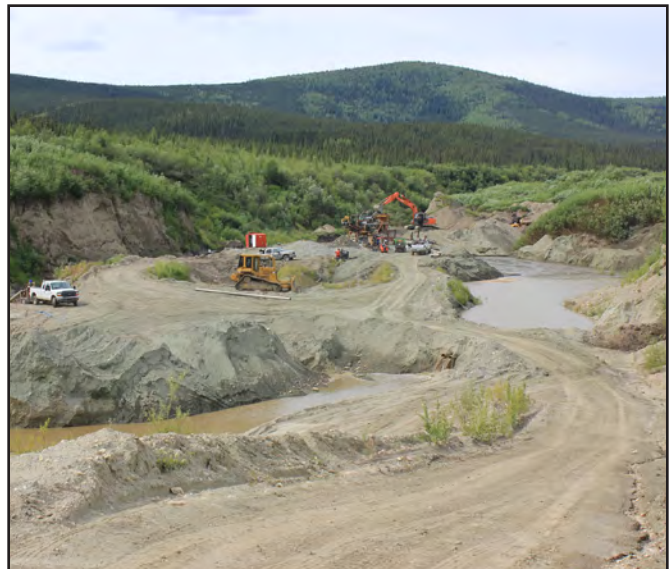
Mammoth Mining's operation on upper Gold Run Creek in 2014, looking upstream towards 71 Pup.

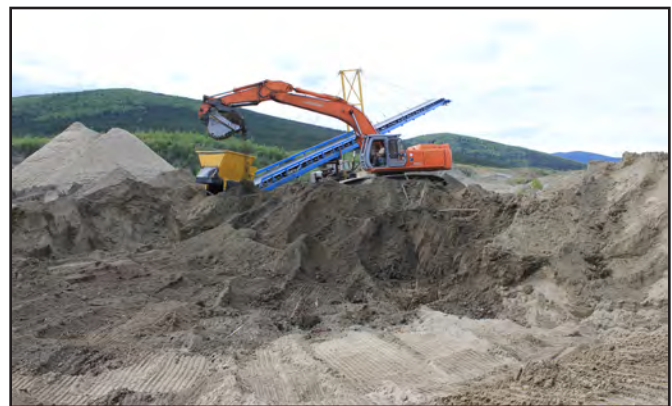
Rical Mining Ltd. moving overburden with their custom fabricated track-mounted conveyor on lower Gold Run Creek in 2014.

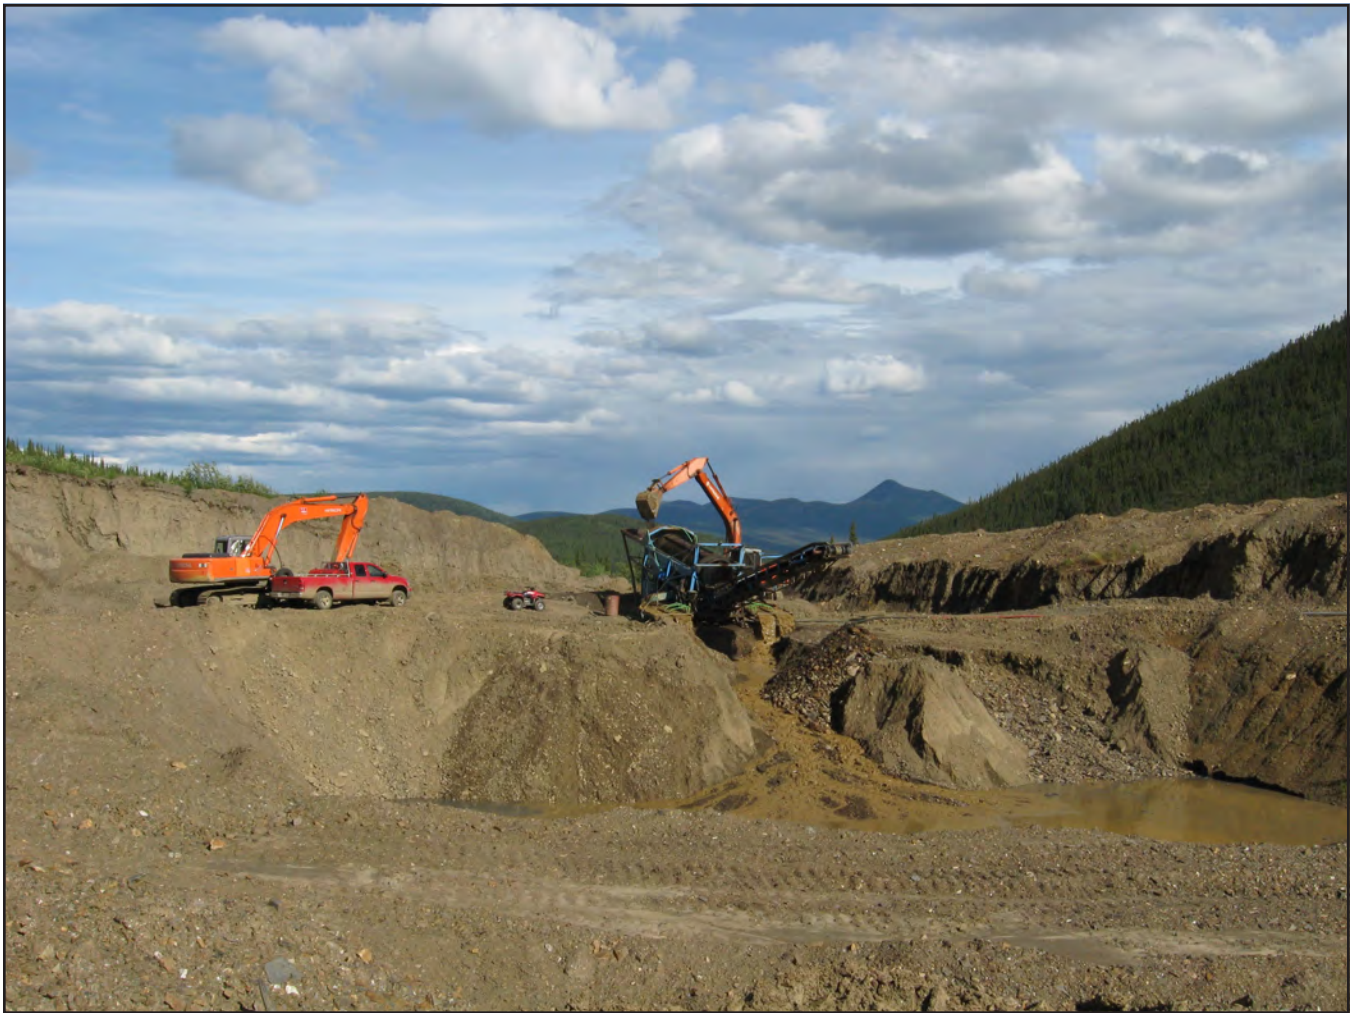
K-1 Mining's sluice operation in 2010 on left limit upper channel, Glacier Creek (Photo credit: M. McDougall).

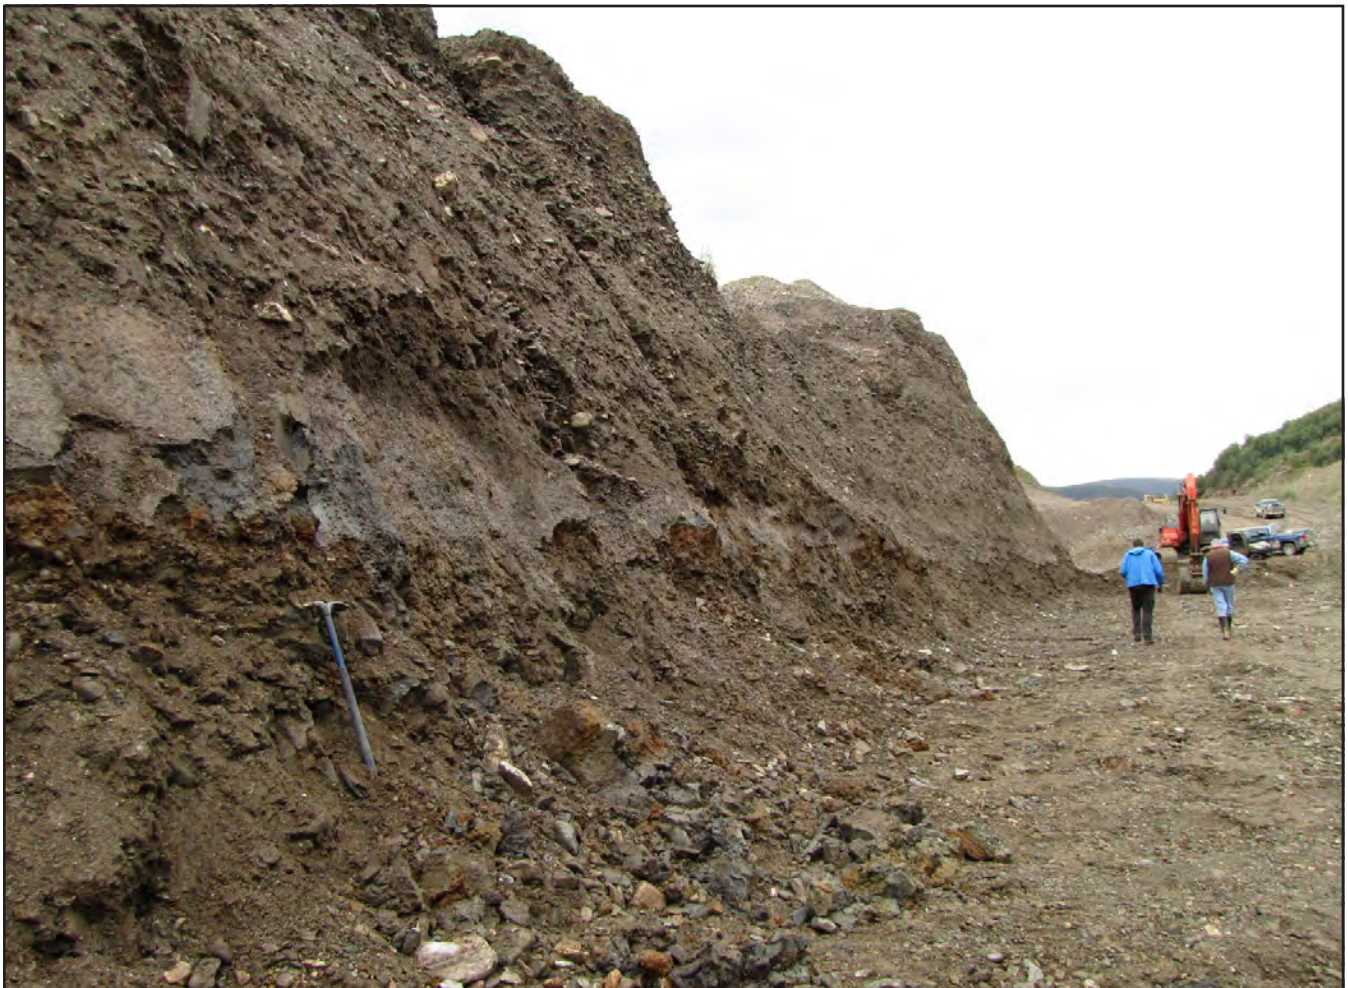
Exposure of the left limit bench gravel in lower Miller Creek. The pick is leaning against the pay gravel which is overlain by a laterally continuous silt and upwards of 24 m (80 ft) of gravel.

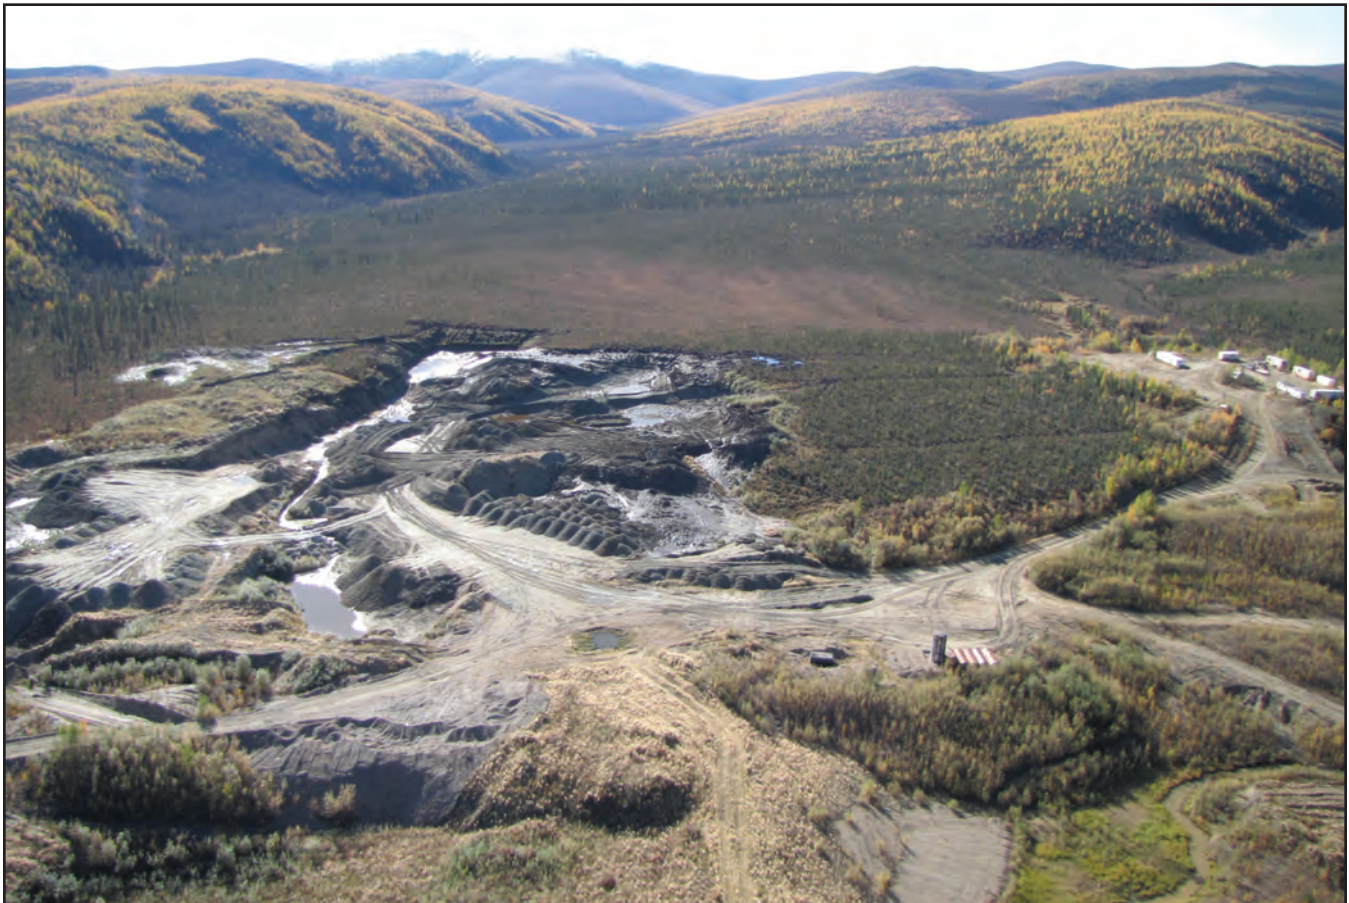
View to the south of Magna North's lower cut on a right limit bench of Matson Creek in 2014. The camp is located on the right hand side of the photo.
