Yukon Placer Mining Industry

2010 to 2014

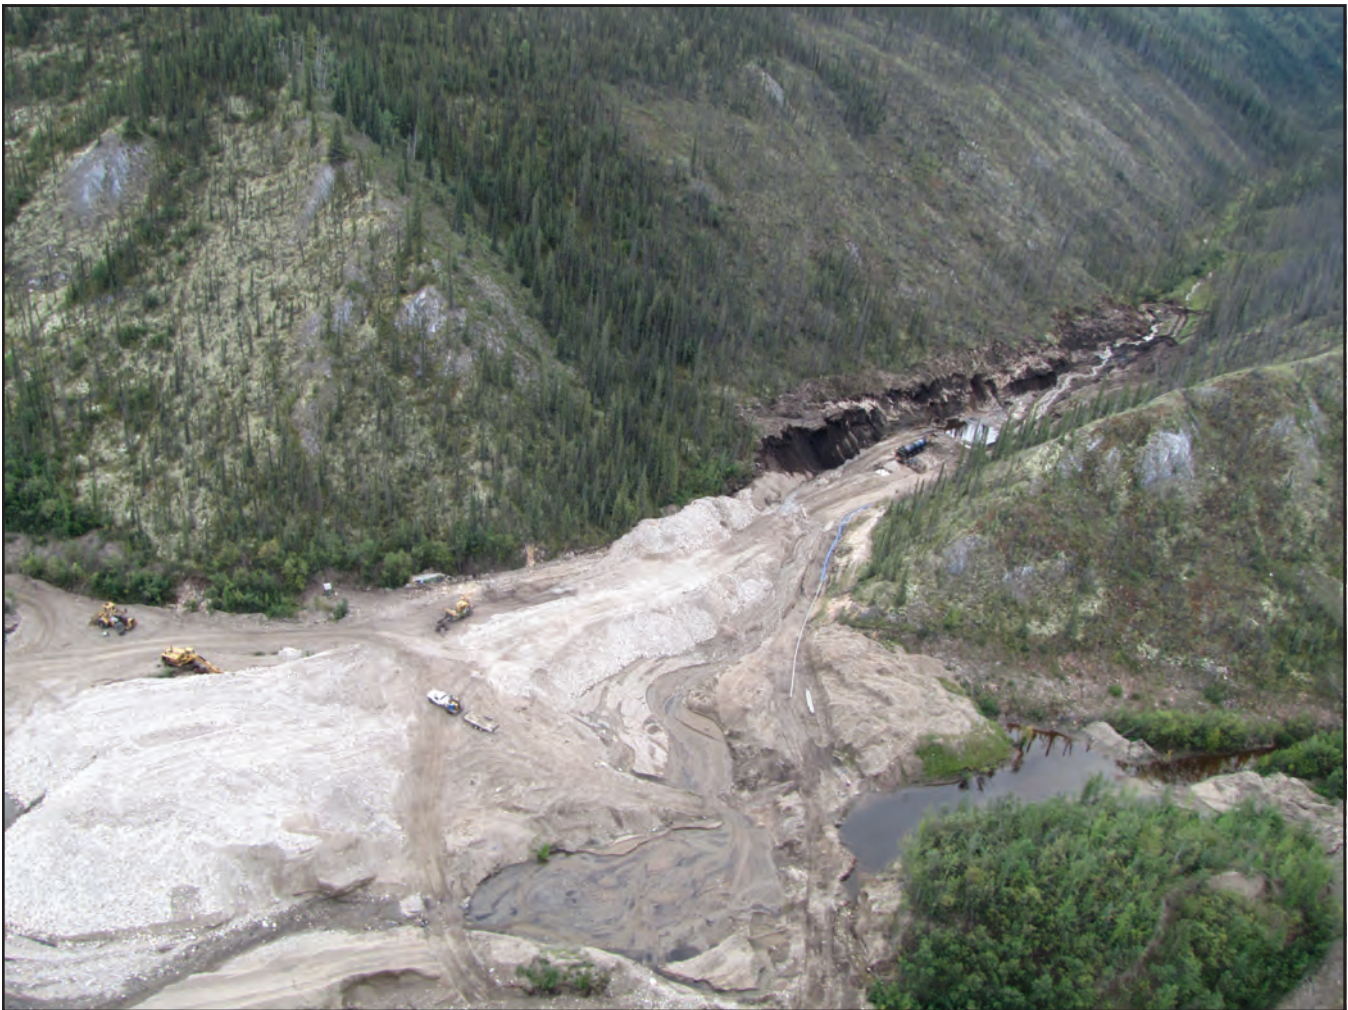
View looking up Donovan Pup from its confluence with 10 Mile Creek. Outcrops of marble are visible on the ridges on either side of the pup. Marble is a relatively resistant rock and creates a narrow valley in the lower part of the drainage.

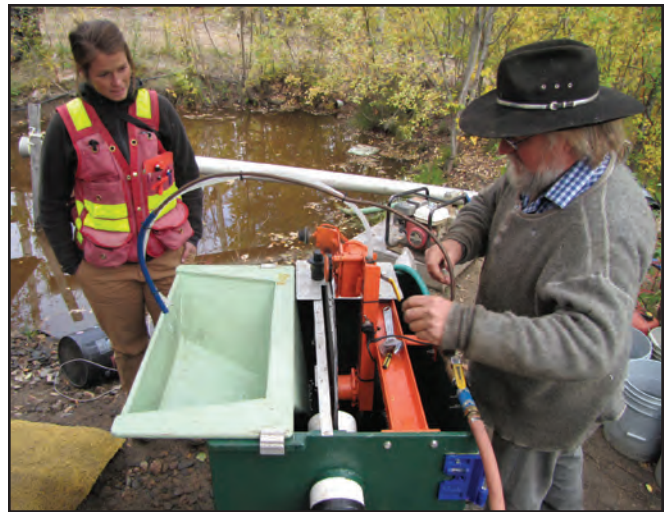
Ian Warrick demonstrates his custom-built magnetic separator used for cleaning concentrates.

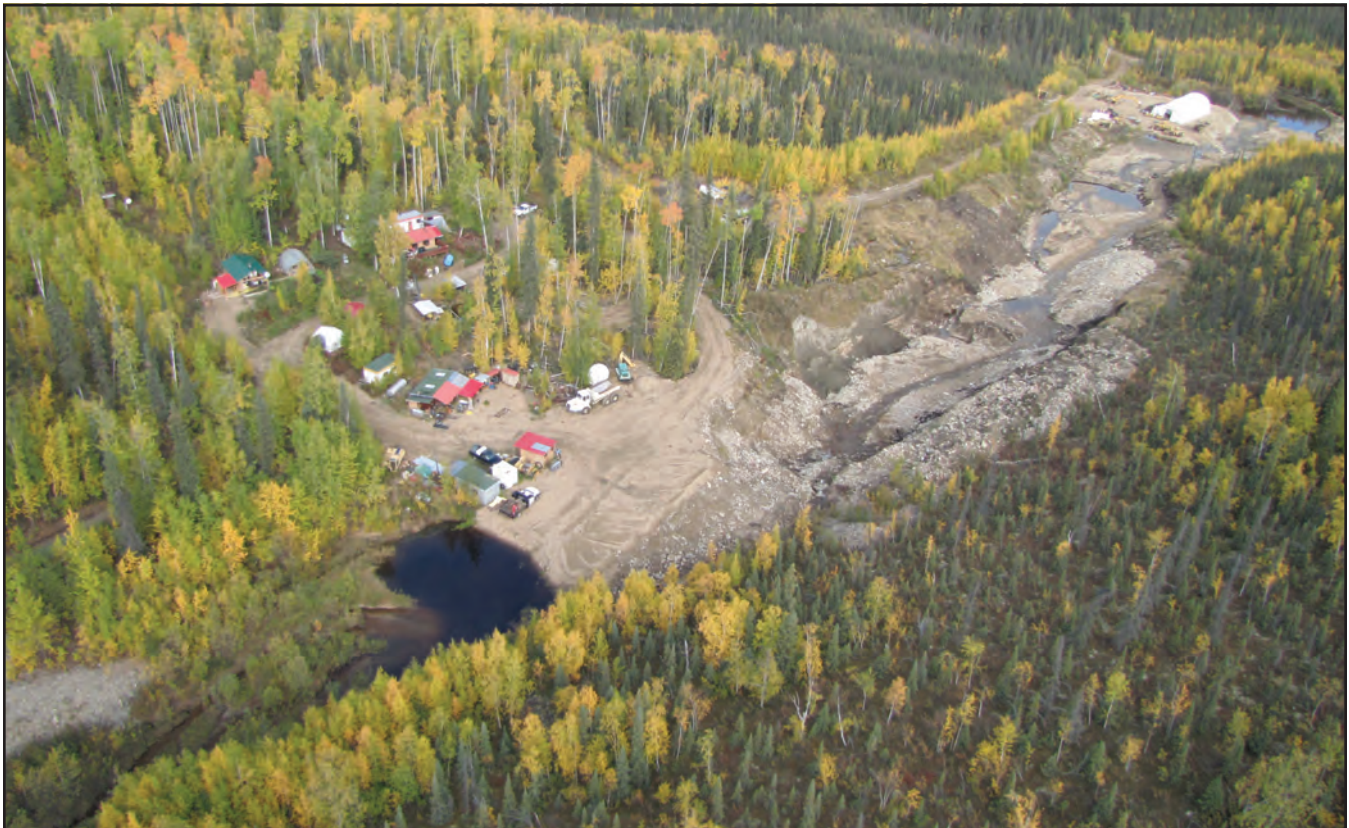
A view of Moosehorn Exploration Ltd's mining cut in 2014 near their camp.

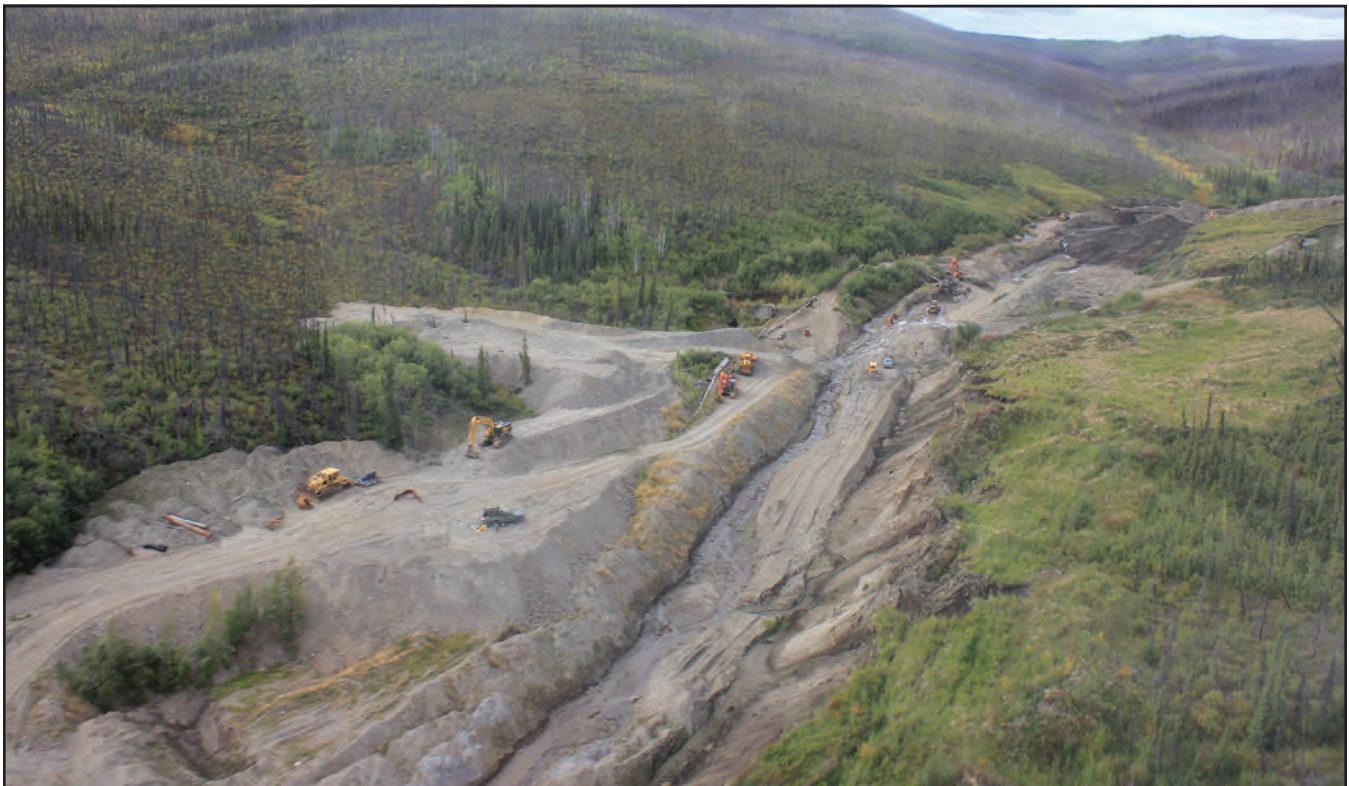
Aerial view in 2014 of Mr. Smith's operation on upper Black Hills creek.

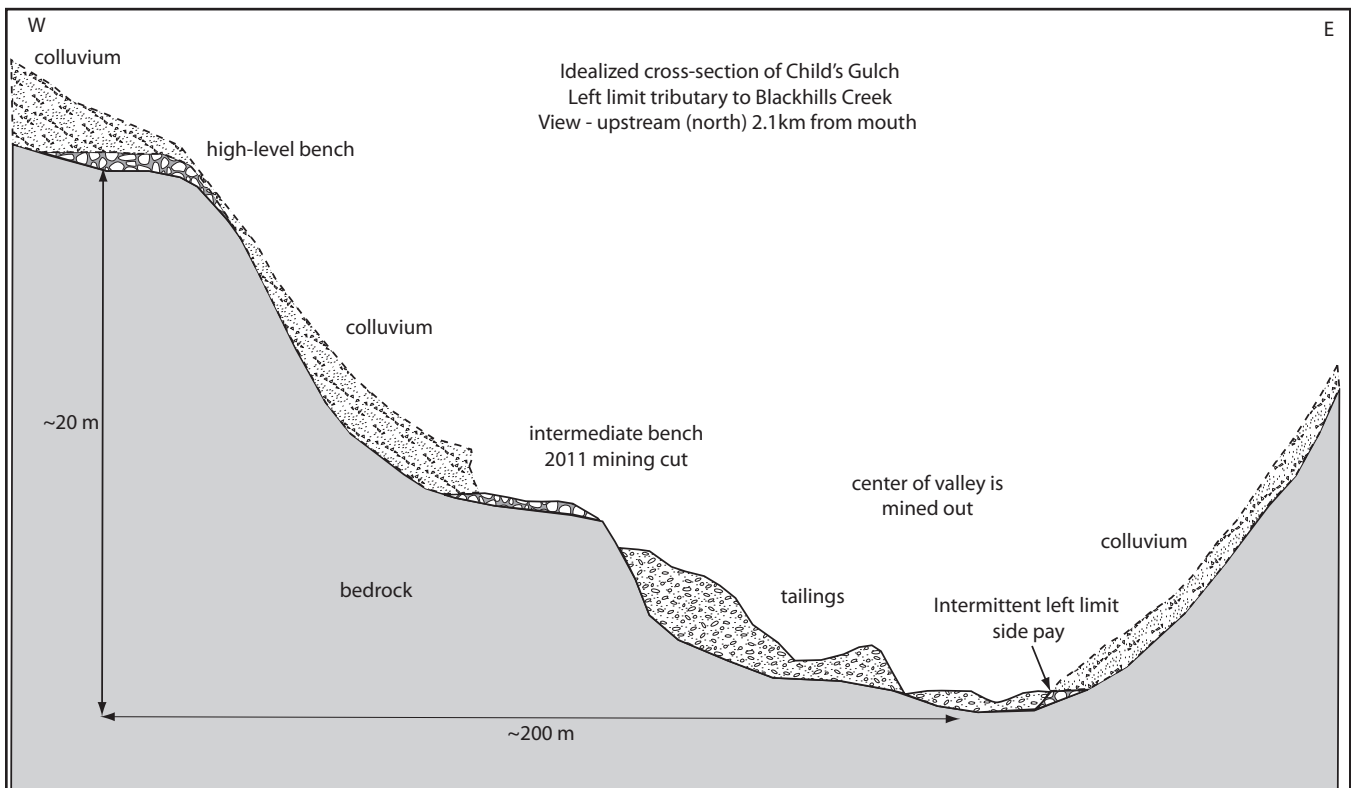
Idealized cross section of Childs Gulch (Source: Jeff Bond).

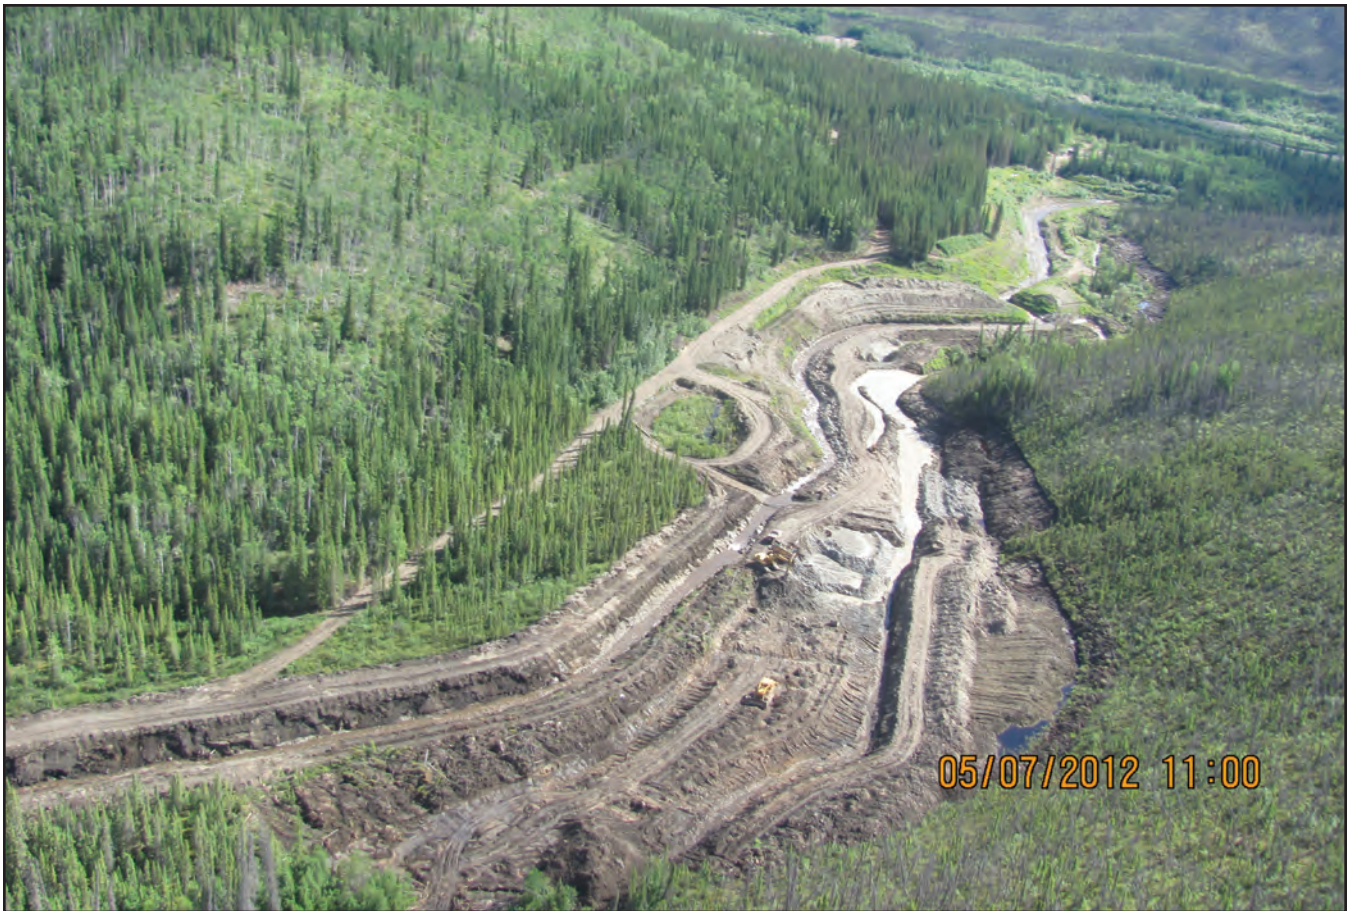
Aerial view of Mr. Armstrong's operation on Dome Creek in 2012 (Photo credit: Jim Leary).

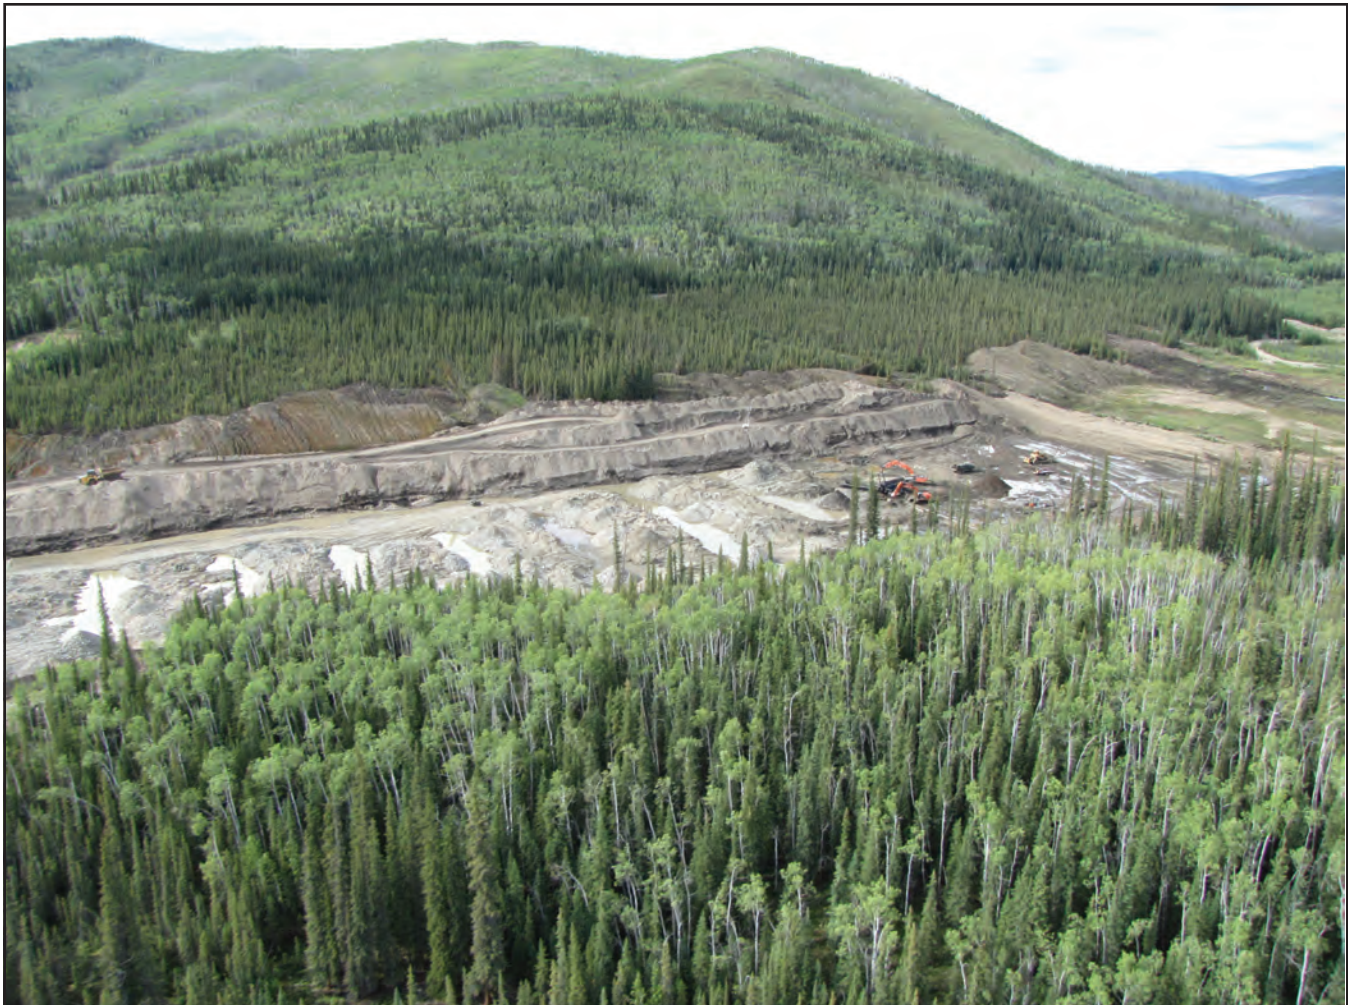
Aerial view from 2014 looking northwest over the Hambrook's operation on Black Hills Creek. A right limit bench is visible immediately above the tailings piles on the far side of the valley. This landform was mined further downstream in 2012.

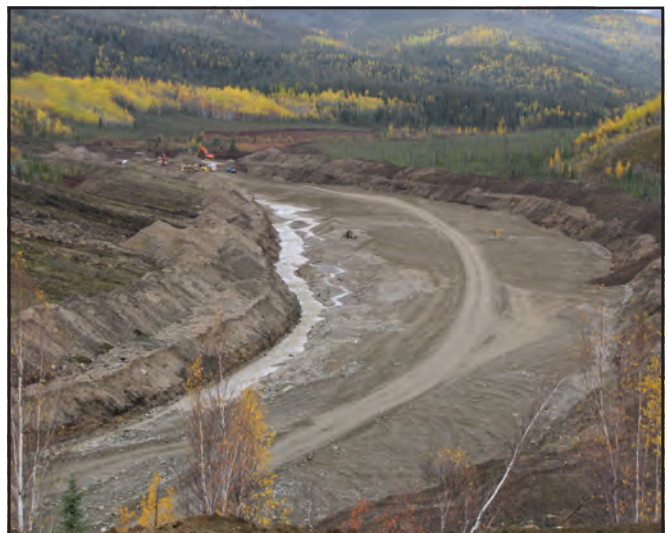
View looking north at H.C. Mining Ltd operation on North Henderson Creek in 2013.

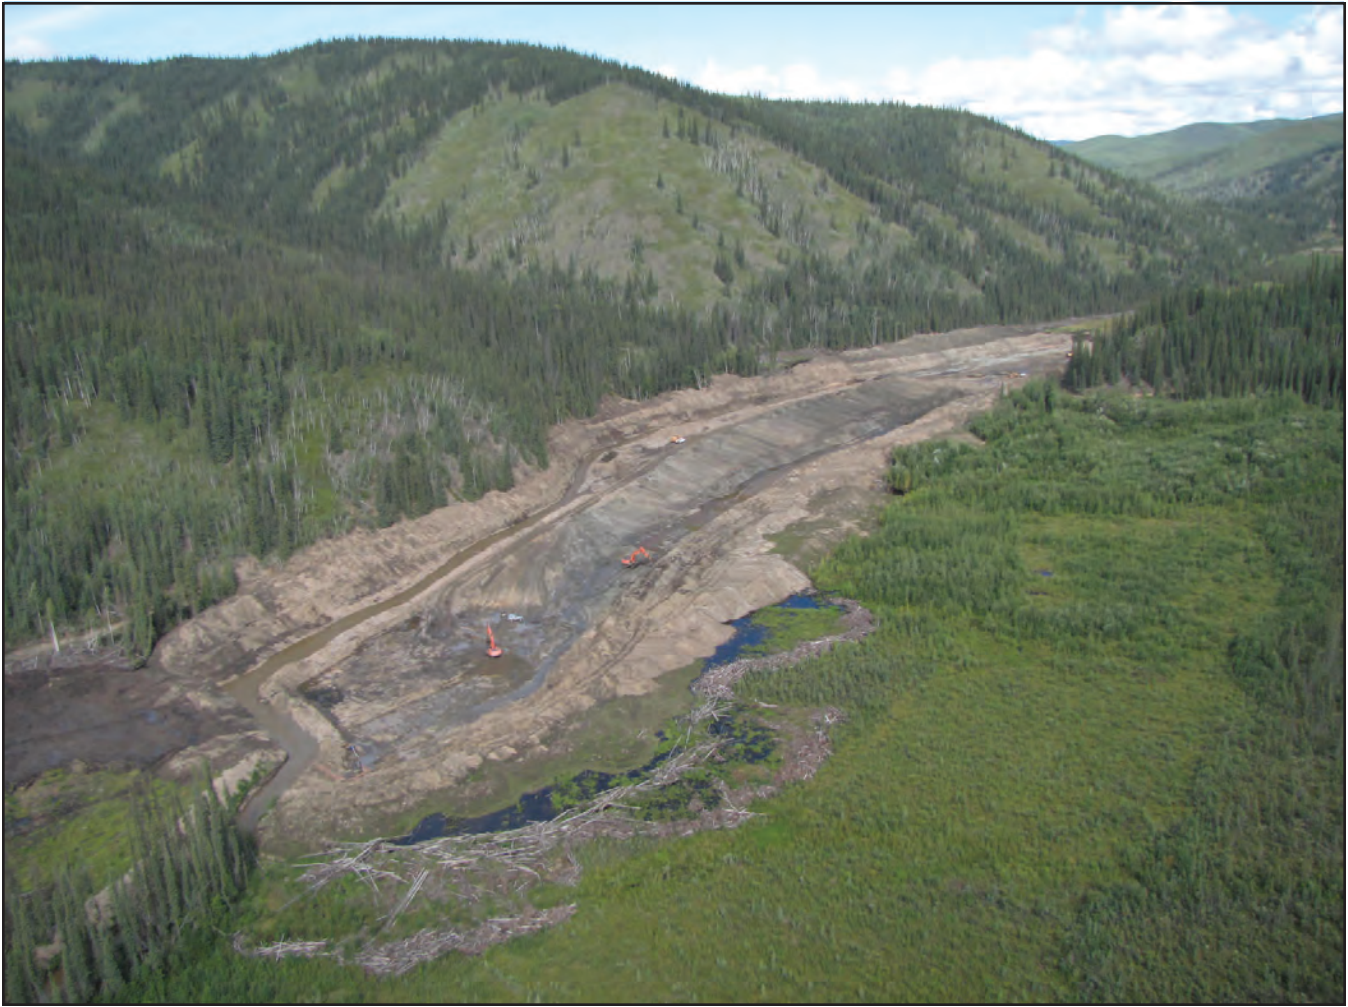
View looking northeast at H.C. Mining Ltd. operation below the confluence between Henderson and North Henderson creeks in 2014.

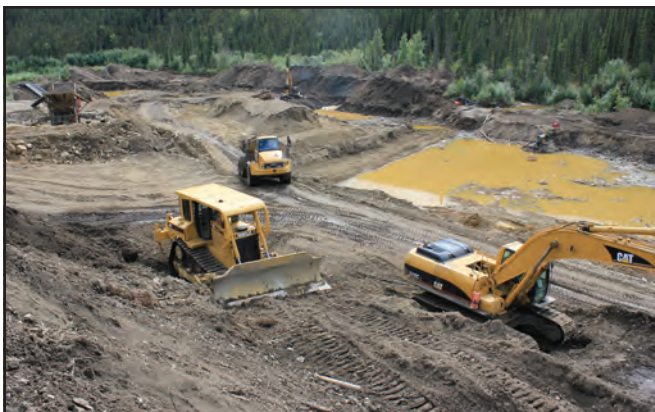
Bedrock Mining Company Inc.'s cut in 2014 on Maisey May Creek.

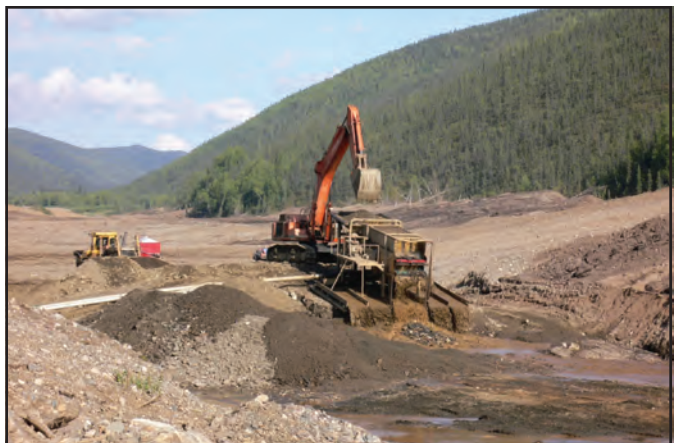
Sluicing at the Midas Rex Mining Inc. operation on Barker Creek (Photo credit: Stuart Schmidt).

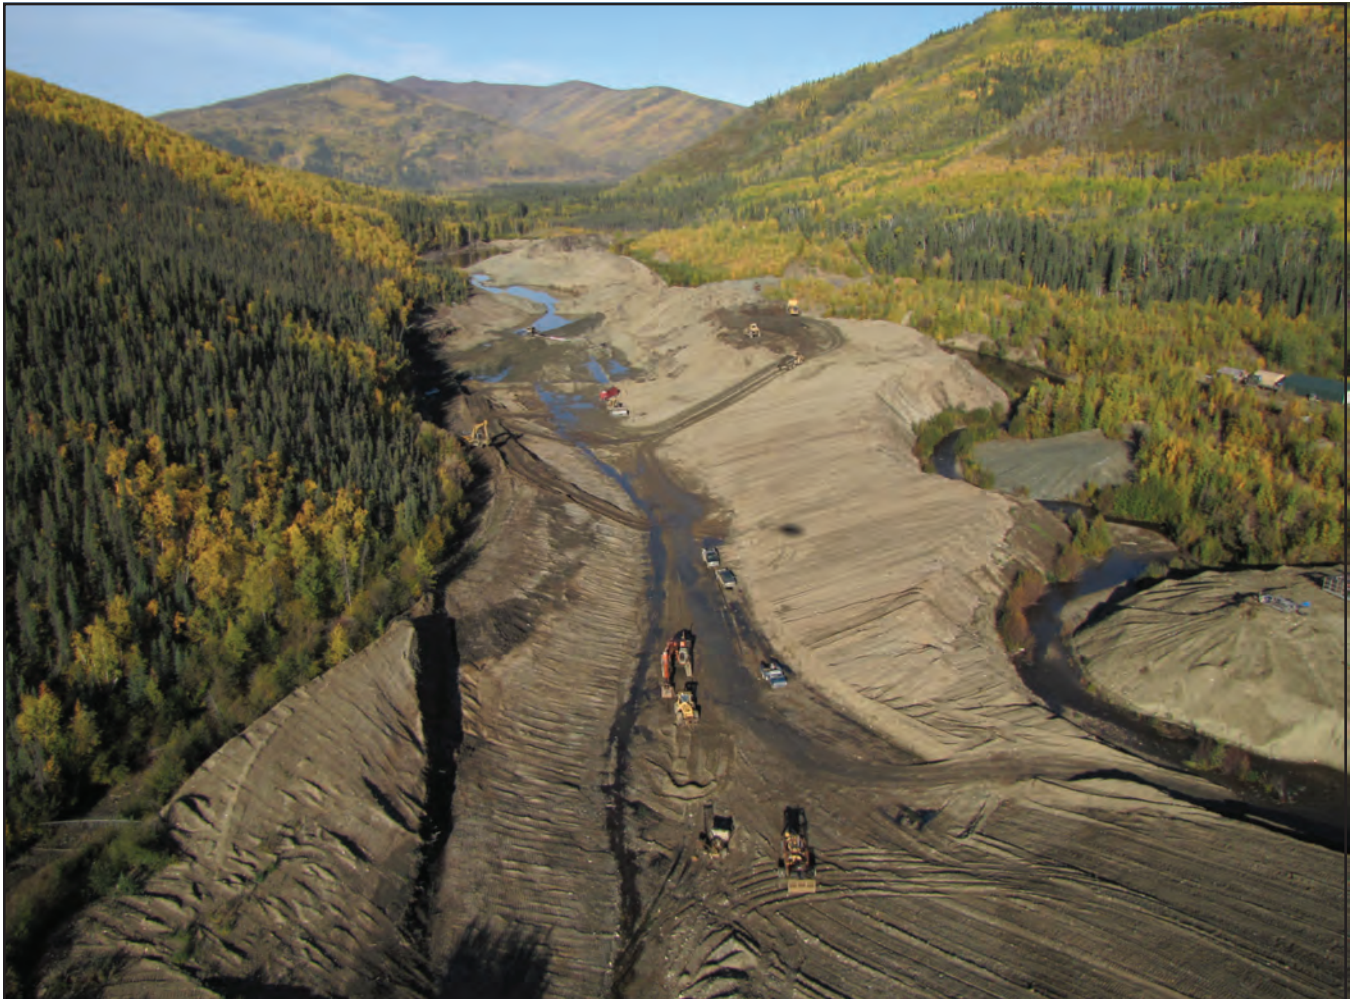
A view looking downstream of Mr. Schmidt's mining operation on the left limit of Thistle Creek in 2014.

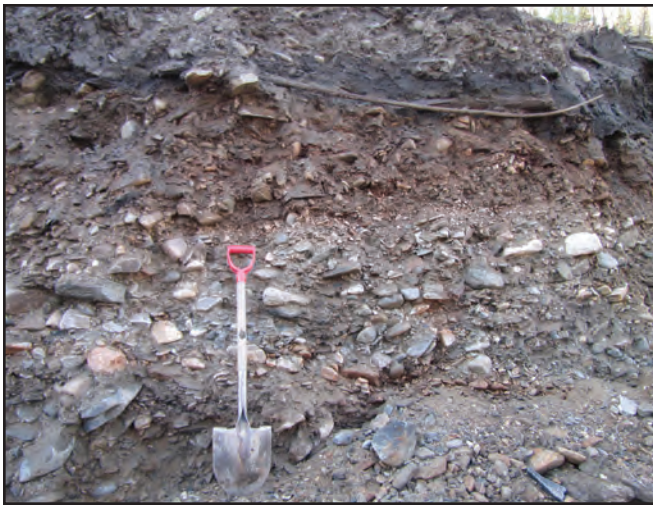
A left limit bank exposure on Mr. Schmidt's Thistle Creek mine operation. Note the abundance of clasts versus matrix in the gravel. This suggests a relatively high energy stream flow was the depositional environment.

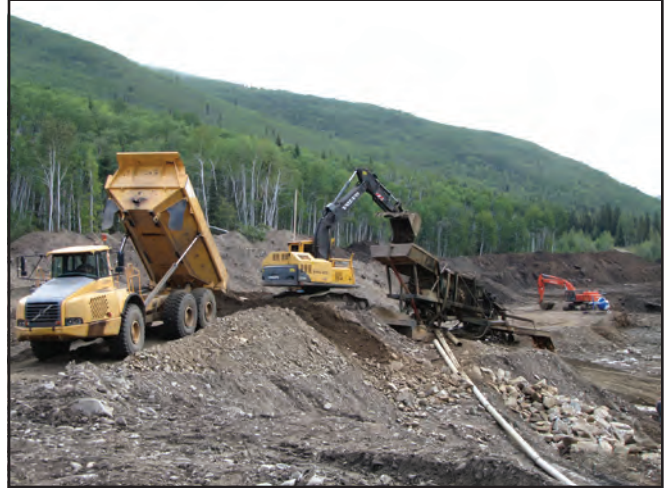
The Sager's mining operation on Kirkman Creek in 2014.

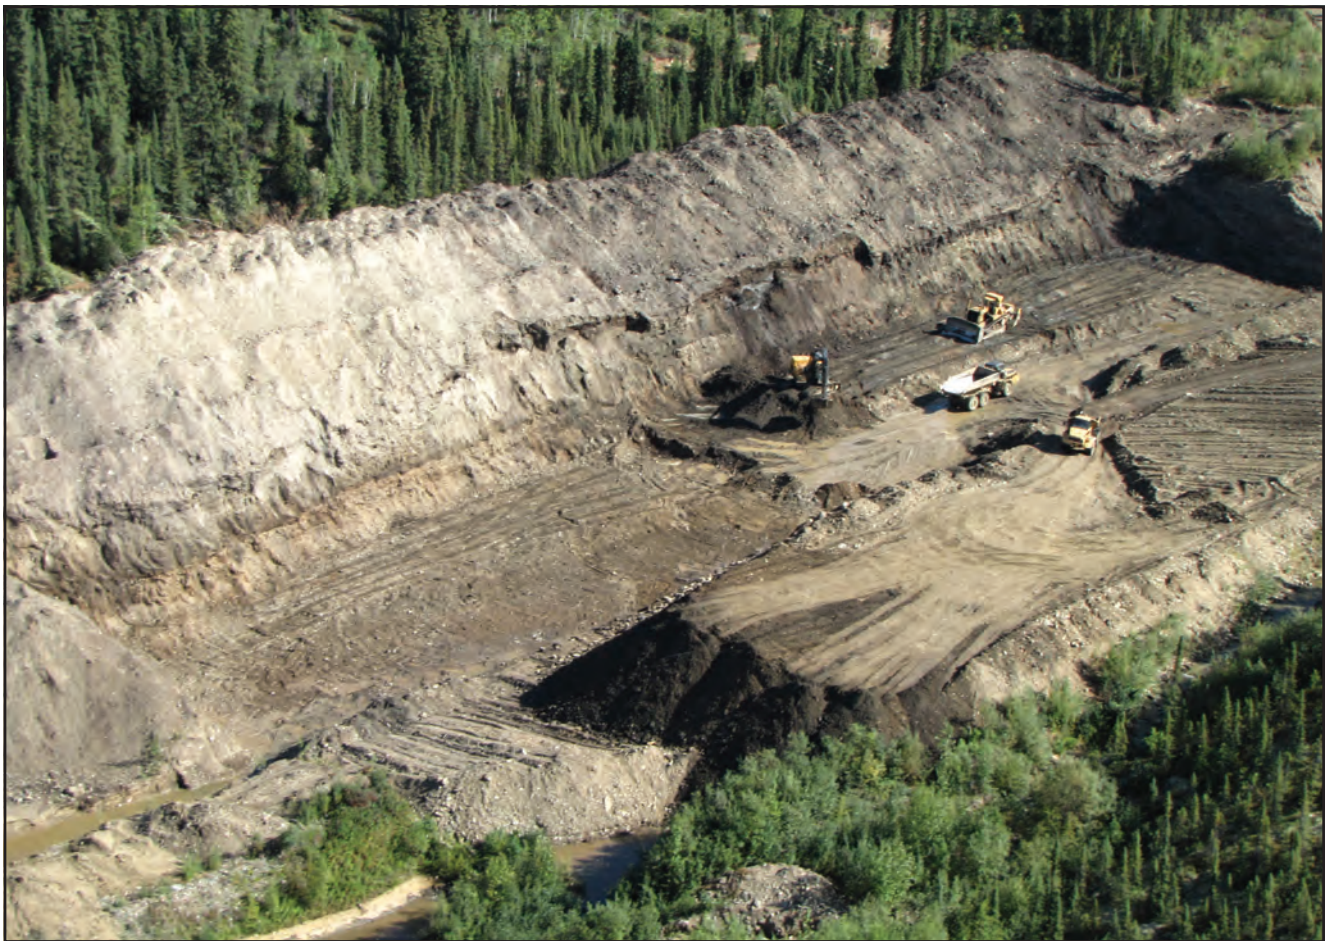
The right-limit lower cut at Fell-Hawk Placers operation on upper Kirkman Creek in 2014. The cut has been stripped down to the pay layer at the left end of the cut. The overburden thickens from 4 to 10 m (13 to 32 ft) as stripping progressed towards the hillside.

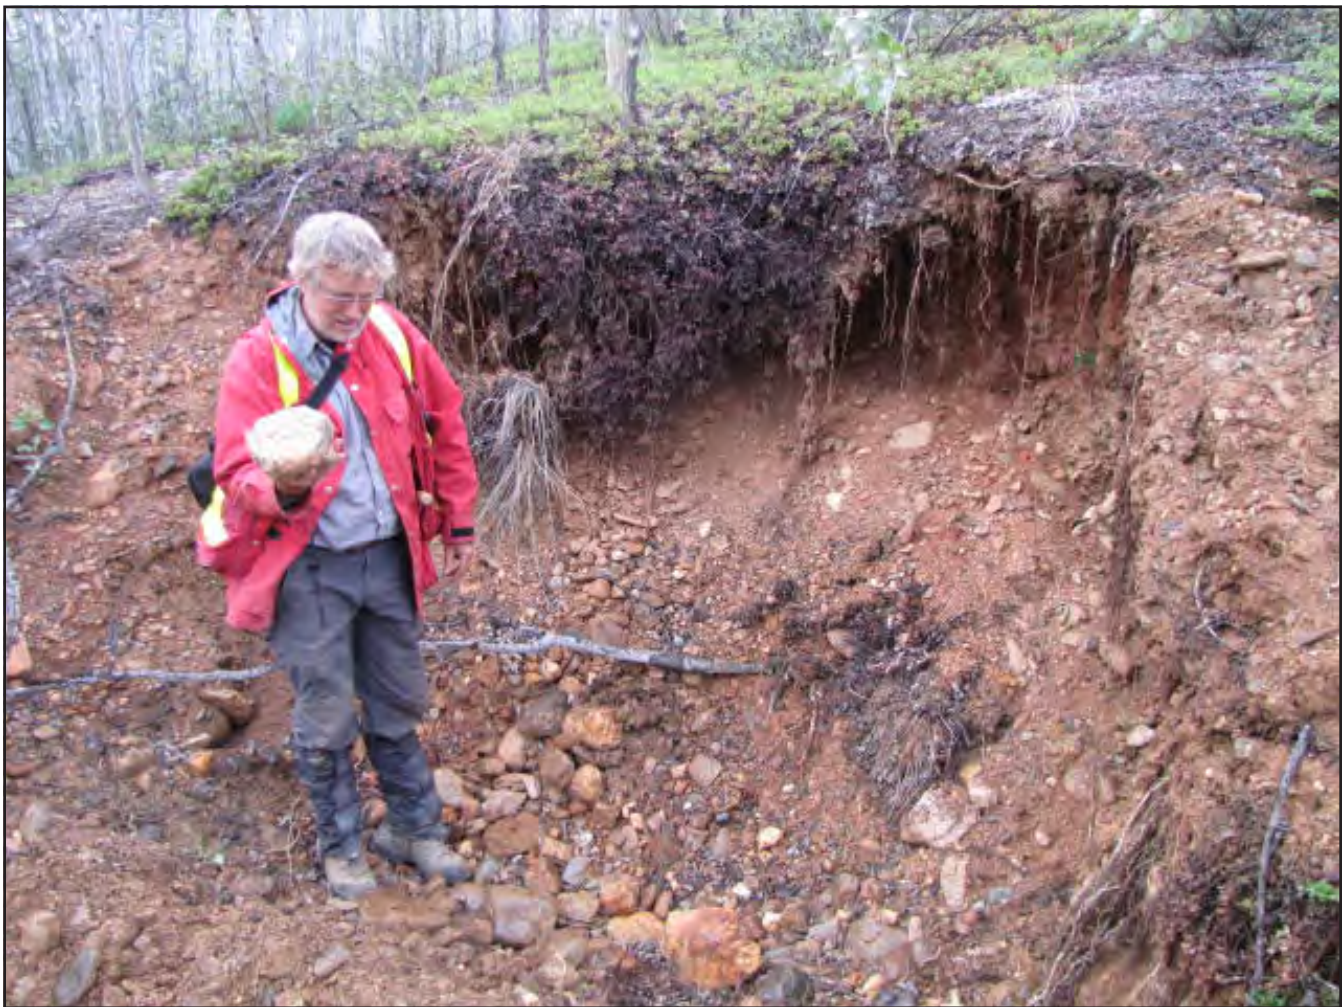
A test pit on the Big Alex bench at Clear Creek. Oxidation of the near surface gravel is the result of soil processes occurring on the relatively stable surface since the early Pleistocene. This is a typical Wounded Moose paleosol found in Tintina Trench.

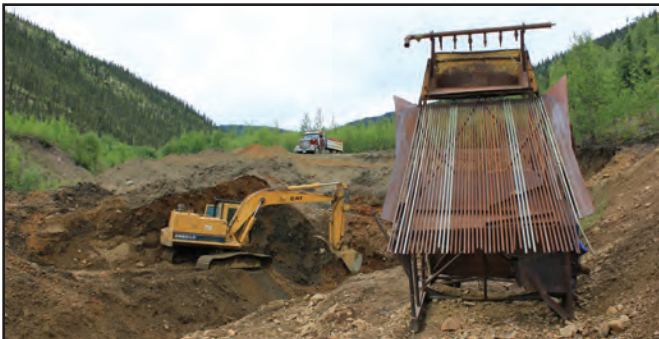
O.H. Transport Inc.'s 2014 cut and wash plant.

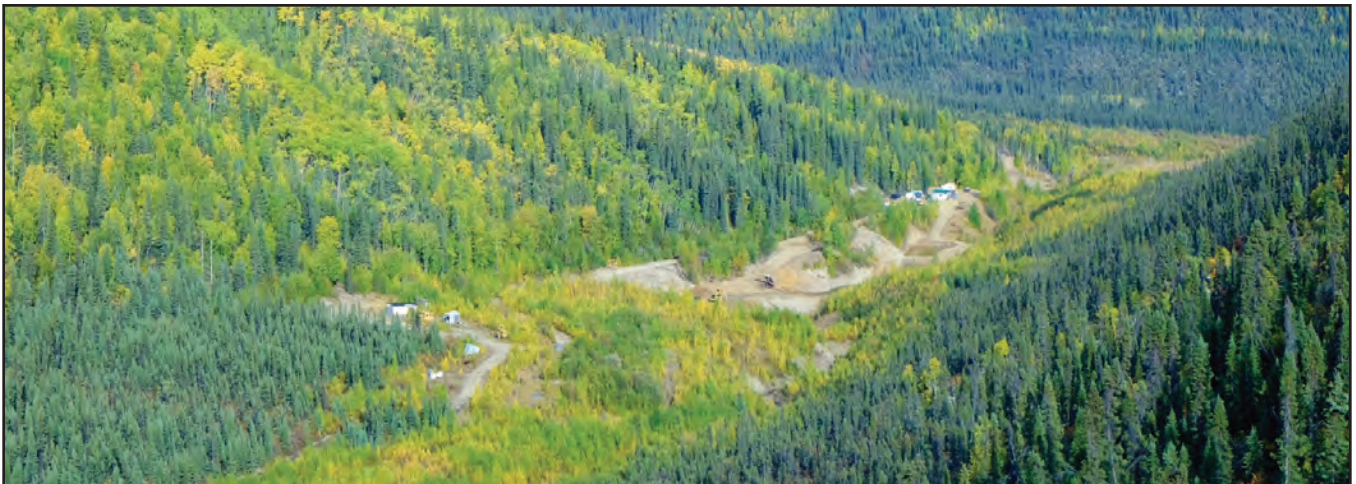
Aerial view of Fisher Gulch in 2014 (Photo credit: Helena Kuikka).

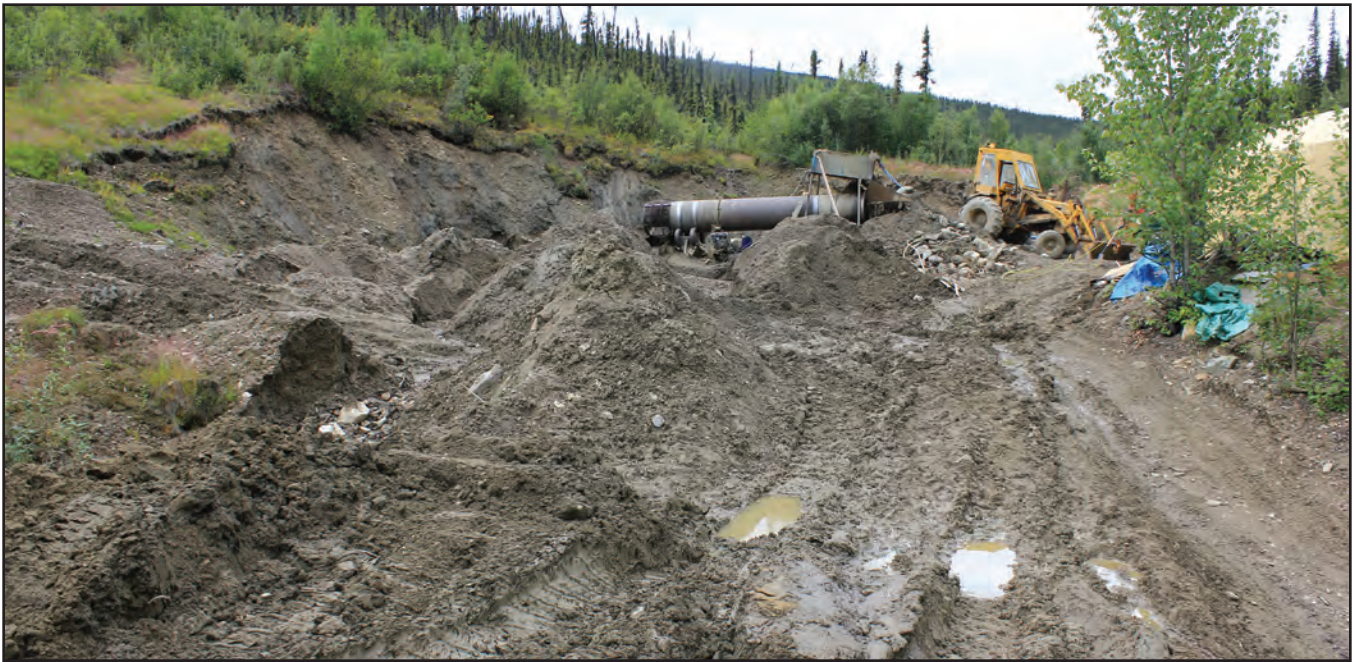
Upstream view of Keith and Betty Dye's cut on Fifteen Pup in 2014.

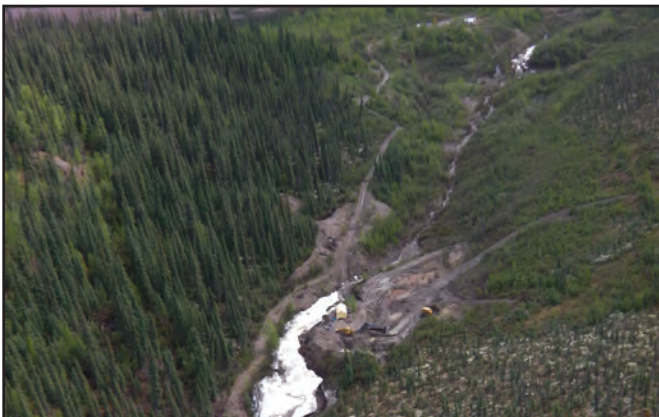
Aerial view of the Dye's operation on Fifteen Pup in 2013 (Photo Credit: Bill Leary).

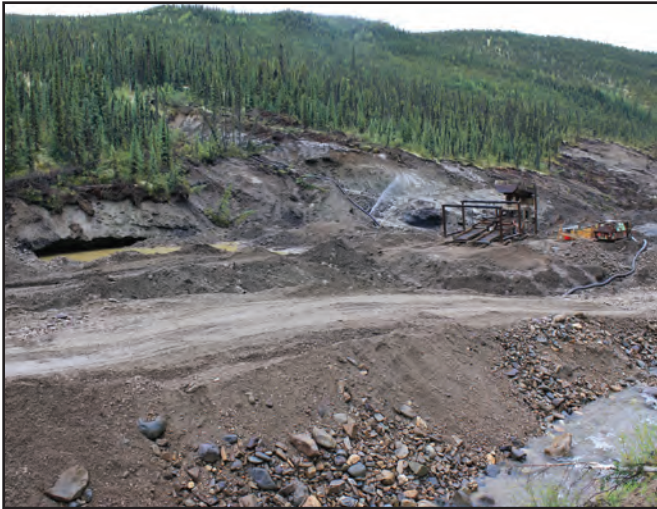
The Minelli's 2014 operation on main Secret Creek.

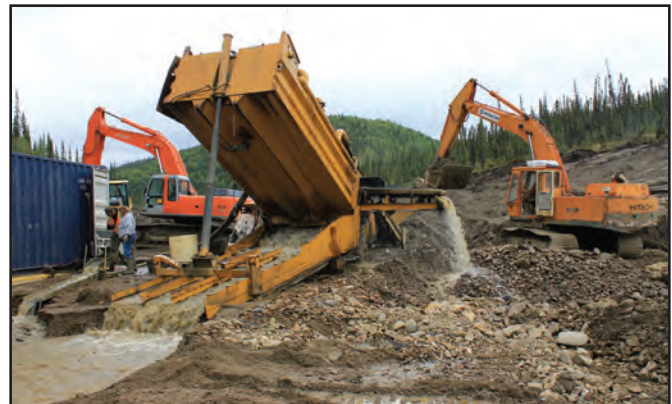
Custom fabricated wash plant on Secret Creek in 2014.

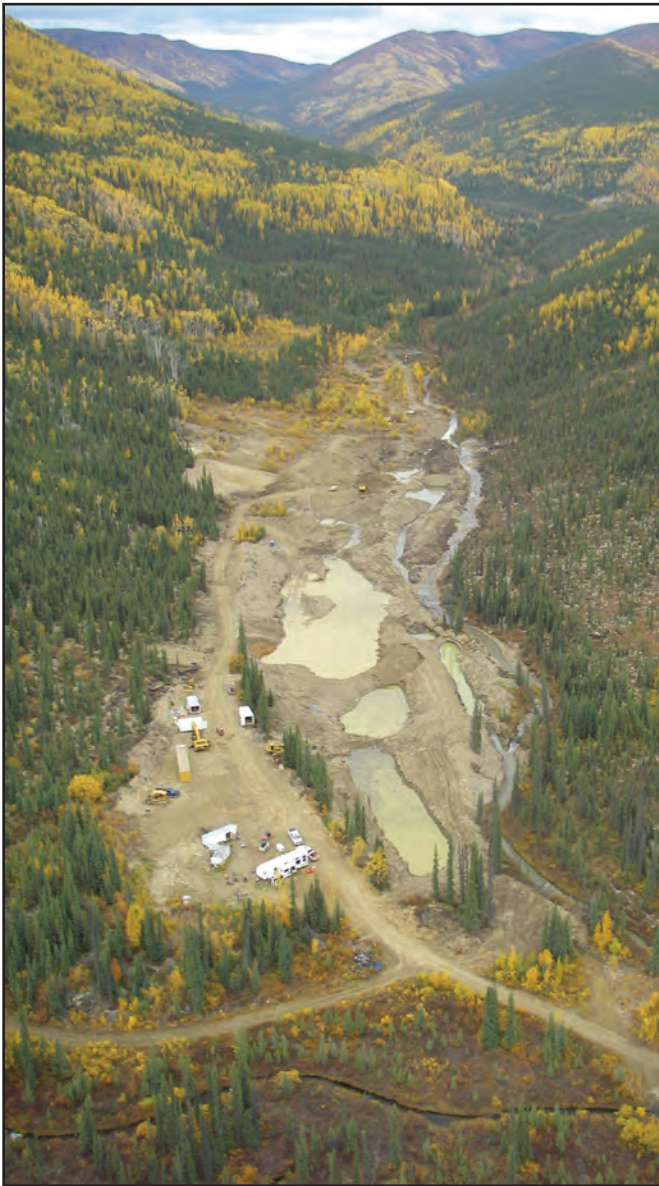
Aerial view of Mr. Evans and Mr. Bowman's operation on Secret Creek in 2011 (Photo credit: Bill Leary).

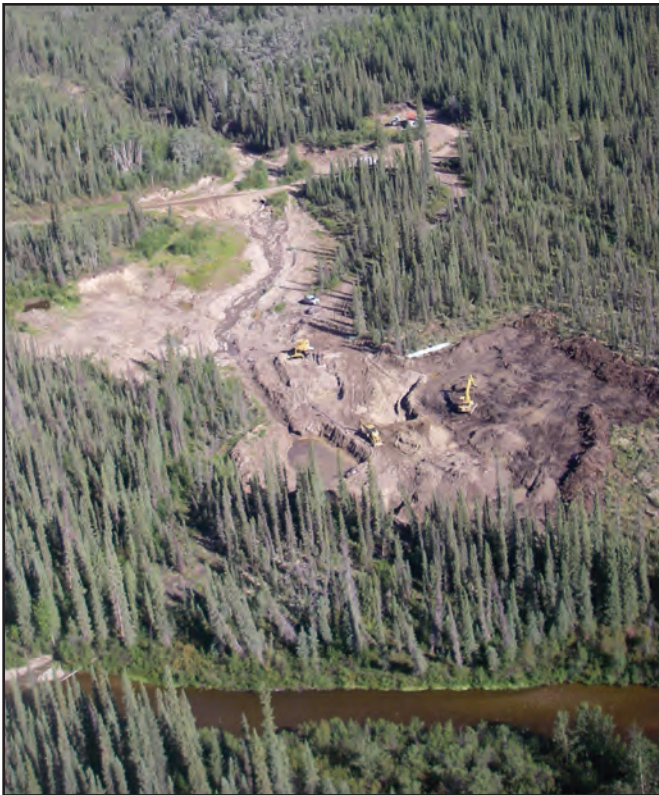
532 Placer Mining on Murphy's Pup in 2011 (Photo credit: Bill Leary).

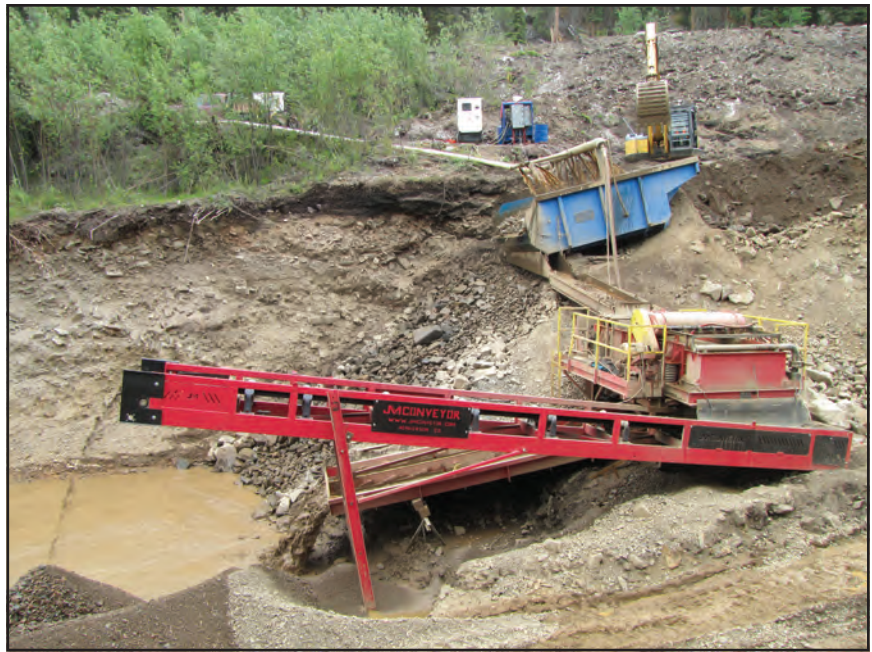
A view of the wash plant used on Guder Creek in 2014. The plant was processing 70 loose cubic yards per hour.

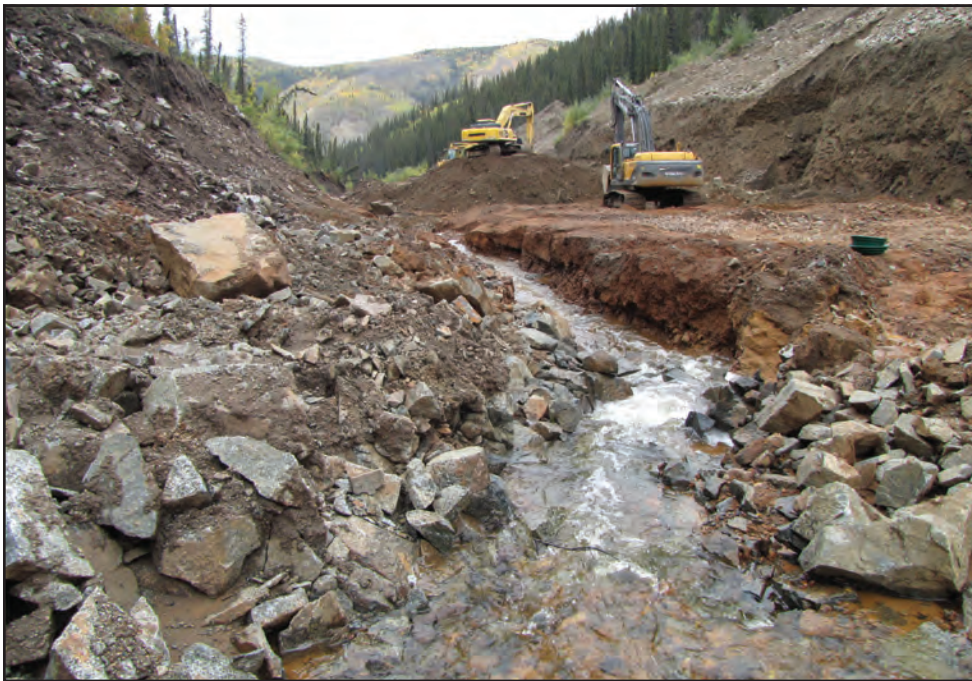
View looking downstream of the 2014 cut on Guder Creek. Unaltered granodiorite is exposed in the foreground whereas a highly altered contact zone is visible further downstream. The pay unit includes the lower 2.2 m (7.5 ft) visible in the section on the right hand side of the photograph (right limit). The overlying units are primarily colluviated weathered bedrock (slide rock).

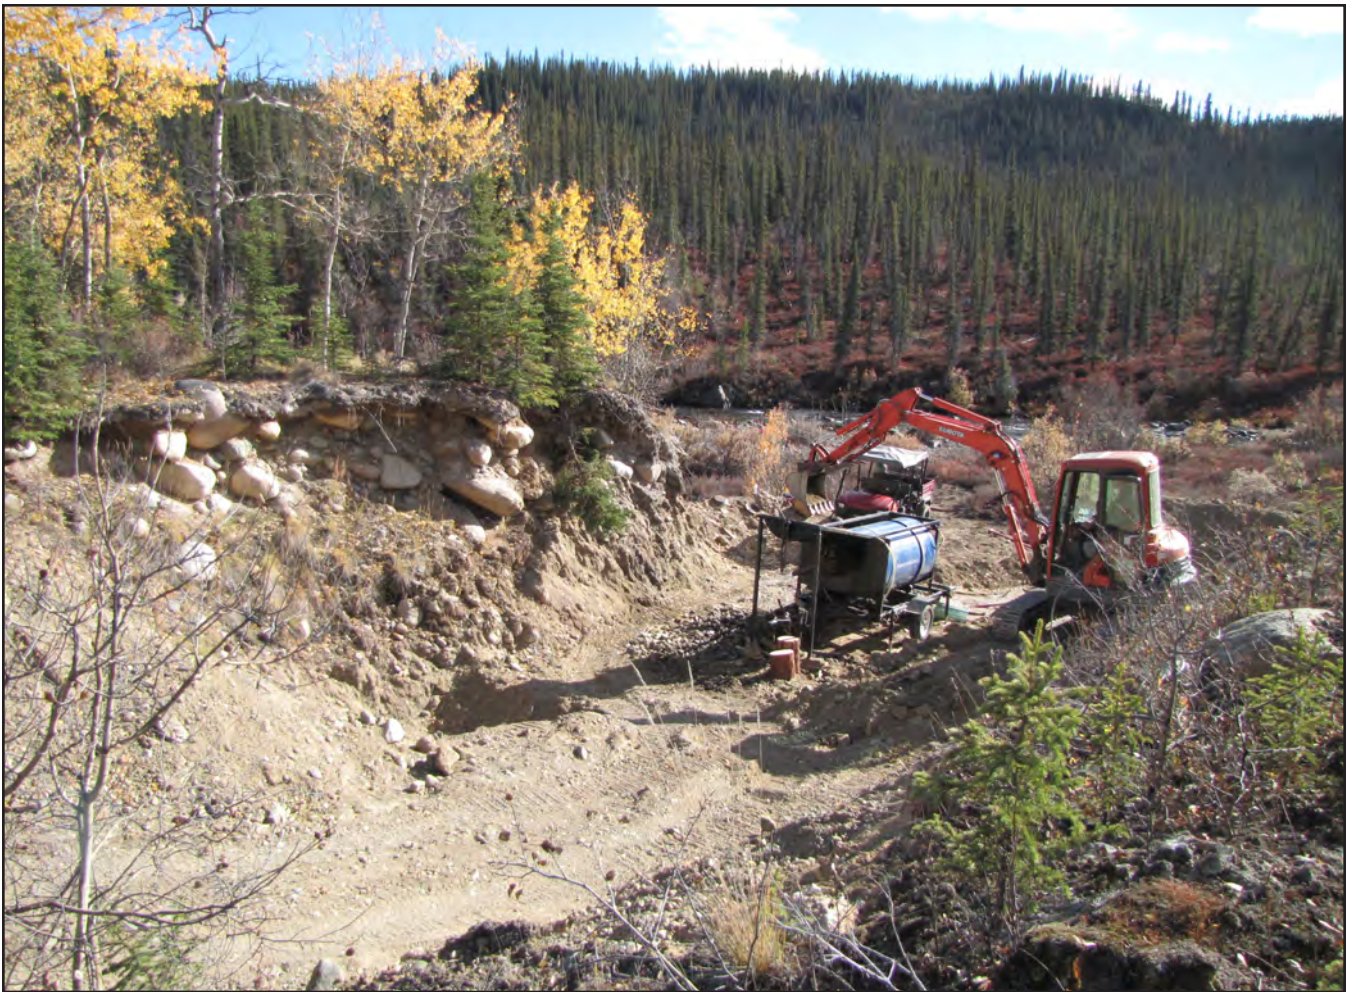
A trench exposure of the gravel in the lowest terrace of Incised Creek. Granitic bedrock is near the base of the cut and Mr. Brown is sluicing a pebble-cobble dominant gravel below the near surface boulder gravel.

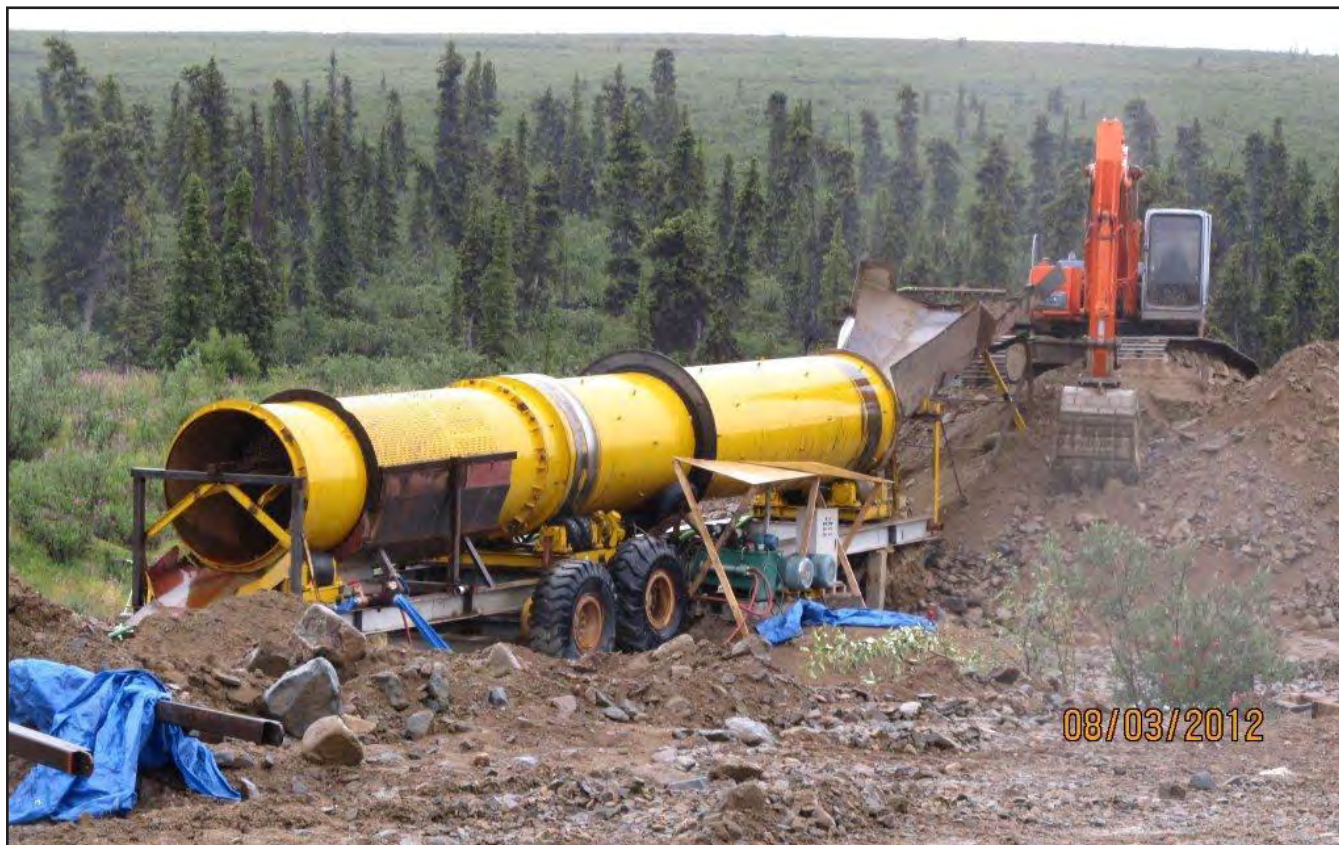
Canaan Gold Resources Inc. wash plant in 2012. (Photo credit: Steve Beaulieu).
