Yukon Placer Mining Industry

2010 to 2014

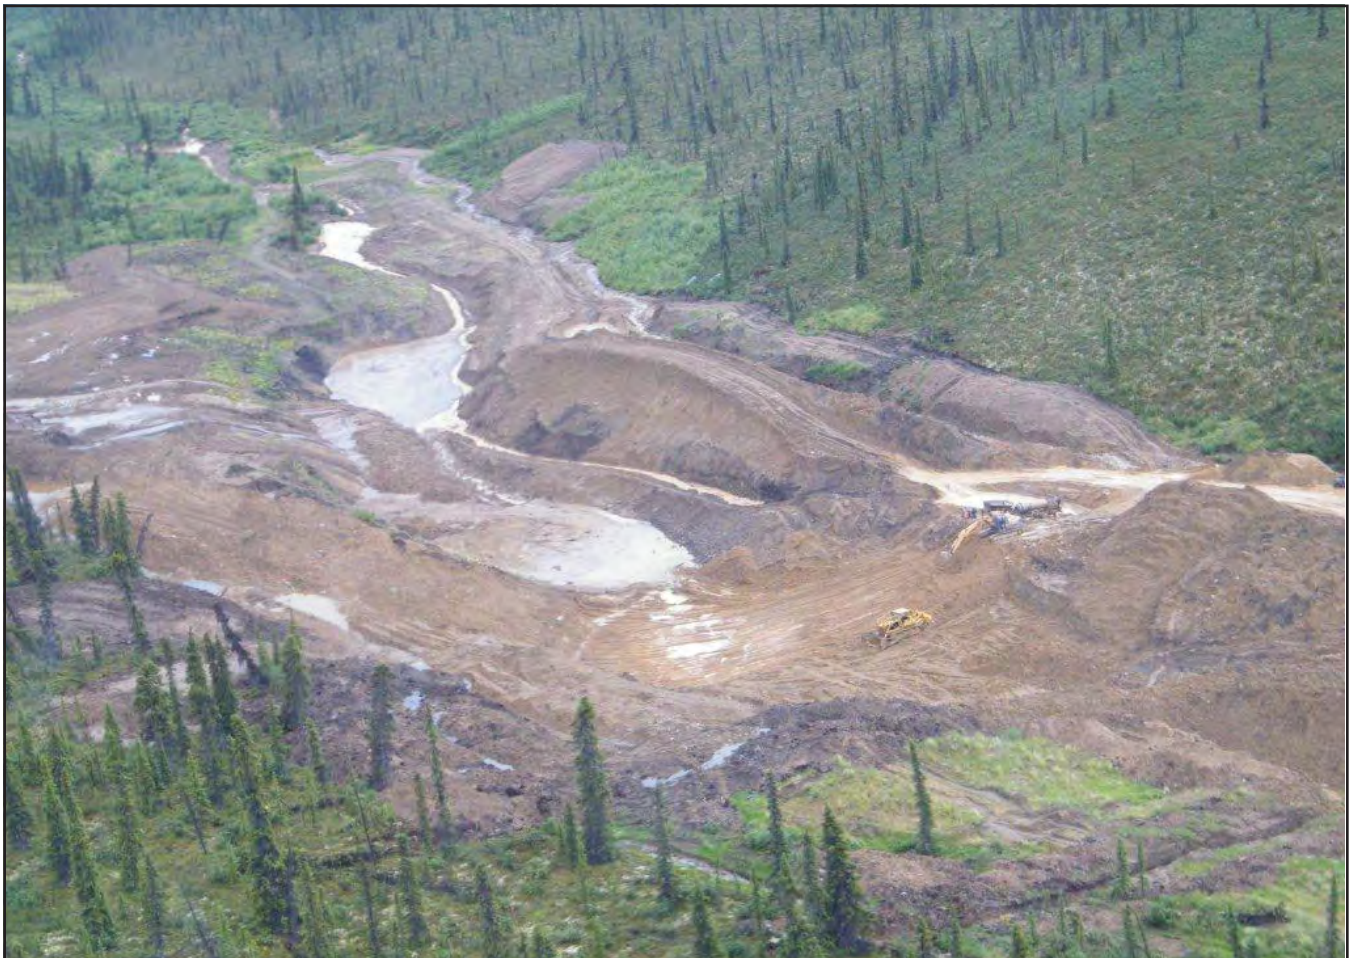
Johnson Exploration's operation in 2011 (Photo credit: Steve Beaulieu).

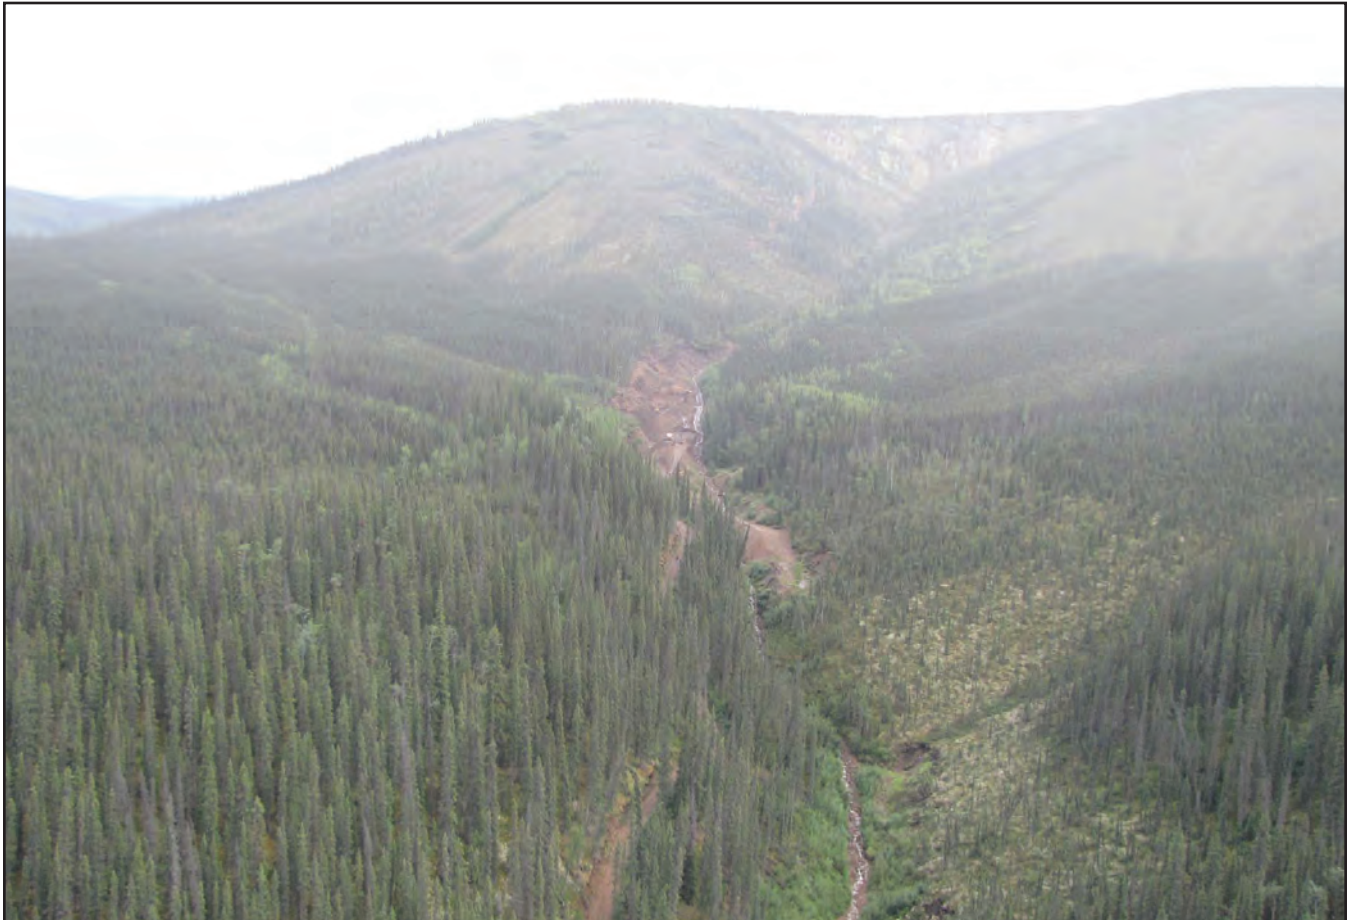
Aerial view of Mr. Wilson's operation up Sonora Gulch in 2010.

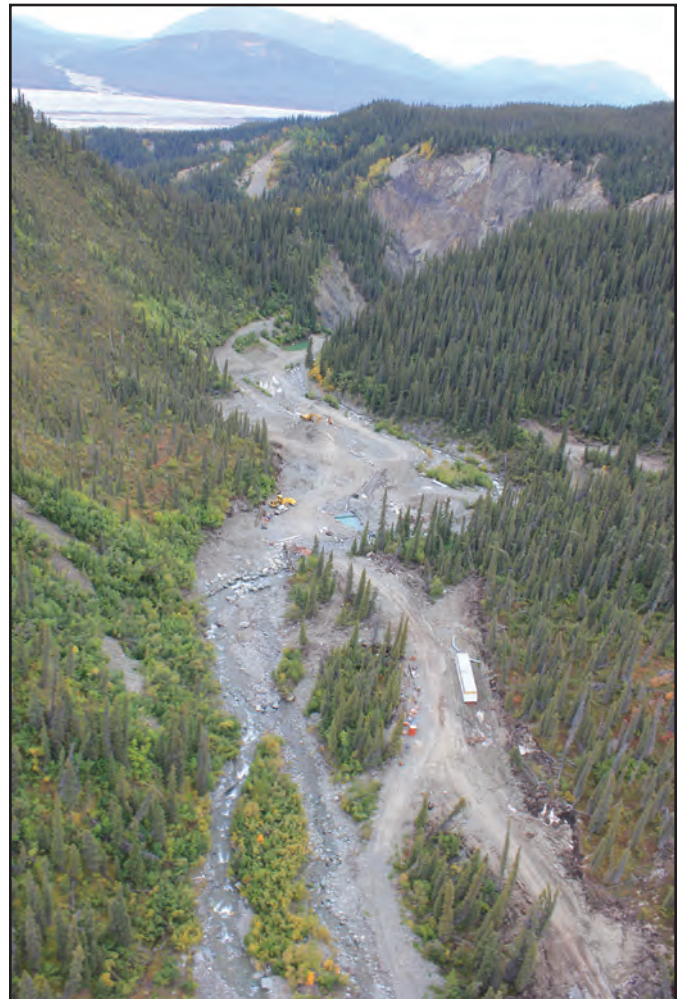
Downstream aerial view of Arch Creek operator, Mr. Nelson, in 2014.

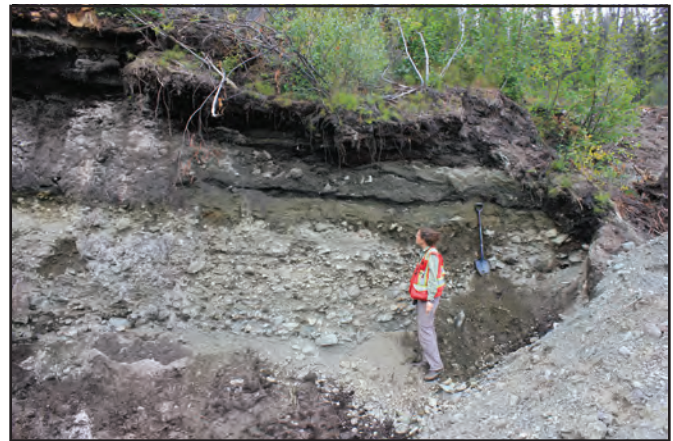
Mine cut exposed on the left limit of Quill Creek in 2014.

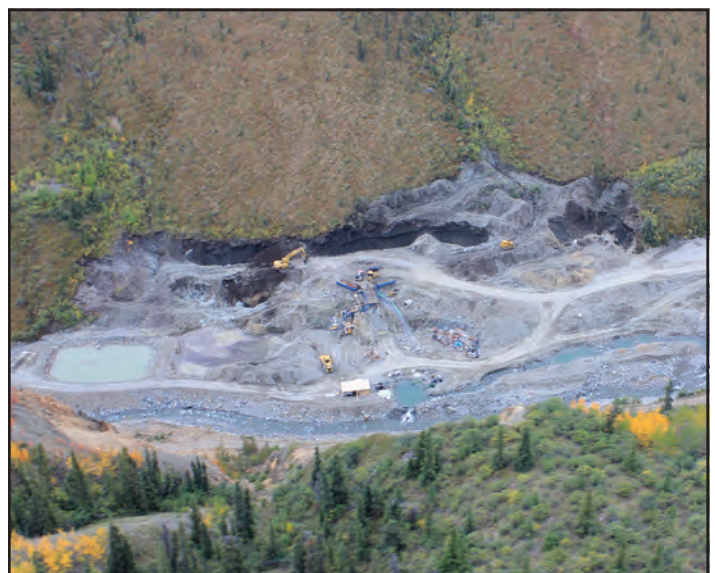
Aurem Alliance's 2014 mining activity on the right limit of upper Burwash Creek.

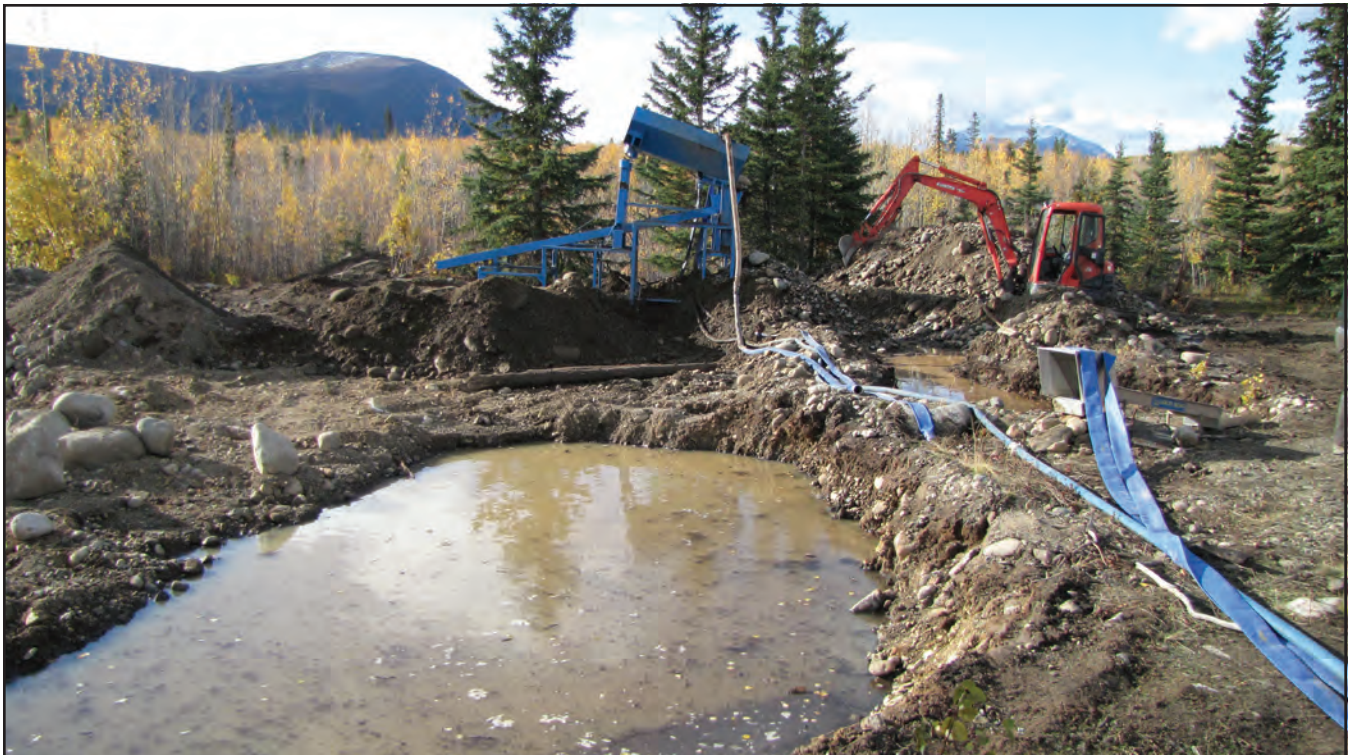
Black Mountain Mining's wash plant and former test pit now used as a settling pond in 2011.

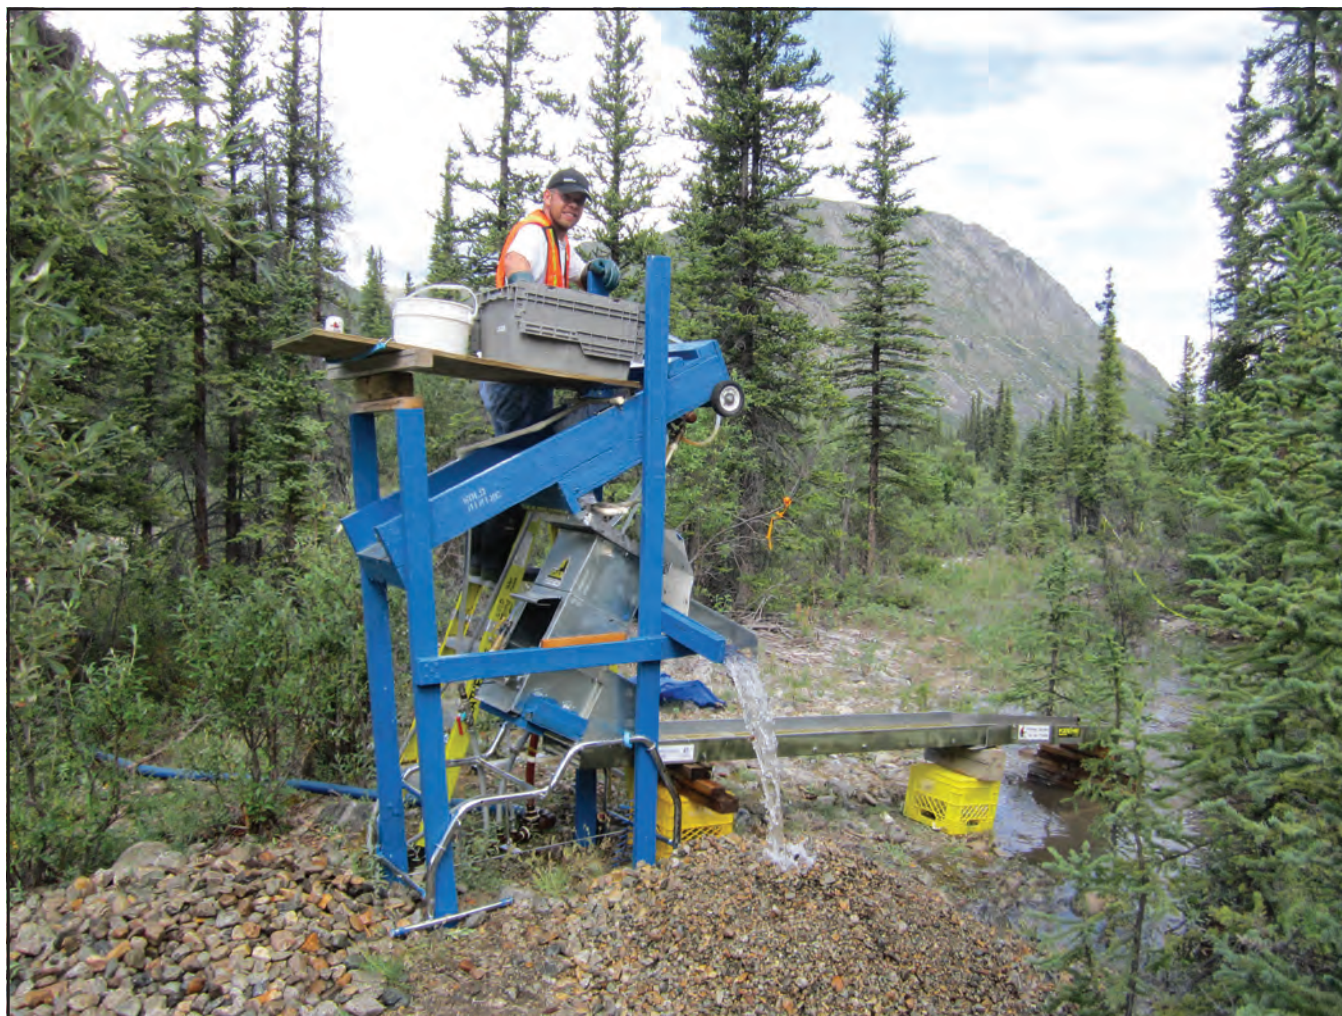
Mr. Wold on his claims at Becker Creek in 2013 (Photo credit: Bryce Wold).
