# Yukon Placer Mining Industry

## 2010 to 2014

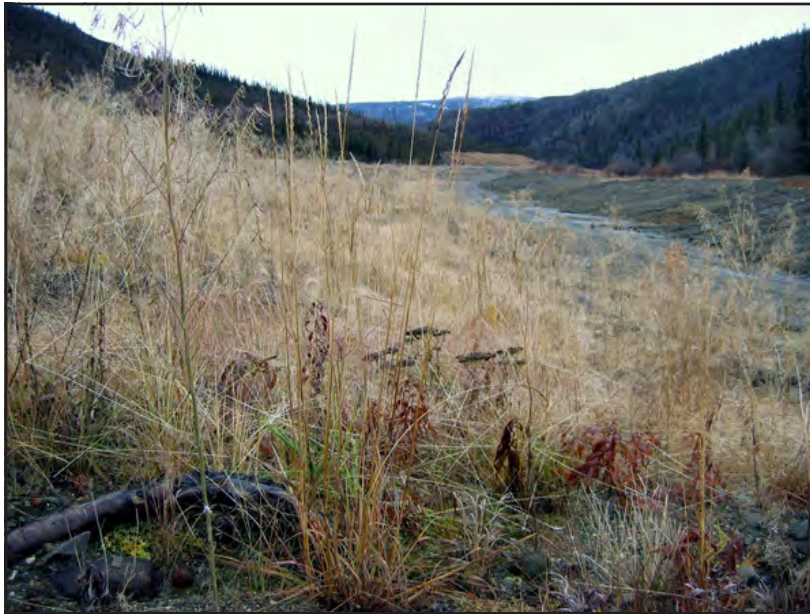
### **2013 award presented to Ben Warnsby and Alex Seely**

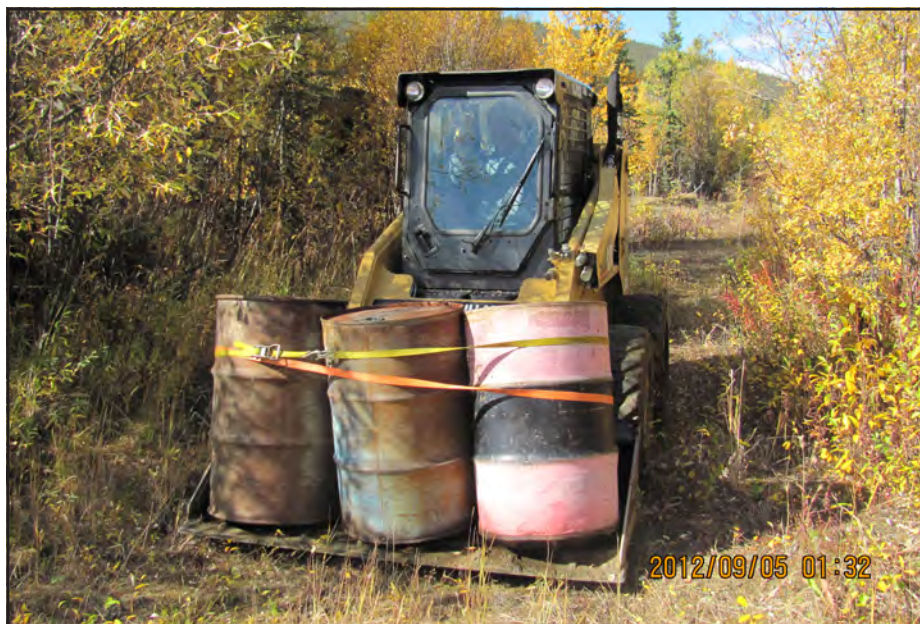
This dedication to site reclamation exceeds expectations and demonstrates exemplary environmental stewardship, benefitting the environment and setting an example for others to follow.

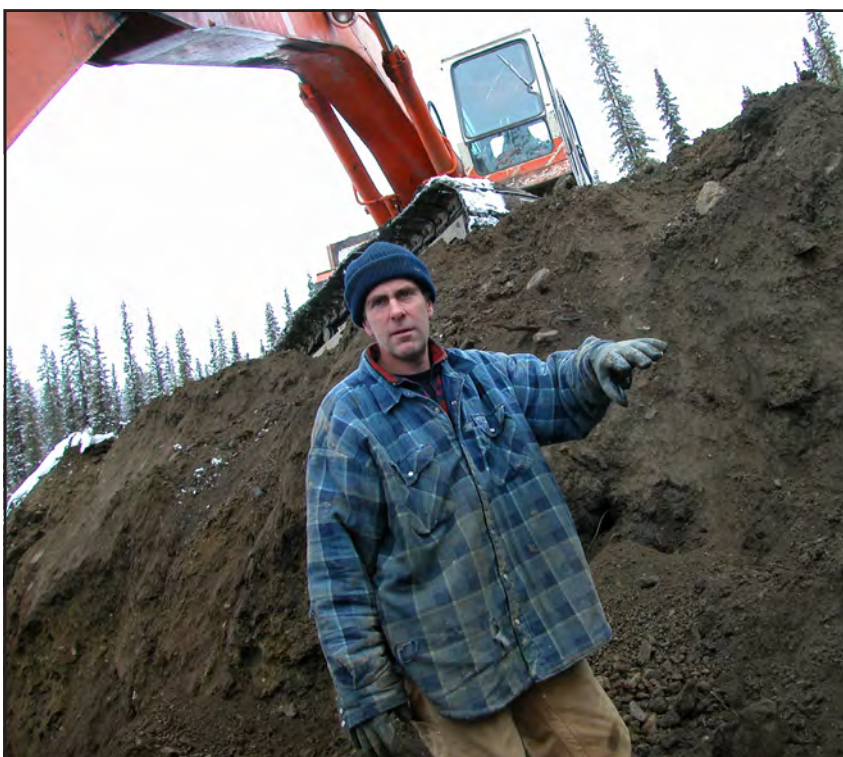
*Kim explaining his theory on the trajectory of the pay unit in Davidson Creek.*

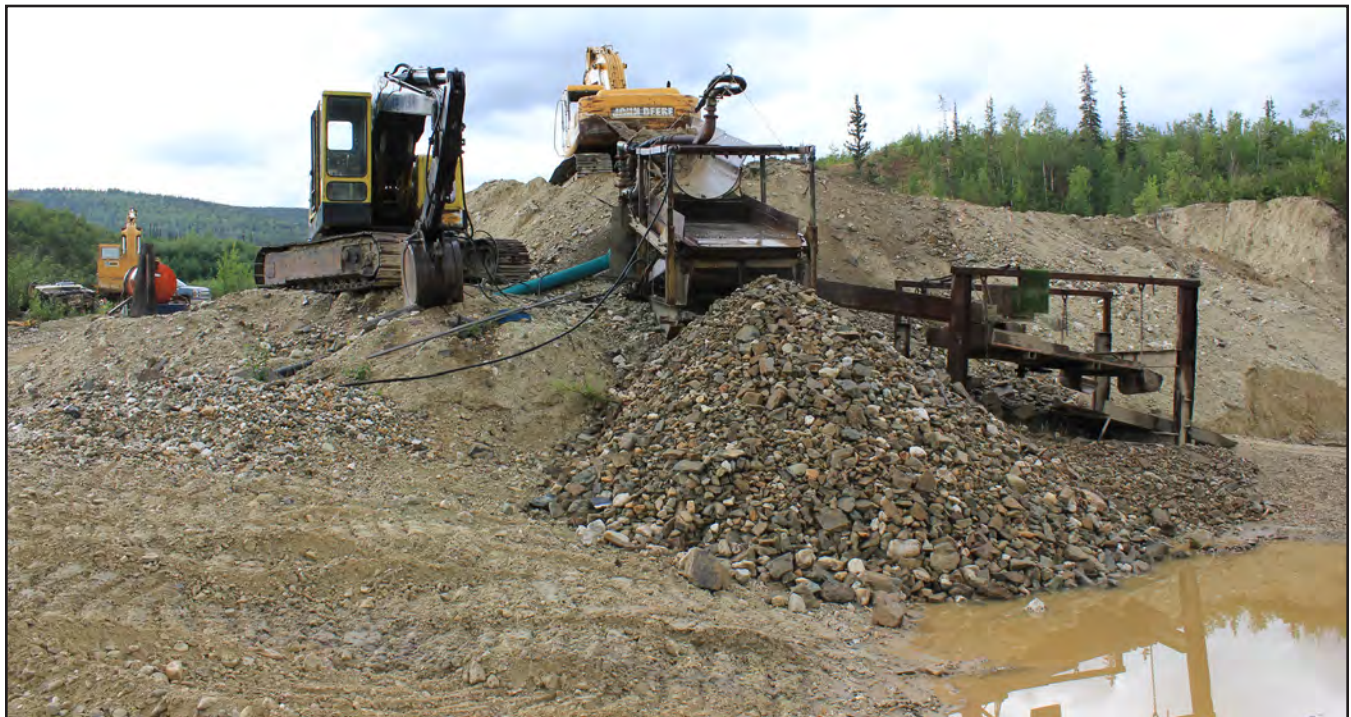
*Mr. Van Bibber's wash plant beside the Bonanza Creek road in 2014.*

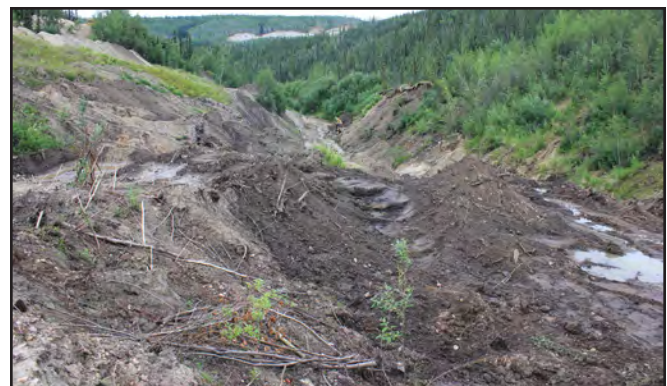
*Downstream view of Mr. Gillespie's operation in 2014.*

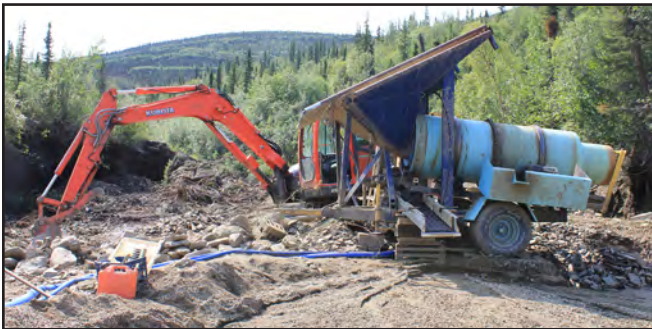
*Mr. Brong and Ms. Dotzler's operation in 2014 at the upper right fork of Hunker Creek (Photo credit: Jim Leary).*

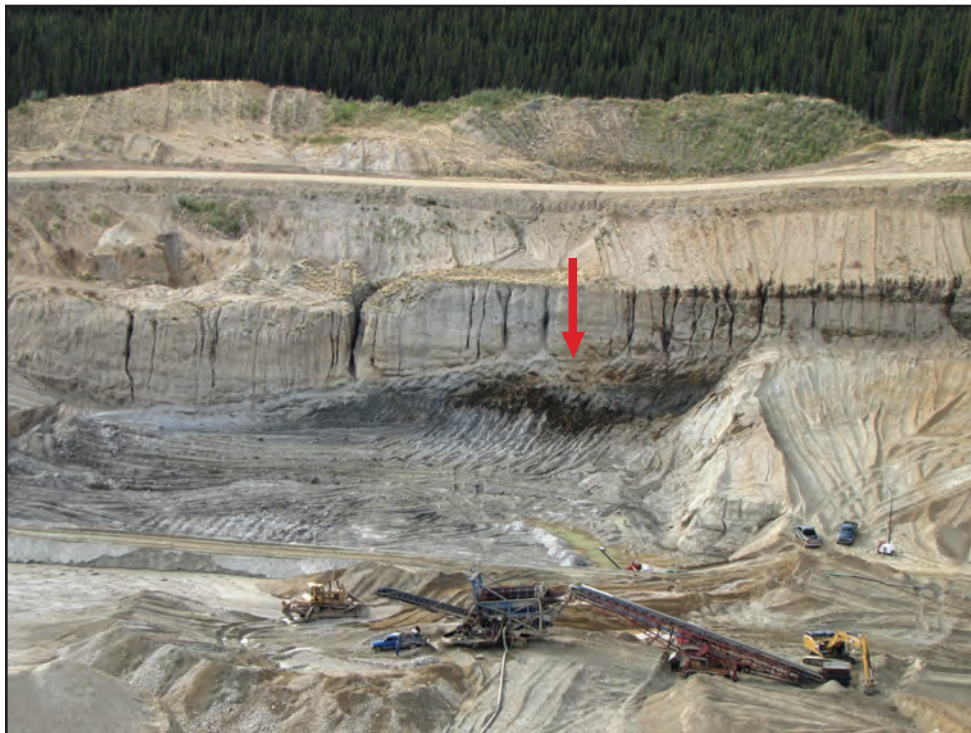
*An aerial photograph from 2014 with a view to the west of Schmidt Mining's Quartz Creek bench. The mafic dike is visible in the lower White Channel gravel behind the wash plant (see arrow). Prolific old timer workings were present in this area.*

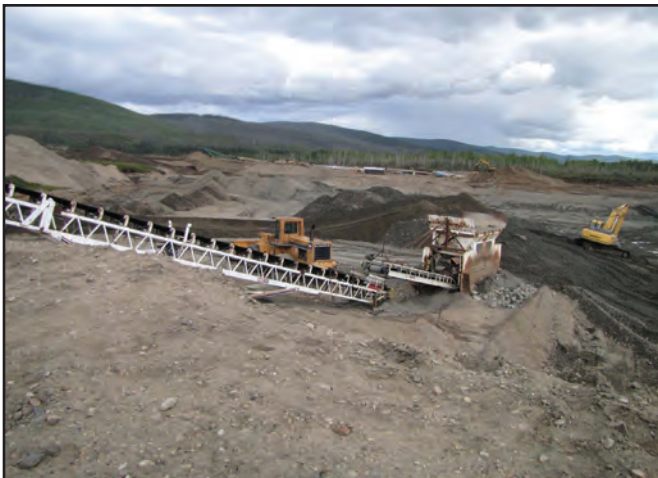
Active cut at Gimlex Enterprises Ltd. in 2011.

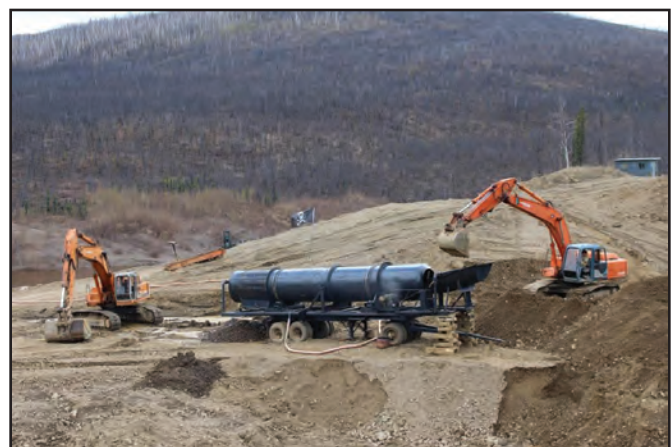
*Them R Gold Ltd. wash plant on Eureka Creek (Photo credit: Marie Charbonneau).*

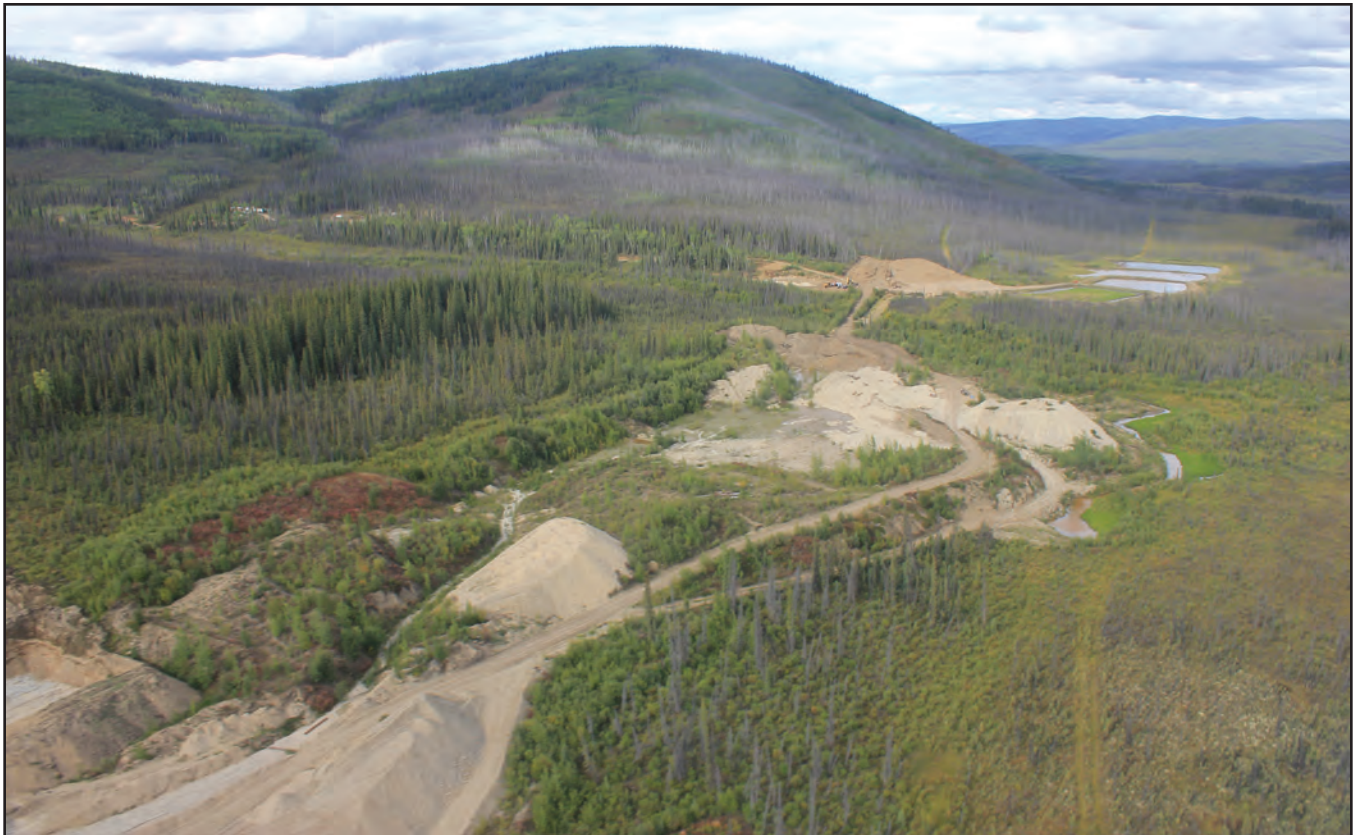
2014 downstream view of cuts on Montana Creek and mouth of Stowe Creek on the left limit.

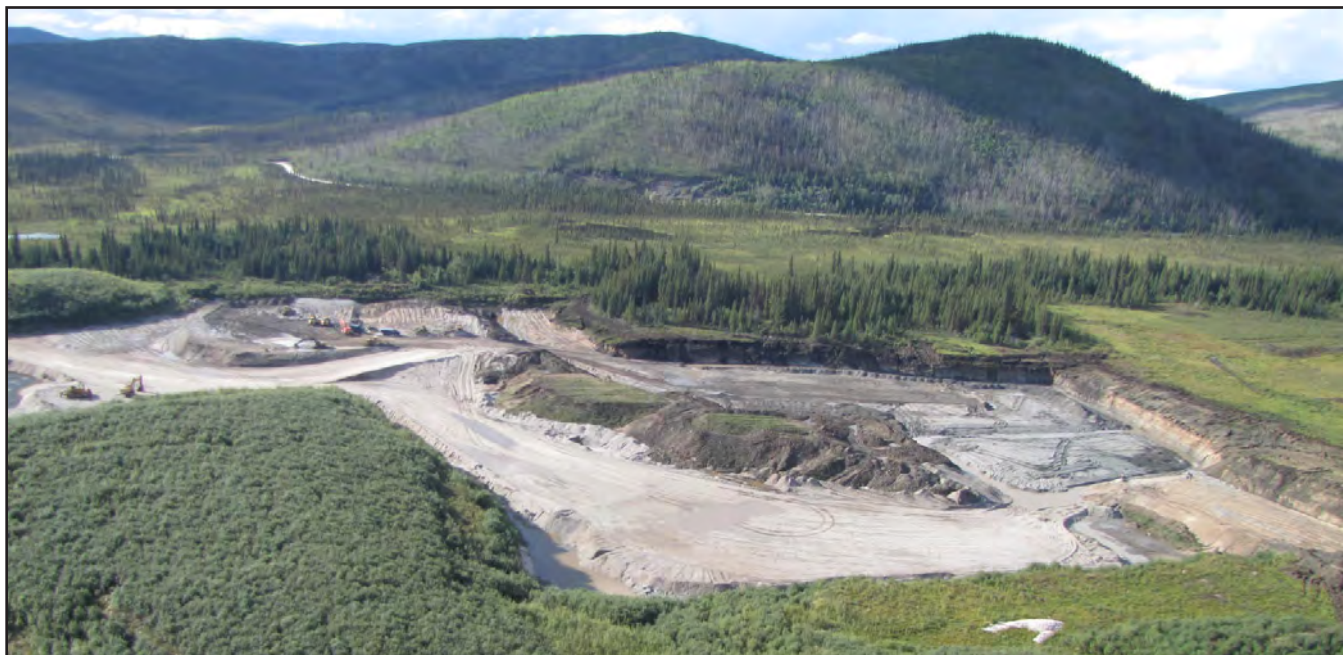
*Dominion Gold Resources operation on Dominion Creek at the mouth of Eagle Creek.*

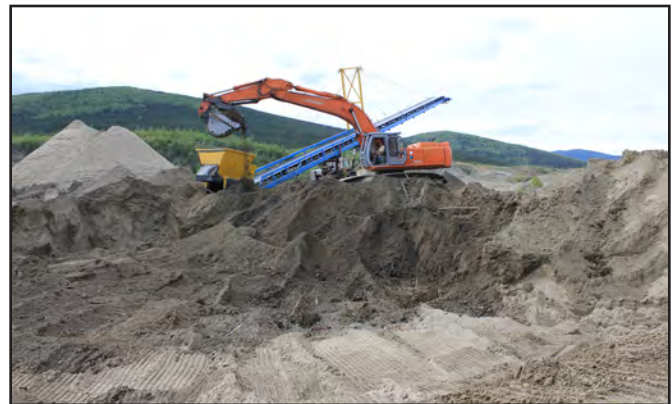
*Rical Mining Ltd. moving overburden with their custom fabricated track-mounted conveyor on lower Gold Run Creek in 2014.*

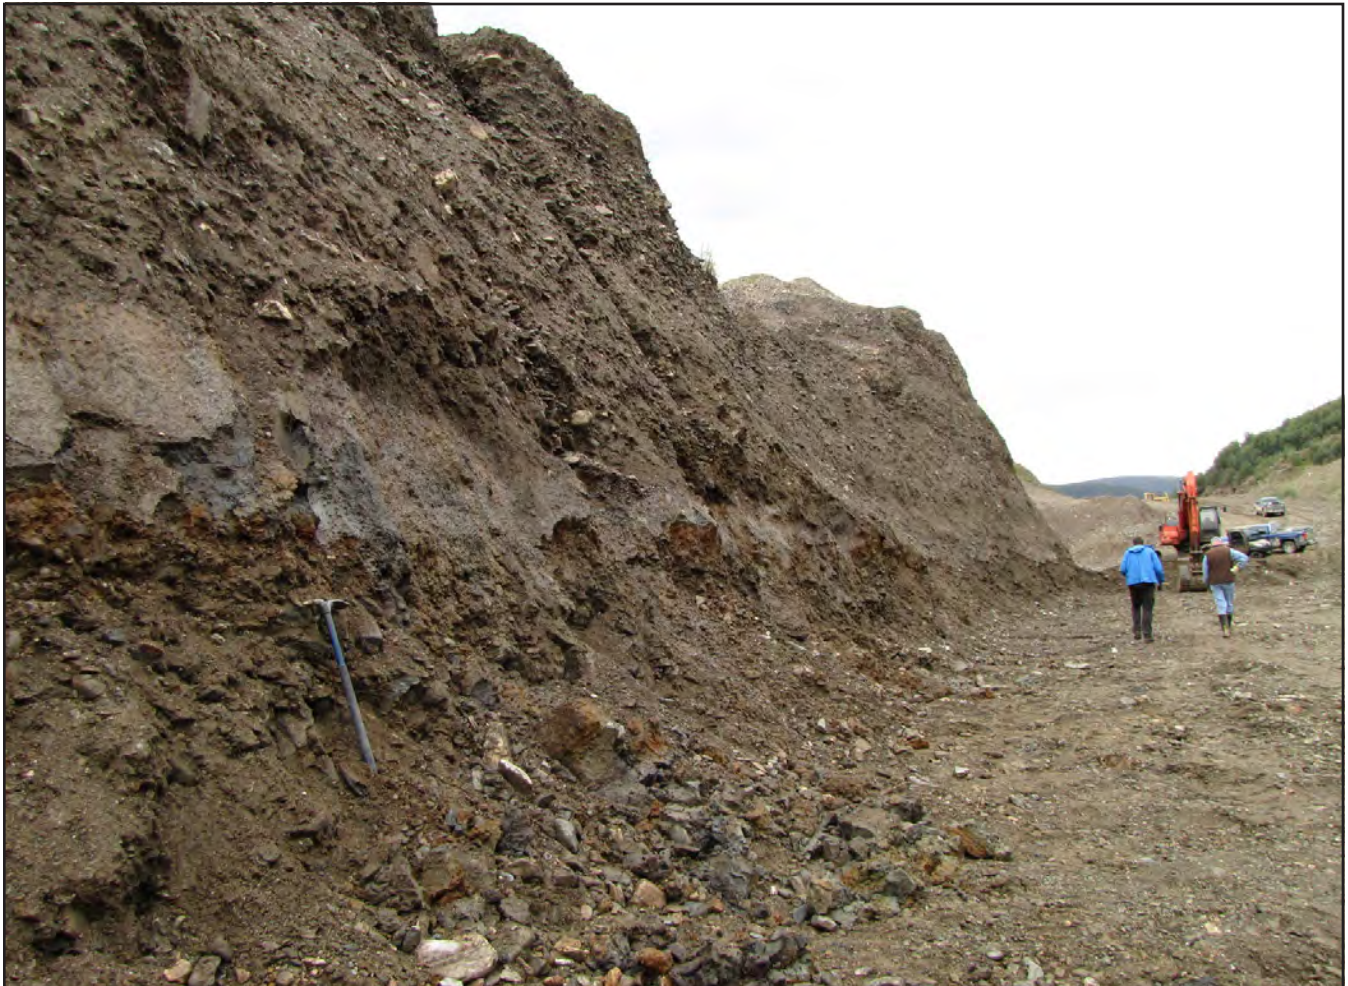
*Exposure of the left limit bench gravel in lower Miller Creek. The pick is leaning against the pay gravel which is overlain by a laterally continuous silt and upwards of 24 m (80 ft) of gravel.*

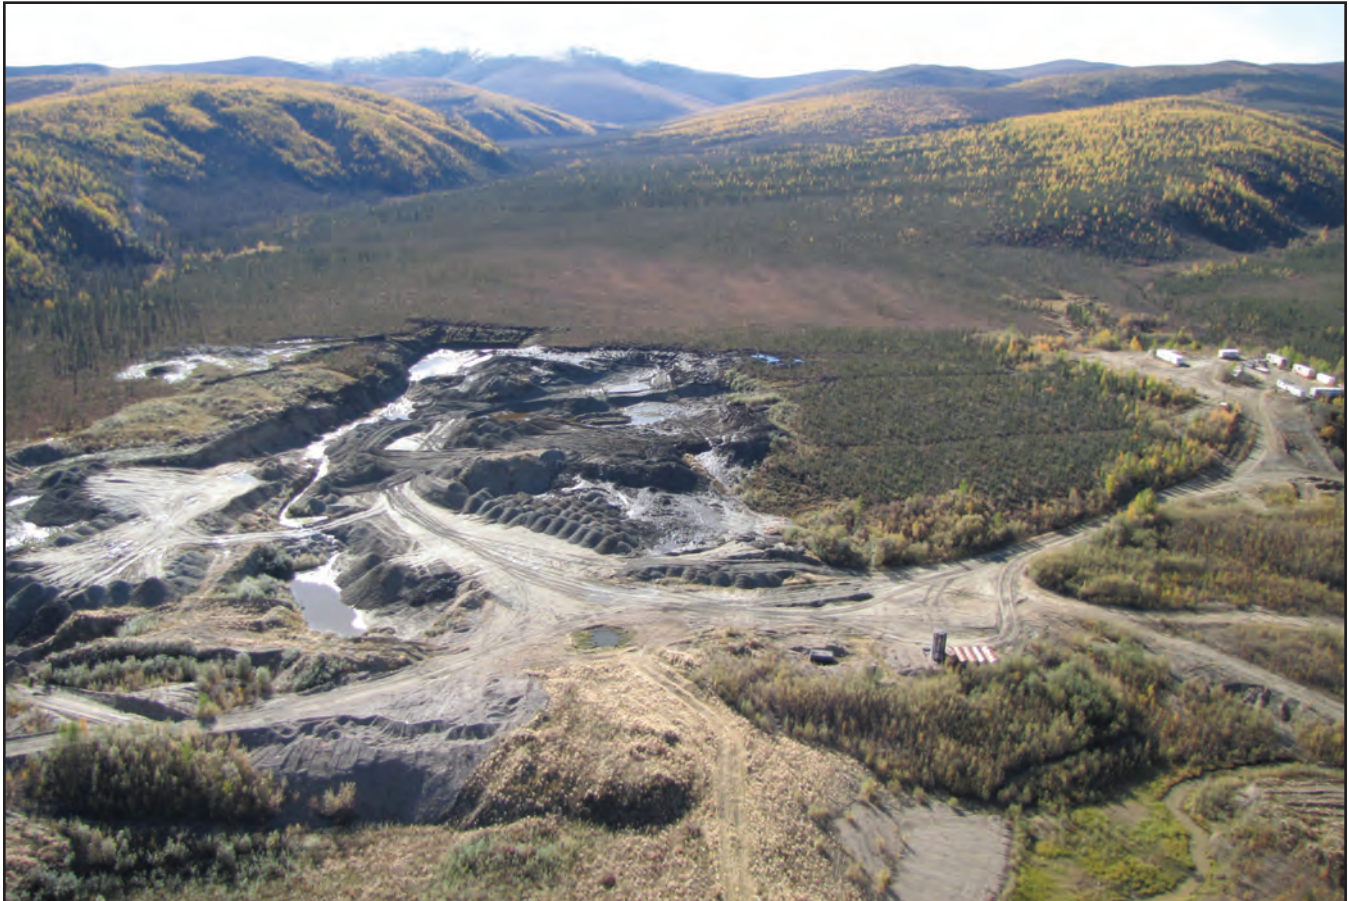
*View to the south of Magna North's lower cut on a right limit bench of Matson Creek in 2014. The camp is located on the right hand side of the photo.*

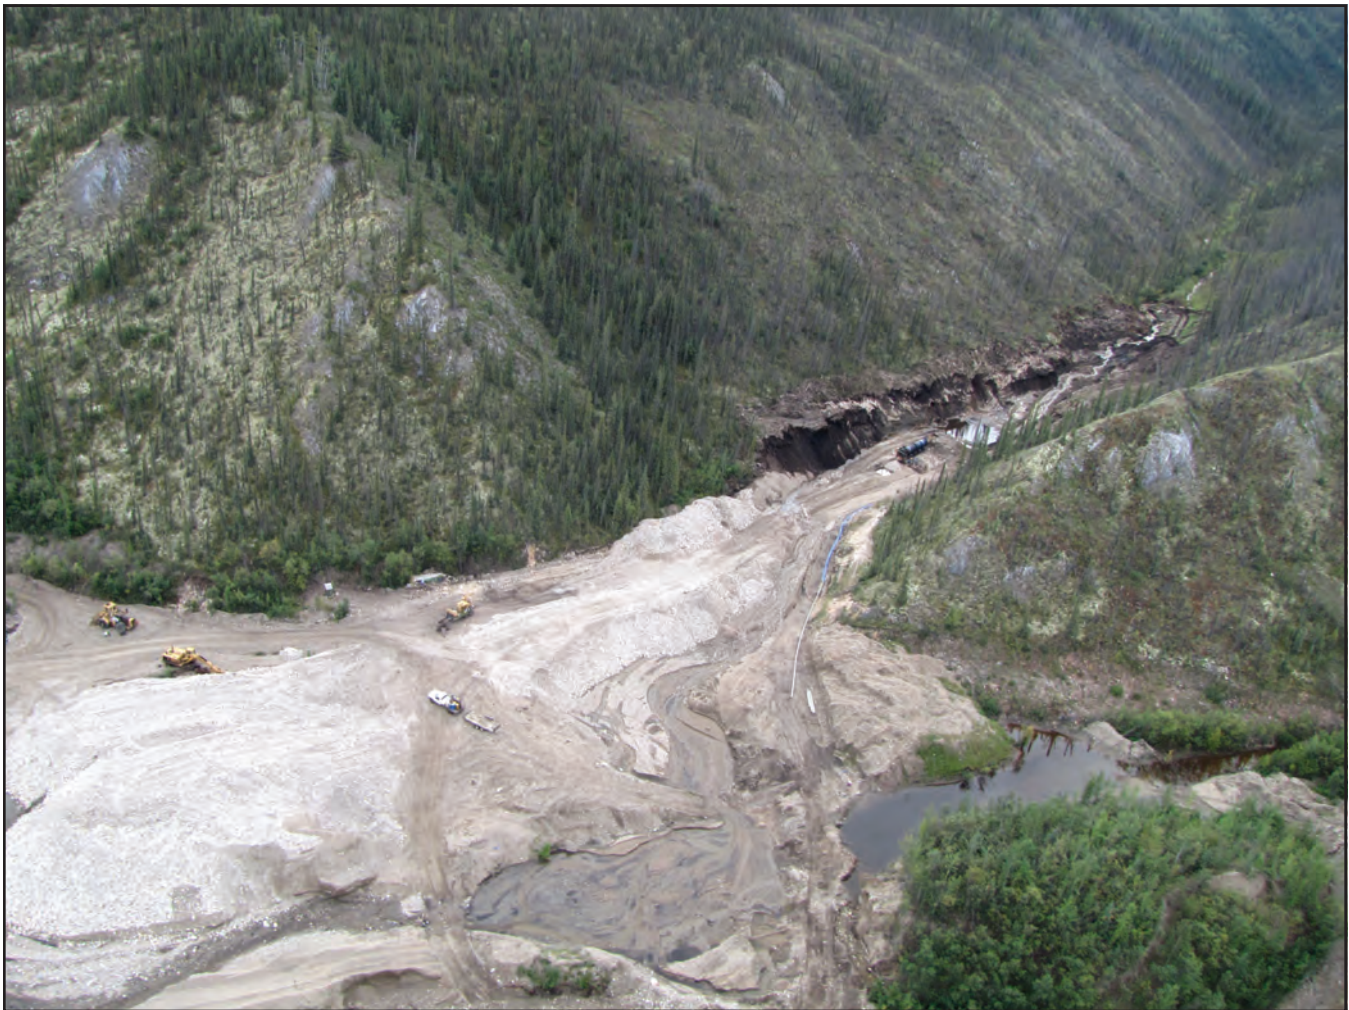
*View looking up Donovan Pup from its confluence with 10 Mile Creek. Outcrops of marble are visible on the ridges on either side of the pup. Marble is a relatively resistant rock and creates a narrow valley in the lower part of the drainage.*

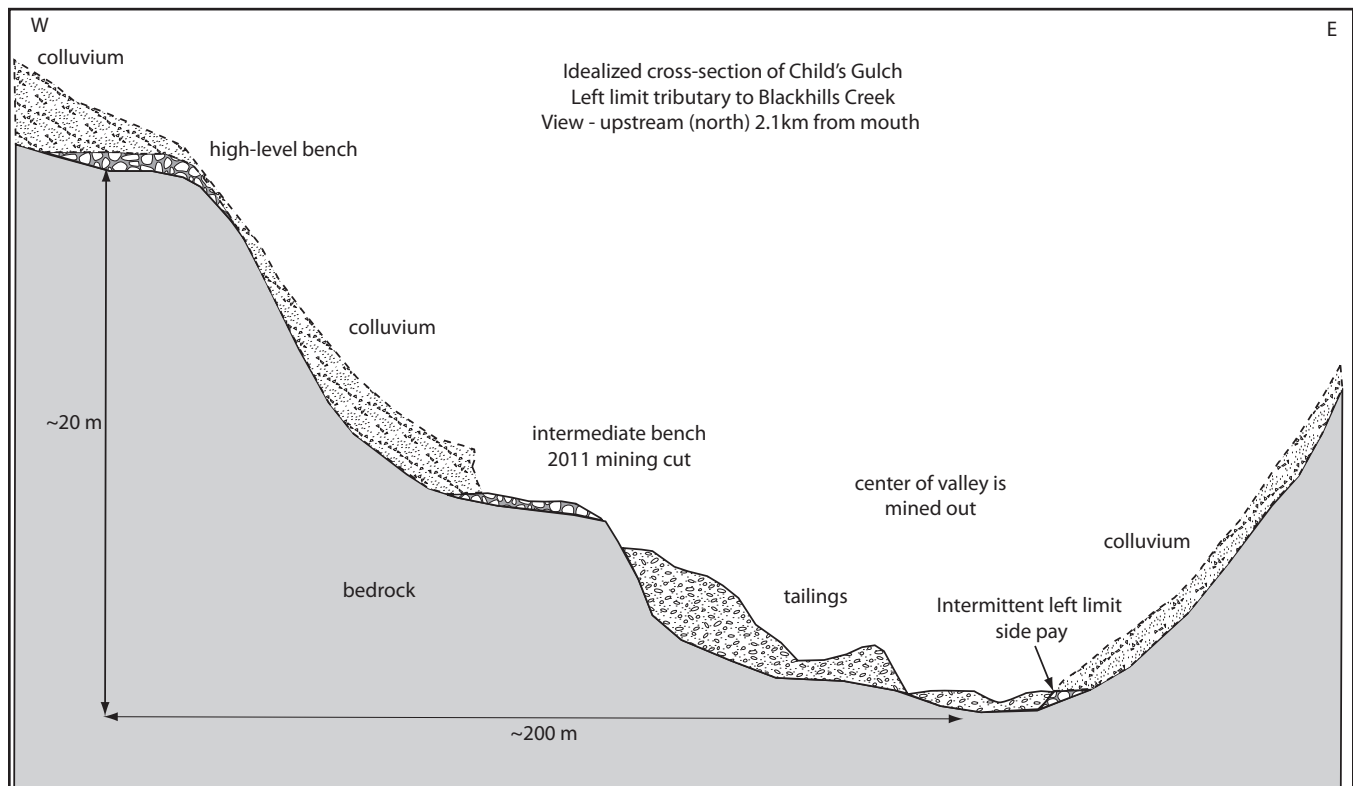
Idealized cross section of Childs Gulch (Source: Jeff Bond).

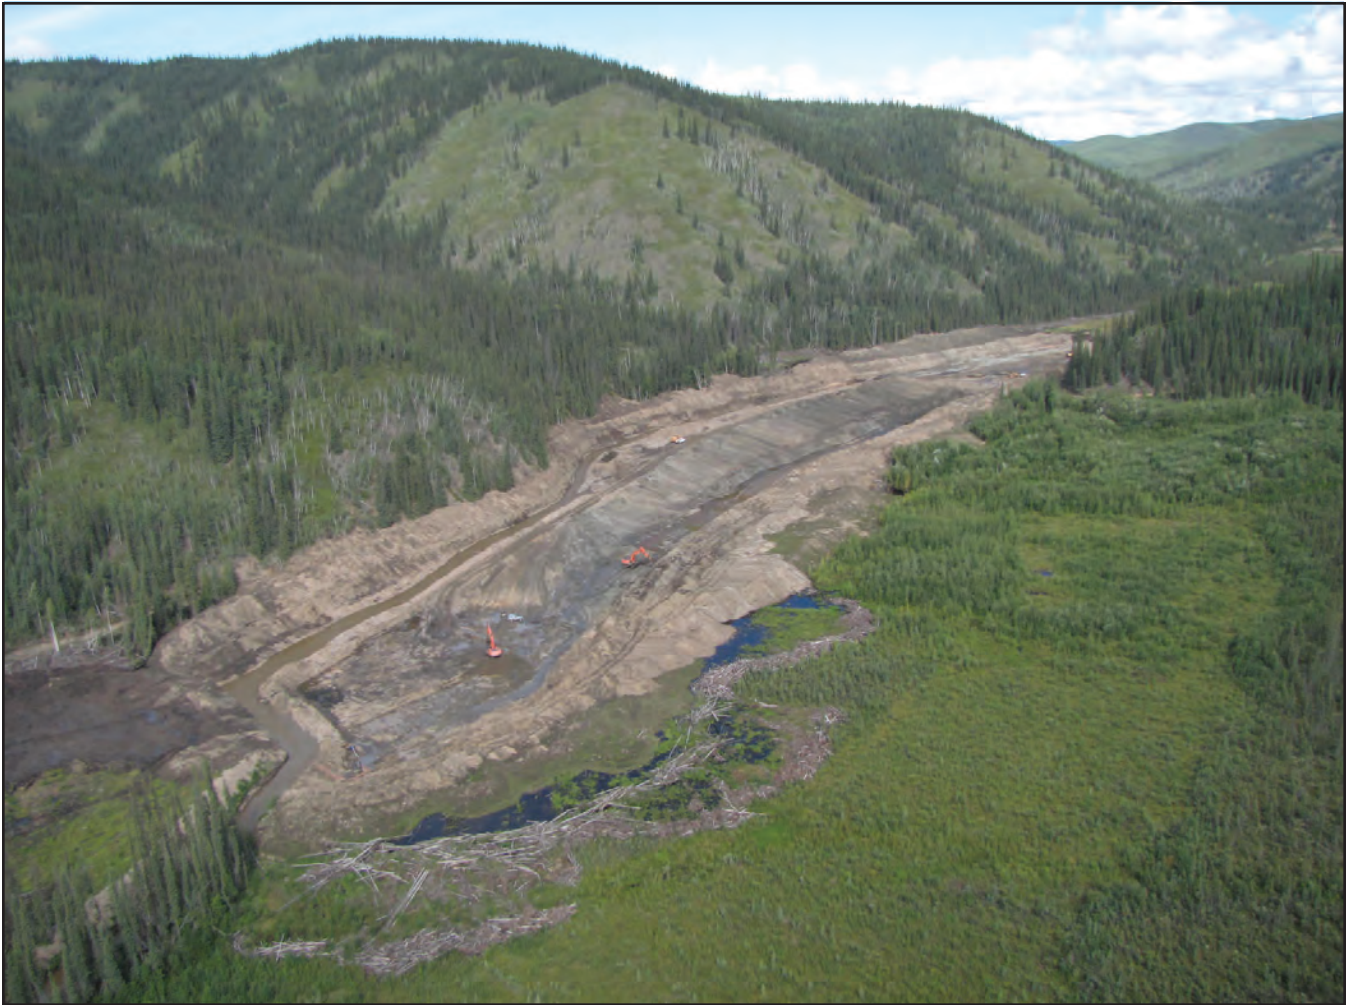
*View looking northeast at H.C. Mining Ltd. operation below the confluence between Henderson and North Henderson creeks in 2014.*

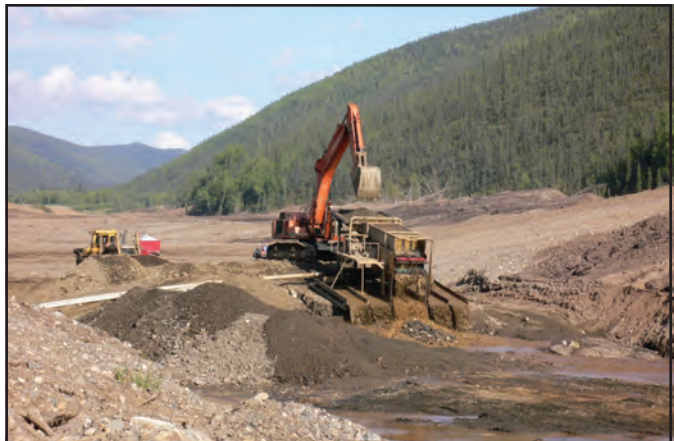
*Sluicing at the Midas Rex Mining Inc. operation on Barker Creek (Photo credit: Stuart Schmidt).*

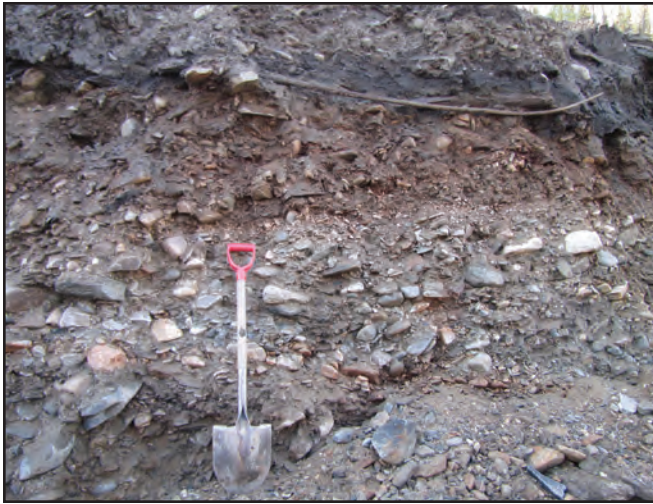
*A left limit bank exposure on Mr. Schmidt's Thistle Creek mine operation. Note the abundance of clasts versus matrix in the gravel. This suggests a relatively high energy stream flow was the depositional environment.*

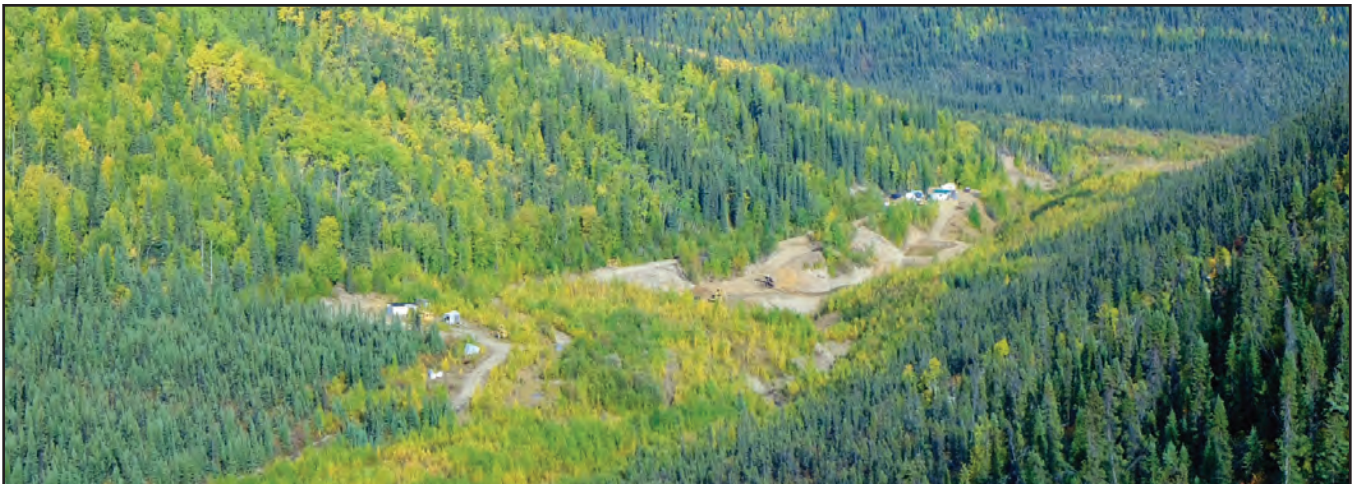
*Aerial view of Fisher Gulch in 2014 (Photo credit: Helena Kuikka).*

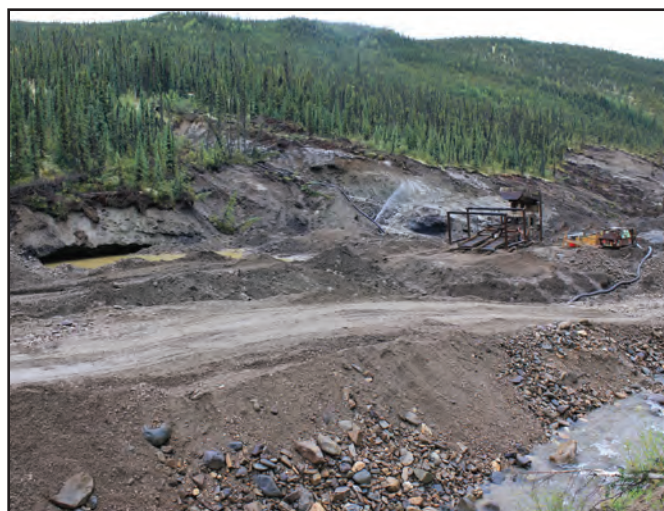
*The Minelli's 2014 operation on main Secret Creek.*

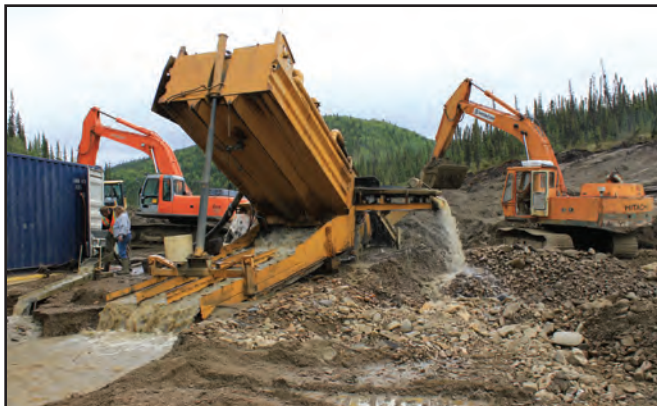
*Custom fabricated wash plant on Secret Creek in 2014.*

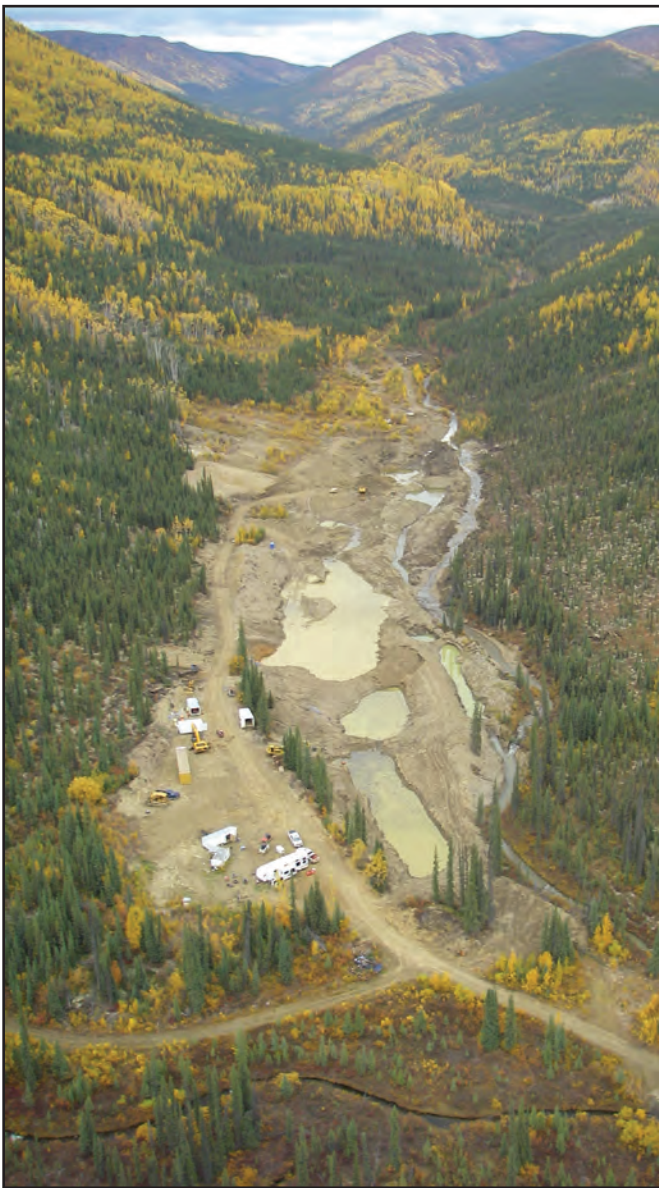
*Aerial view of Mr. Evans and Mr. Bowman's operation on Secret Creek in 2011 (Photo credit: Bill Leary).*

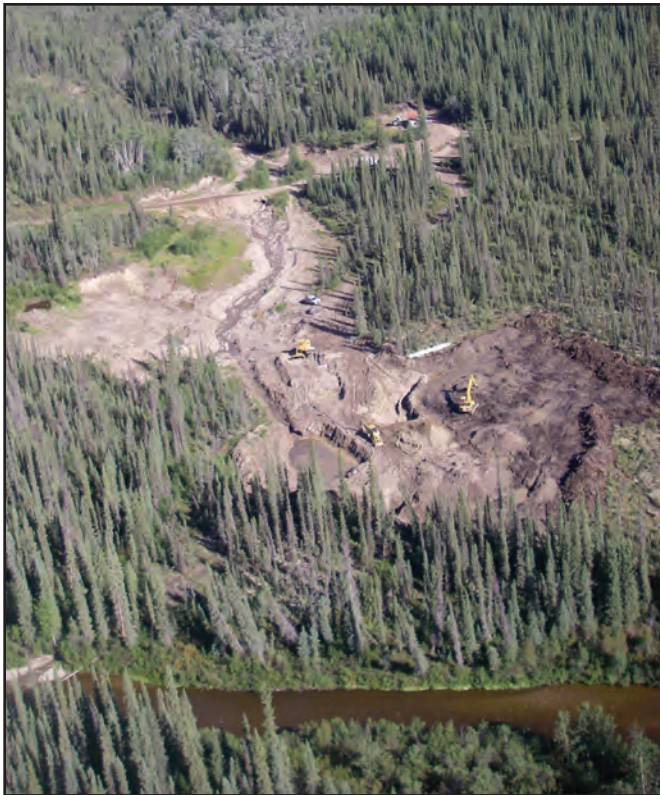
532 Placer Mining on Murphy's Pup in 2011 (Photo credit: Bill Leary).

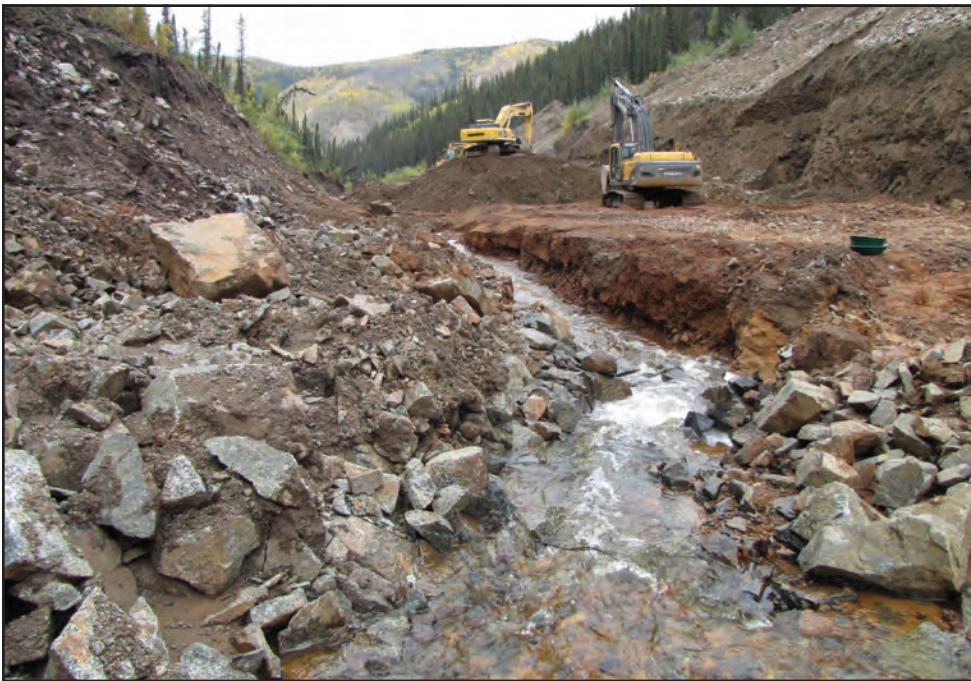
*View looking downstream of the 2014 cut on Guder Creek. Unaltered granodiorite is exposed in the foreground whereas a highly altered contact zone is visible further downstream. The pay unit includes the lower 2.2 m (7.5 ft) visible in the section on the right hand side of the photograph (right limit). The overlying units are primarily colluviated weathered bedrock (slide rock).*

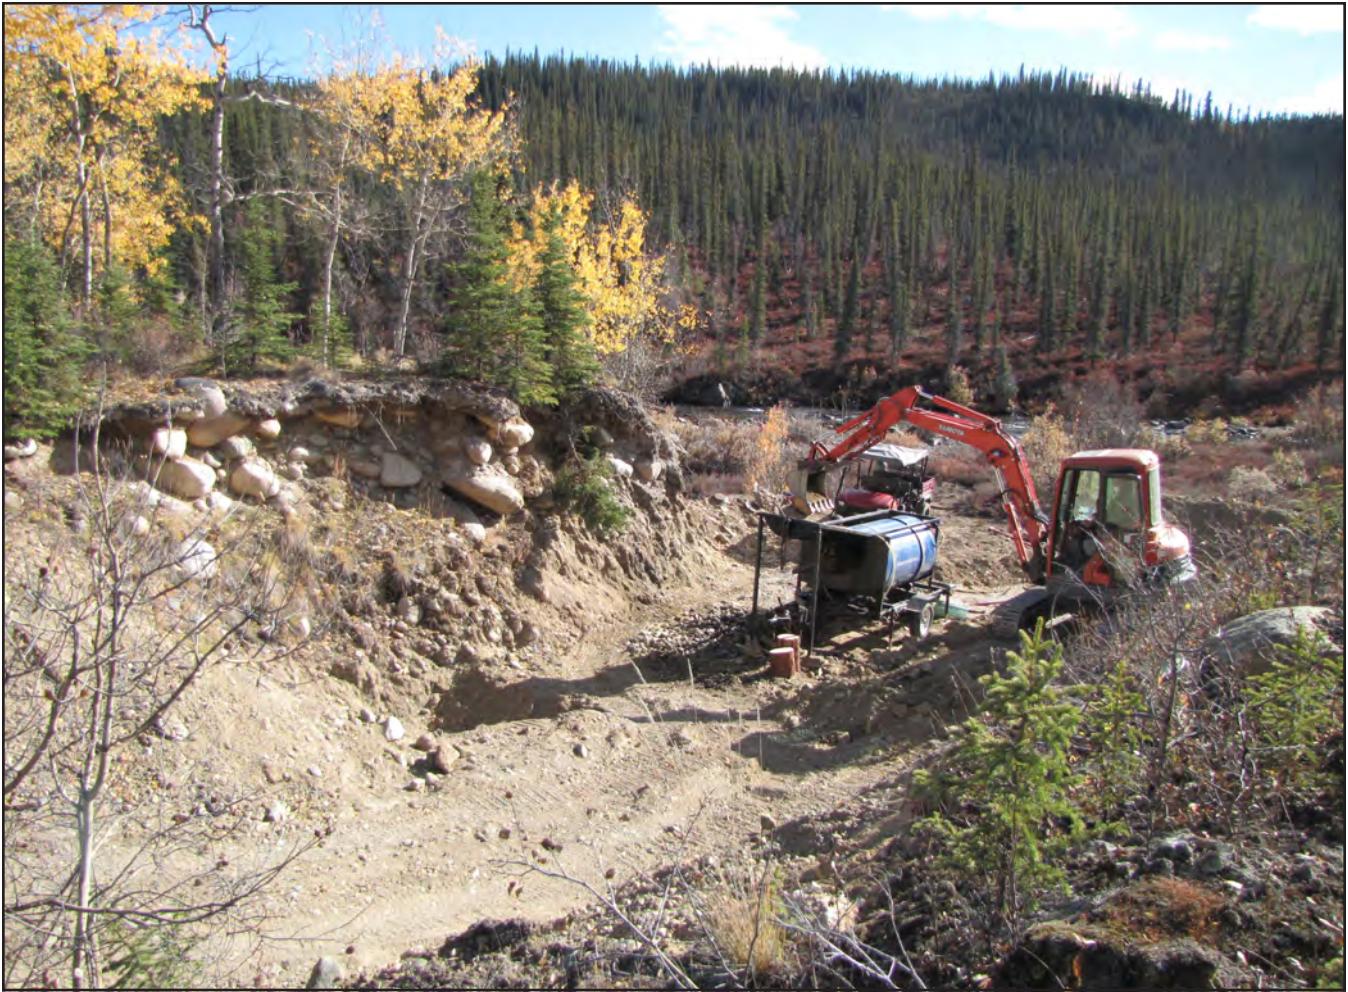
*A trench exposure of the gravel in the lowest terrace of Incised Creek. Granitic bedrock is near the base of the cut and Mr. Brown is sluicing a pebble-cobble dominant gravel below the near surface boulder gravel.*

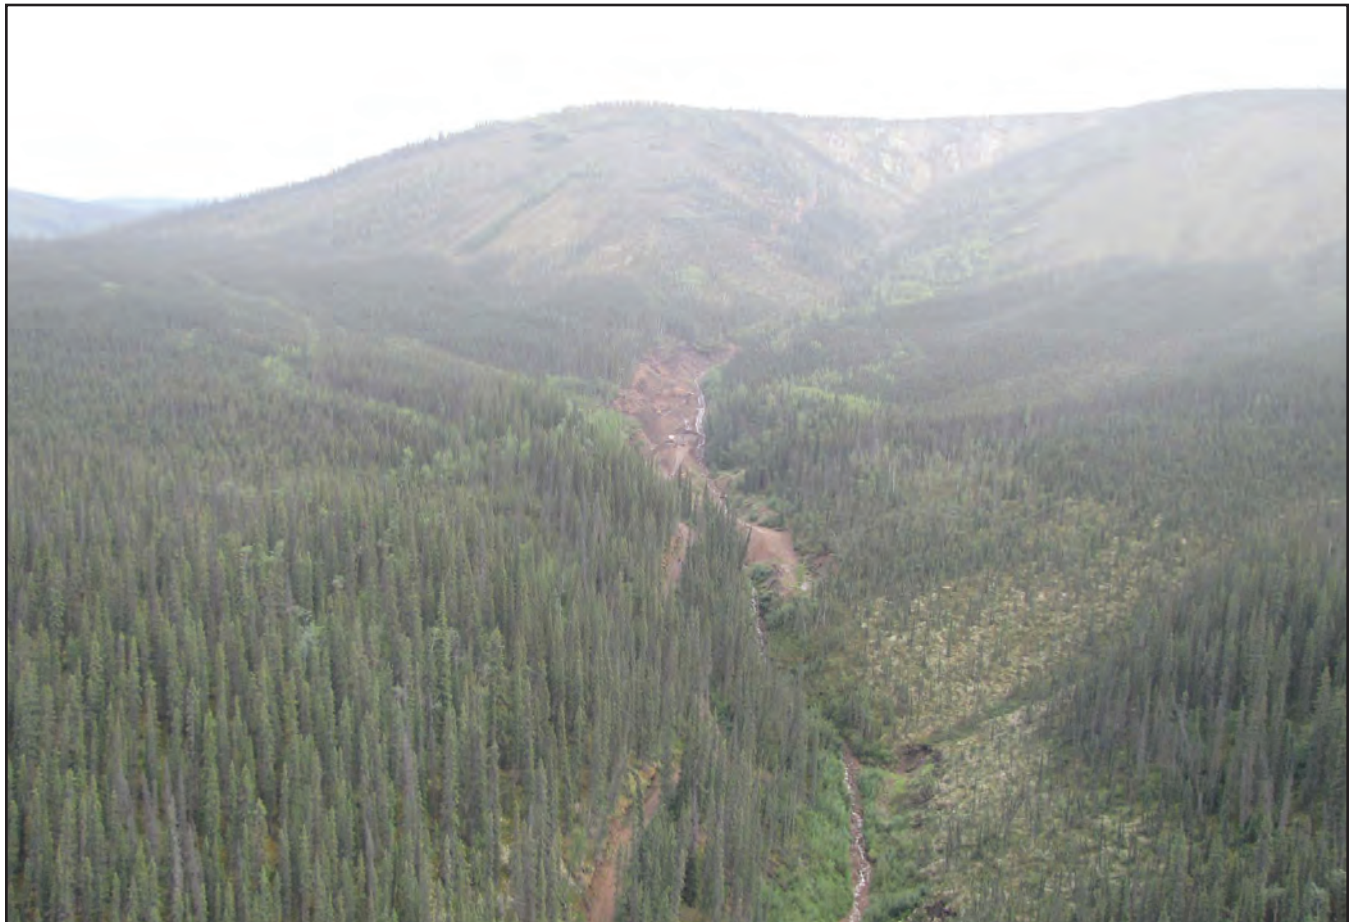
*Aerial view of Mr. Wilson's operation up Sonora Gulch in 2010.*

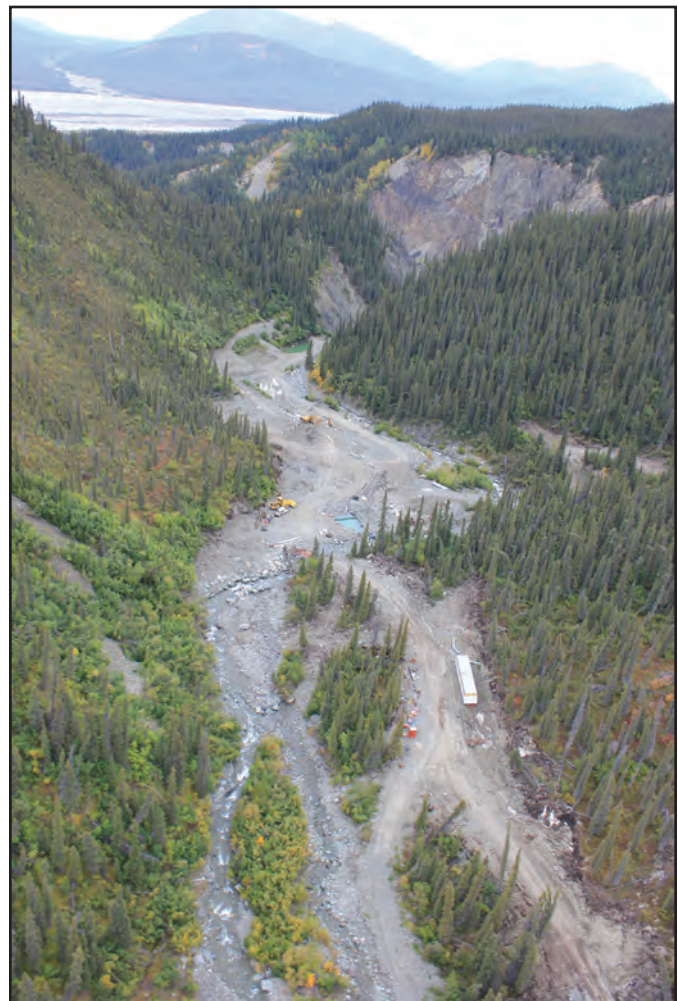
*Downstream aerial view of Arch Creek operator, Mr. Nelson, in 2014.*

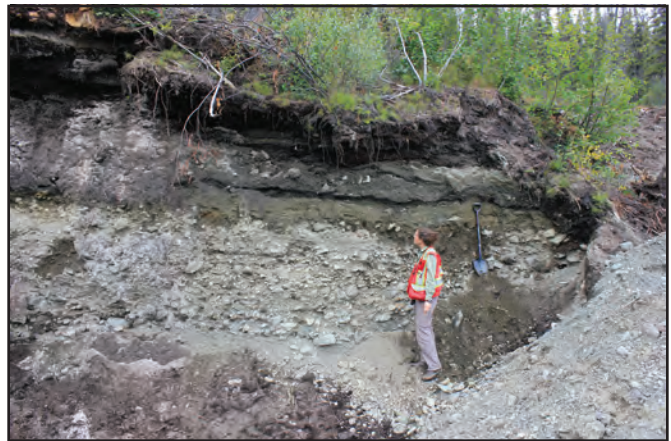
*Mine cut exposed on the left limit of Quill Creek in 2014.*
