TECHNICAL MEMO

SUBJECT: Larson Creek/Beaver River Open Water Survey

2009 GEOTHERMAL ASSESSMENT PROGRAM

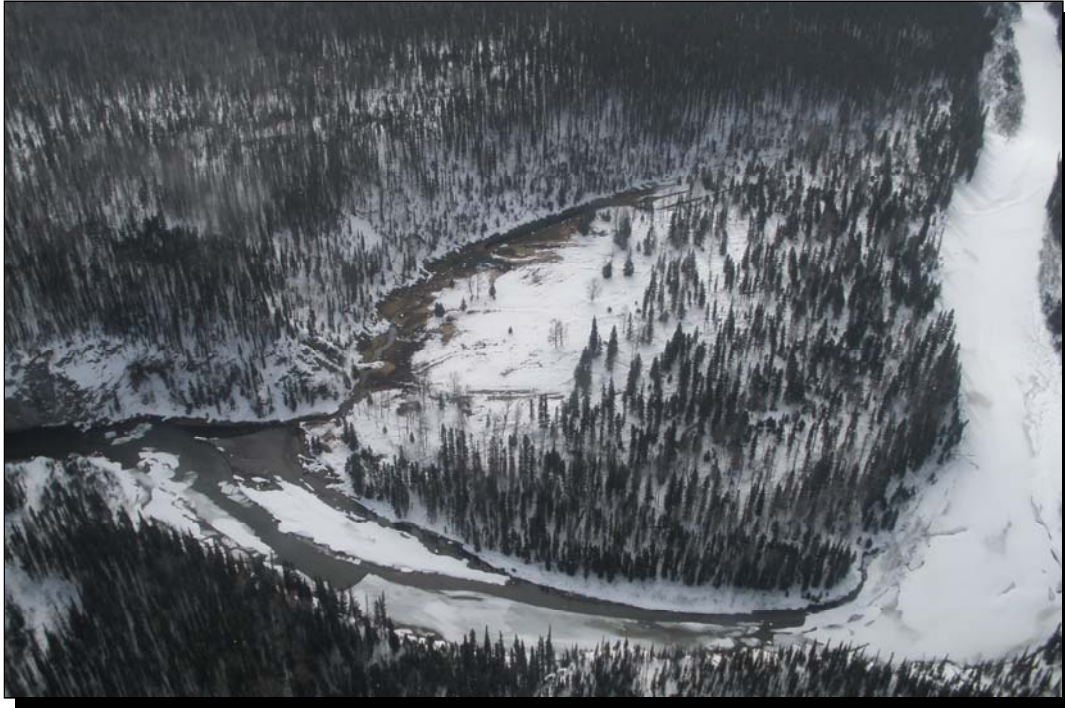
Photograph 1

April 2, 2009. WP123. Pool Creek Hot Springs (upstream site).

The seven open water sites with high probability of geothermal influence [WP120, WP123 (Pool Creek Springs), WP136, WP137 (Larson Creek Hotsprings), WP146/WP147 and WP154] contained round pools and/or seepage areas with open patches of vegetation that drained into a nearby stream or river channel. The associated streams were typically open downstream of the springs but were partially or completely frozen upstream. From this we infer that warm water discharging from the springs was preventing the main channel from freezing. Many of the sites with high potential were first identified by such open channels. Source ponds and areas of snow-free ground vegetation were typically discovered upon follow-up inspection when circling the aircraft. Areas with snow-free vegetation strongly indicate geothermal influence, since snow cover in the surrounding area was 100% and air temperatures were below freezing. Detailed observations of the vegetation was not possible during the aerial survey, but typically the vegetation was brown and appeared dormant.

Geothermal springs or seeps could not be confirmed during the open water survey and ground reconnaissance is required to assess water parameters. All high and moderate probability sites should be evaluated with ground-based assessment methods including water sampling. Many of the moderate sites contained unusual sections of open channels that could not be attributed to hydrologic activity. When convenient, during ground checking of high and moderate ranked sites, low ranked sites could also be documented with a brief ground stop.

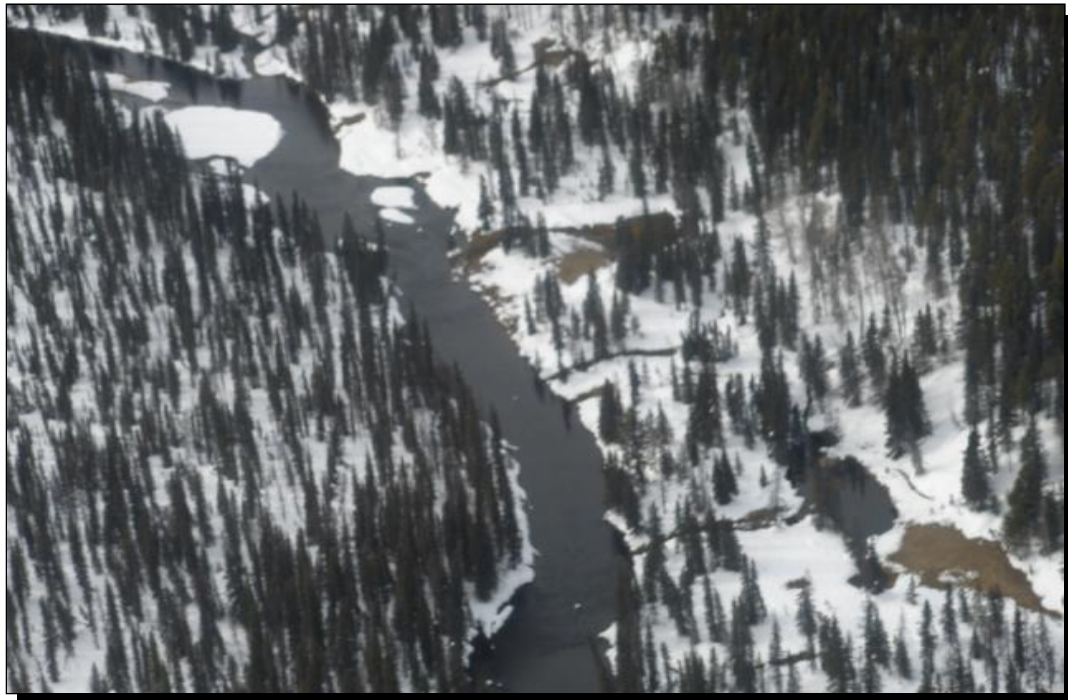
Photograph 3
April 2, 2009. WP136. Upper Crow River, north side of the stream.

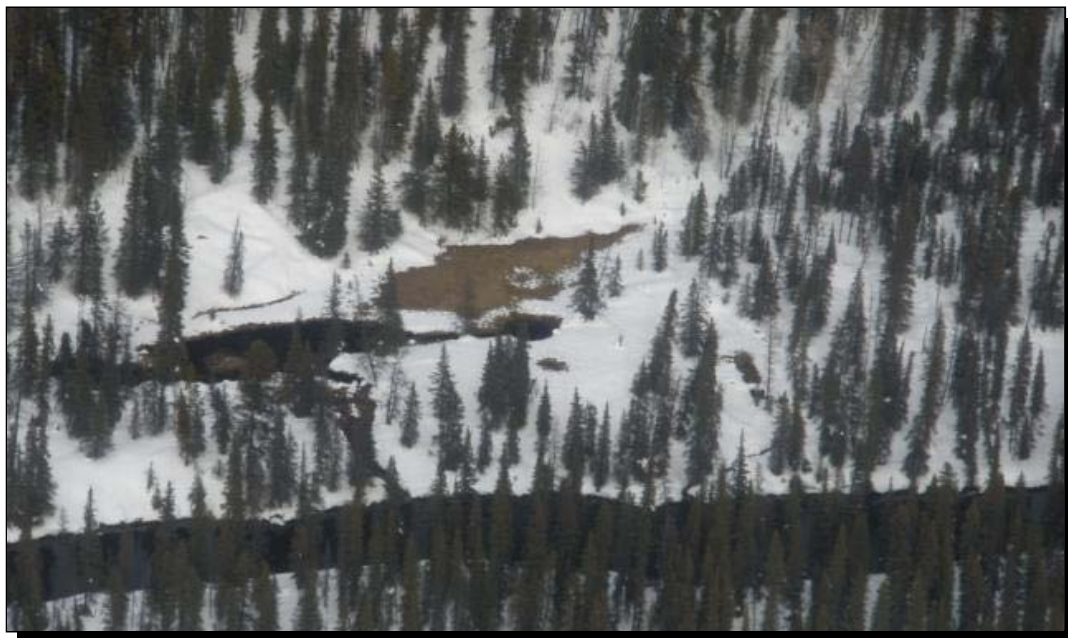
Photograph 4
April 2, 2009. WP136. Upper Crow River. Closer view of the previously undocumented upstream thermal springs

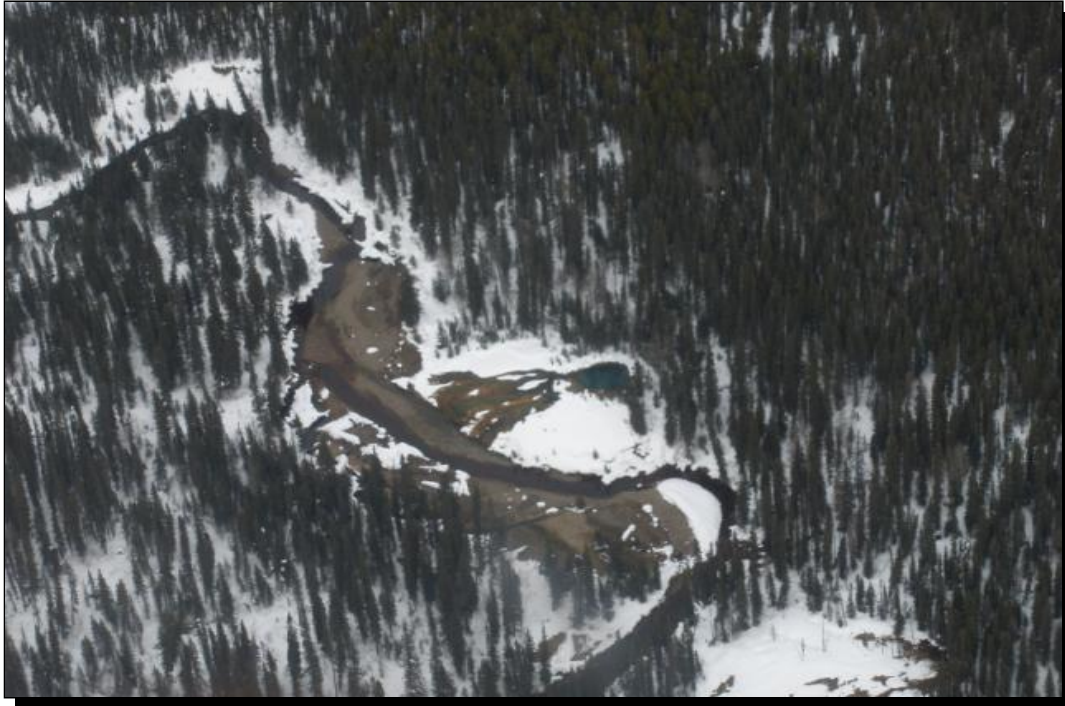
Photograph 5

WP137	stream	sparse	coniferous forest	Larson Creek Hot Springs 2 open areas; 1 distinct pool with vegetation down slope; turquoise colour. Large open sections in river; lots of exposed areas (i.e. with veg showing
WP146	stream	dense	coniferous forest	Side stream tributary; some pooling areas; seepage out of ground; starts from spring; some vegetation on rocks; entire channel is open for significant portion of the stream
WP147	stream	dense	coniferous forest	Same site as WP146 but upstream
WP154	> 1 pond/stream	sparse	coniferous forest	Open vegetated seepage area and then flows into open stream for large portion

April 2, 2009. WP137. Larson Creek Hot Springs. Note the large pool draining Larson Creek.

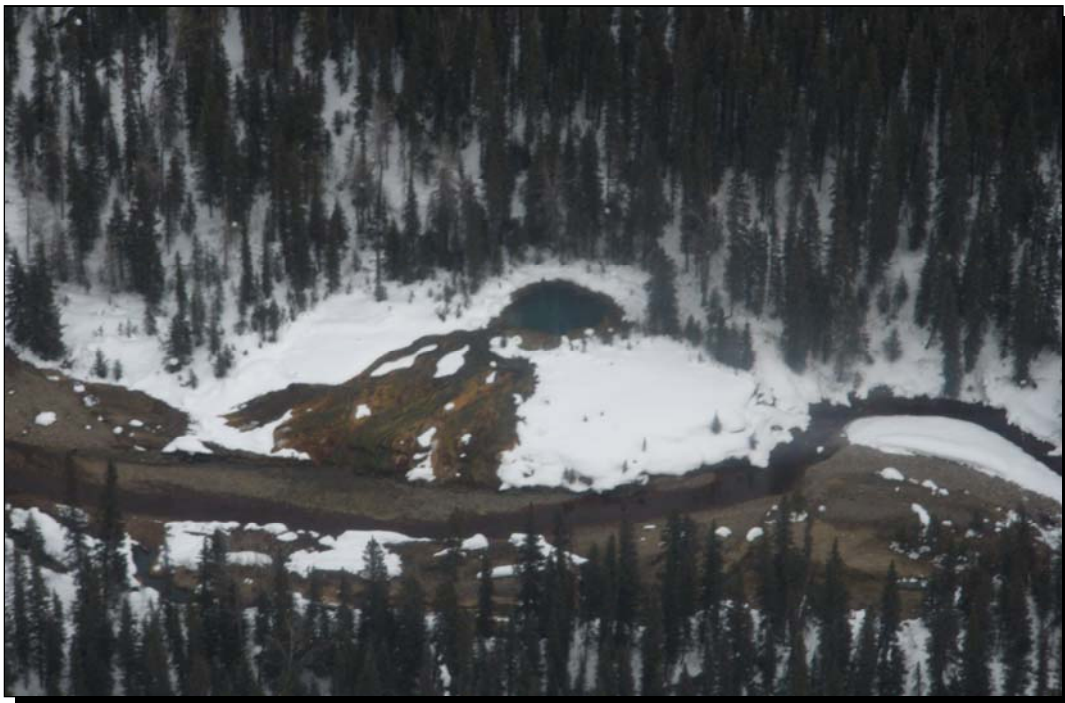
Photograph 6

April 2, 2009. WP137. Larson Creek Hot Springs. Closer view.

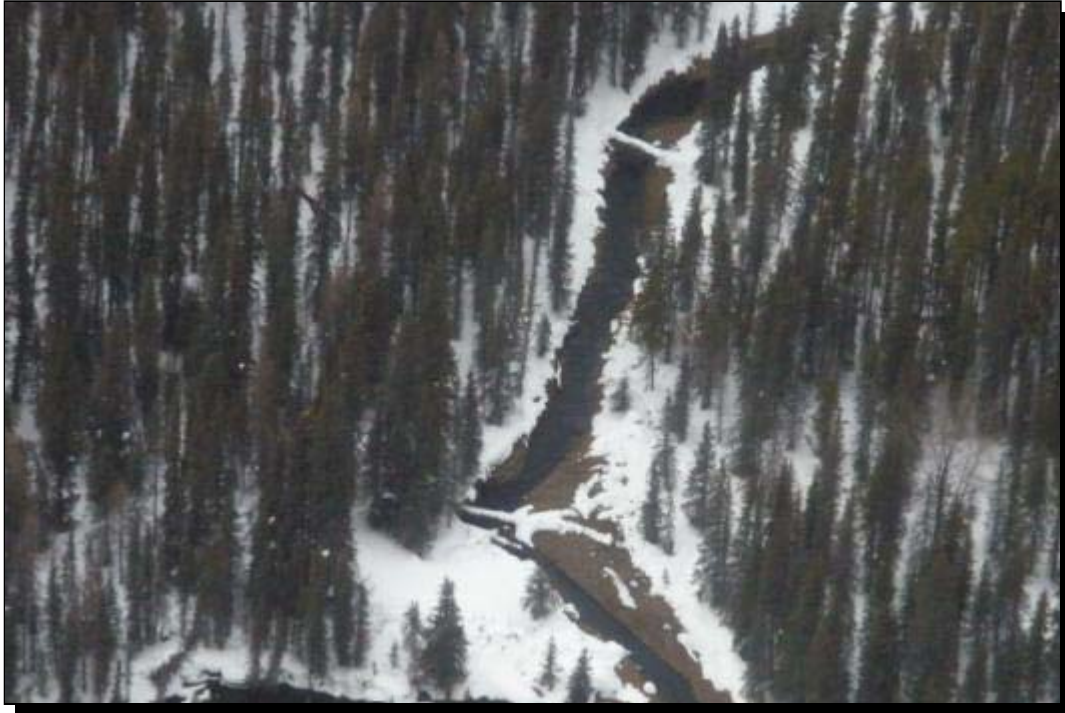
Photograph 7
April 2, 2009. WP146 and WP147. Open channel with vegetation.

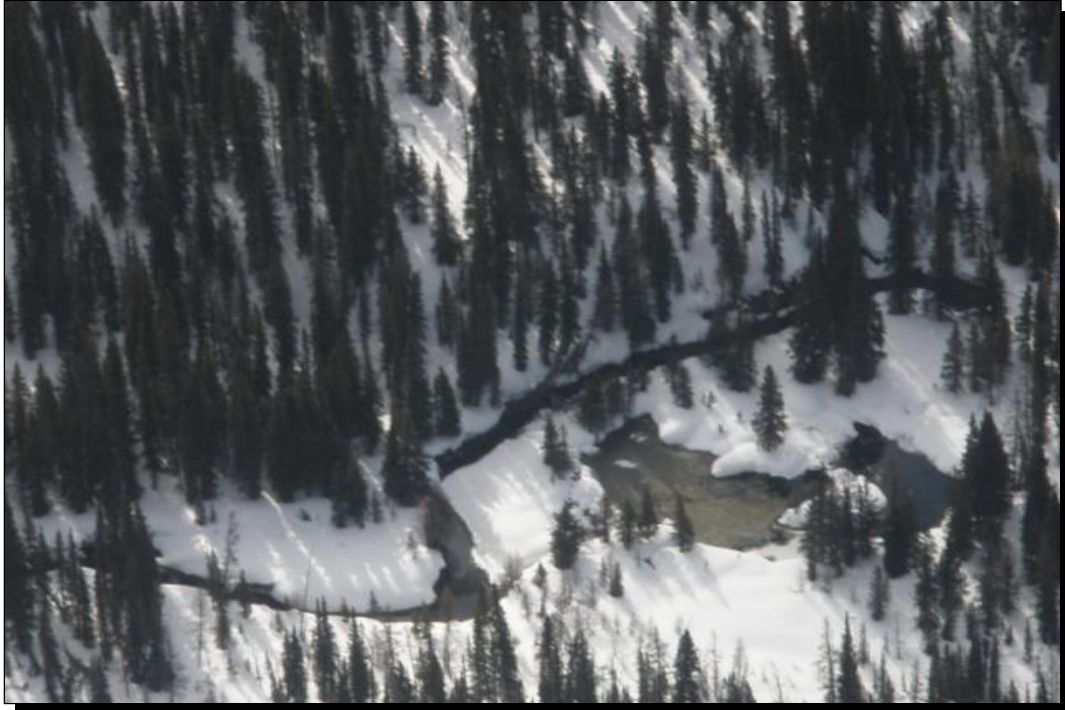
Photograph 8
April 3, 2009. WP154. Previously undocumented geothermal spring with exposed patches of vegetation, open spring and stream channel.
