1990 Warm Water Supply Well (PW2)

Field Program Results
Yukon Territory

Prepared for
Village of Mayo

January 2011

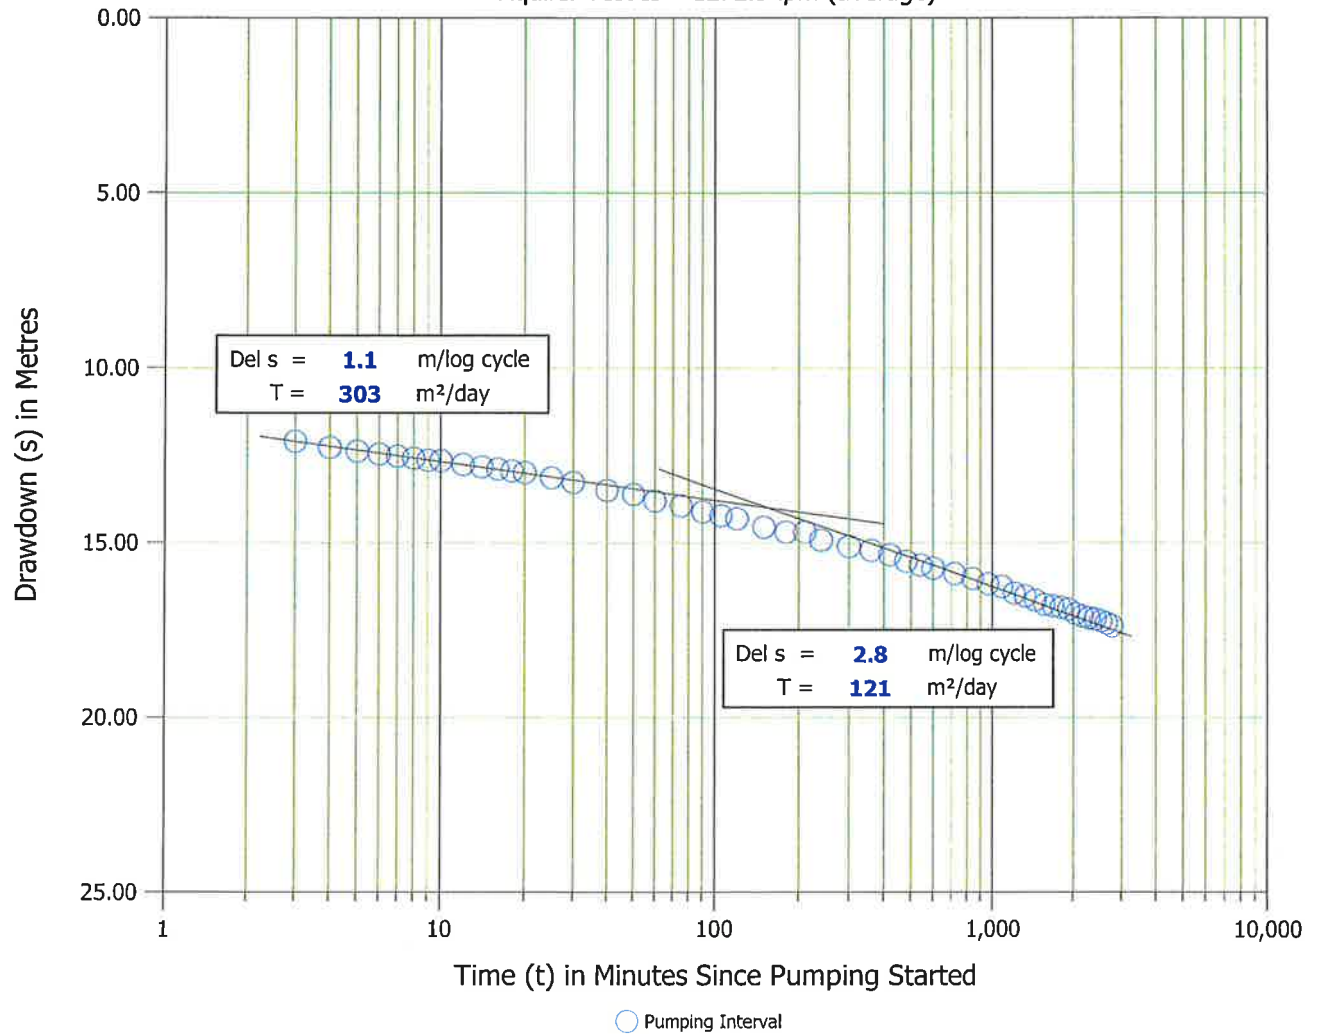
1990 Mayo Warm Water Supply Well (PW2)
Aquifer Test II -- 1272.9 lpm (average)

Confined constant-rate test conducted by Hi-Rate Drilling 1985 Ltd. Water well tester had difficulty inserting tape probe through rubber packer in well head assembly. Reported datum was the top of the four inch tee. The generator stopped working after 2,760 minutes of pumping. Flowing water well recovered to flowing conditions within 10 minutes.

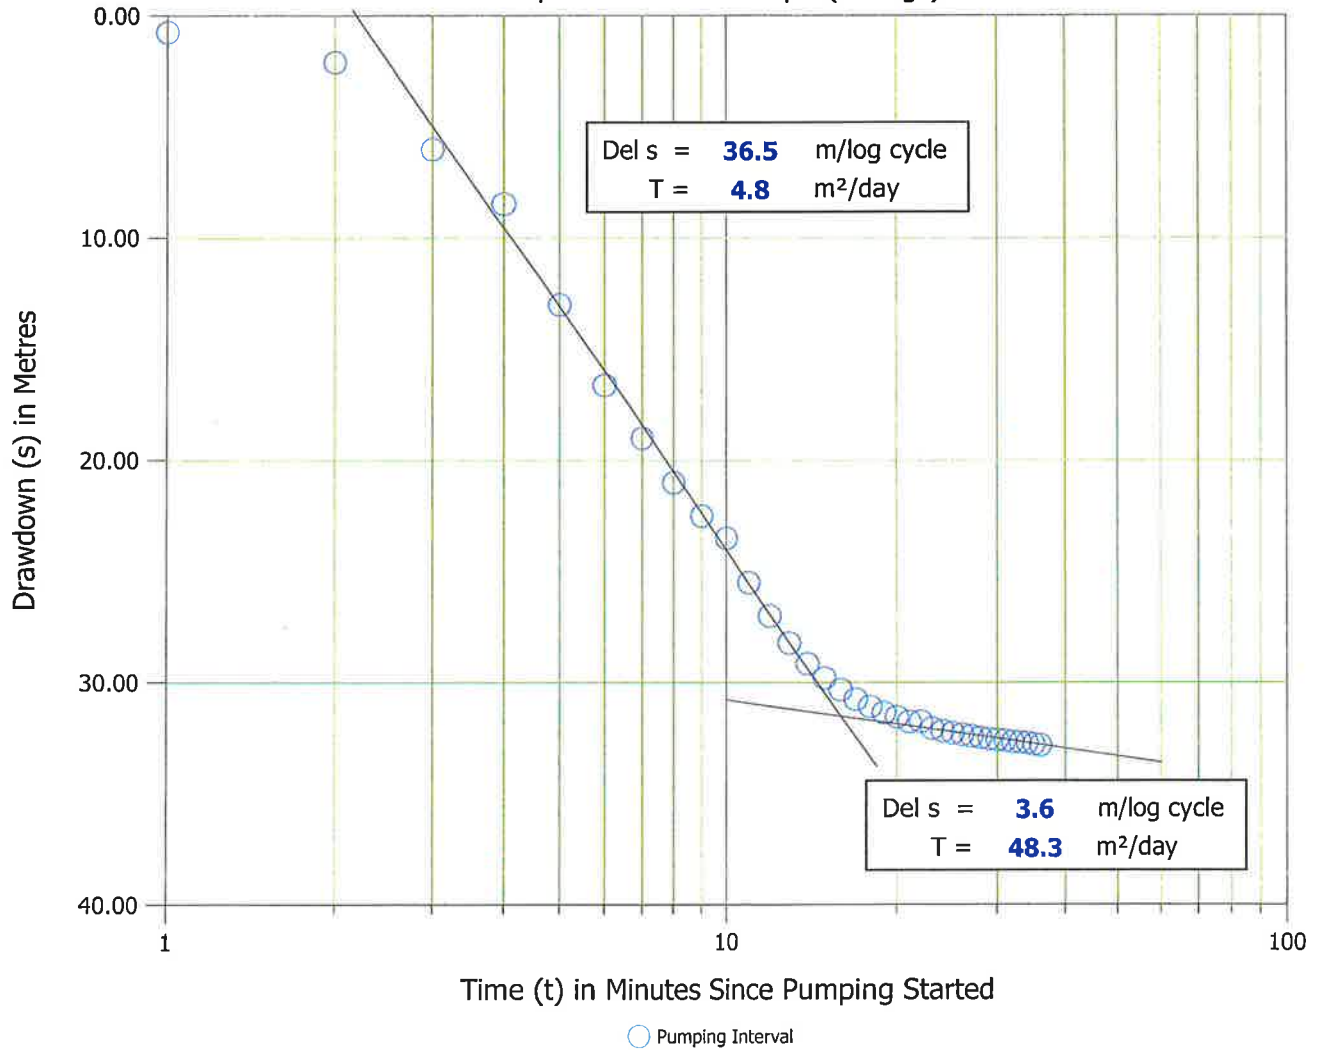
1990 Mayo Warm Water Supply Well (PW2)
Aquifer Test V -- 662.5 lpm (average)

Aquifer test conducted by Aqua Tech Supplies & Services Ltd. The NPWL was not obtained from the water well tester because the water well was flowing at the start of the pumping interval. Water well returned to flowing conditions following 3:37 minutes of recovery.

AT V with PW2 was conducted after the water level had recovered from AT IV. AT V was conducted on October 15, 2010 by Aqua Tech and consisted of measuring the water level while pumping PW2 at an average of 663 lpm for 36 minutes. Prior to AT V, the water supply well was flowing.

During the pumping interval of AT V, the water level was lowered to a depth of 32.82 metres BTOC. Aqua Tech personnel reported the water level began to flow again after 3:37 minutes of recovery. The early pumping data indicate an aquifer transmissivity of 4.8 m²/day and the late pumping data indicate an effective transmissivity of 48.3 m²/day. AT IV and AT V data are in Appendix A.

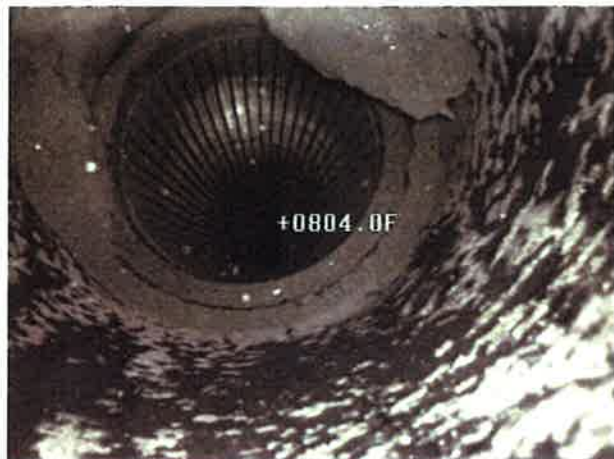
Top of Water Well Screen

- Sand entering the water supply well between the screen and liner.
- There was no noticeable change in the condition of the water supply well screen.

There was no noticeable change in the condition of the water supply well screen from before and after the servicing of PW2. After the servicing though, sand was observed entering the water well from the top of the water well screen, between the screen and the liner; this was not observed prior to servicing.

It is recommended that the sand observed to be entering the water supply well between the liner and the screen in the post-servicing video inspection be monitored using the previously recommended turbidity meter. Before any additional servicing of PW2, it is recommended that another video inspection of the water supply well be completed and, if the video inspection shows that sediment is still entering the water well from between the screen and the liner, PW2 may need to be recompleted in a similar manner as to that proposed for PW1³.

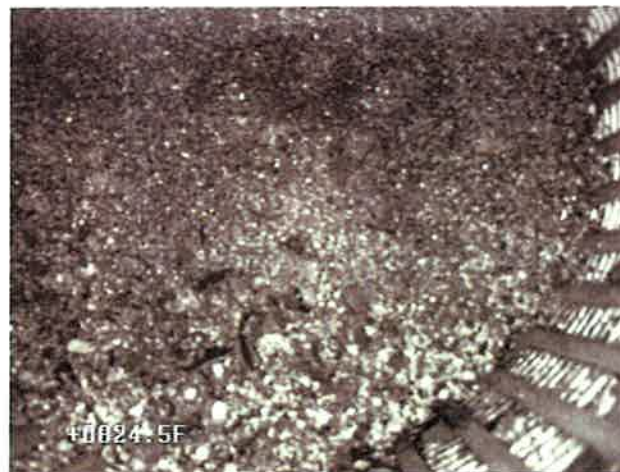
Bottom of Water Well

- The total depth of the water supply well was 251 metres below top of casing (BTOC).
- Significant amounts of sand were present in the bottom ten centimetres of the water supply well.
- The top of the water supply well screen was at 245.5 metres.
- Some encrustation on the water supply well screen, although the encrustation did not appear to be significant.

- The total depth of the water supply well was 251 metres BTOC.
- Sand was no longer present in significant amounts in the bottom ten centimetres of the water supply well. Sand was present on the well bottom, but only several small upwellings of sand were observed.

There appears to be less groundwater entering PW2 through the bottom of the water supply well after the servicing was conducted. Prior to servicing, the flow of groundwater into the water supply well through the well bottom was enough to cause the bottom ten centimetres of PW2 to have considerable amounts of sand present. After servicing, the sand was no longer swirling around the bottom of the water supply well, but a few upwellings of sand on the well bottom indicate that a lesser volume of groundwater continues to enter PW2 from the well bottom. Screen shots of selected observations made during the pre- and post-servicing video inspections are included in Appendix B.

It is possible that there is less water entering the well bottom because the servicing has made it easier for groundwater to enter PW2 through the water well screen. The fact that the groundwater is more easily entering PW2 is shown by the increased specific capacity.
