## Steele Creek detachment failures

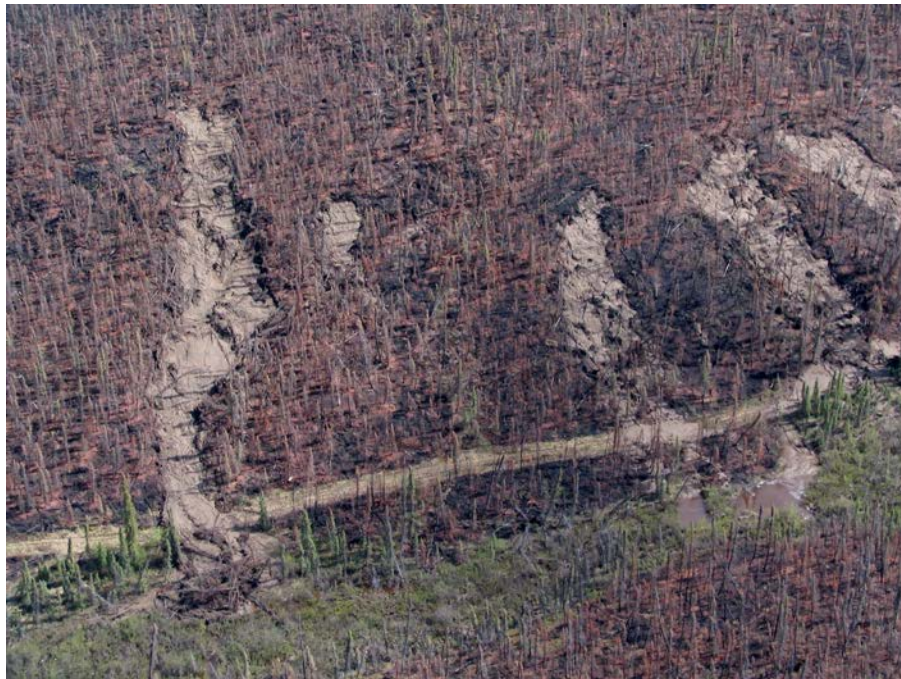
**Figure 1.** Post-fire detachment failures on northeast-facing slopes in the Steele Creek watershed.

Lipovsky et al. (2006) and Coates (2009) studied the thermal regime of more than 35 active-layer detachments within two years of forest fires that burned during the summer of 2004 in the Steele Creek watershed. The Steele Creek watershed lies within the northwestern sector of the Klondike Plateau and within the extensive discontinuous permafrost zone (Heginbottom et al., 1995; Bonnaventure et al., 2012). Permafrost underlies all but well-drained south-facing slopes (Lipovsky et al., 2006). Coates (2008) determined that the forest fires destroyed the organic mat causing the permafrost table to lower an average of 20 cm. Most of the detachments occurred the same summer as the fires.

The detachments occurred in coarse grained deposits (Coates, 2009). A representative failure was described as being initiated within “sandy gravel and gravelly sands with trace silt and clay” p59 (Coates, 2009). Froese and Jackson (2005) map these initiation zones to be within colluvial blankets and veneers. Lipovsky et al (2006) describe that most failures occurred proximal to convex breaks in slope. Many of the failures ran out onto the subdued terraces that are mapped by Froese and Jackson (2005) as Pleistocene aprons of reworked ice-rich eolian and colluvial aprons regionally known as “muck” overlying Tertiary gravel terraces. Coates (2008) postulated that with fire recurrence intervals in the order of 100 years, post-fire active layer detachments have likely been an important factor in shaping the form of the region’s slopes. Specifically, the gentler gradient and presence of mid-slope breaks observed on permafrost slopes within the region could be due to post-fire ALDS.
