Fifty Mile active-layer detachment failures

Location: 63.822632°N 140.298913°W

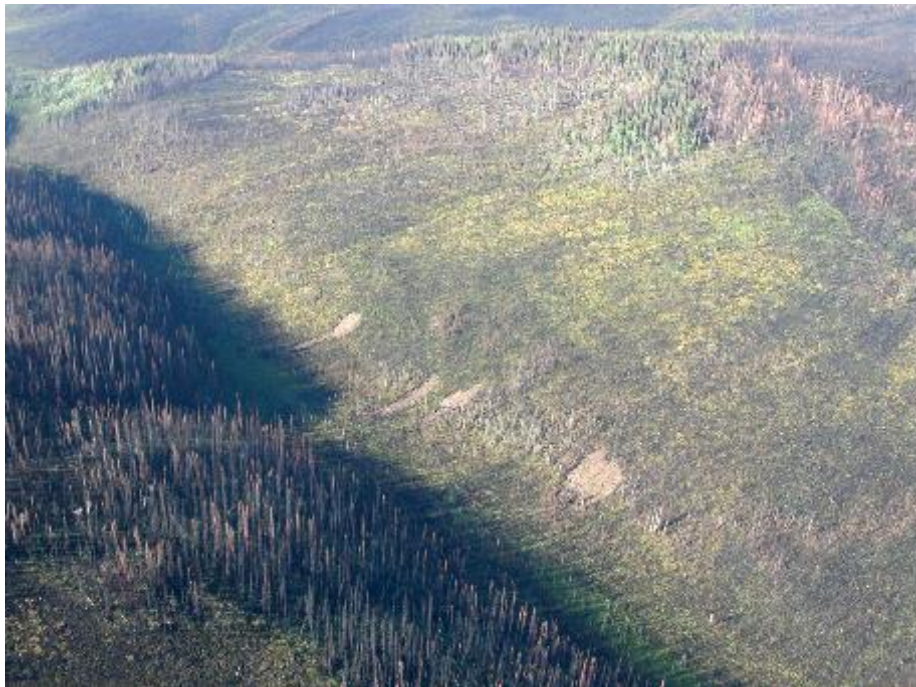
Figure 1. Oblique aerial view of four detachments that occurred on the lower portion of a moderately steep east-facing slope (05PL056a,b,c,d). This photograph was taken one year after the forest fire (July 2005).

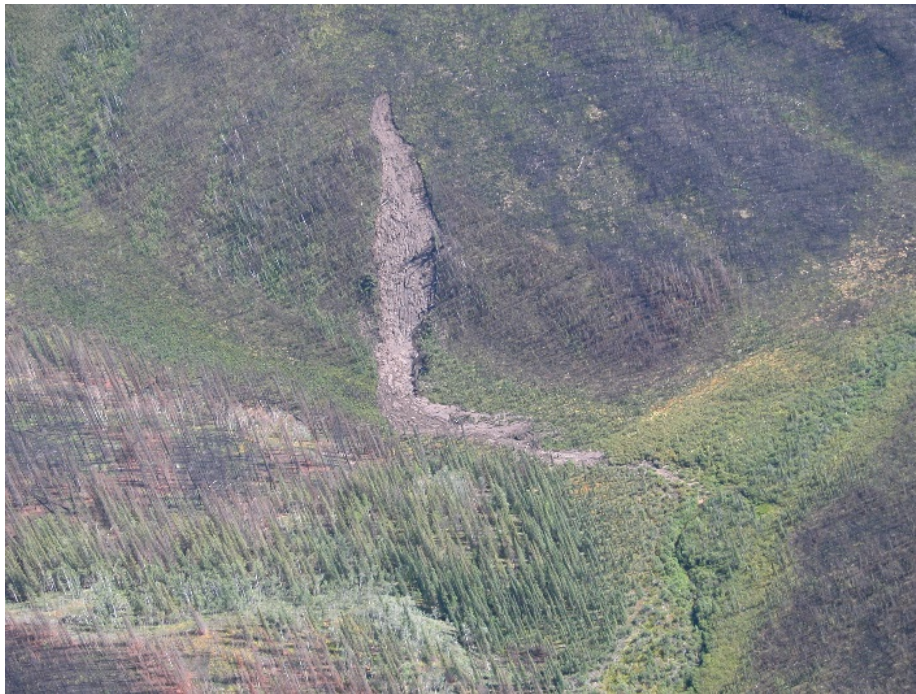
Figure 2. Oblique aerial view of a north-facing detachment that reached the valley floor and a tributary stream channel (05PL088). This photograph was taken one year after the forest fire.

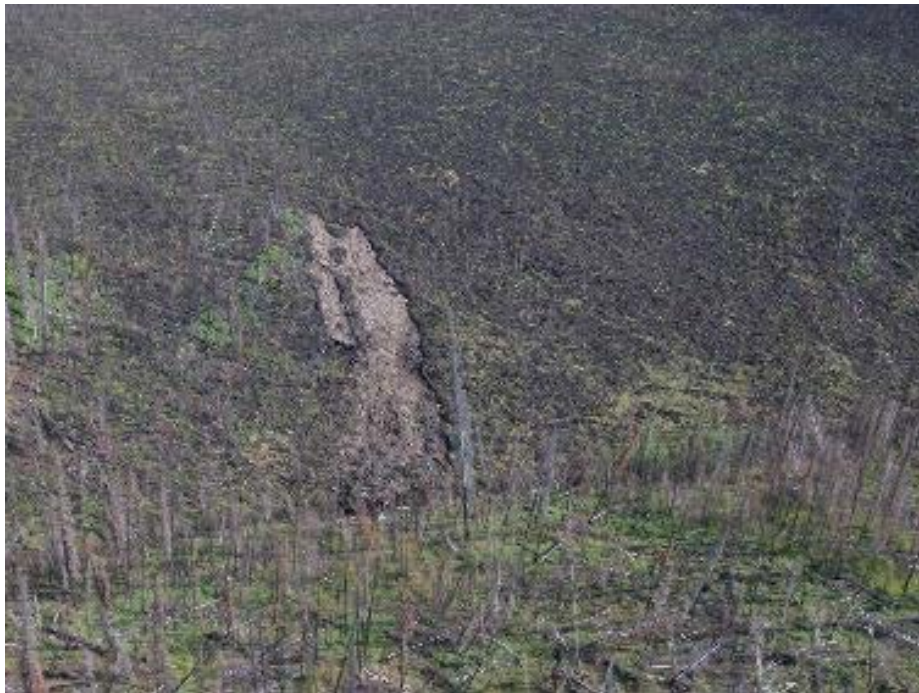
Figure 3. Northwest-facing detachment developed within silt-rich colluvium. This slide is 63 m long and 19 m wide and initiated on a 19 degree slope (05PL012).
