## Dip Creek thermokarst lake

**Location:** 62.656502°N 138.745962°W

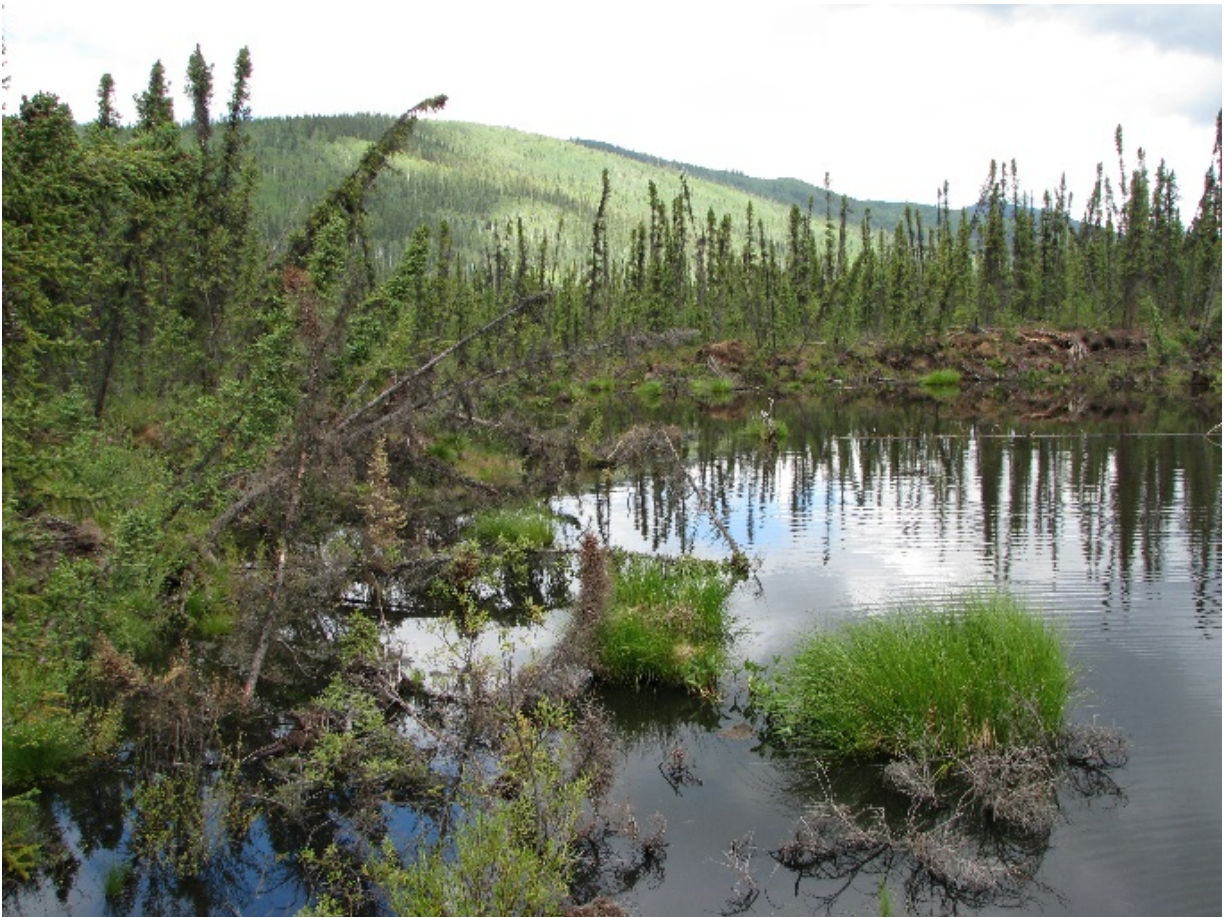
Lipovsky and Bond (2012; 10PL040) map an oval shaped thermokarst lake 64 m in length in the valley bottom of upper Dip Creek. The banks of the lake are up to 6 m high and composed of organic-rich fine sandy silt derived from resedimented loess (colluvial-eolian apron sediments). A field visit in July 2010 revealed that the frost table was at 140 cm. Less than 5% visible ice was observed at the permafrost surface, including discontinuous veins of ice up to 3 cm thick.

**Figure 1.** Photograph taken in 2010 of a thermokarst lake in the upper Dip Creek valley bottom. Collapsing banks are up to 6 m high. Tipped (drunken) trees indicate that permafrost thaw is occurring, and the lake is still expanding.

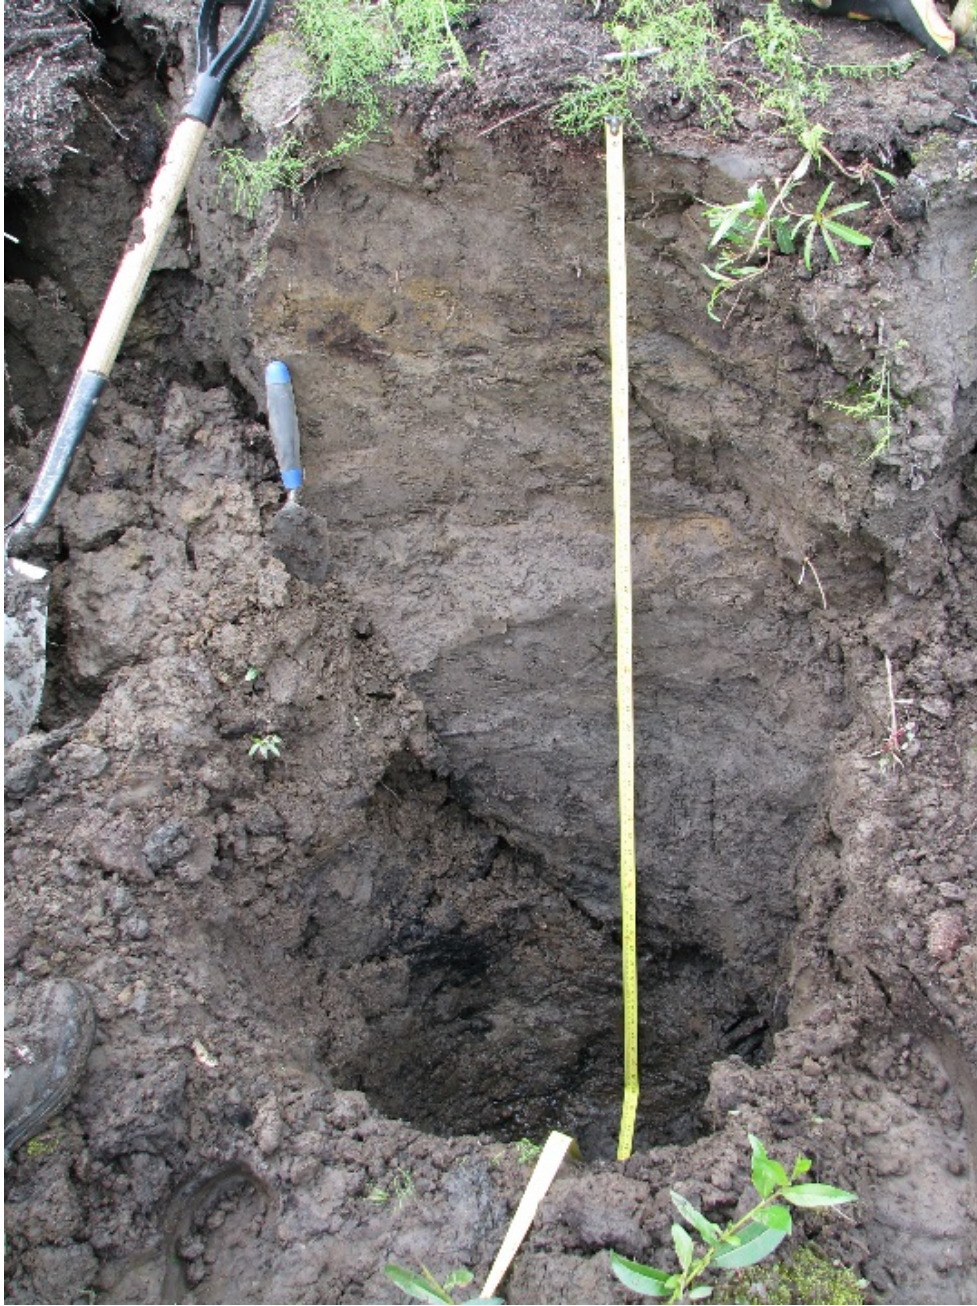
**Figure 2.** 140 cm deep soil pit dug within the bank of the Thermokarst pond in July 2010 revealing organic-rich fine sandy silt derived from resedimented loess (colluvial-eolian apron sediments).
