May 21, 2014

FILE: W14103395-01

Subject: Slope Stability Assessment South of Hawkins Street
Whitehorse, YT

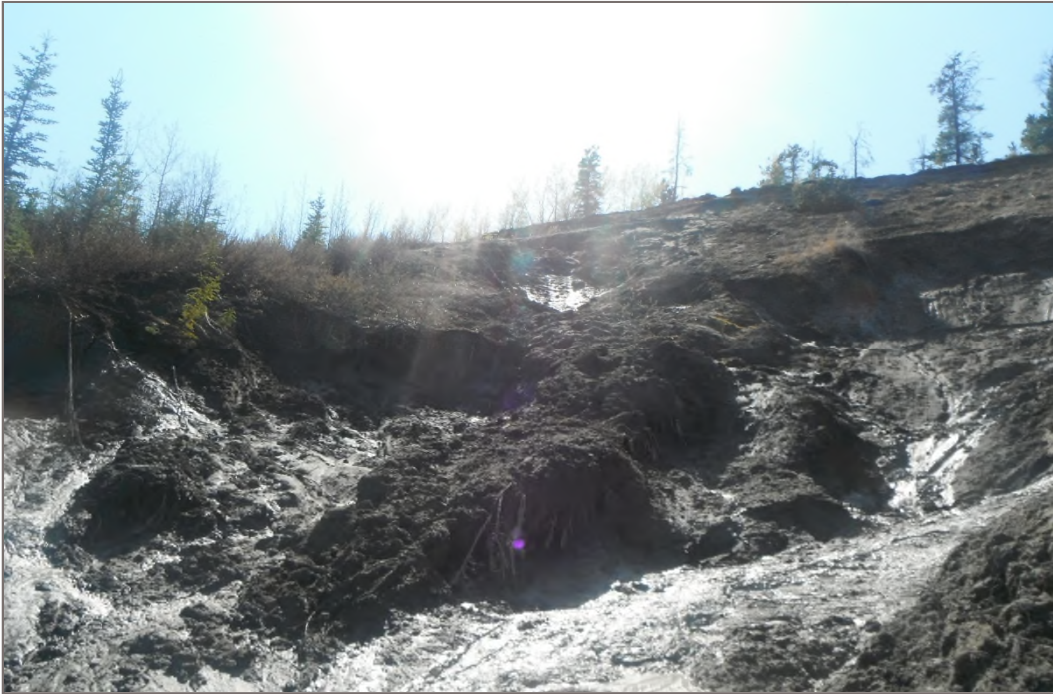
- This landslide is considered a surface mudflow, rather than a classic "landslide" with a deep seated rotational failure plane.
- Four back scarps were observed, all of which contributed to the recent mudflow. Photo 1 shows three of the four back scarps.

Photo 1: Three of the four back scarps at the site (May 15, 2014)

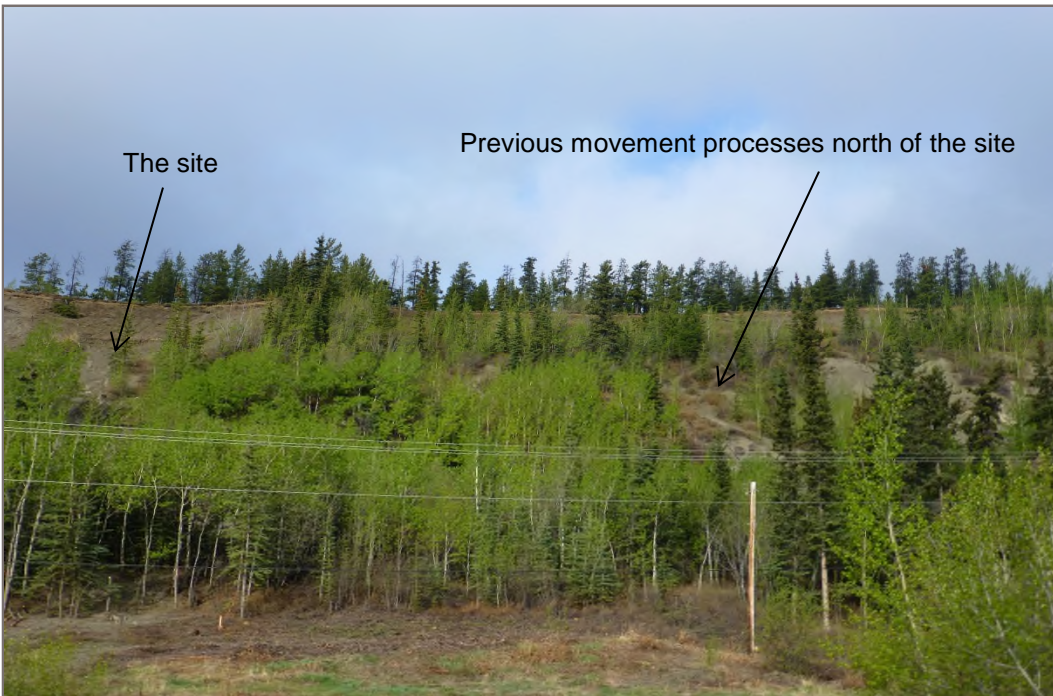
- Evidence of previous instabilities was observed north and south of the recent landslide (see Photo 2).
- The general soil stratigraphy in this area is eolian sand overlying glaciolacustrine silt. The landscape of the study site south of Hawkins Street is a natural gully created by erosion and previous slope instability processes. It is believed that seasonal snowmelt water from the airport above permeated the surficial sand layer and then seeped horizontally out towards the cliff face on top of the less permeable silt. This additional water would further contribute to a reduction in shear strength of the naturally thawing soil on the slope, resulting in a wet mudflow flowing down the slope.

Photo 2: Evidence of previous movement processes north of the site (May 20, 2014)

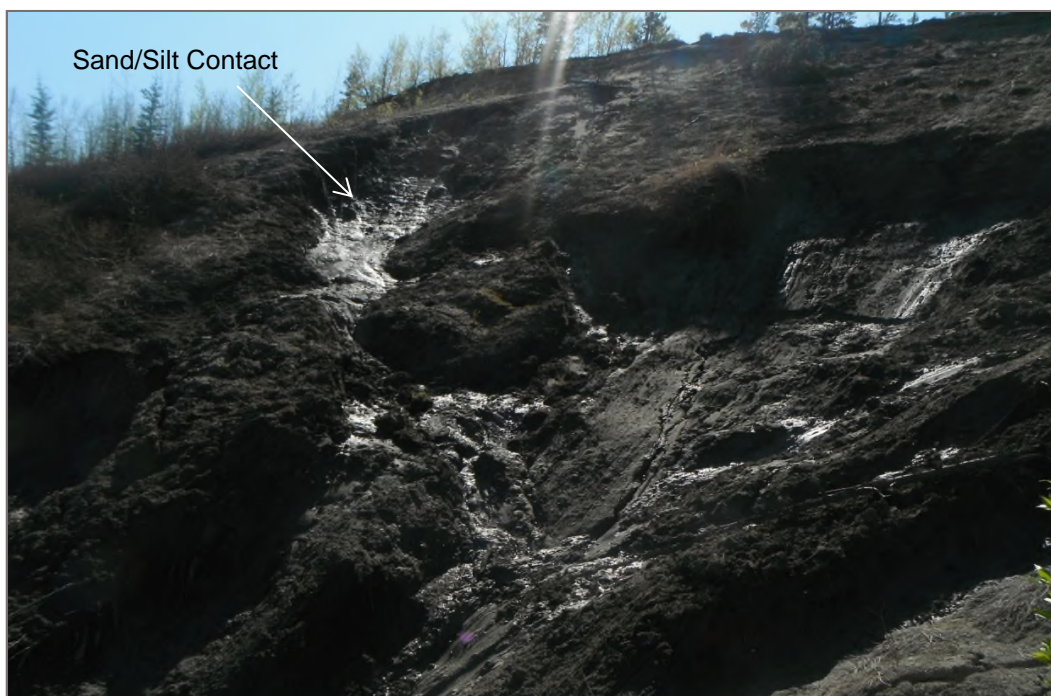
- The sand/silt contact is shown in Photo 3. Water is evident (looks shiny in the picture) just below the top of the back scarp where the silt layer begins.

Photo 3: Sand/Silt contact (May 15, 2014)
