**Geotechnical Evaluation
Proposed Airport Connector Road
Teslin, Yukon – 2017**

Prepared For: Village of Teslin

Date : December 26th, 2017

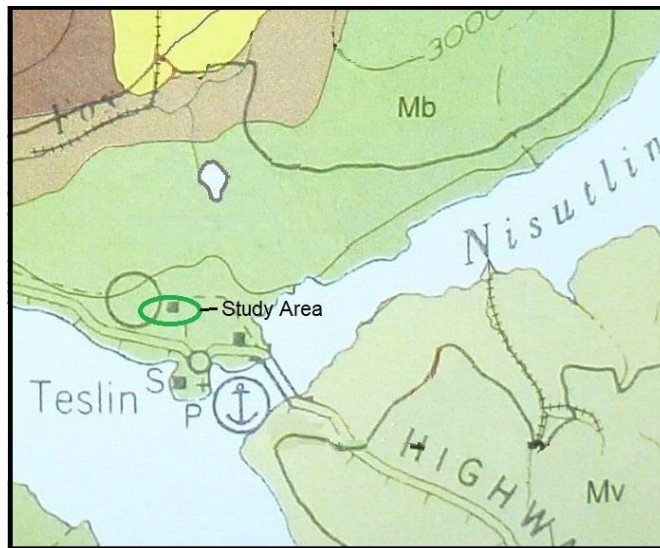
The surficial geology map identified landform terrain types and indicated the generic composition with textural, morphological and erosional modifiers as follows;

The surficial geology map described the area as being comprised of morainal blanket (Glacial Till) deposits. Morainal blankets consist of lodgment and ablation till with a silty to sandy matrix which varies between 1 to 30 meters thick. The morphological expression is described as gently irregular to strongly irregular bedrock controlled topography blanketed by till. Although not identified (likely due to the scale of mapping), the glacial tills are covered with glaciofluvial and organic materials.

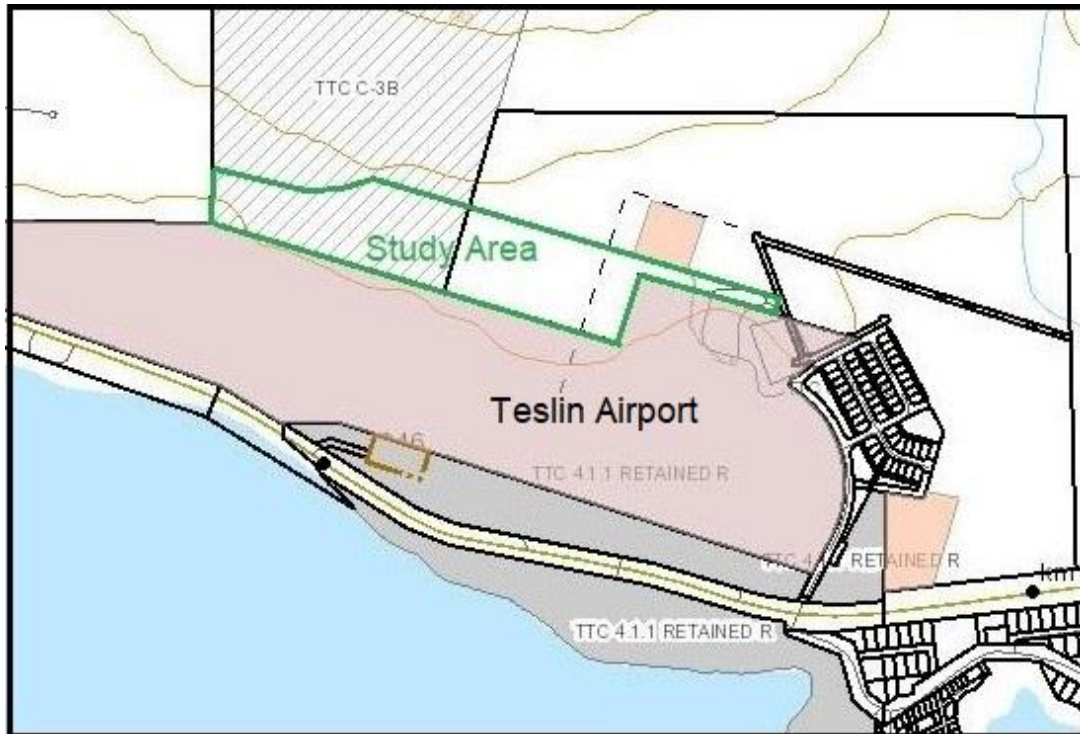
The *Yukon Government – Water Placer Atlas* website was reviewed as it provided the boundaries of various land dispositions, drainage regimes and other similar types of information. The corresponding boundaries of the study area have been illustrated on the *Water Placer Atlas* map as noted below.

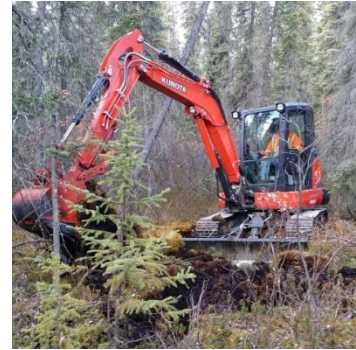
Conditions at TP 8-17

The test pits were excavated across the study area to better characterize the types of terrain which were identified during the site reconnaissance. The work consisted of excavating eleven (11) test pits utilizing a *Kubota kx-057* tracked excavator equipped with a digging bucket. The excavator was supplied and operated by *Flag Hill Woodworks* of Teslin, Yukon.

The test pits were excavated to an average depth of 1.6 meters (but varied between 0.7 and 2.0 meters) below the existing ground surface at the approximate locations noted in Figure 2.

In brief, although there were no signs of sidewall slough, the sidewall stability in the test pits excavated in Area 3 (TP 1-17 & TP 8-17) was considered poor due to the saturated soil conditions which were encountered at these locations.

Free flowing groundwater was encountered in TP 1-17 & TP 8-17 at a depth of approximately 0.35 meters below the ground surface.

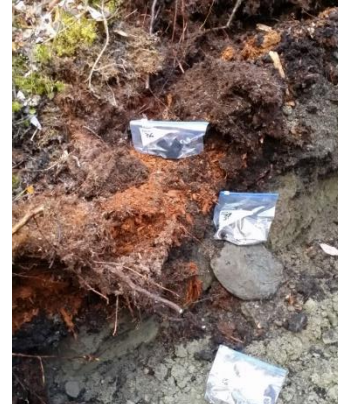
TP 9-17 Sidewall Samples

Typically, samples located within the upper meter of each test pit were retained by hand from the excavation sidewalls. The remainder of the samples were retained from the leading edge of the excavator bucket.

Once the soil samples were retained, they were described on the field soil logs, sealed in air-tight plastic bags and numbered consecutively to allow for subsequent laboratory analysis.

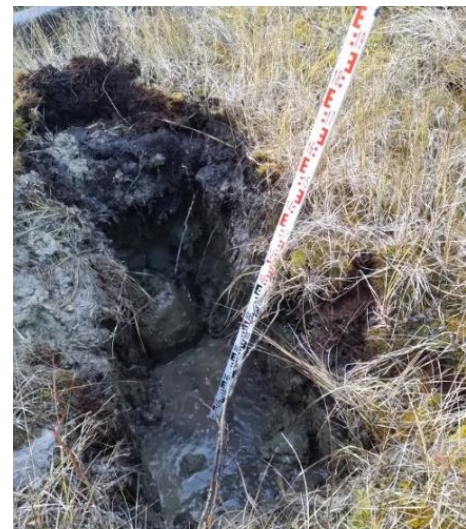
The groundwater influx in TP 1-17 was considerable enough to force abandonment of the test pit at a depth of 1.4 meters. By comparison, although a steady influx was observed in TP 8-17, the rate of groundwater seepage was not enough to halt excavation.

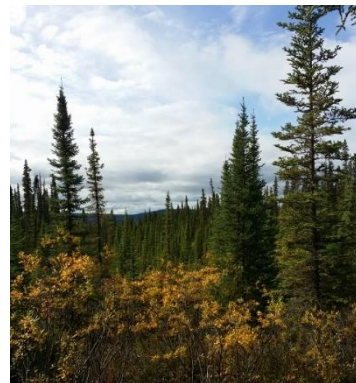
Former cat trail facing south

The site is bound by Teslin Airport lands (Lot 1030-1) which lie to the south. A cut-line is located along this southern boundary. A square *Nav Canada* site is located immediately north of the study areas eastern half. A former (50-meter-wide) cat trail (which has become overgrown), trends approximately north-south along the eastern side of the site.

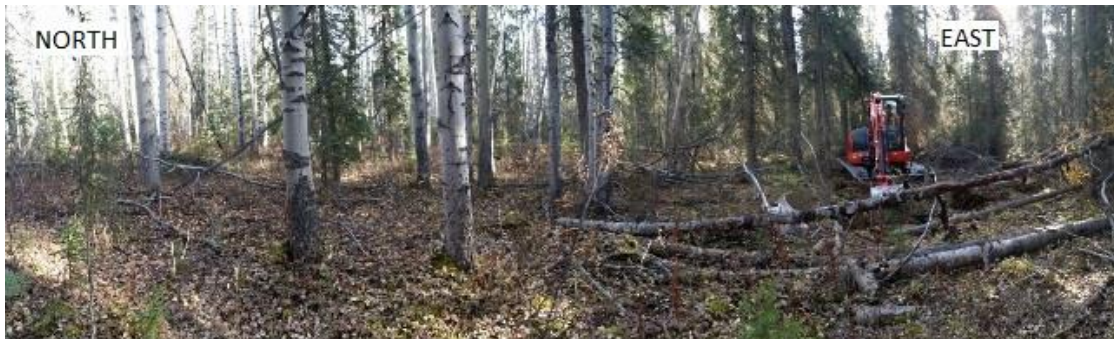
Site Conditions at TP 10-17

- Area 1 – Elevated Terrain
The terrain in this area lay several meters higher in elevation relative to the peripheral drainage areas and drainage course identified in Area 3. Healthy forests dominated this region. The slope angle in this region varies between 8-12%.
- Area 2 - Peripheral Drainage Areas
These regions (2a & 2b) lie adjacent to the existing (Area 3) drainage course and coincide with areas of former (or else seasonally intermittent) drainage. Portions of these areas slope steeply towards Area 3.

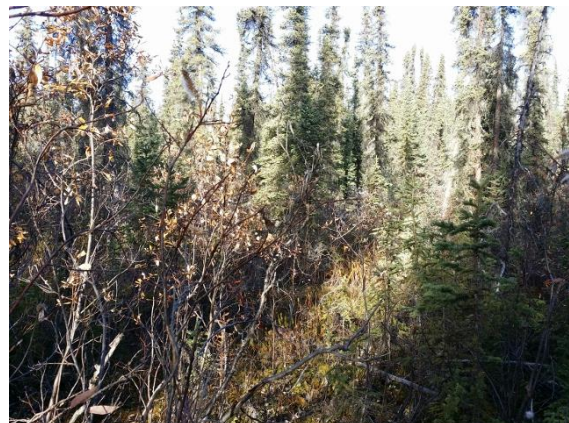
- Area 3 - Drainage Course
Relative to the other areas within the study area, this area lies several meters lower. The area is best characterized as a swamp, with regions of thick saturated organic deposits, standing water, stunted black spruce trees and signs of potential permafrost noted throughout. However, it also contains small areas of isolated terrain islands where more erosion resistant soil units are present.

This area may have infilled following channel erosion which occurred during the glacial recession.

The area likely harbors permafrost at some locations. Lower slope angles in the order of 6% are present in this area.

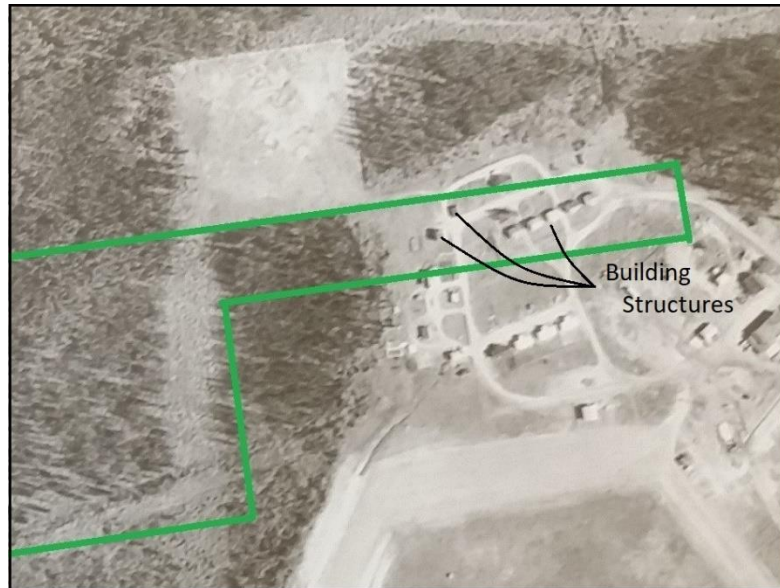
This area is located in an historically developed region of the airport where building structures and related infrastructure were once present. An existing roadway is located in this area.

Area 4 – The soils in this region will generally be suitable for use as road sub-grade following removal of the organic stratum. However, if poor quality fills or remnants of building infrastructure are encountered, then these materials will need to be removed until suitable founding materials are exposed in order to allow for road construction.

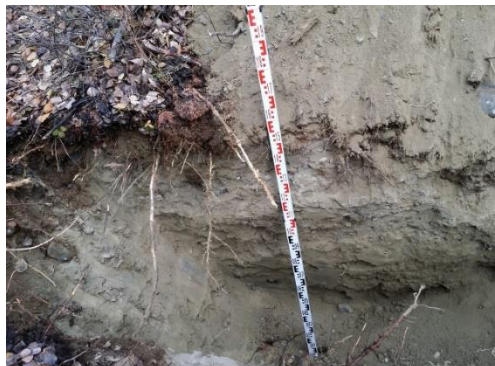
TP 4-17

These deposits are comprised of unsorted silt, sand and gravel mixtures which contain varying amounts of both fractured and sub-rounded cobble to boulder sized materials.

The laboratory analysis generally classified the materials as silty sands (SM) which contained varying amounts of gravel.

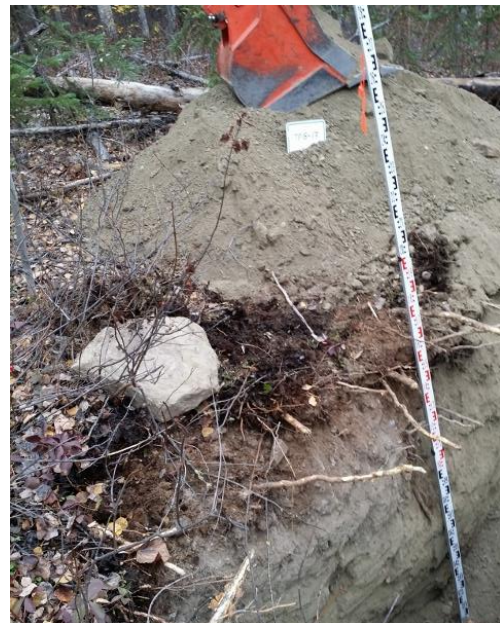
TP 6-17

The nature of the deposit varied with depth. In general, compact grey-brown tills were encountered immediately below the glaciofluvial deposits at an average depth of 0.25 meters. Platy fracture rocks (which measured up to 500 mm in size at some locations) were encountered in nine (9) of the eleven (11) test pits at the interface between the glaciofluvial and glacial till deposits at this depth. While this zone of till contained cobble to boulder sized materials at some locations, the frequency of cobbles and boulders increased beyond a depth of 1.0 meters where dense dark-grey-brown tills were generally encountered. Here, sub-rounded and fractured boulders in size to 1.3 meters and 0.7 meters, respectively, were encountered. As with generally all till deposits, larger boulders can be expected.

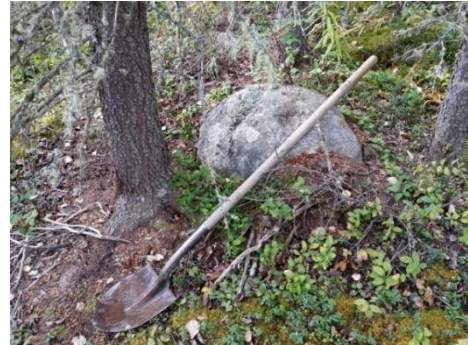
Surficial boulders in size to 2.0 meters were noted sporadically throughout the study area.

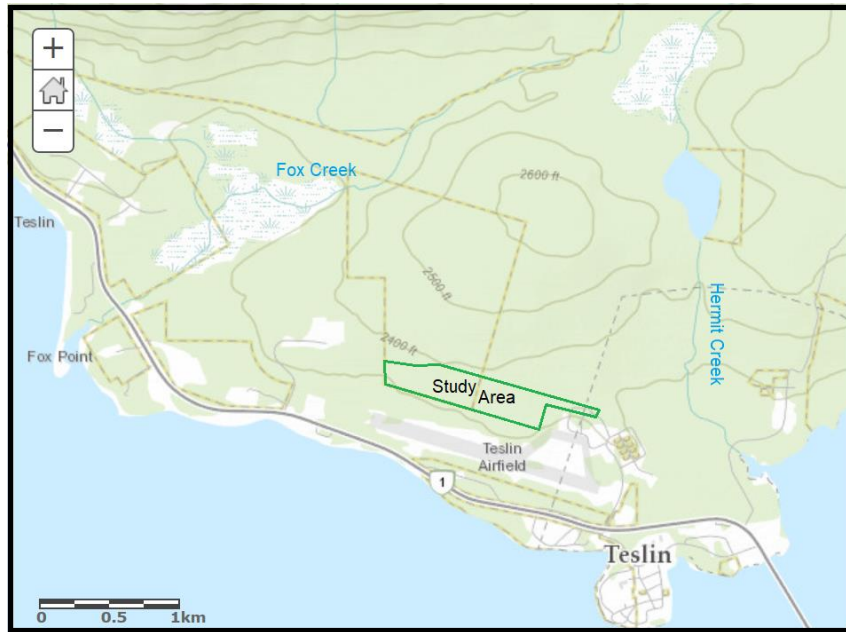
The study area lies between Fox and Hermit Creeks, as noted in the attached topographical map (retained from *Yukon Geology* website).

The study area lies approximately 800 meters north of Teslin Lake. While there was no indication of flowing surface waters, a former drainage course was identified in the Area 3 (as noted in Figure 3). This region of the study area allows for drainage of higher elevation terrain located to the north, some of which is subterranean.

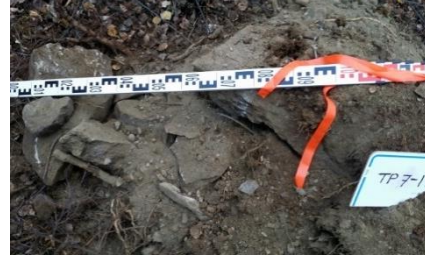
The nature of refusal in test pit TP 7-17 suggests that bedrock may be encountered at shallow depths within this region of the study area. TP 1-17 encountered fractured rocks which could also be an indication of shallow bedrock.

Otherwise, bedrock was not encountered in any of the other test pits.

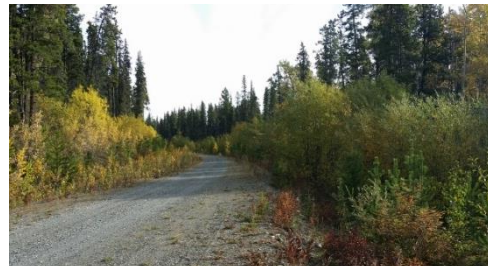
Airport West Subdivision Road Conditions

The existing roads located within the Airport West Subdivision and the Teslin Airport Subdivision would need to be upgraded to allow for public use.

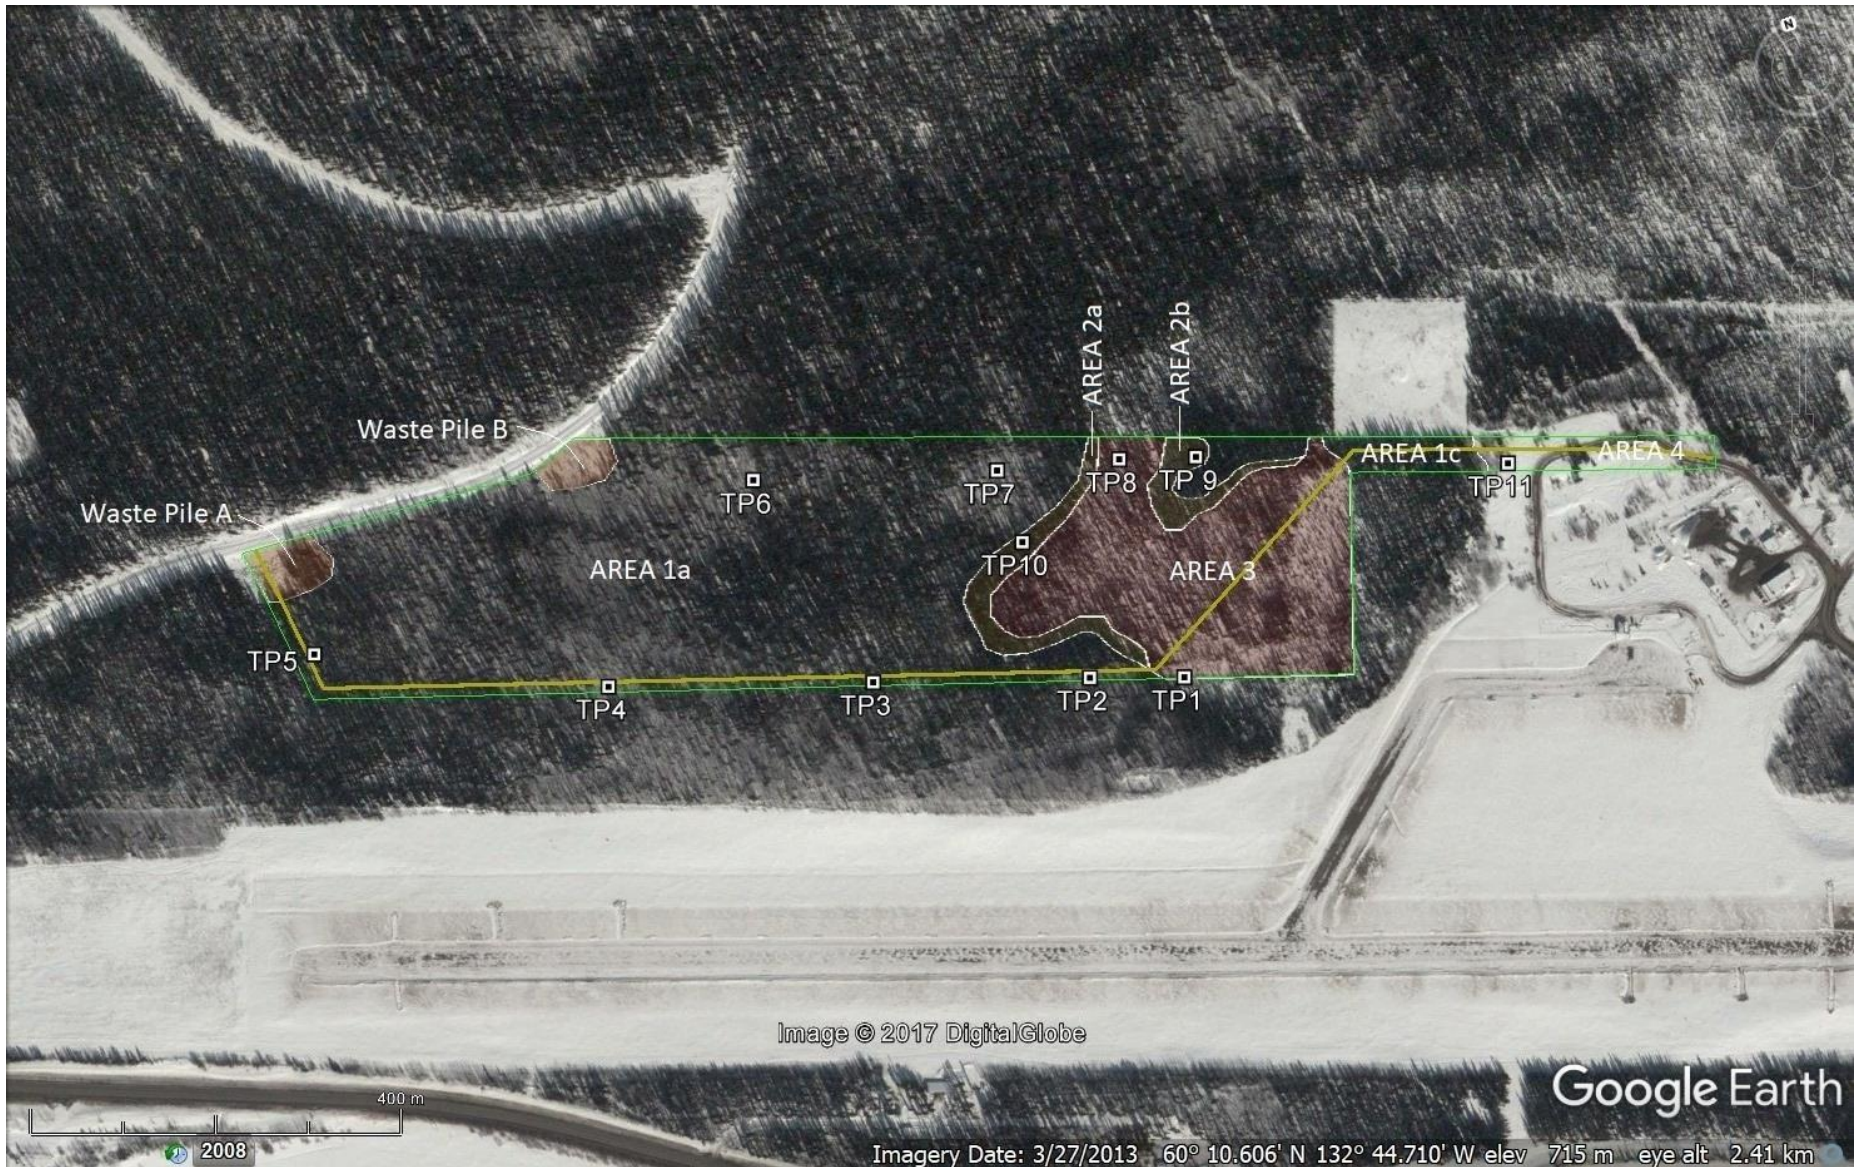
Geotechnical Evaluation
Proposed Airport Connector Road – Teslin, Yukon - 2017
Figure 3 – Terrain Areas

The terrain in these areas varied as follows;

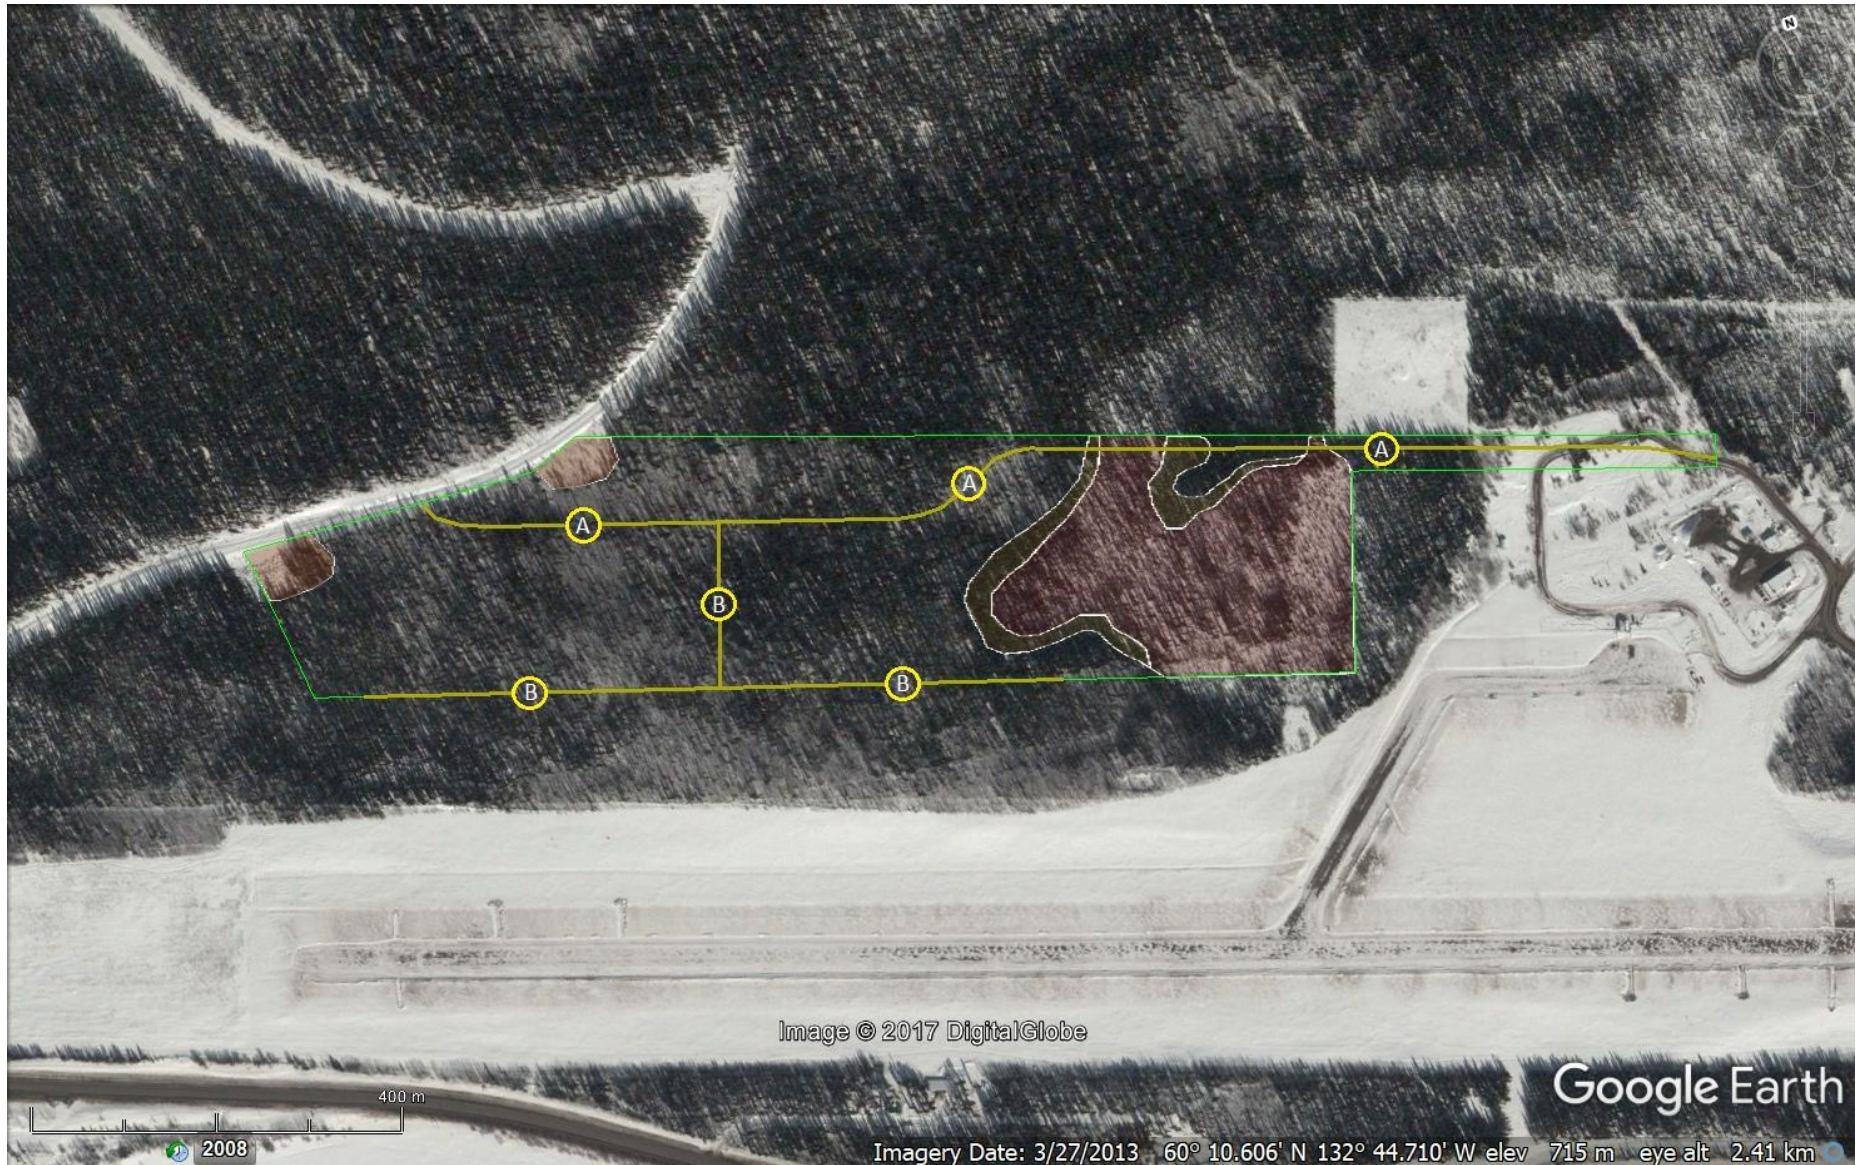
Geotechnical Evaluation
Proposed Airport Connector Road – Teslin, Yukon - 2017
Figure 4 – Proposed Road A & B Alignments

While construction of the proposed *YESAB* and Road A alignments are feasible, the *YESAB* alignment may prove to be more difficult as it crosses larger portions of Area 3 (where poor soil conditions are anticipated).

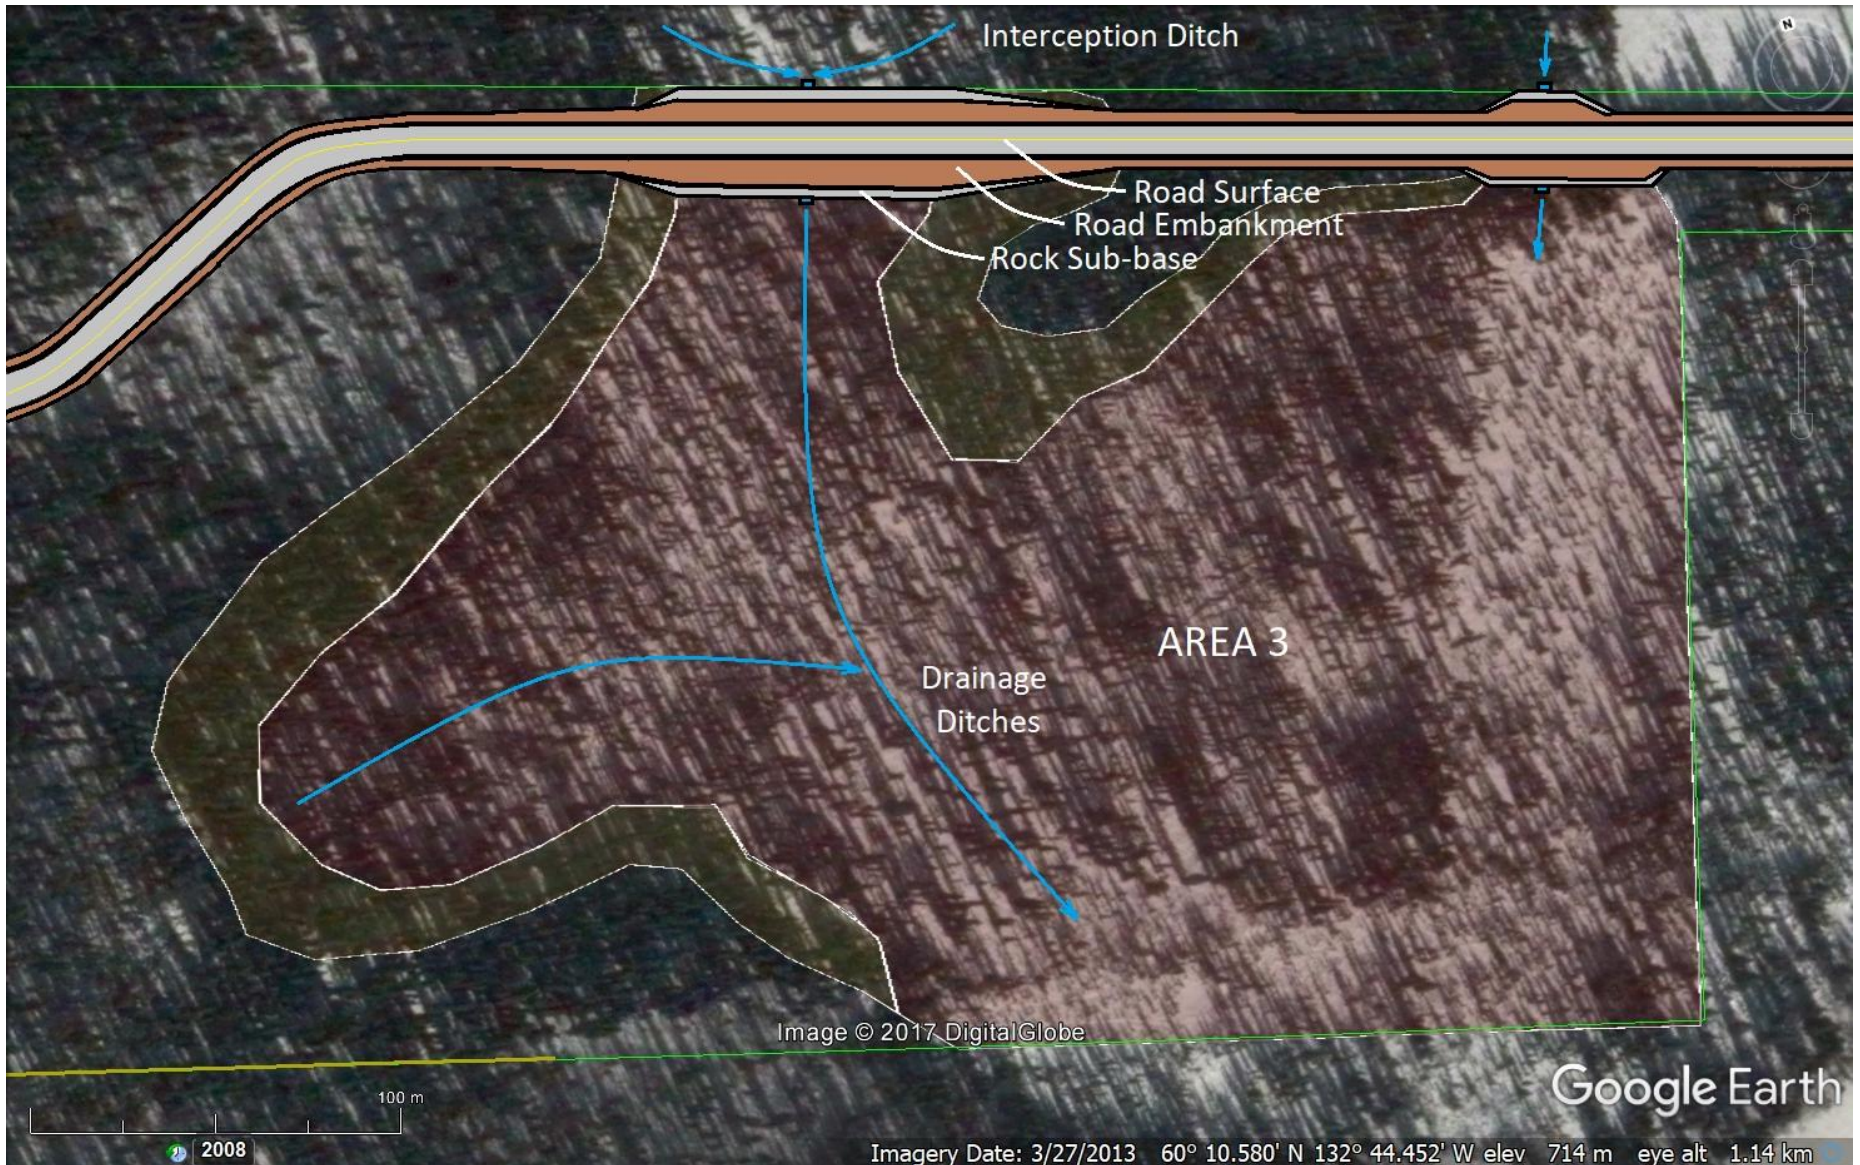
Geotechnical Evaluation
Proposed Airport Connector Road – Teslin, Yukon - 2017
Figure 5 – Proposed Area 3 Ditch Configuration

Consideration could be given to constructing a drainage ditch through the region of Area 3 to assist in local drainage as noted in Figure 5. This may ultimately allow for infilling of regions in Areas 2 & 3 as determined on a case-by-case basis.

Ideally, ditching work should be conducted in the early winter/spring, when frozen ground conditions will prevail. The use of rig mats may be required to allow for adequate bearing for construction equipment. Ditch construction during the summer/fall months would not be recommended given the poor soil conditions in this region.

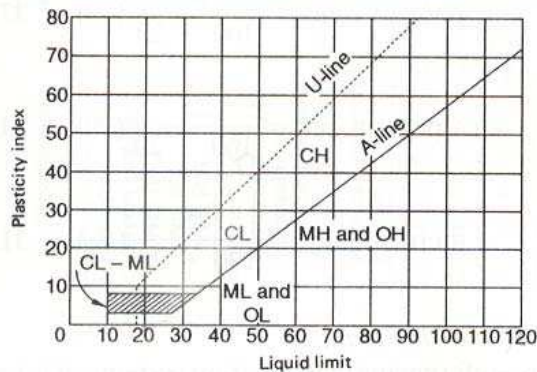
Plasticity chart for the classification of fine-grained soils.
Tests made on fraction finer than No. 40 sieve.
