ISSUED FOR USE  
FILE: W14103335-01

**Subject:** Downtown South - 6<sup>th</sup> Avenue – Between Taylor Street and Drury Street  
Predesign Level Geotechnical Evaluation

**DOWNTOWN SOUTH GEOTECHNICAL EVALUATION  
6TH & DRURY STREET - WHITEHORSE, YUKON**

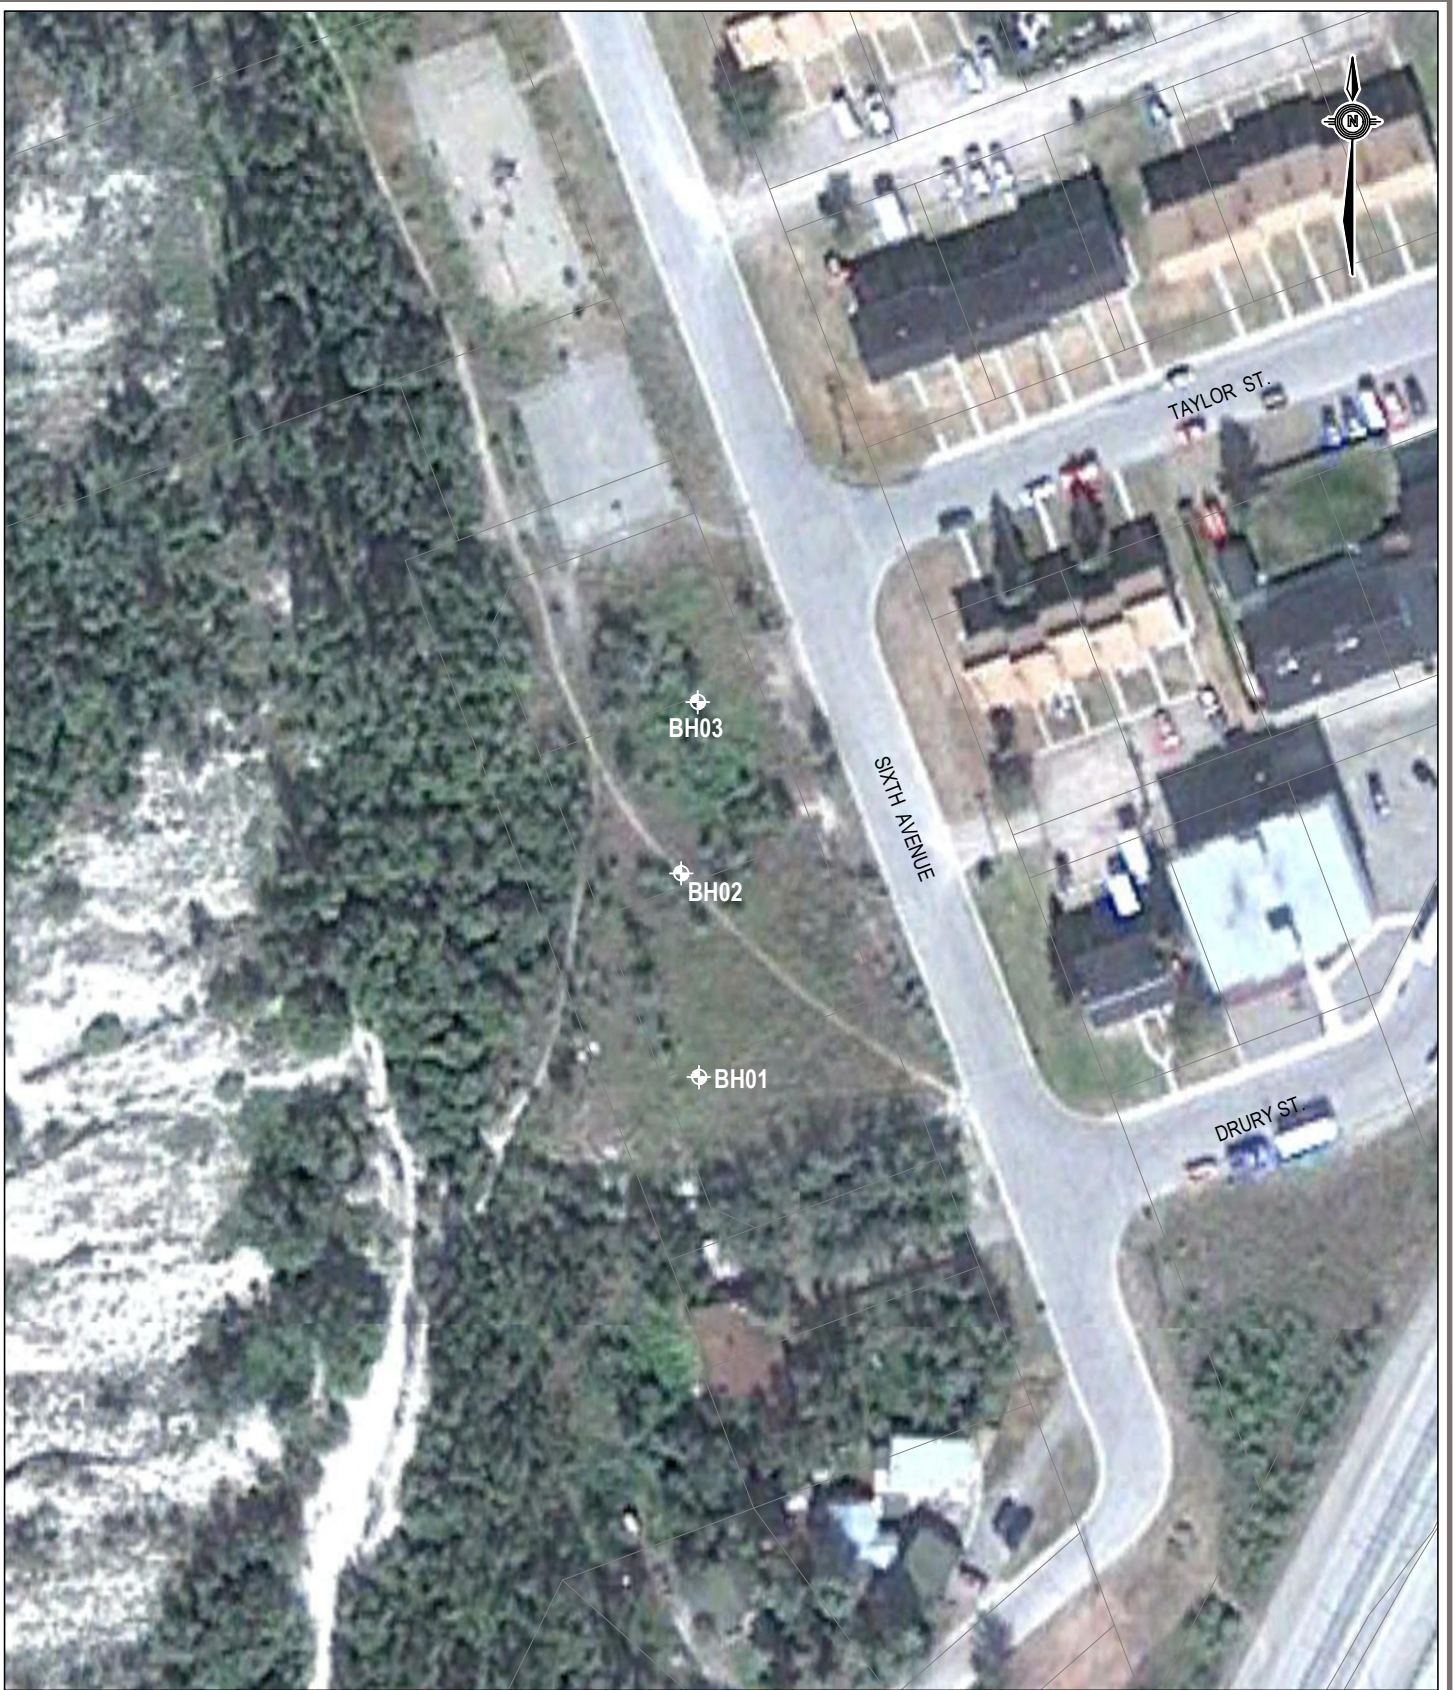
**Figure 1**

On December 13, 2013, a geotechnical drilling program was completed at the subject site. A total of 3 boreholes were advanced to a depth of 5.8 m. All boreholes were drilled with a Nodwell mounted CME 75 drill rig subcontracted from Donjek Services of Whitehorse, Yukon. EBA's site representative was Mr. Myles Plaunt, CET, of EBA's Whitehorse office. The locations of all boreholes drilled are presented on Figure 1, attached.

As mentioned above, all borehole locations are presented on Figure 1 attached, and the detailed borehole logs and associated laboratory test results are presented in Appendix B.

**SITE PLAN SHOWING BOREHOLE LOCATIONS**
