**Geotechnical Evaluation  
Preliminary Site Assessment  
Proposed YG Residential Subdivision  
Mayo, Yukon - 2015**

**Prepared For:           Urban Systems**  
**Date :                     September 7, 2015**

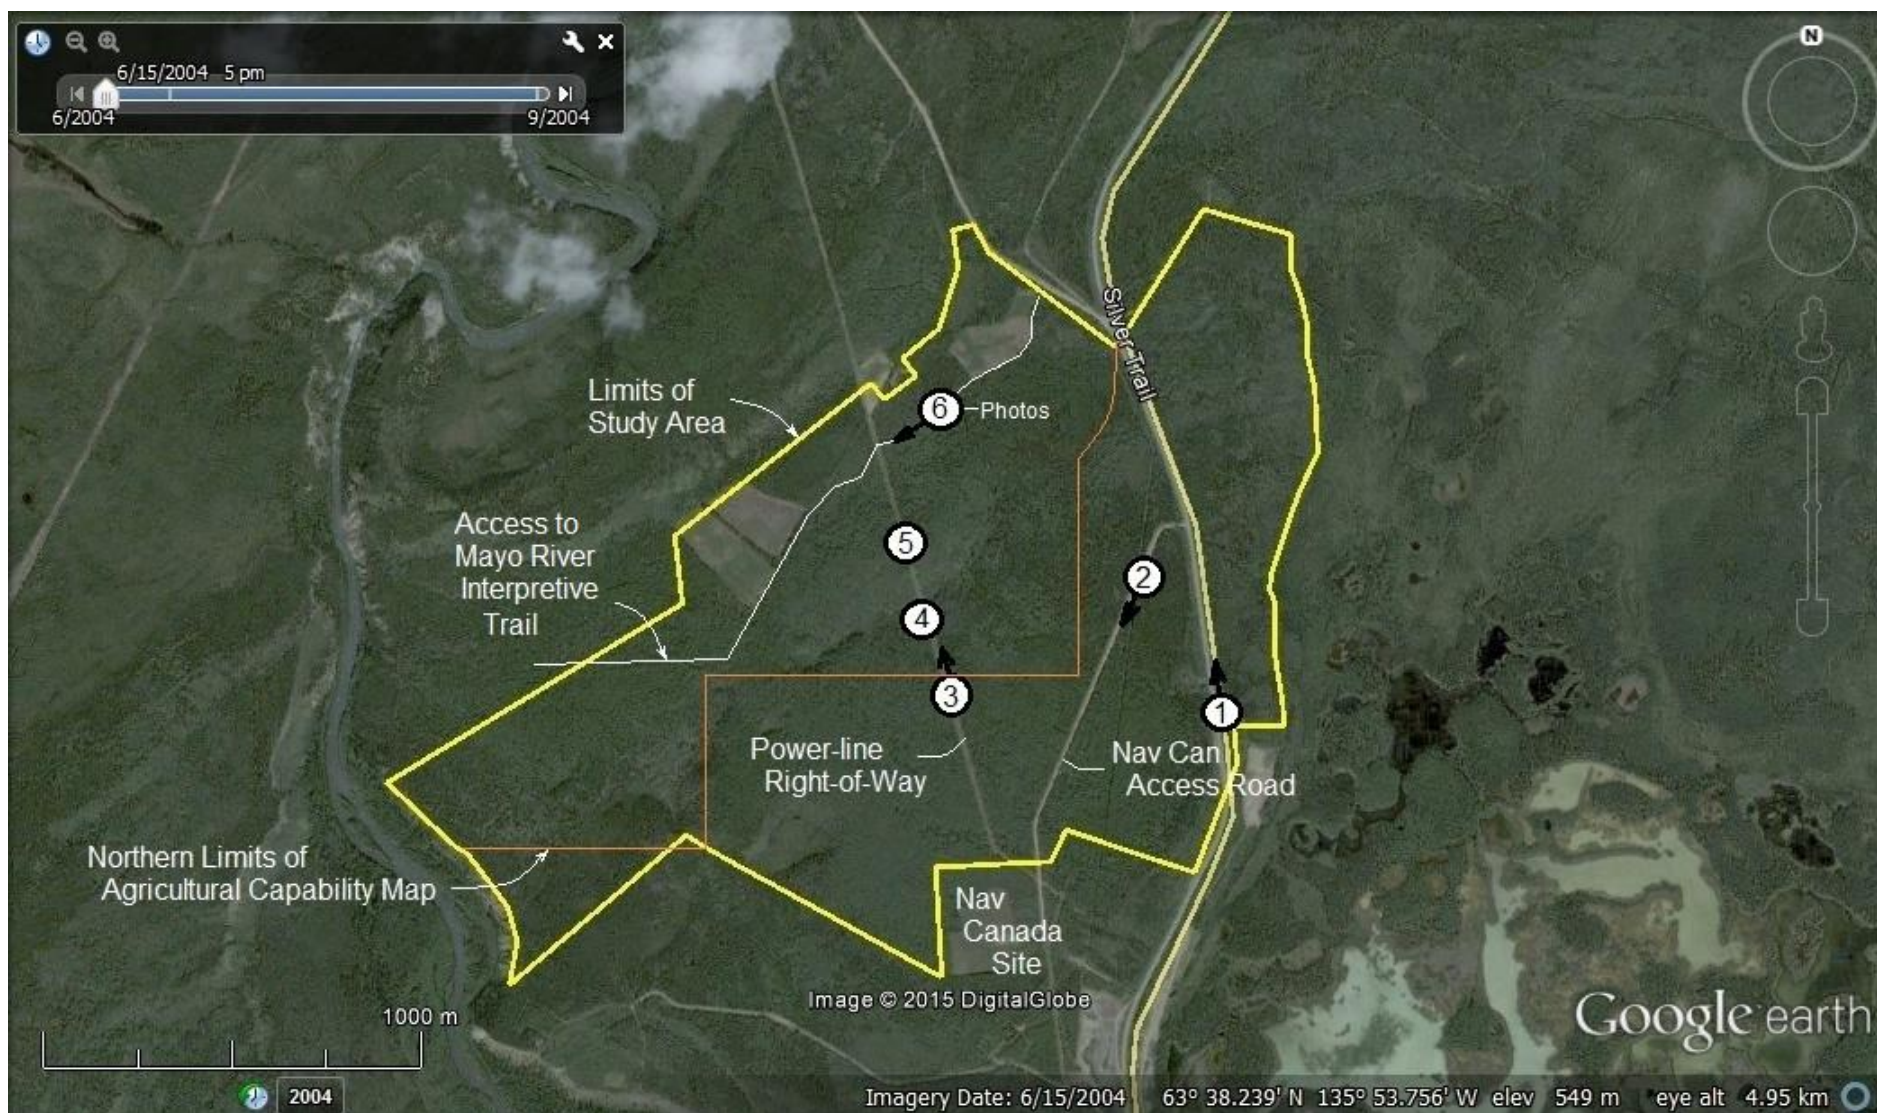
Geotechnical Evaluation – Preliminary Site Assessment  
Proposed YG Residential Subdivision - Mayo, Yukon – 2015  
FIGURE 2 – Site Plan & Photo Locations

Based map modified from Google Earth – Not to Scale – Locations are approximate

A site reconnaissance was conducted on July 7<sup>th</sup>, 2015 to note relevant site features and stratigraphic conditions along the exposed road embankments which traverse the study area and to assess the overall field conditions. The intent of the reconnaissance was to identify regions within the study area which may be more favorable for rural residential subdivision development. The effectiveness of the site reconnaissance was somewhat restricted as it was not possible to complete the aerial photograph component of the literature review prior to the field work. As such, there were certain regions (such as the disturbed regions along the *Nav Canada* Access Road, which were not explored, as these areas were overgrown and thus not readily apparent at the time of our reconnaissance. In brief, the work involved traversing the site by 4x4 vehicle as well as on foot to note the local conditions. During this time our observations were documented through a combination of field notes, photographs and (hand held) GPS. A selection of photographs which were taken to document the field conditions have been attached as Appendix B. The approximate locations of these photos have been noted in Figure 2.

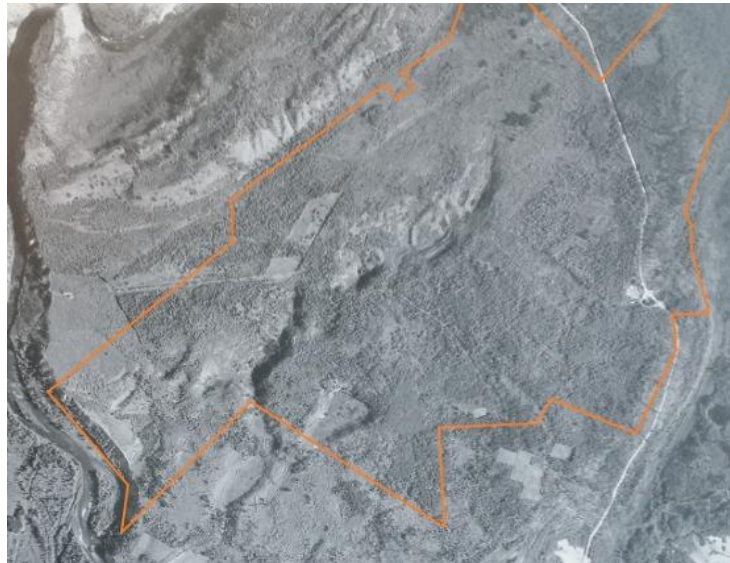
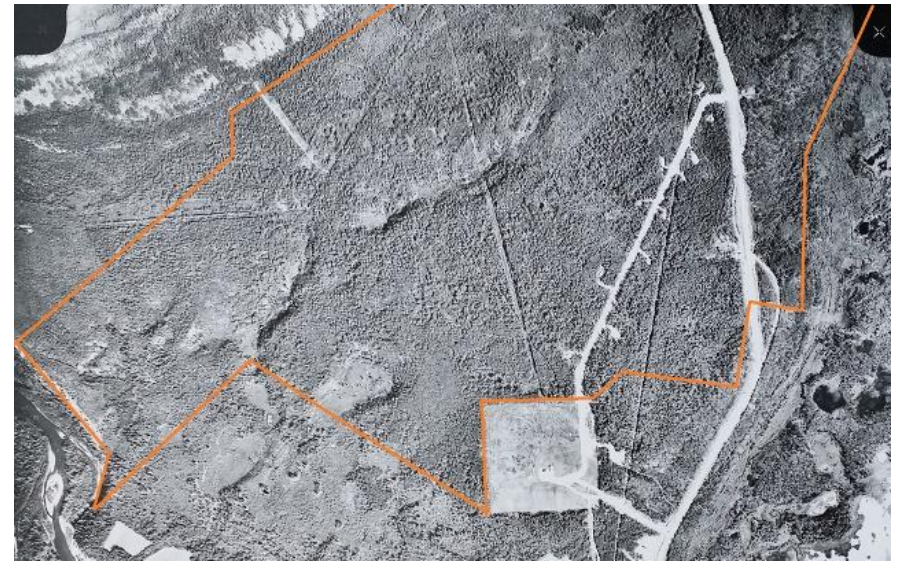
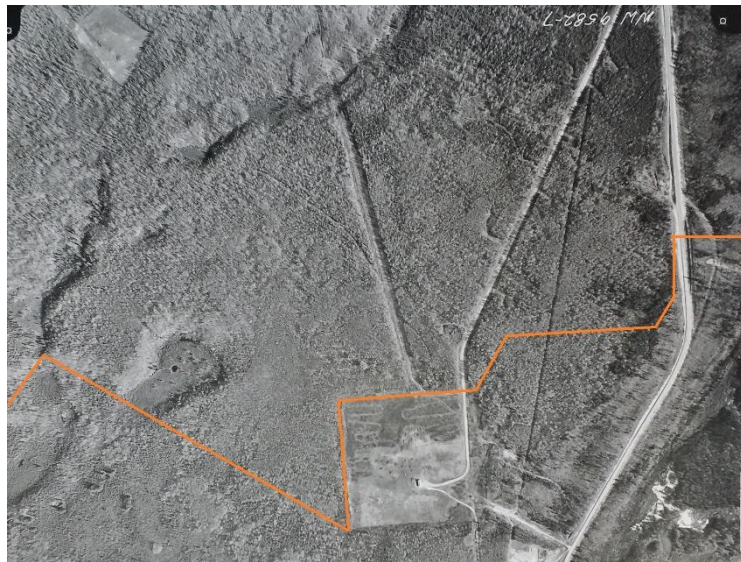
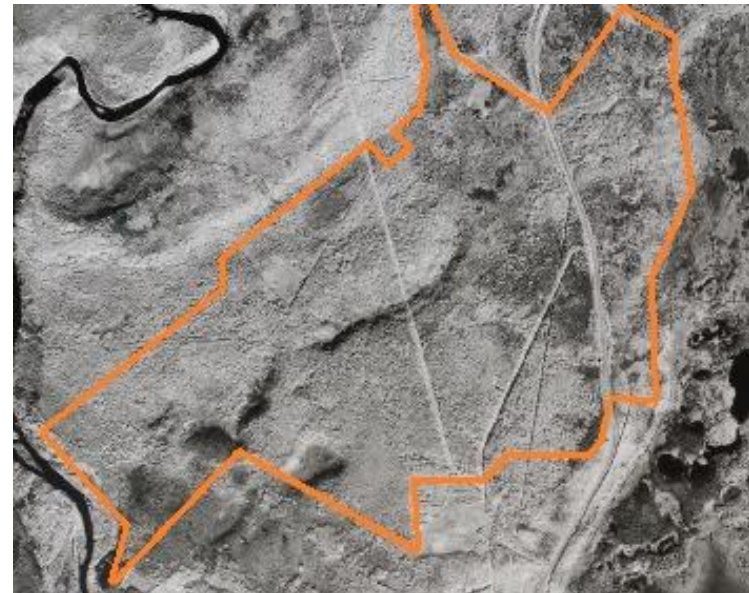
FIGURE 3 – Selection of Airphotos

A selection of these airphotos have been attached as Figure 3. The approximate limits of the study area has been super-imposed on the respective aerial photos.

### 1949 – Flight Line A12133

The airphoto notes the presence of a residence located just beyond the north-western limits. A number of large clearings are present in this area and along an access road which leads to the residence. The access road is located at the approximate location of present day Mayo River Interpretive Trail which runs roughly east-west on the north periphery of the study area. A trail crosses through the central areas of the study area. It appears that a borrow pit is located within the confines of the study area near the eastern periphery along the old Silver Trail. Some plots of land have been cleared in the *Nav Canada* site which is centrally located adjacent to the study areas southern periphery.

### 1958 - Flight Line A18953

The residence located just beyond the north-western limits is still present. A considerable amount of disturbances (indicative of potential mining/exploration bull-dozed test-pits or else oil/gas exploration) can be noted on either side of the present day *Nav Canada* access road. The *Nav Canada* site has been cleared and several structures can be noted. Several trails lead to the *Nav Canada* site directly from the Silver Trail. The present day power-line right-of-way which bisects the central regions of the study area approximately north-south can be seen. A slight re-alignment to the Silver Trail to essentially its present day configuration can be noted.

### 1982 - Flight Line NW9582

The exploration sites along the *Nav Canada* trail are overgrown. A considerable number of vehicles can be seen at the Nav Canada site. The width of the power-line right-of-way appears to have been increased. A prominent clearing (which appears to an agricultural plot) can be noted within the northern limits of the site. This area appears to be an expansion to clearing work conducted in the 1958 photo. It's apparent that a small cleared area (located approximately 100 m north-west of the *Nav Canada* access road) has

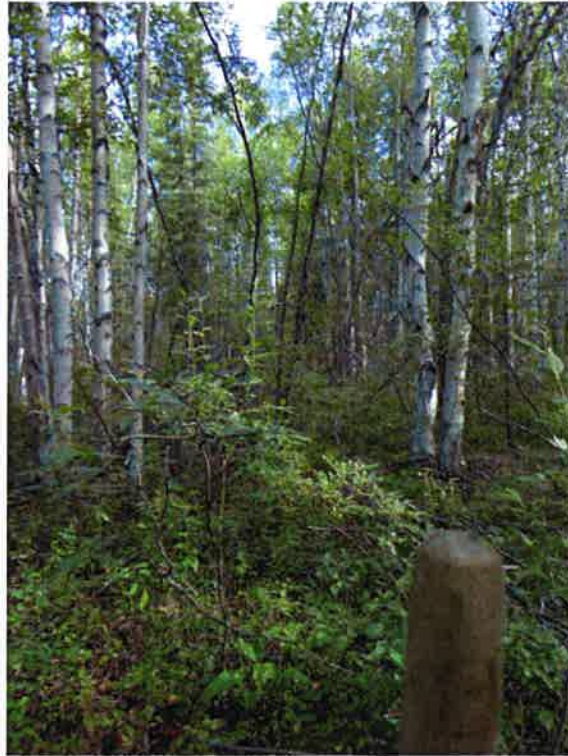
Photo 1: Class 4C land – deep fine textured soils

Much of this land parcel is rated as 4CM. The agricultural capability is limited only by climate (C) in places where there is a layer >30 cm of sandy loam or finer textured soil, (Photo 1) and the agricultural capability is limited by moisture holding capacity (M) in places where the loamy veneer is >20cm but <30 cm (Photo 2). This agriculture capability rating is excellent in the Yukon context.

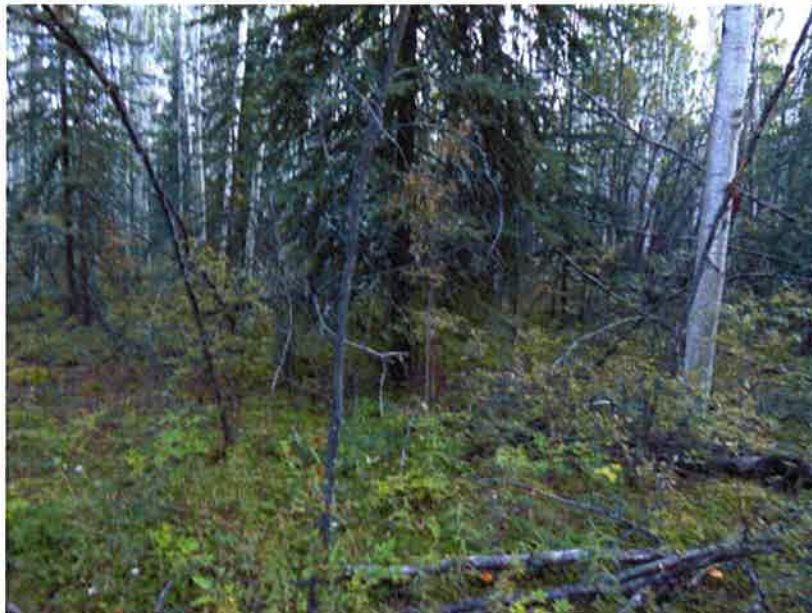
Photo 2: Class 4CM land – less than 30cm of fine textured material over gravel

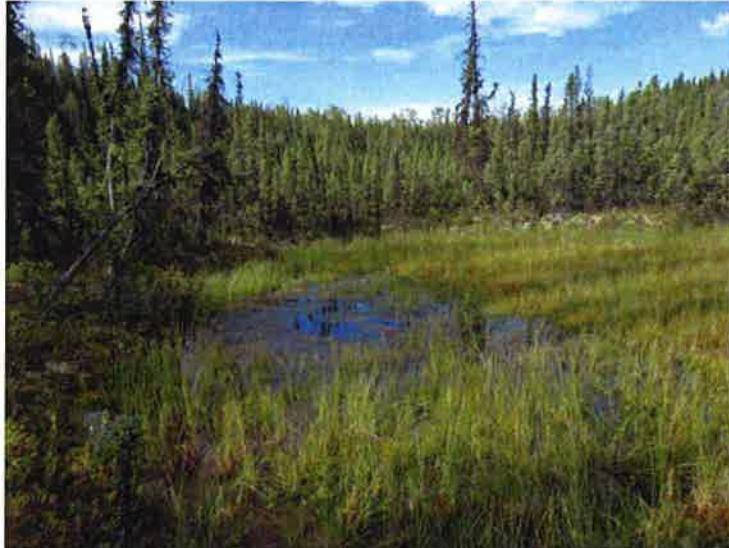
Within the parcel there are a series of depressions rated as 6T. These areas have slopes too steep for farming or other development and the lowest parts of the depressions are ponded and underlain by permafrost (Photos 3 and 4).

Photo 3: Permafrost and pond – depression bottom

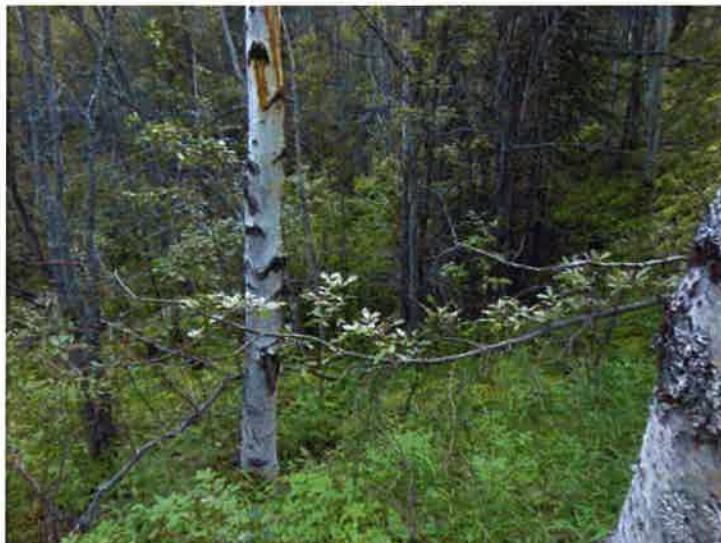
Photo 4: Steep north aspect of depression

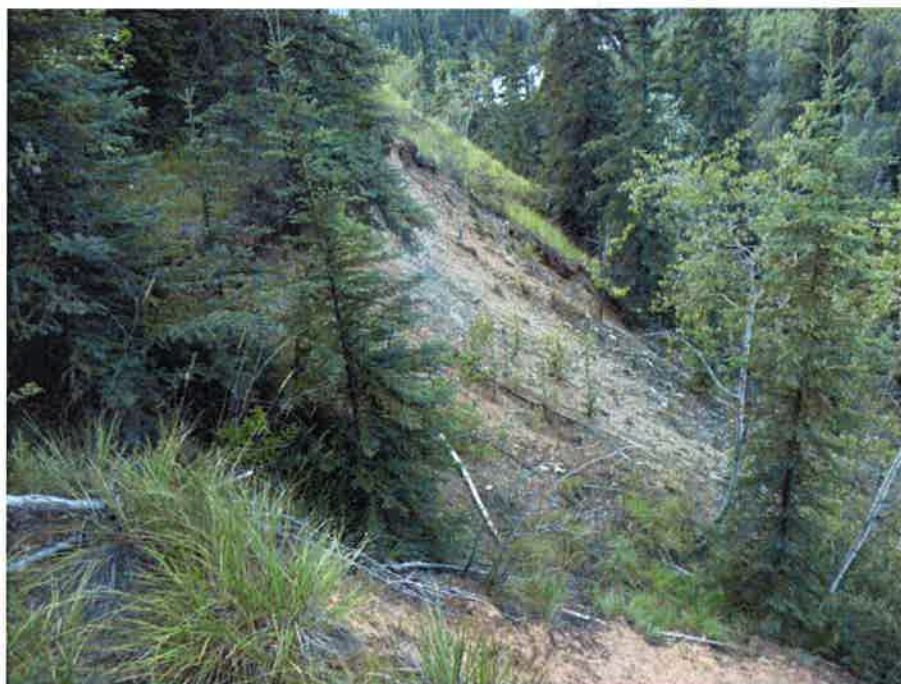
The escarpment edge overlooking the Mayo River is steep, but vegetated and is stable over most of its extent. There is evidence of some minor erosion along the terrace edge as evidenced below. There is a small rise between the escarpment edge and the

Photo 5: Minor erosion along escarpment. Most of the escarpment is vegetated as shown in distance.

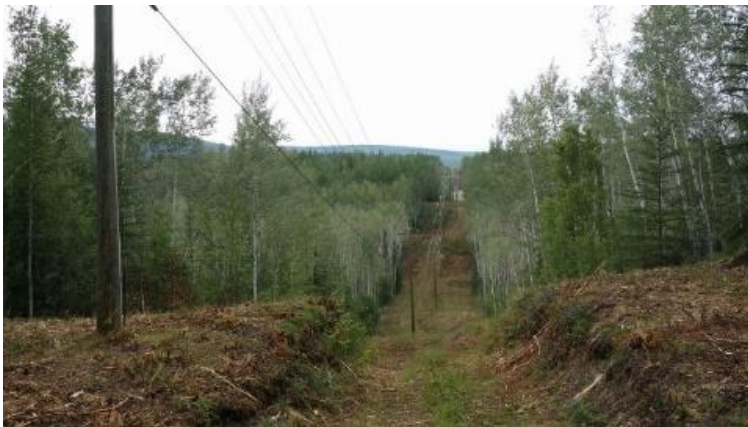
Photo # 3 (left)  
Powerline  
right-  
of-way facing  
north. Note  
meltwater  
channel  
crossing mid-  
photo.

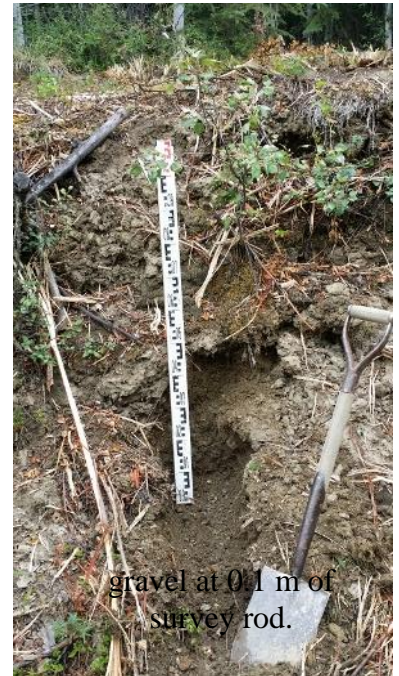
Based upon our observations of the road cut embankments along the power-line right-of-way, it appears that ~ 0.9 meters of fine grained silty soils overlie the granular glacio-fluvial deposit. These fine grained materials are overlain with approximately 0.1 to 0.2 meters of surficial organics.

Photo # 4 (right)  
ROW trail embankment conditions.  
Note

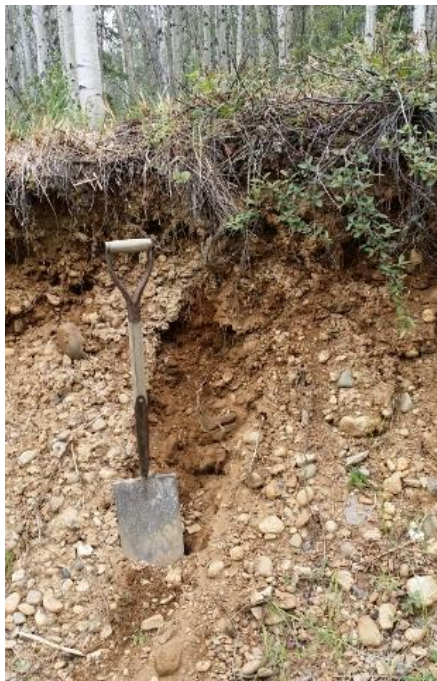
Photo # 5 (left) –  
Embankment conditions  
along the powerline  
ROW, north of the meltwater channel. Note cobbles.
