**Geotechnical Feasibility Assessment
Proposed Country Residential Development
km 574.5 RHS Robert Campbell Highway #4
Carmacks, Yukon – 2018**

Prepared For: Yukon Government

Date : December 27th, 2018

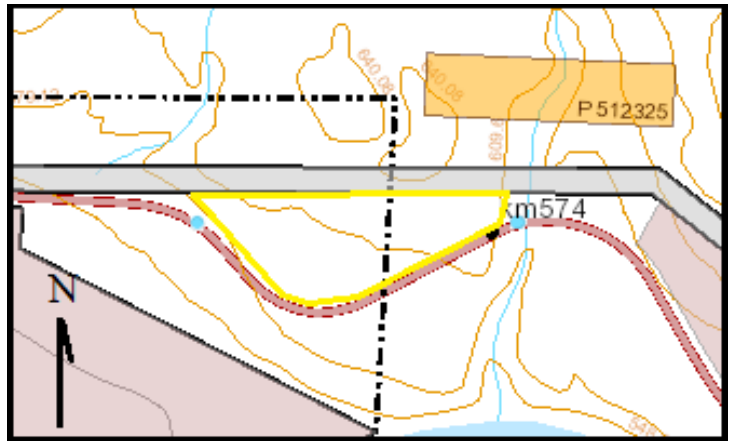
The map retained from the *YG - Water Placer Atlas* website noted that the northern periphery of the study area is bound by powerline right-of-way. The eastern edge of the study area borders a drainage gully which directs seasonal drainage to the south. The remainder of the site is bound by the Robert Campbell Highway #4 right-of-way. The eastern portions of the site lies beyond the municipal limits of the *Village of Carmacks*.

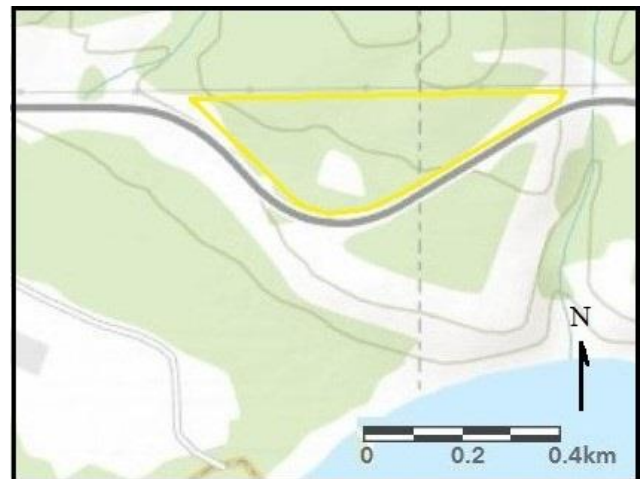
While the study area is best described as a gradually sloping terrace, steeper slopes are located within the western and eastern realms of the site. The terrain in the eastern portion is undulating.

The topography of the study area is best described as a terrace which transitions into a gradual slope which increases in elevation towards the north. The lower (central) elevations of the terrace are in the order of 590 meters (asl). The higher elevations located on the north-eastern portions of the study area approach elevations in the order of 630 meters. As such, the elevation gain across the study area is in the order of 40 meters.

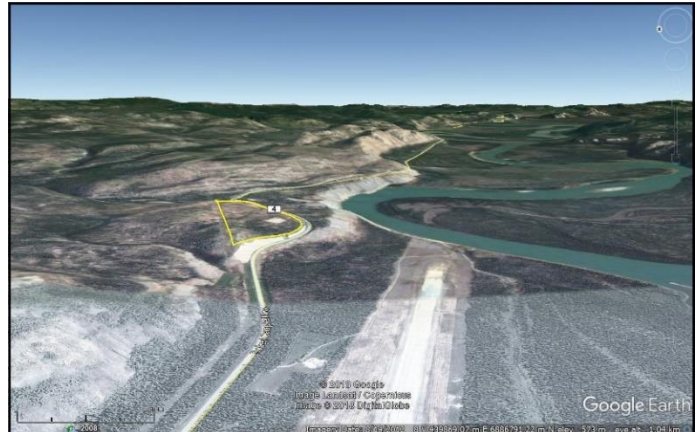
Orthogonal view from Google Earth facing south-east.

The regional terrain can be described as rolling, glaciated terrain, which is incised by broad, U-shaped valleys.

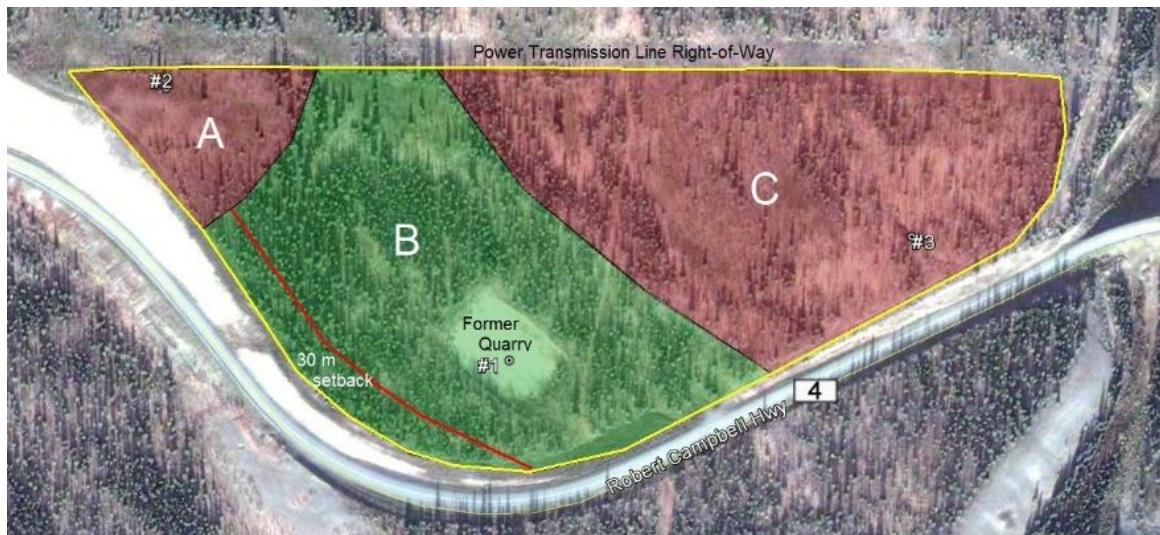
The study area is comprised of three (3) distinct regions as noted below and in Figure 2.

Area A, located in the western realms of the study area, is dominated by glaciofluvial complex deposits. The terrain in this area has moderate to steep slopes and is sparsely treed.

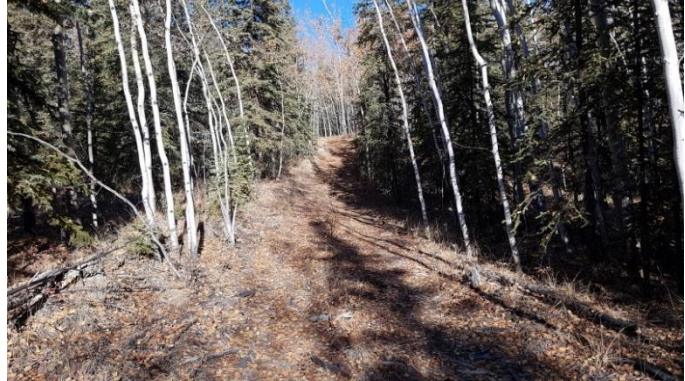
Area B, located in the central region of the study area, is dominated by glaciofluvial terrace deposits which harbors a moderately dense spruce forest with interspersed poplar trees and willow bush understory. The terrain in this area is generally level with increasing gradients towards the north (photo right).

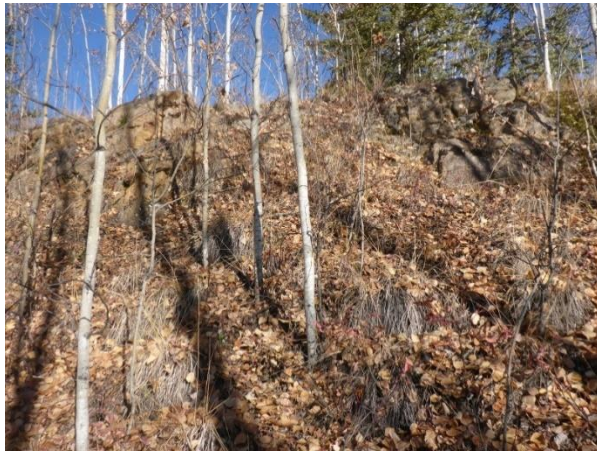
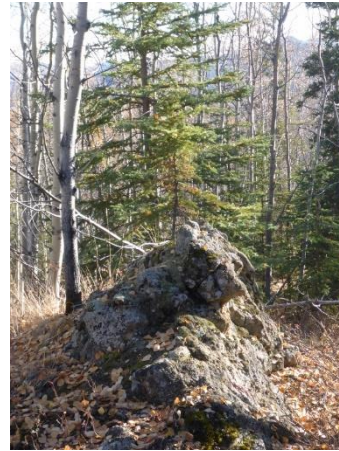
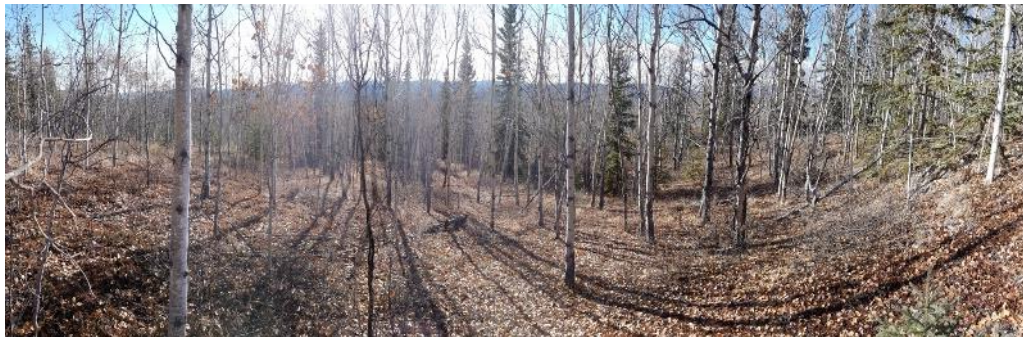
Area C, located in the eastern realms of the study area, is dominated by morainal blanket deposits which overlie shallow bedrock (photos below). The terrain in this region is generally undulating and bedrock outcrops are common. Poplar (and other deciduous) trees dominate this region.

Bedrock outcrops were noted during our site reconnaissance throughout Area C.

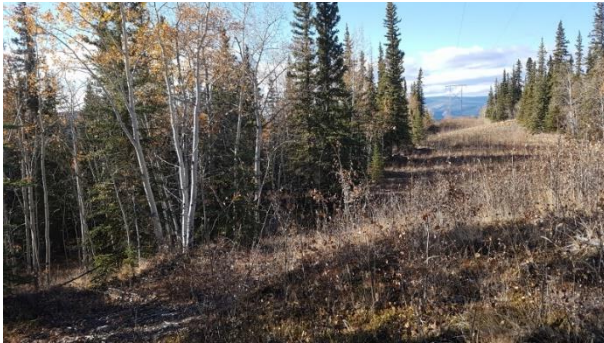
Overhead power transmission lines are located within the powerline right-of-way located along the northern edge of the site.

View of Powerline ROW facing west from central trail.

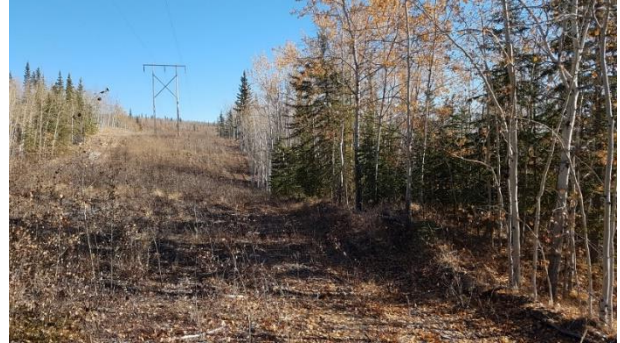
View of Powerline ROW facing east from central trail.

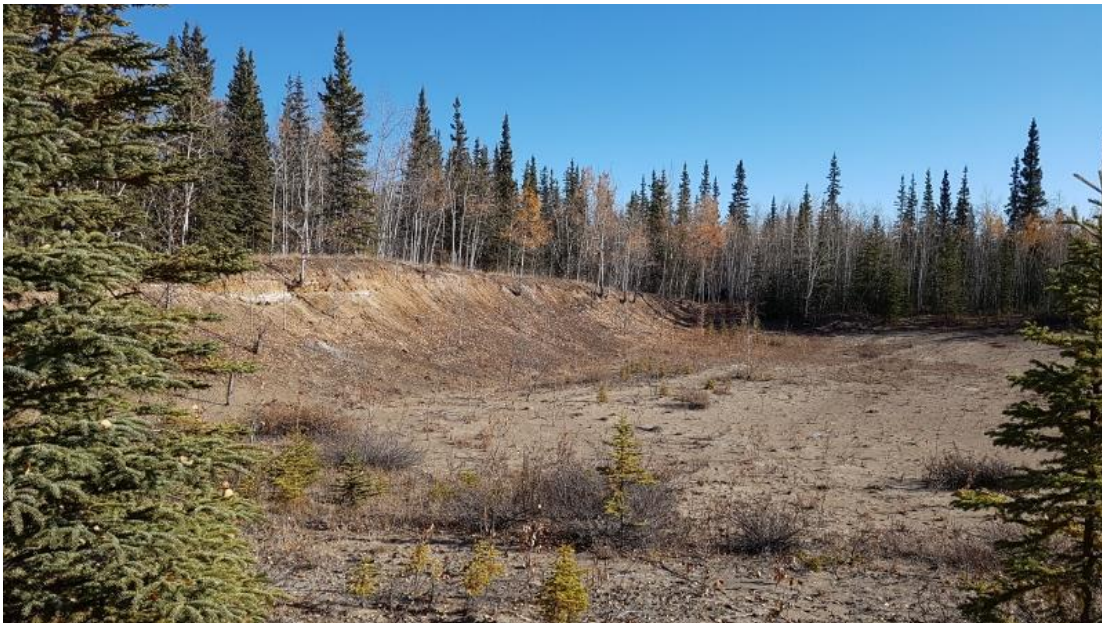
An abandoned gravel pit is centrally located in the study area (Area B). This granular reserve appears to be predominately comprised of clean sands which contain varying amounts of gravel. The northern and southern working faces of the quarry measured in the order of 5 and 3 meters tall, respectively.

View of quarry facing east.

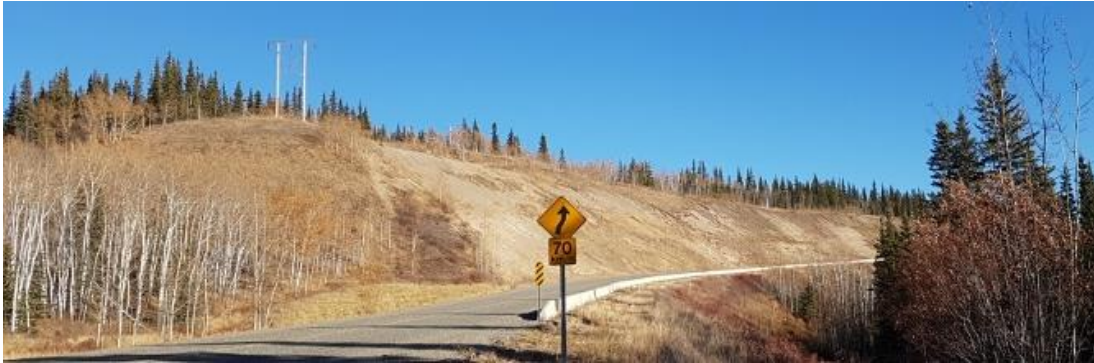
A moderately steep slope, which was shaped during construction of the Robert Campbell Highway, is located adjacent to the south-western periphery of the study area.

View of south-western slope facing east along the Robert Campbell Highway #4.

The stability of the slope located in the south-western realm of the study area should be assessed to determine whether or not it may pose a hazard relative to anticipated site development.

A slope stability assessment should be conducted to determine the potential hazards related to the slope located along the south-western side of the study area.

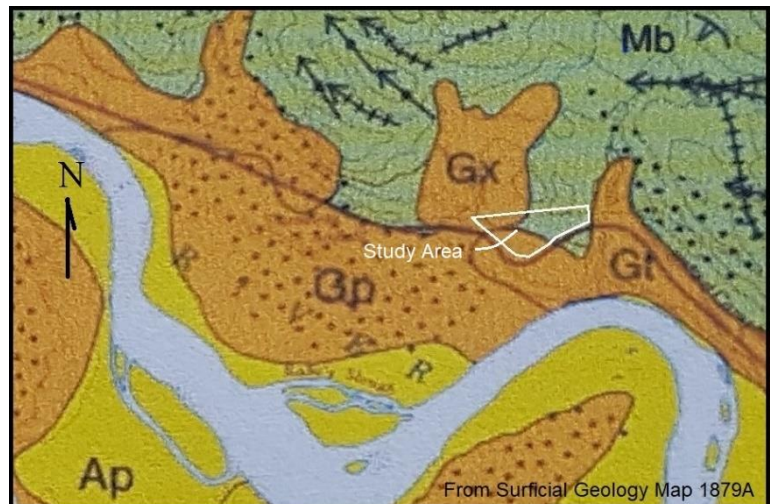
The distribution of surficial deposits within the study area has been illustrated in the (1:100,000 scale) surficial geology map Tantalus Butte - Yukon Territory - Map 1879A compiled by L.E.Jackson Jr., 1997. The approximate limits of the study area have been illustrated on a portion of the surficial geology map as noted below.

In brief, the map shows that the surficial deposits which are located within the study area are comprised of a combination of glaciofluvial terrace, glaciofluvial complex and morainal blanket deposits.

Glaciofluvial Terrace Deposits (Gt)

These deposits are comprised of pebble to cobble gravel, massive to thick bedded. They are often incised into flights of terraces by glacial streams and measure between 1 meter to greater than 10 meters thick.

Glaciofluvial Ice Stagnation Complex Deposits (Gx)

These deposits are typically comprised of poorly to moderately sorted sand and gravel diamicton, which have been deposited during equilibrium phases of glacial retreat. These deposits can contain cobble to boulder sized materials and minor amounts of silt and clay. They exhibit thick to massive bedding which is commonly folded and faulted from depositional ice melt. The surface expression commonly consists of hummocks, kettles, eskers and crevasse filled ridges with minor elements of glaciofluvial plain, delta and terrace sediments.

Morainal (Till) Blanket Deposits (Mb)

The sediments in morainal blanket deposits are commonly comprised of a stony diamicton which has a sandy/silty matrix. These deposits are massive to crudely stratified and generally measure between 1 to 5 meters thick. The surface conforms to the underlying topography.

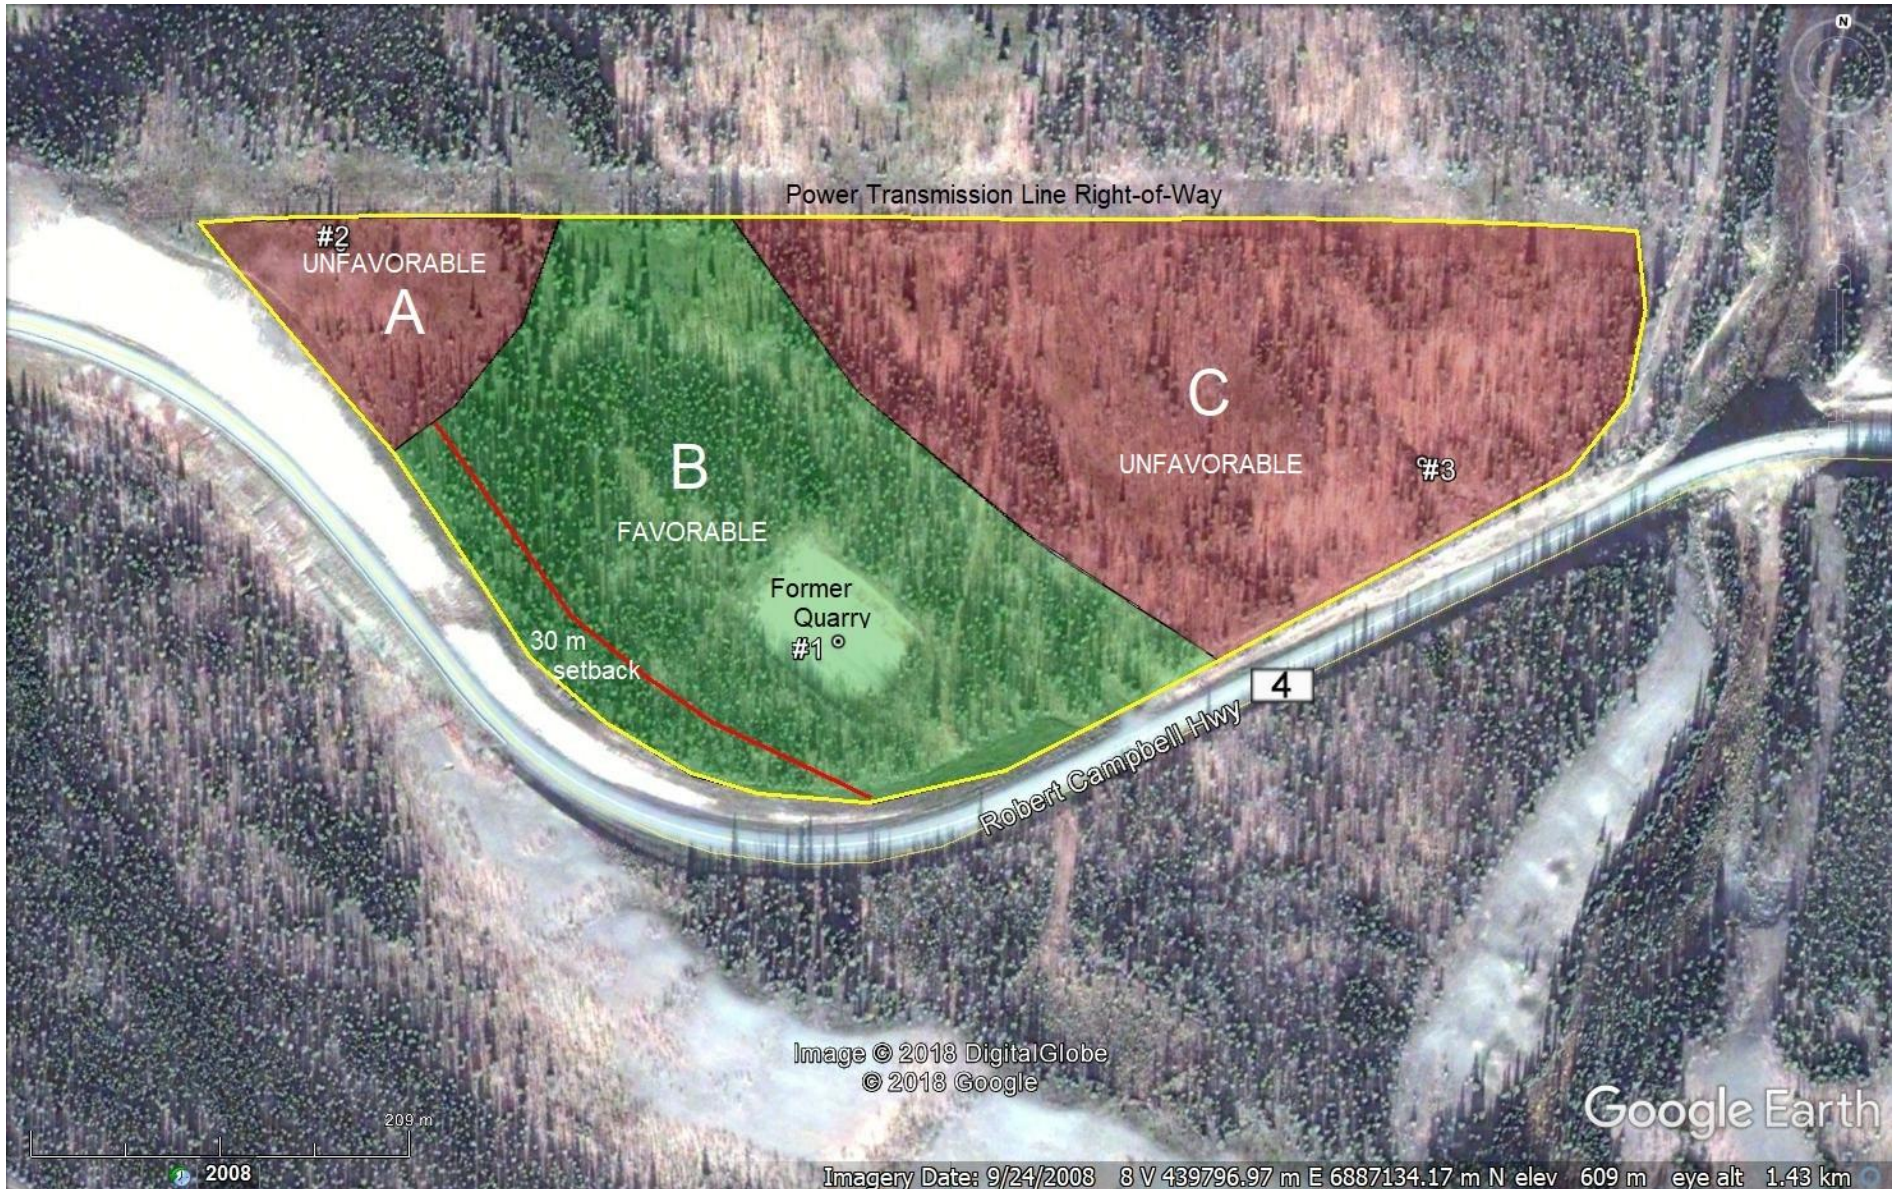
Geotechnical Feasibility Assessment
Proposed Country Residential Development – Carmacks, Yukon – 2018
Figure 2 – Development Potential

favorable to allow for unrestricted site development in the region denoted as Area B (as noted in Figure 2). This area generally coincides with glaciofluvial terrace deposits.

During the course of the traverse, three (3) near surface soil samples were retained by utilizing a hand shovel to allow for subsequent laboratory analysis as described in Section 3.3, below. These samples (#1-#3) were retained from the locations noted in Figure 2.

Bedrock outcrops were encountered during our field work program in the eastern realms (Figure 2 - Area C) of the site.

Based upon the information retained during our assessment, the anticipated soil and terrain conditions will be favorable to allow for unrestricted site development in the region denoted as Area B (Figure 2). This area generally coincides with glaciofluvial terrace deposits. Additional consideration would be required in the regions denoted as Areas A & C (Figure 2) as steeper slopes and presence of shallow bedrock (located in Area C) will restrict and potentially prohibit development in these areas. Some adjustments to individual building foundation, road structures and septic field designs may be required to accommodate site-specific conditions as the soil types and subsurface conditions will vary across the study area.

At this stage, a standard 30-meter setback should be observed for building construction relative to the crest of the steep slope located in the south-western region of the study area (as noted in Figure 2).

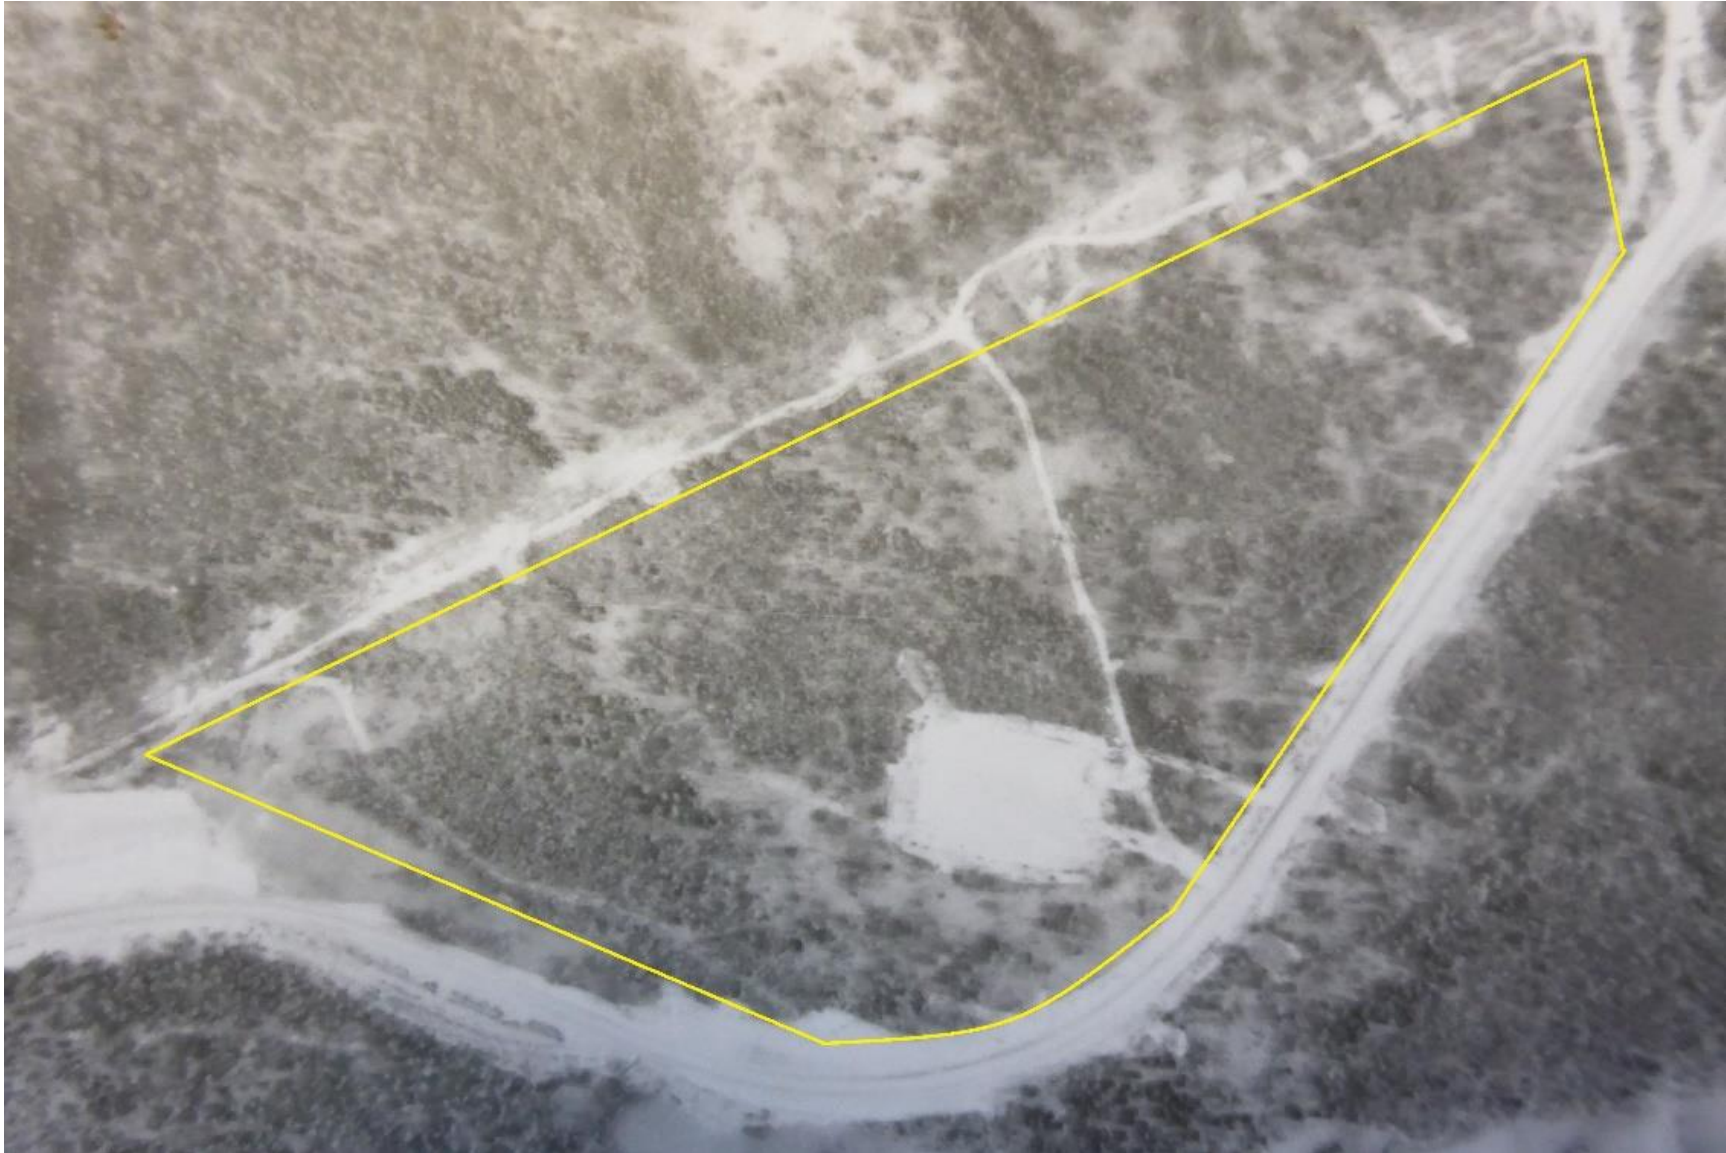
Geotechnical Feasibility Assessment
Proposed Country Residential Development – Carmacks, Yukon – 2018
Appendix A – Airphoto A22355 #73 (July 27th, 1971)

A selection of aerial photographs was obtained from *YG – Energy, Mines and Resources* to allow for a more detailed assessment through airphoto terrain analysis. The following airphotos were available;

<i>Flight Line</i>	<i>Photo No.</i>	<i>Date</i>
A22356	56-58	1971
A22355	73-74	1971
