**Geotechnical Feasibility Assessment
Proposed Country Residential Development
Lot #1 – Group 10 (CLSR 8887)
Carmacks, Yukon – 2018**

Prepared For: Yukon Government

Date : December 27th, 2018

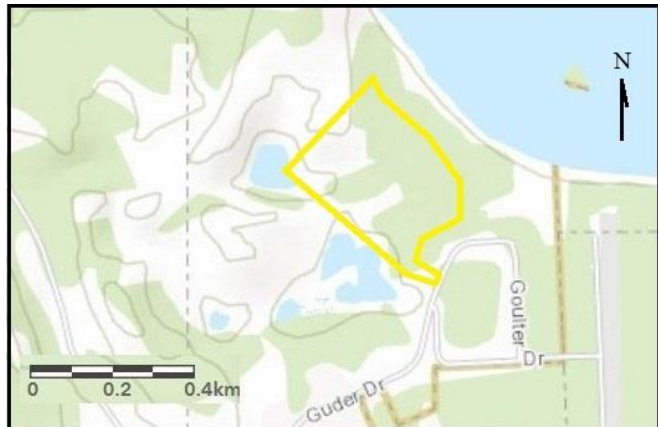
The topography of the study area is best described as undulating terrain which increases in elevation towards the north-west. The lower (south-western) elevations of the ponds parallel those of the Yukon River and measure in the order of 515 meters (asl). The higher elevations located in the north-western and eastern portions of the study area approach elevations in the order of 550 and 540 meters, respectively. As such, the elevation gain across the study area measures in the order of 35 meters. A central region, which trends approximately south-west to north-east, lies in the order of 15 to 20 meters below the higher terrain located to the north-west and east.

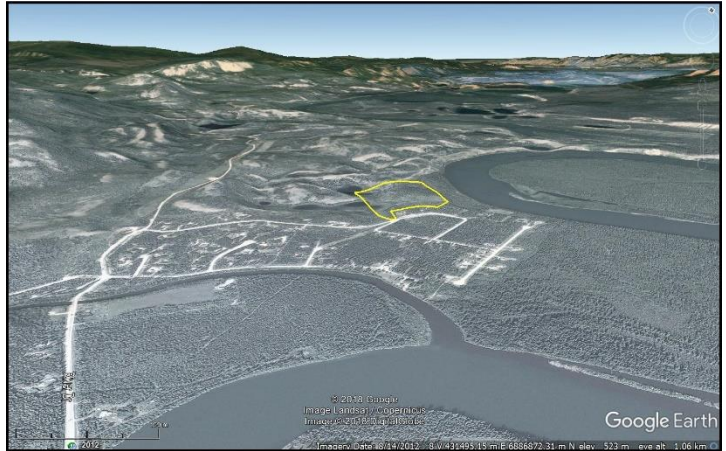
Orthogonal view from Google Earth facing north-west.

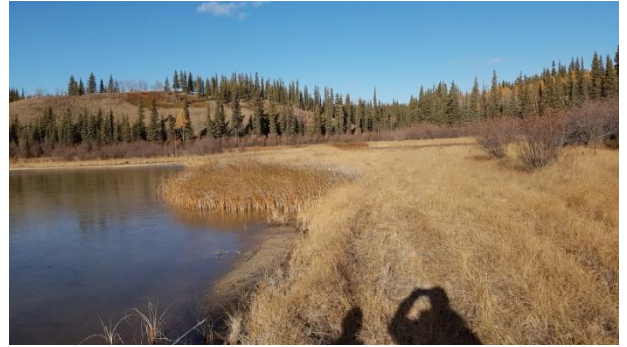
Area A is dominated by low lying ponds which harbor peripheral areas where swamp-like conditions and vegetation are present (photo right).

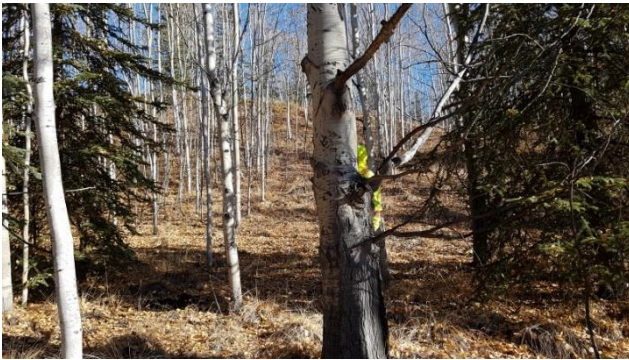
The slopes in Area B (photo below left) are extremely steep and predominately forested with deciduous trees.

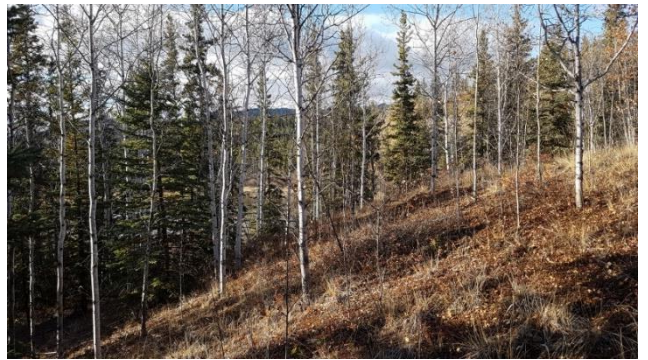
The slopes in Area C (photo above right) by comparison are more gradual. The spruce trees in this region are sparse and interspersed with poplar trees.

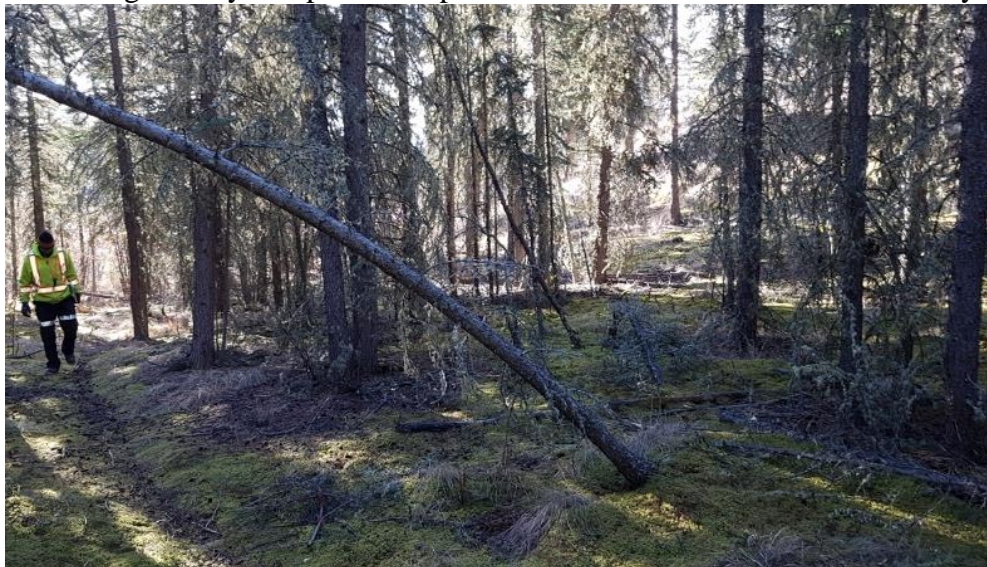
A series of hiking trails are present throughout the site (photo below right).

A short access road has been preliminarily constructed immediately south of the site stemming off Guder Drive as noted in Figure 2 (photo below left).
