**Geotechnical Feasibility Assessment
Proposed Urban Residential Lot
Lot #15 (CLSR 55659)
Carmacks, Yukon – 2018**

Prepared For: Yukon Government

Date : December 27th, 2018

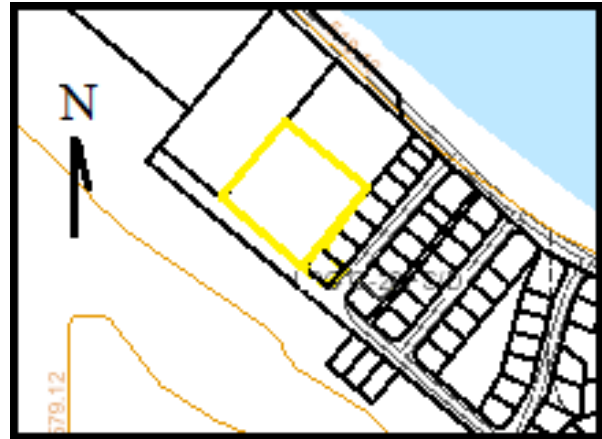
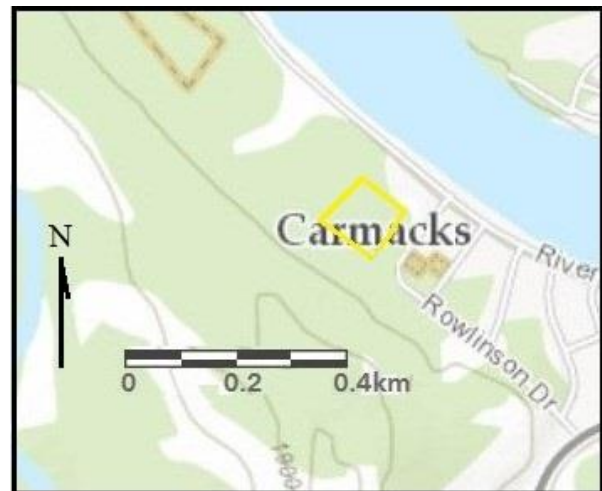
The map retained from the *YG - Water Placer Atlas* website noted that the north-western periphery of the study area is bound by a community use lot (#181). The north-eastern periphery of the study area borders a commercial lot (#16). Single detached residences (lots #20-22) are located along the south-eastern realms of the study area. A vacant residential lot (#23) is located adjacent to the south-eastern corner of the study area and borders Rowlinson Drive.

The topography of the study area is best described as level ground. However, slightly lower elevations encroached up to ~ 20 meters into the southwestern realms of the site. These lower elevations coincide with a drainage course which parallels the Yukon River.

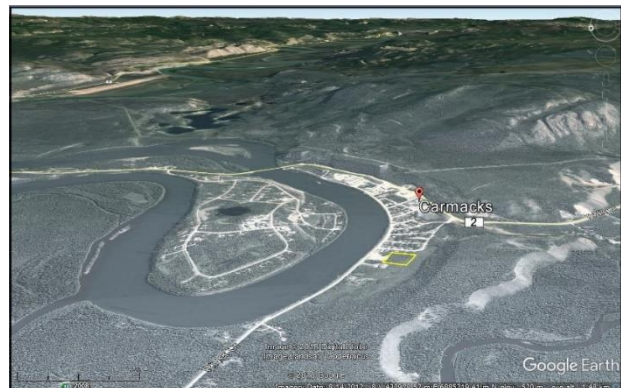
Orthogonal view from Google Earth facing east.

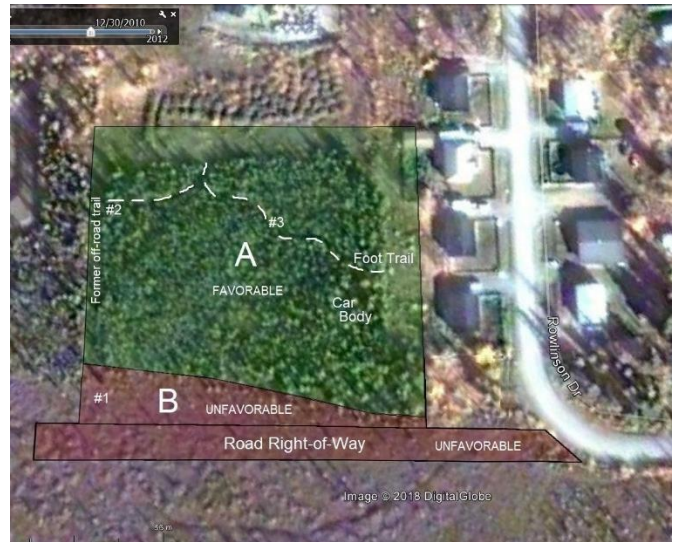
By comparison, the terrain in Area B and the road right-of-way is several meters lower in elevation and exhibits poorly drained conditions.

The vegetation in this area is sparse and is predominately comprised of low-lying shrubs.

View of Area B facing north-west.

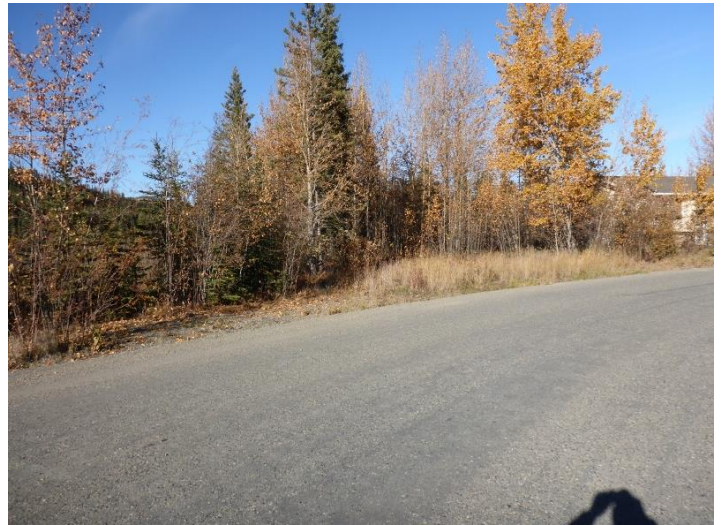
View of Lot 23 from Rowlinson Drive.

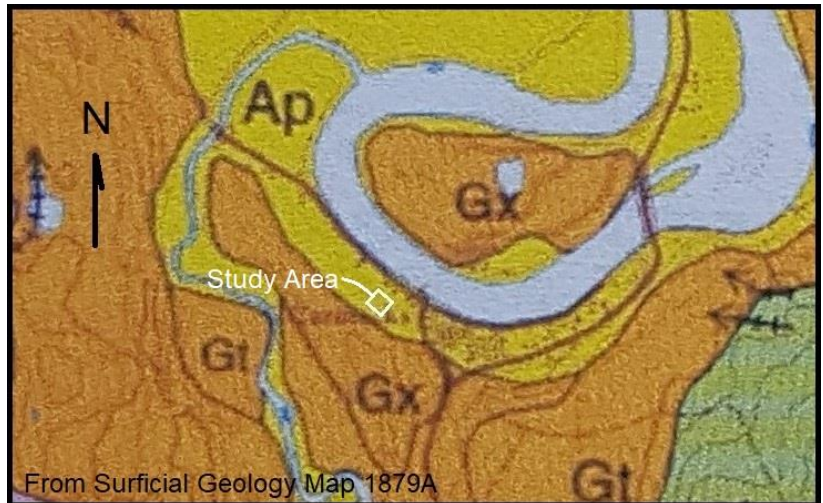
The distribution of surficial deposits within the study area has been illustrated in the (1:100,000 scale) surficial geology map Tantalus Butte - Yukon Territory - Map 1879A compiled by L.E.Jackson Jr., 1997. The approximate limits of the study area have been illustrated on a portion of the surficial geology map (right).

In brief, the map shows that the surficial deposits which are located within the study area are comprised of alluvial plain deposits.

Alluvial Floodplain Deposits (Ap)

The deposits within alluvial floodplains are generally comprised of coarse grained gravel and cobbles which are overlain by silts and sands which have been deposited as a result of meandering river/alluvial processes. Organic and fine-grained deposits may be encountered in abandoned channels. Thickness generally measures between 1 to 5 meters.

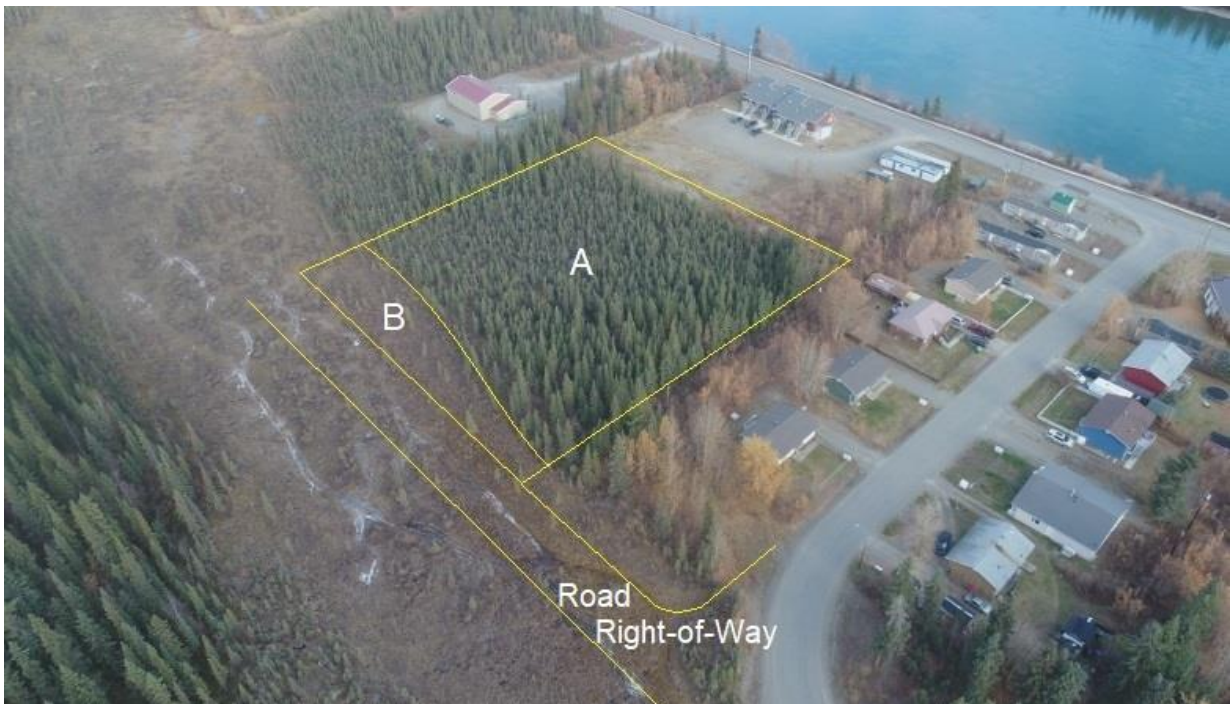
Geotechnical Feasibility Assessment
Proposed Urban Residential Lot – Carmacks, Yukon – 2018
Figure 2 – Development Potential

Based upon the information retained during our assessment, the development potential of the site will vary. In general, the anticipated soil and terrain conditions will be favorable to allow for unrestricted site development in Area A (as noted in Figure 2).

Based upon the information retained during our assessment, the development potential of the site will vary. In general, the anticipated soil and terrain conditions will be favorable to allow for unrestricted site development in Area A (Figure 2). By contrast, development within Area B should be limited to access road/parking areas construction as poor soil conditions and shallow groundwater are anticipated in this area.

The following recommendations have been provided to outline the envisioned geotechnical requirements for site development in the regions identified in Figure 2. However, as our recommendations are preliminary in nature, additional consideration may be required once the geotechnical parameters have been determined following a subsurface geotechnical evaluation (test pit/drilling and laboratory work programs).

The construction of roads and surface utilities should be feasible throughout Area A (Figure 2). While the road structure would need to be determined based upon the subgrade conditions and expected traffic loads, we anticipate the granular components of the road structure in this area would measure in the order of 0.7-1.0 meters thick.

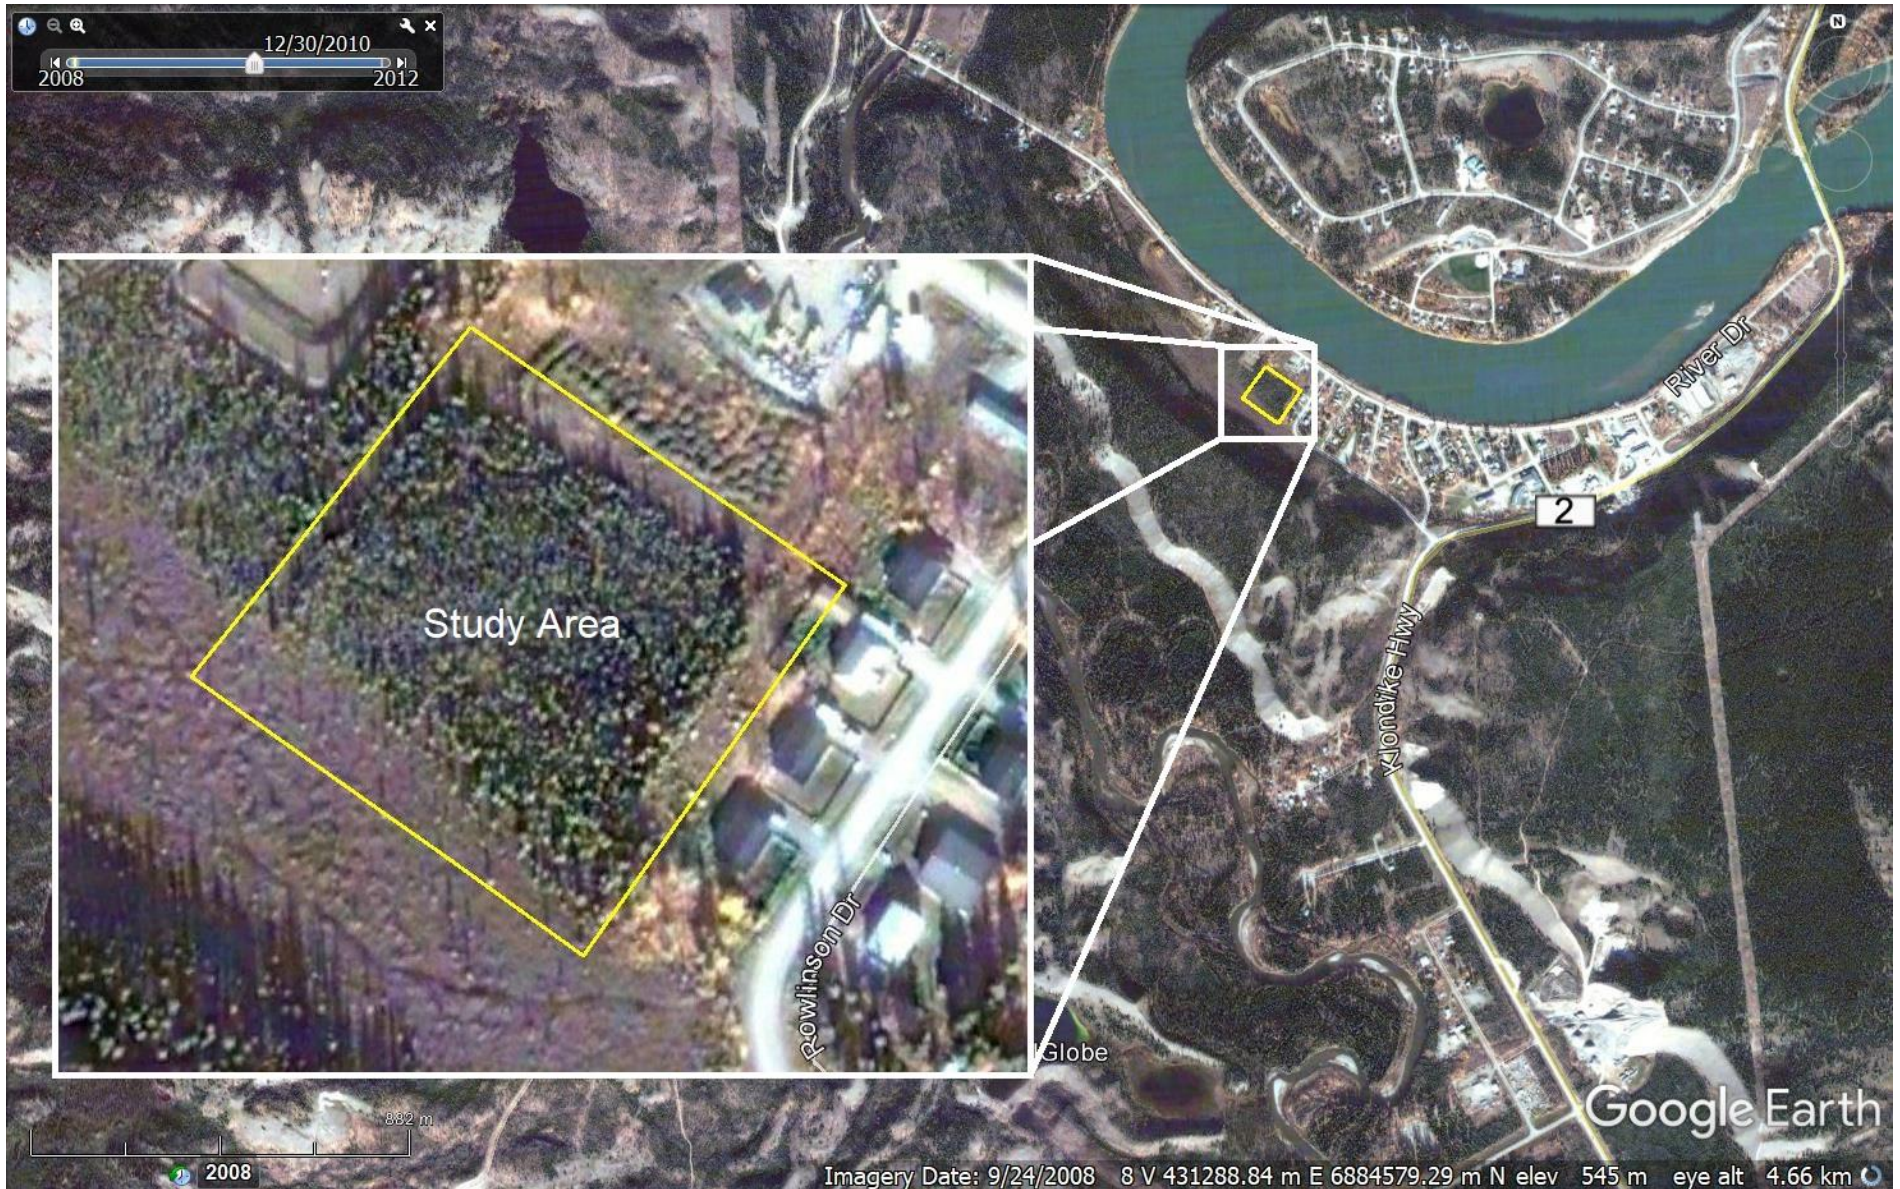
Geotechnical Feasibility Assessment
Proposed Urban Residential Lot – Carmacks, Yukon – 2018
Figure 1 – Location of Study Area

The study area, which measures 1.1 ha in size, is comprised of *Village of Carmacks* Lots #15 (CLSR 55659) as noted in Figure 1. The *Village of Carmacks* is located ~ 180 km north of Whitehorse along the North Klondike Highway # 2.

The study area measures 1.0 ha in size and is comprised of *Village of Carmacks* Lots #15 (CLSR 55659) as noted in Figure 1.

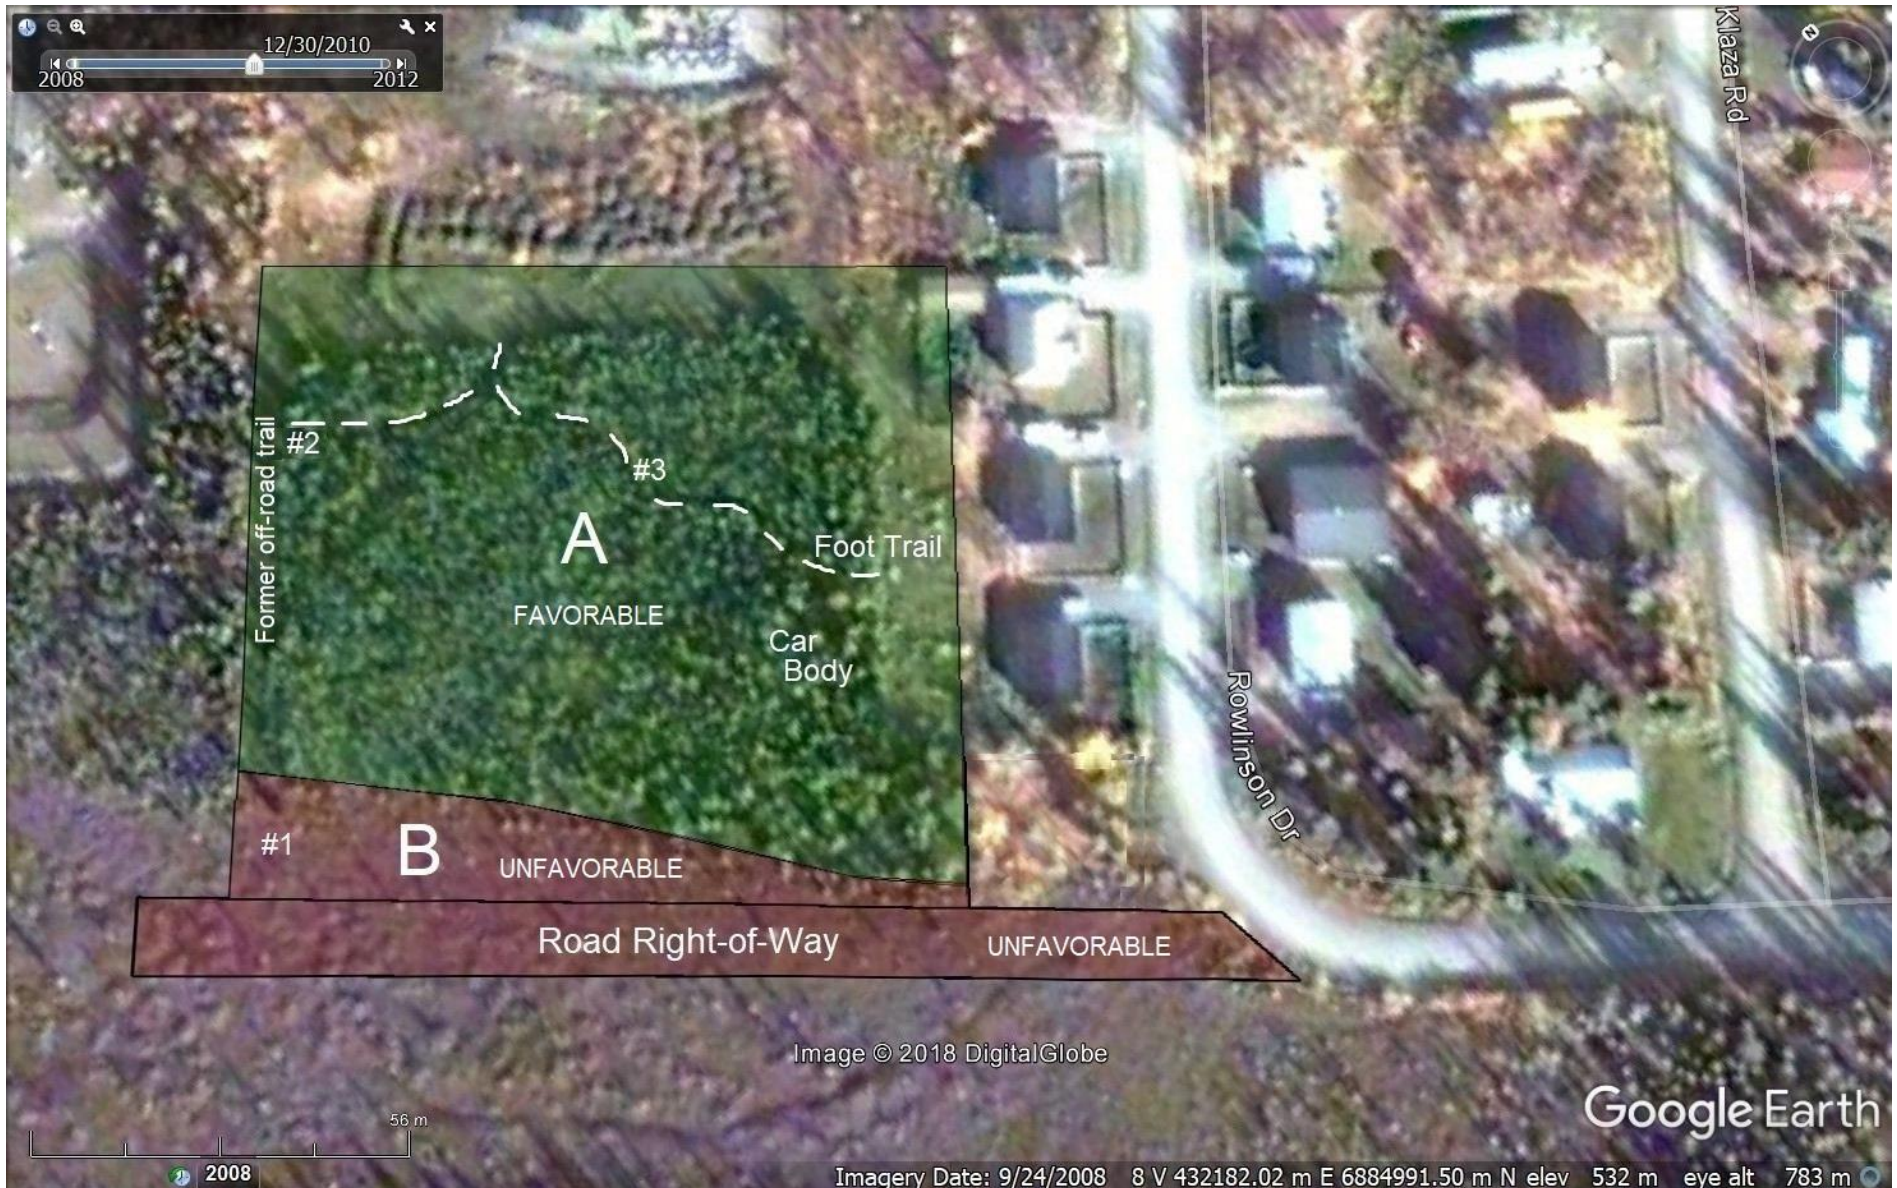
The study area is comprised of two (2) distinct regions as noted below and in Figure 2.

The terrain in Area A is generally level and harbors a moderately dense spruce forest. A thick willow bush understory is present.

A hiking trail traversed across the northern portion of the site as noted in Figure 2. An overgrown off-road vehicle trail is located along the western edge of the site.

An abandoned car body is located within the limits of the site as noted in Figure 2 (below right).

During the course of the traverse, three (3) near surface soil samples were retained by utilizing a hand shovel to allow for subsequent laboratory analysis as described in Section 3.3, below. These samples (#1-#3) were retained from the locations noted in Figure 2.

By contrast, development within Area B (and the road right-of-way) will be unfavorable as poor soil conditions and shallow groundwater are anticipated in these areas. As such, development within Area B should be limited to access road/parking area construction.

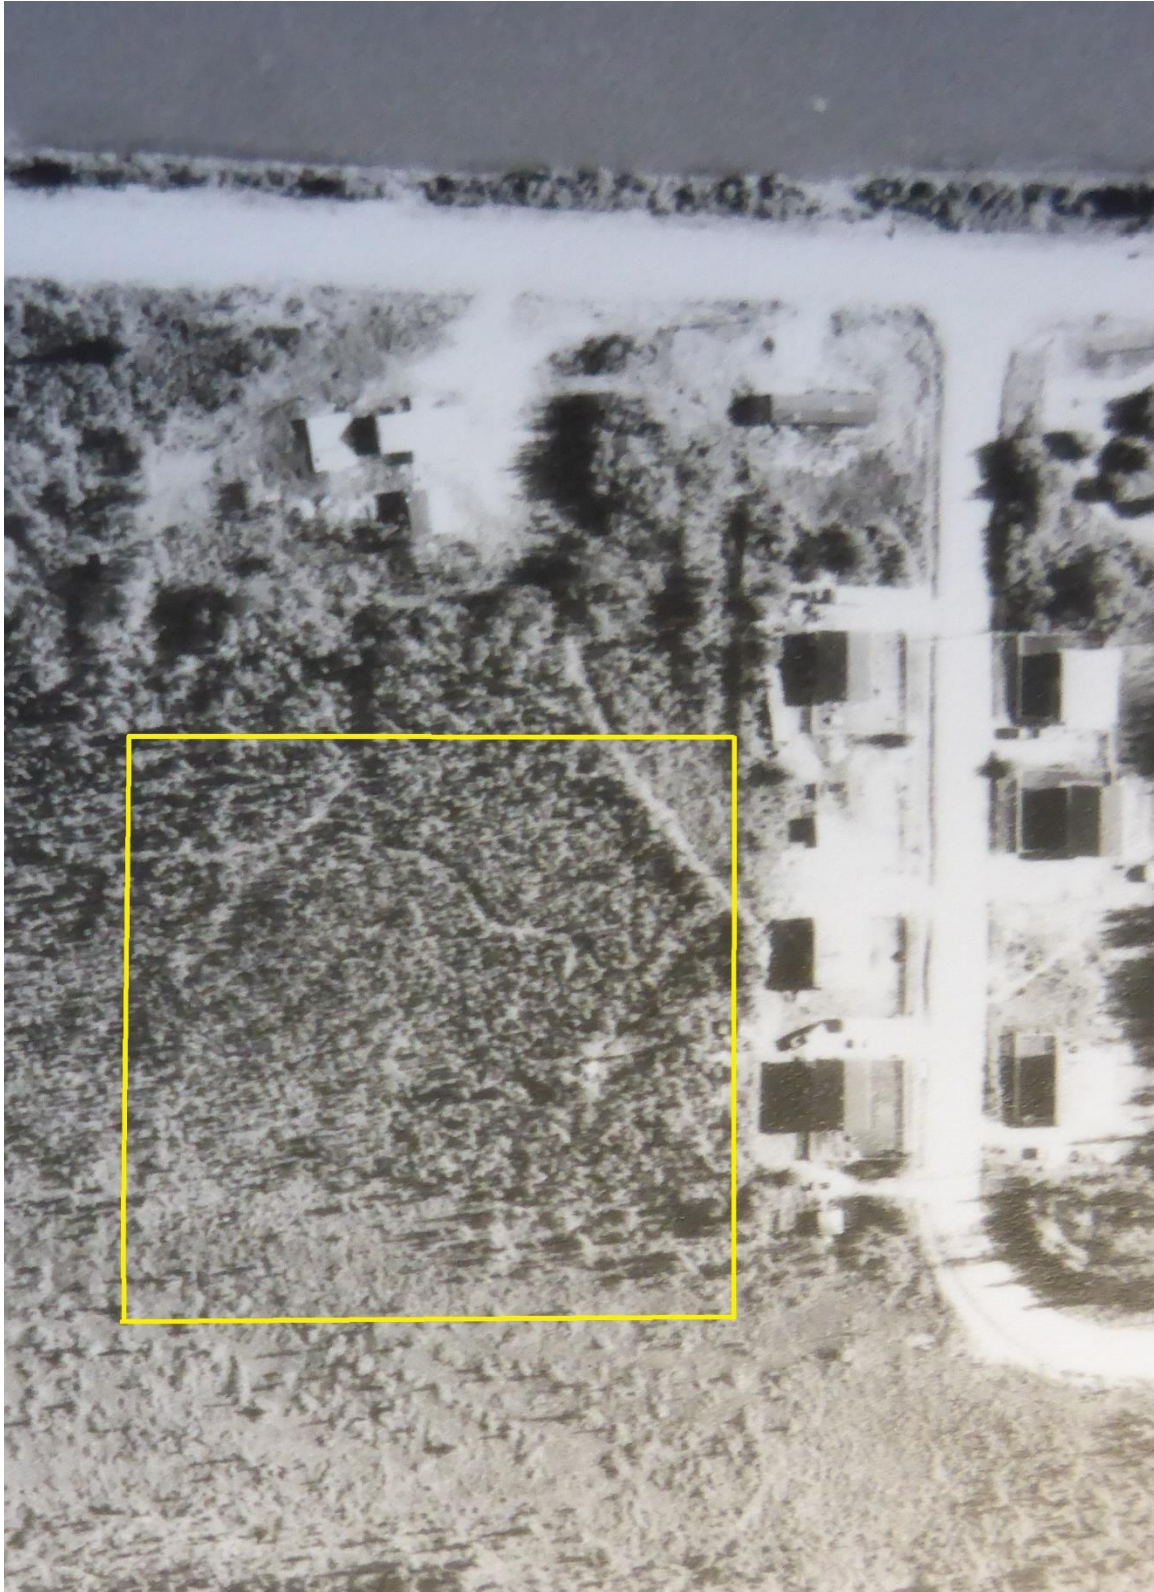
Geotechnical Feasibility Assessment
Proposed Urban Residential Lot – Carmacks, Yukon – 2018
Appendix A – Airphoto A27009 #7 (August 18th, 1986)

A review of the 1986 airphoto indicates that the north-eastern corner of the site was cleared as noted in Appendix A.
