**Geotechnical Evaluation**  
**Lot 2 Block 3**  
**Dawson City, Yukon – 2014**

**Prepared For:** Yukon Government – Energy, Mines & Resources

**Date :** August 19, 2014

**Project No:** 200-002-14

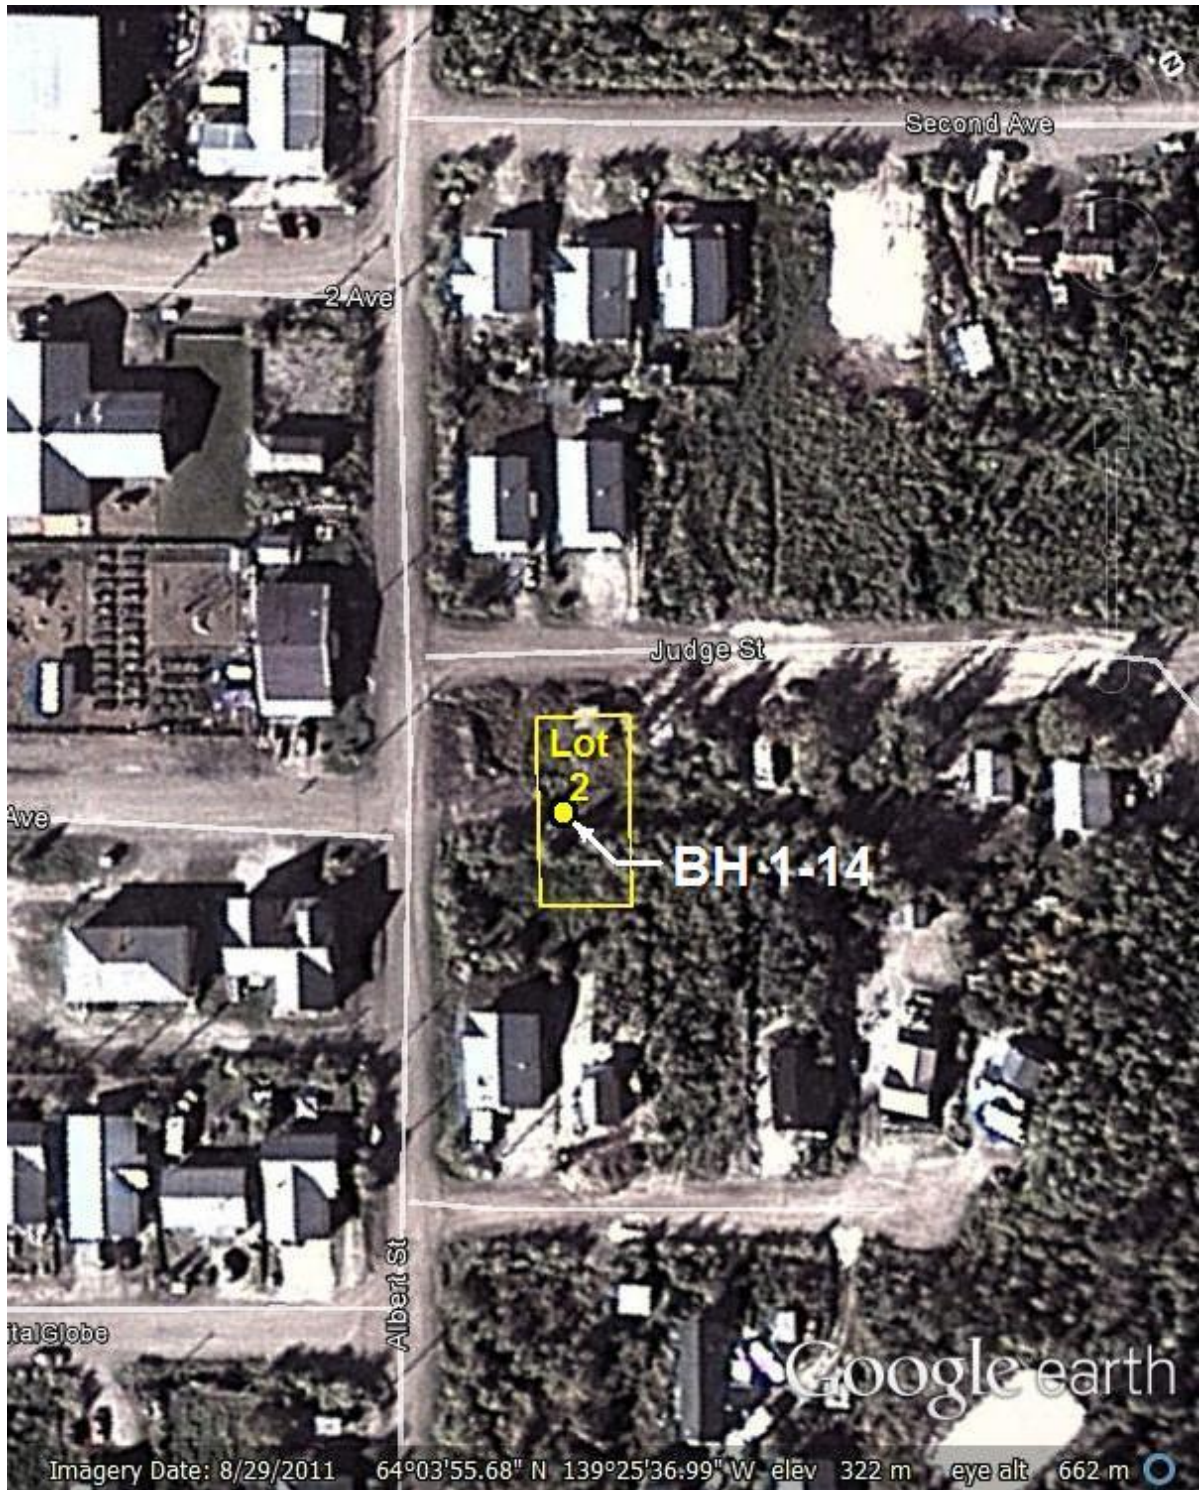
Geotechnical Evaluation  
Lot 2 Block 3 - Dawson, Yukon – 2014  
FIGURE 2 – Borehole Location

The location of the borehole was measured relative to prominent reference points and has been plotted on the Figure 2.

Not to Scale – Locations are approximate  
Base plan from Google Earth

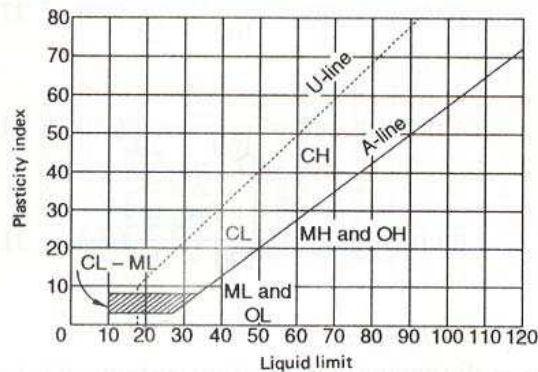
Note: U-line represents approximate upper limit of LL and PI combinations for natural soils

Plasticity chart for the classification of fine-grained soils.  
Tests made on fraction finer than No. 40 sieve.

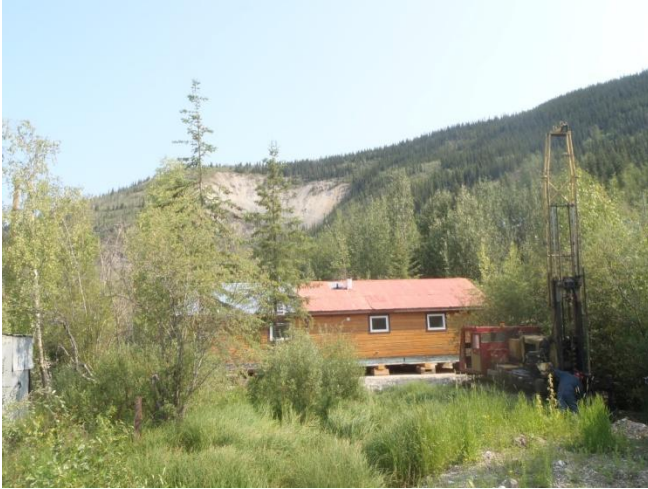
Photo # 1 – Site conditions during drilling operations facing north-east from Albert Street.

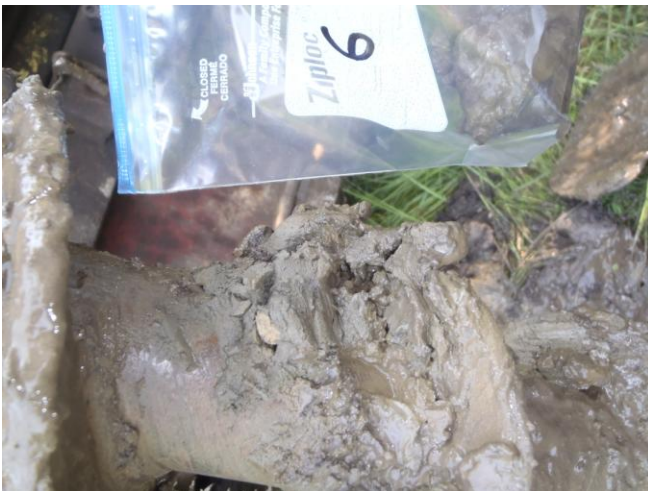
Photo # 2 – BH 1-14  
Sample No.6 – 3.35 meters

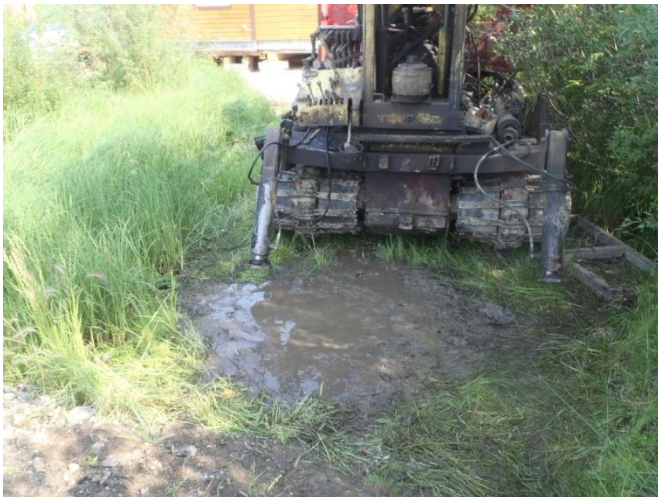
Following drilling the borehole was left undisturbed for approximately 15 minutes to assess the sidewall stability and better assess groundwater conditions. In brief, the excavation sidewalls were noted to collapse to a depth of 0.6 meters below the ground surface.

While groundwater was encountered during drilling at a depth of 2.44 meters, following drilling operations the groundwater was noted at the ground surface.

Photo # 3 – BH 1-14 – Site conditions upon completion of drilling operations.
