**Geotechnical Evaluation and  
Limited Phase II Environmental Site Assessment  
Lot 2, Block HB, Haper Estate (8338A CLSR)  
Dawson City, Yukon – 2015**

**Prepared For:** Yukon Government – Energy, Mines & Resources  
**Date :** September 8, 2015  
**Project No:** 200-006-15

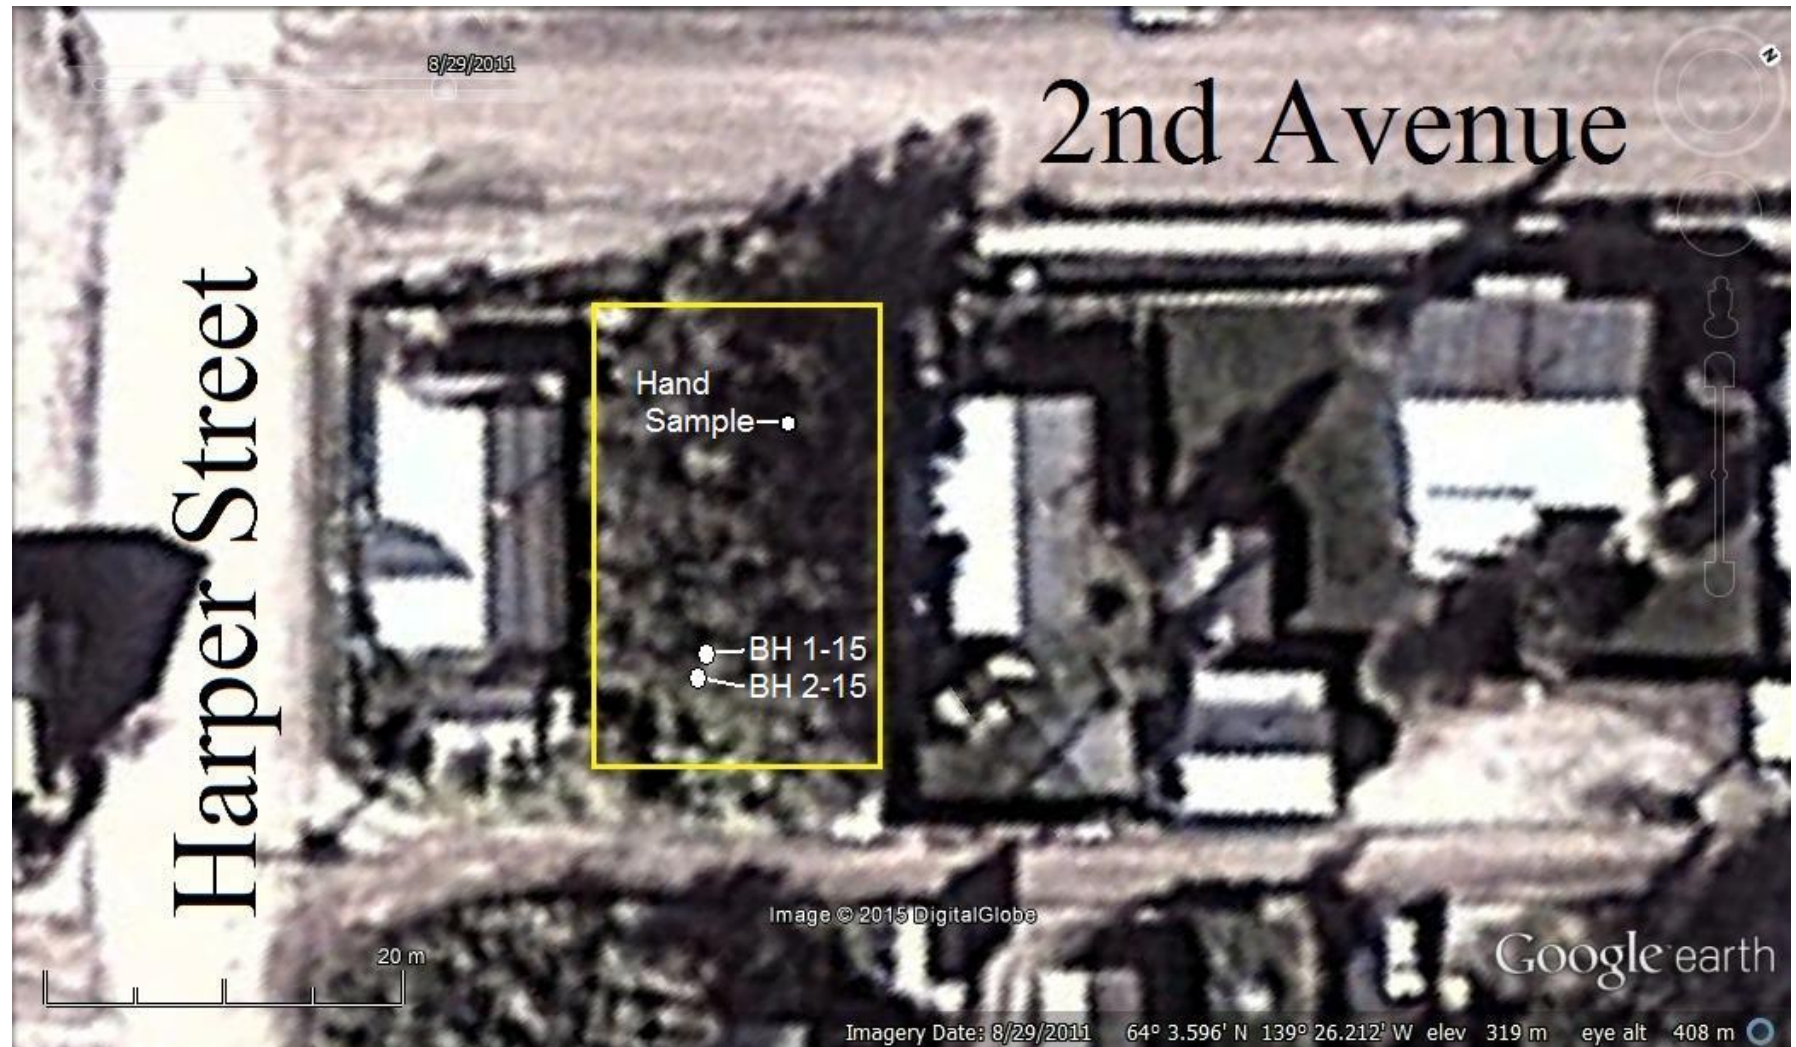
FIGURE 2 – Borehole and Hand Sample Locations

In addition to the drilling samples, a single soil sample was obtained from a local low spot (noted in Figure 2) through hand sampling techniques. The sample was retained from soils located directly below a 0.1 meter thick organic mat which was encountered at this location.

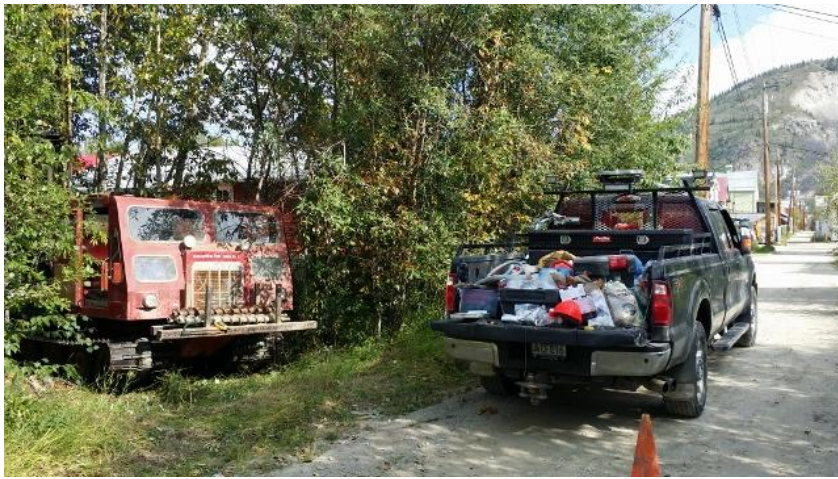
Photo # 1 (above) – Site conditions from back alley.

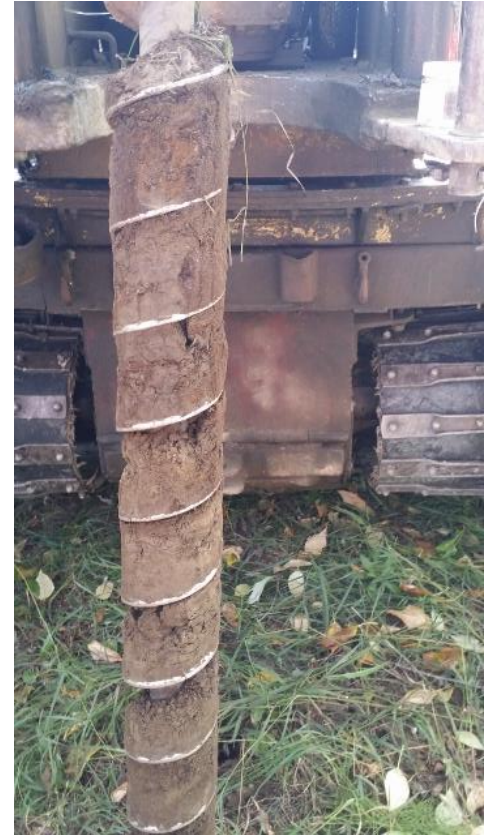
Photo # 2 (right) – BH 1-15 – 0 to 5 feet

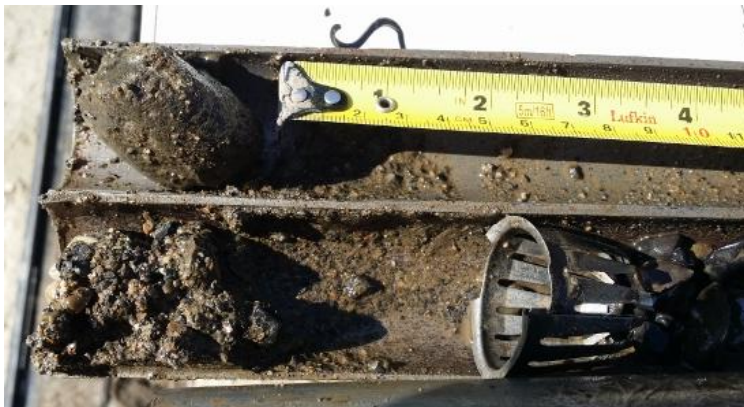
Photo # 3 (left) – Sample No.10 - Sandy Gravel

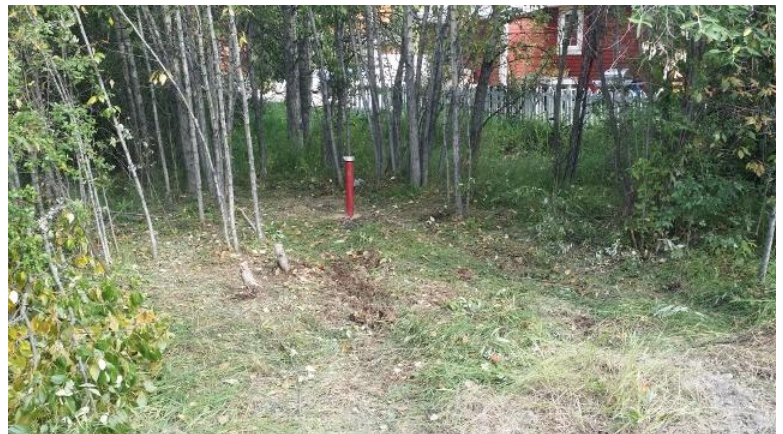
Photo # 4 (right) – Site conditions following well installation

A 2" diameter ABS monitoring well was installed to a depth of approximately 4.41 meters below the existing ground surface to allow for future monitoring of the local groundwater conditions.
