**Geotechnical Evaluation and
Limited Phase II Environmental Site Assessment
Lot 3, Block H, Stewart Menzies Subdivision (28743 LTO)
Dawson City, Yukon – 2015**

Prepared For: Yukon Government – Energy, Mines & Resources
Date : September 8, 2015
Project No: 200-006-15

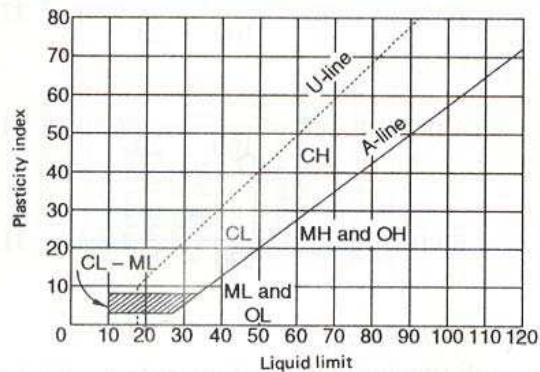
Plasticity chart for the classification of fine-grained soils.
Tests made on fraction finer than No. 40 sieve.

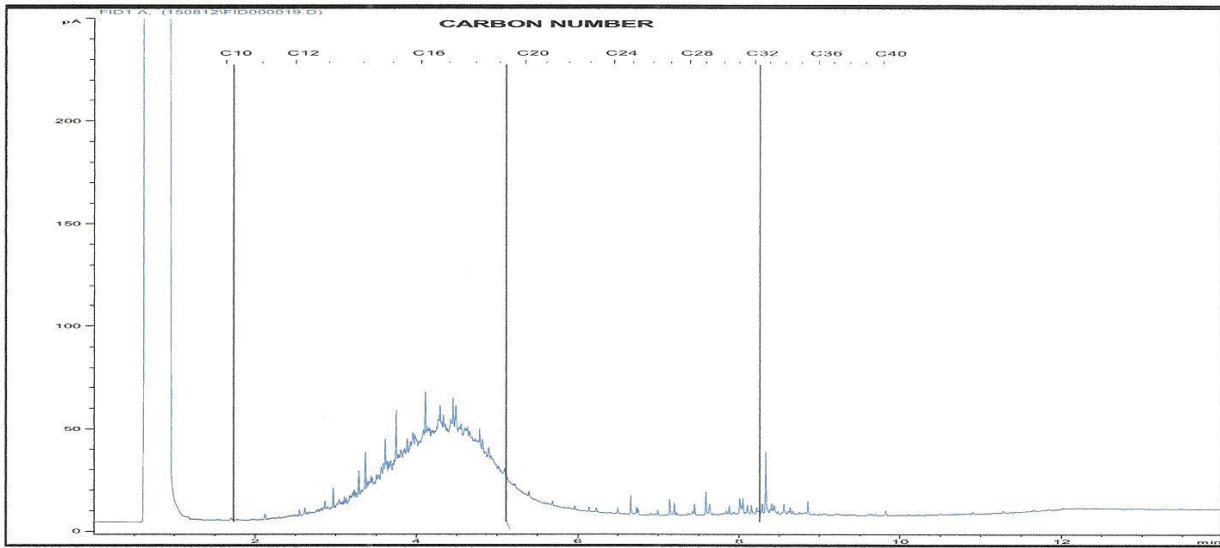
Exova Number: 1087728-2 Sample Description: Lot 3
 Sample Date: Aug 10, 2015

Although the results of the analytical results of the soil sample retained from below the AGST did not exceed any of the recommended soil criteria for residential limits as noted in the CSR, the LEPH reading of 348 ppm suggests that there may be a possibility that nearby soils may have been impacted by hydrocarbons.

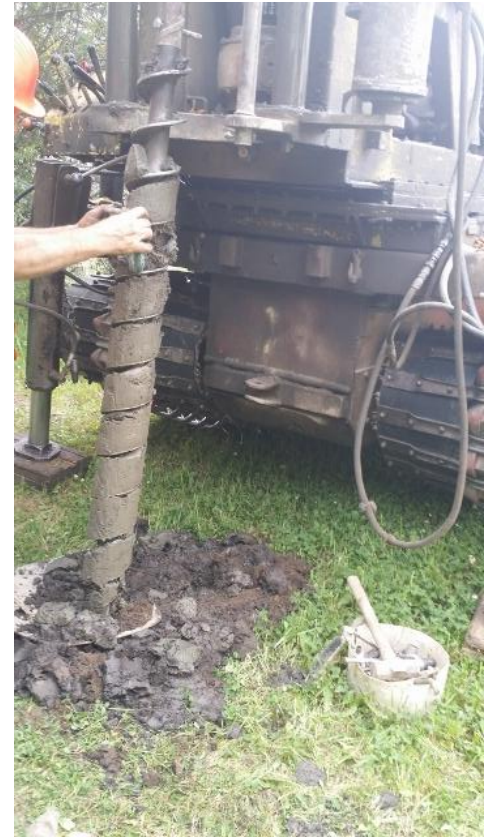
Photo # 2 (right) – BH 1-15 – 10 to 15 feet

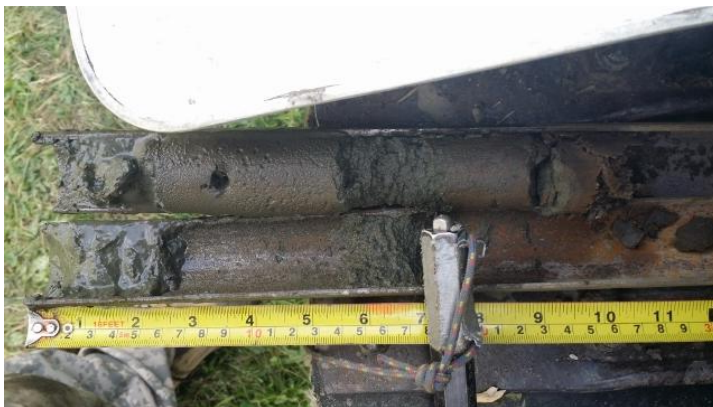
Photo # 3 (left) – BH 2-15 - Sample No.10

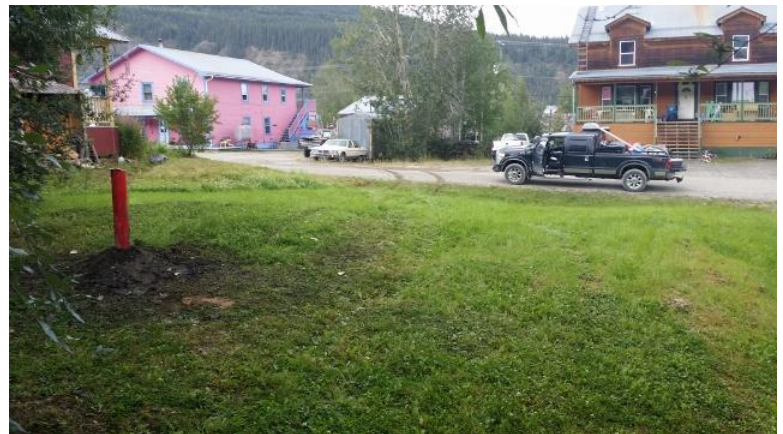
Photo # 4 (right) – Site conditions following well installation facing 7th Avenue.

A 2" diameter ABS monitoring well was installed to a depth of approximately 4.54 meters below the existing ground surface to allow for future monitoring of the local groundwater conditions.
