Geotechnical Evaluation

Lot 7, Block B, Stewart Menzies Subdivision (2007-0058 LTO)

Dawson City, Yukon – 2015

Prepared For: Yukon Government – Energy, Mines & Resources
Date : September 8, 2015
Project No: 200-006-15

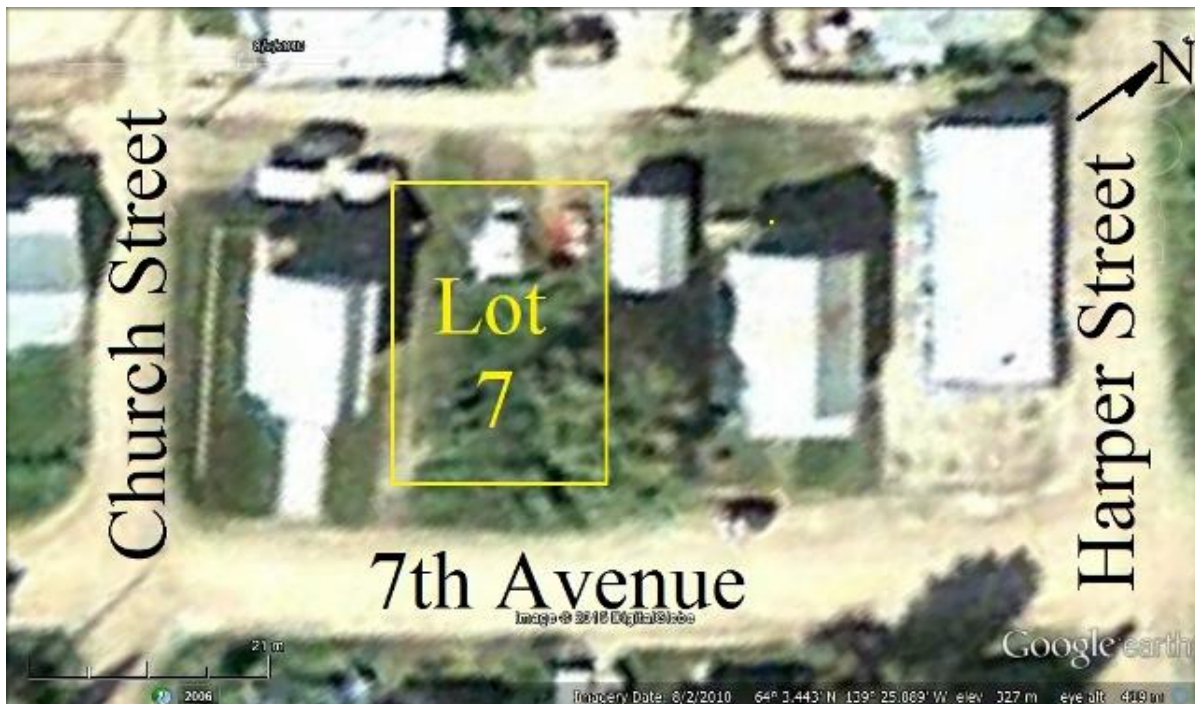
Geotechnical Evaluation
Lot 7, Block B, Stewart Menzies Subdivision 2007-0058 LTO - Dawson, Yukon – 2015
FIGURE 2 – Borehole Locations

The location of the boreholes were measured relative to prominent reference points and have been plotted on Figure 2.

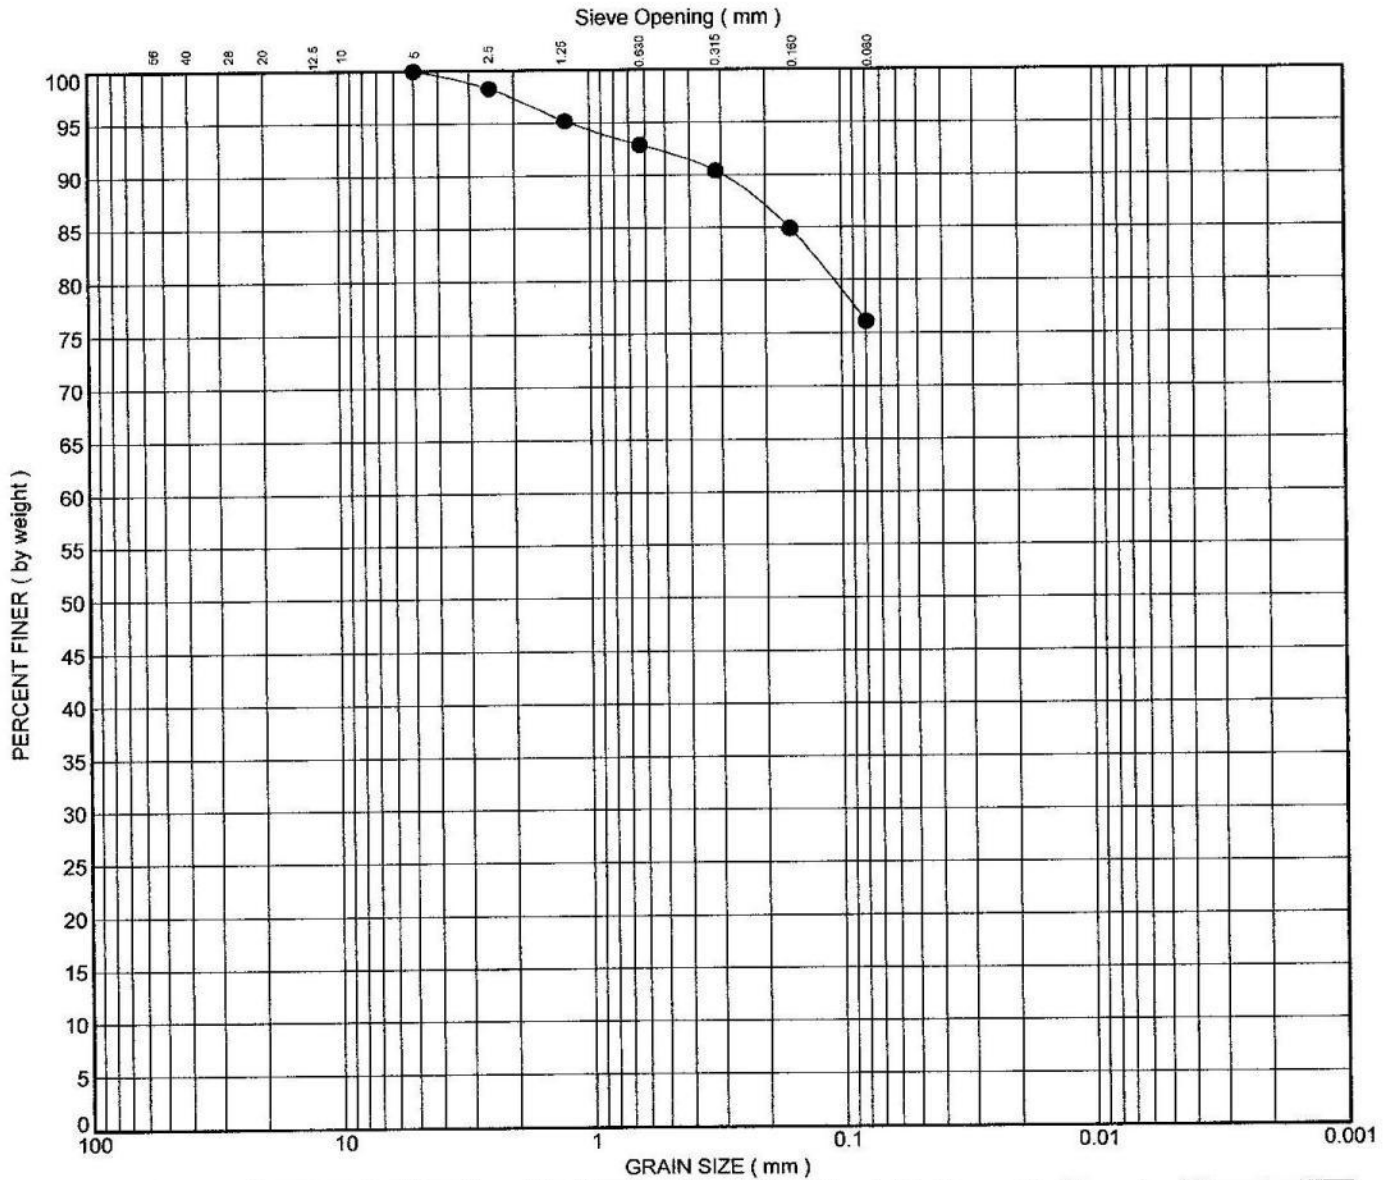
Gravel (%)	Sand (%)	Fines - (%) <0.063 mm	Moisture (%)	D100	D60	D30	D10	Cc	Cu
0.0	23.9	76.1	32.8	5

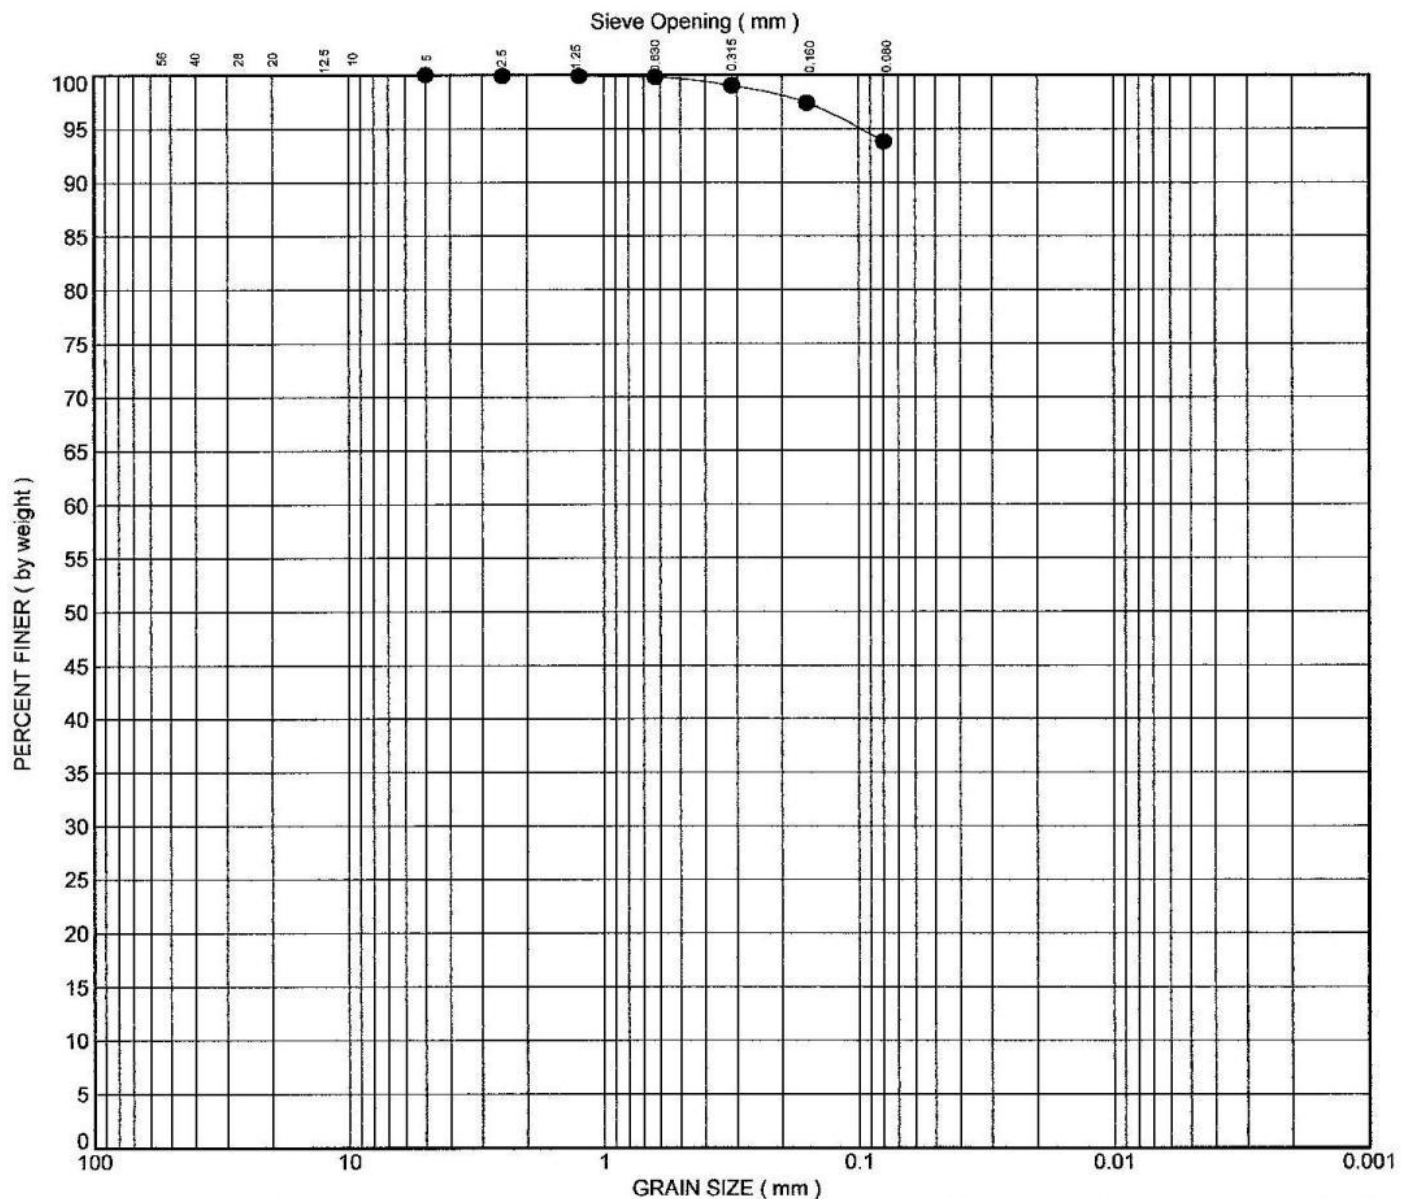
Gravel (%)	Sand (%)	Fines - (%) <0.063 mm	Moisture (%)	D100	D60	D30	D10	Cc	Cu
0.0	6.2	93.8	25.9	5

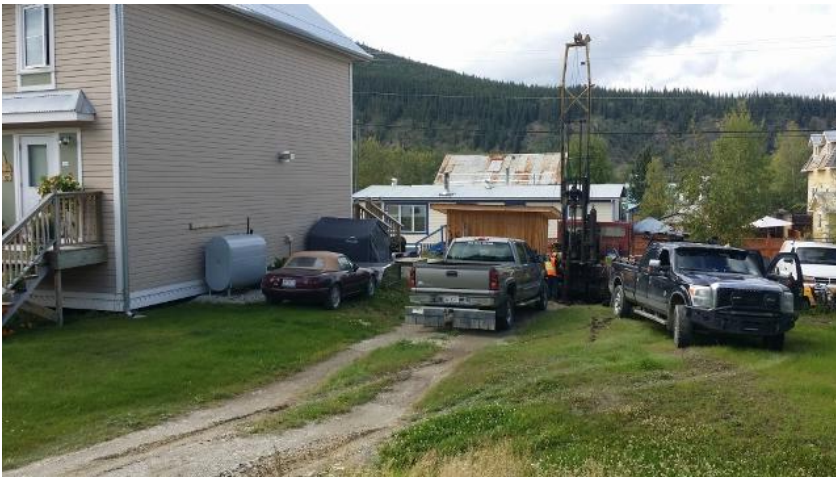
Photo # 1 (above) – Drilling BH 1-15 - As viewed from 7th Ave.

The drilling program was conducted on August 10th, 2015 by *Donjek Services* utilizing a CME-750 drill mounted on an FN-60 Nodwell.

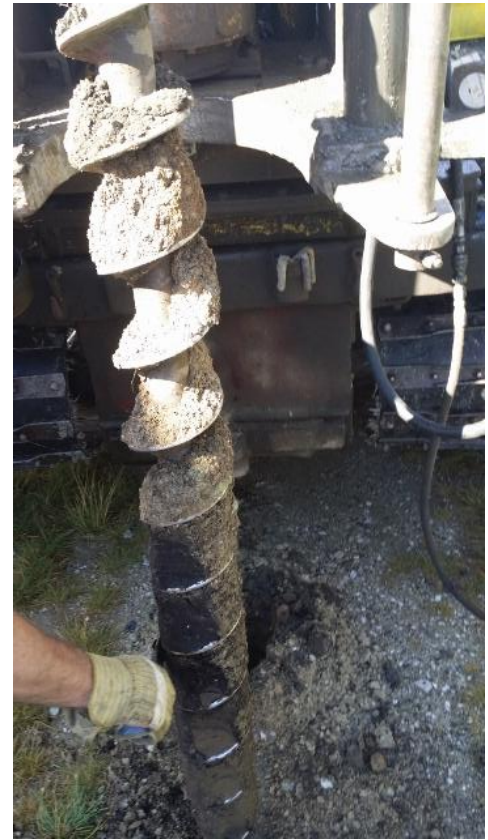
Photo # 2 (right) – BH 1-15 – Fill/Native soil interface.

15 encountered approximately 1.06 meters of fill while BH 2-15 encountered thicker amounts, approaching 2 meters (as measured from the existing ground surface at the borehole locations). As with all undocumented fills in regions where previous residences were located, the fill may also contain construction/foundation rubble, scrap steel, high levels of fines/organics and/or other deleterious materials and/or abandoned infrastructure.

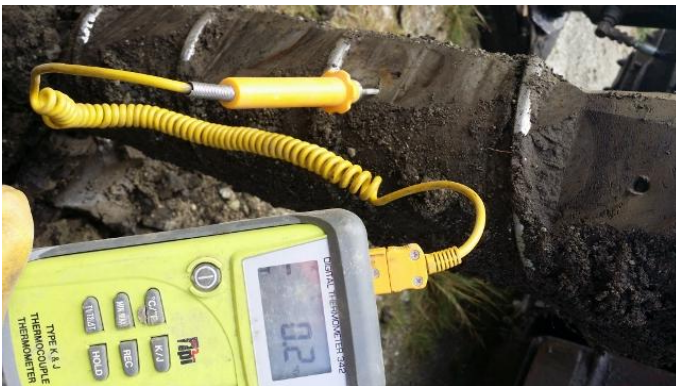
Photo # 3 (left) – BH 1-15 Temperature Reading

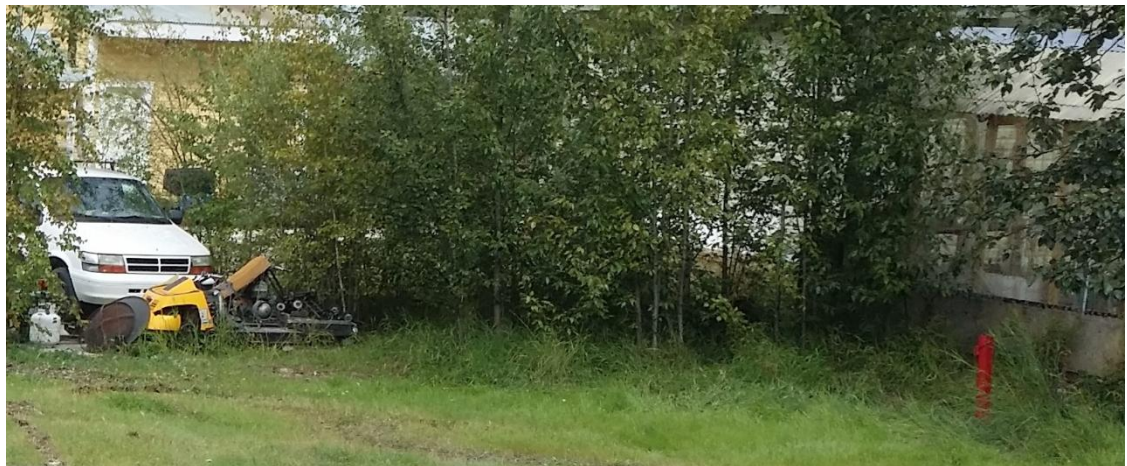
Photo # 4 (right)

Site conditions -
Well on right
side of photo.
