CHILKOOT GEOLOGICAL ENGINEERS LTD.

Phase I Environmental Site Assessment

Lot 8 Block 2

Geotechnical Evaluation

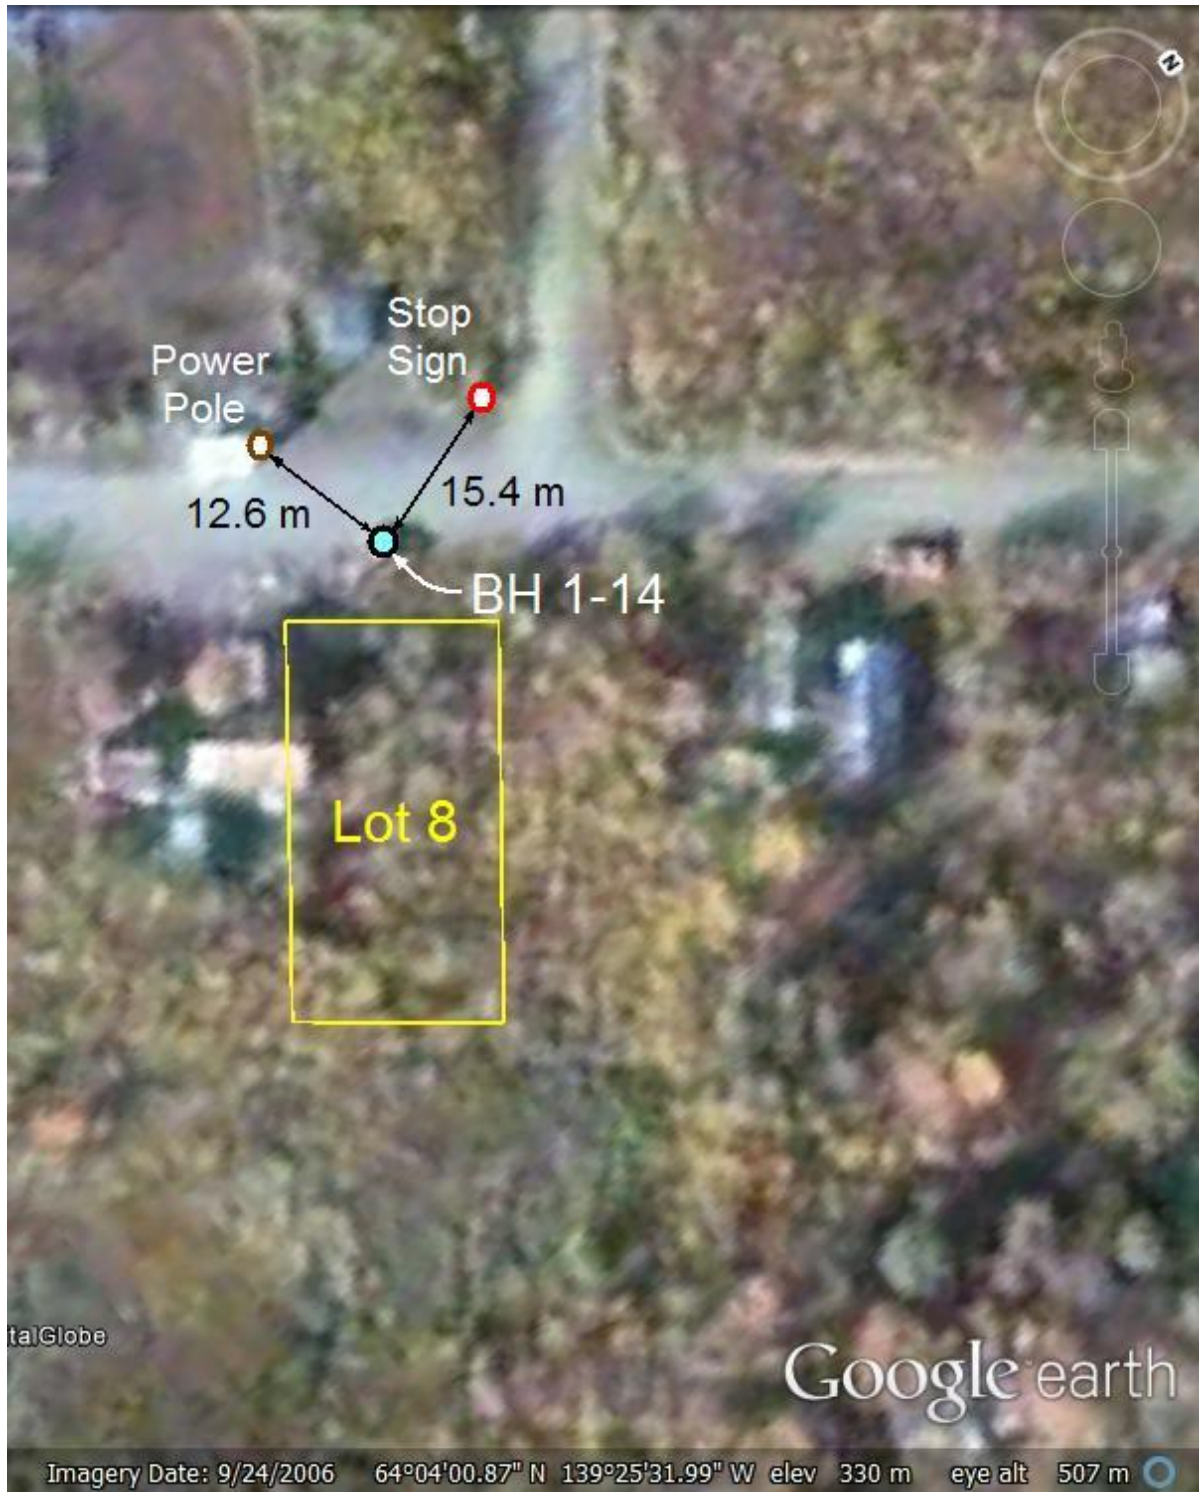
Geotechnical Evaluation
Lot 8 Block 2 - Dawson, Yukon – 2014
FIGURE 2 – Borehole Location

Not to Scale – Locations are approximate
Base plan from Google Earth

The location of the borehole was measured relative to prominent reference points and has been plotted on the Figure 2.

Channel gravel and measured relative to the stop sign and nearby power pole as noted in Figure 2.

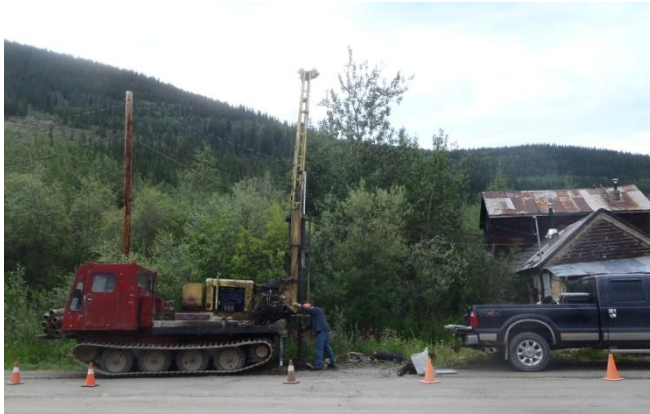
Photo # 1 – Site conditions during drilling operations facing west from Judge Street.

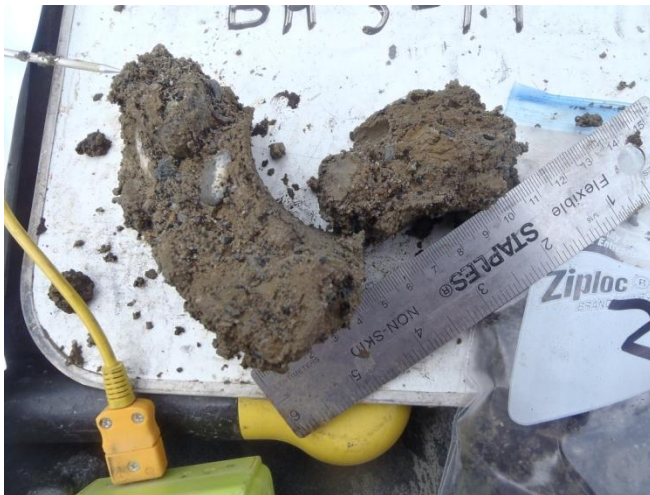
Photo # 2 – Sample No. 5 – 2.44 meters

Alluvial channel deposits were encountered a depth of 2.44 meters. This soil unit was noted to be frozen at a depth of 1.52 meters. There was no sign of visible ice.

The deposits were comprised of moist to wet, non to low plastic silt which contained varying amounts of clay, sand and gravel. Due to the nature of channel deposition,

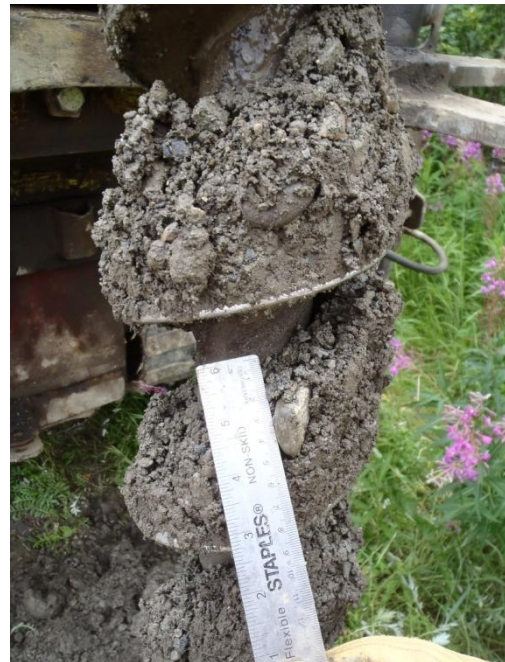
Photo # 3 – Sample No. 7 – 3.66 meters

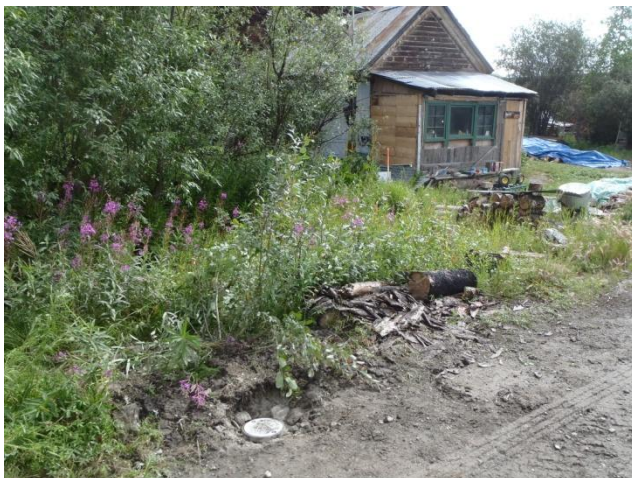
Photo # 4 – Flush mounted well following drilling operations

A 2" diameter ABS monitoring well was installed to a depth of approximately 3.61 meters below the existing ground surface to allow for future monitoring of the local groundwater conditions.

The lower 3.05 meters of the well was slotted and a silt sock was utilized to minimize the influx of fines and extend the life of the well. The annular space was backfilled with imported filter sand. The exception to this was above the slotted portions of the pipe where a bentonite plug was installed to seal the annular space in accordance with good installation practices. Access to the well was restricted through the installation of a flush mounted steel casing which was concreted into the existing ground surface. As the well was installed along the road shoulder of 2nd Avenue, the top of the steel casing was placed 0.15 meters below the road surface to minimize the potential for disturbance during road grading operations. The casing was covered with White
