**Geotechnical Evaluation and
Limited Phase II Environmental Site Assessment
Lot 8, Block G, Ladue Estate (8338A CLSR)
Dawson City, Yukon – 2015**

Prepared For: Yukon Government – Energy, Mines & Resources
Date : September 8, 2015
Project No: 200-006-15

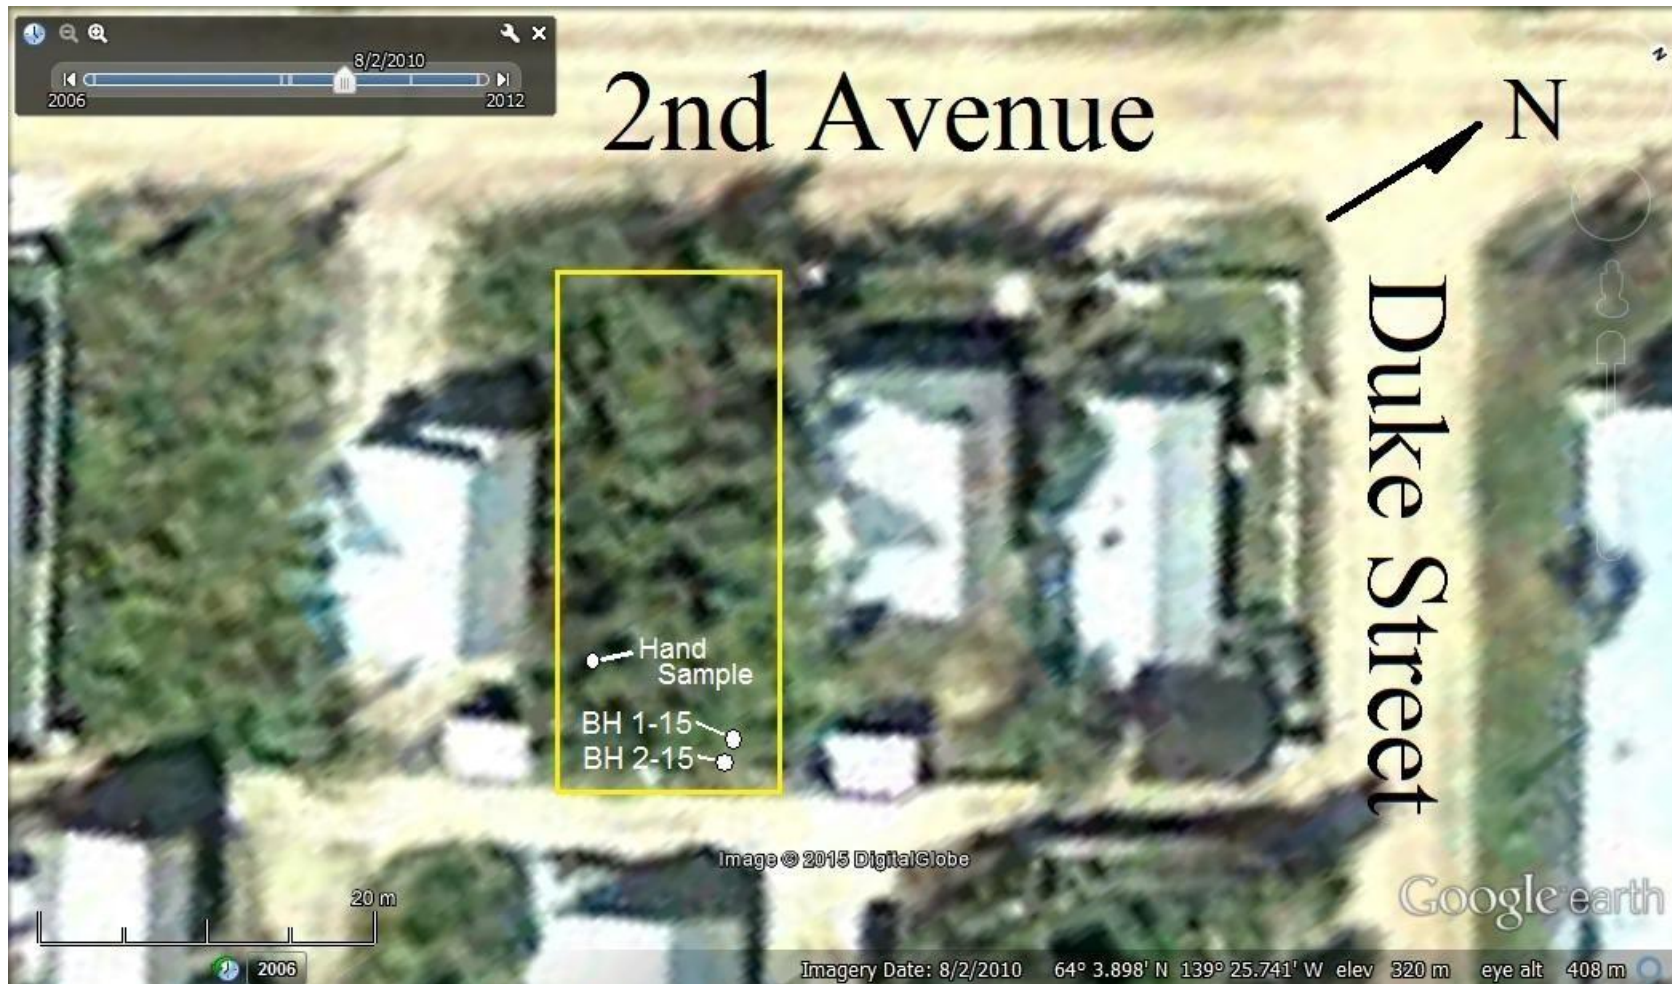
FIGURE 2 – Borehole Locations

In addition to the drilling samples, a single soil sample was obtained from a local low spot (noted in Figure 2) through hand sampling techniques. The sample was retained from soils located directly below a 0.15 meter thick organic mat which was encountered at this location.

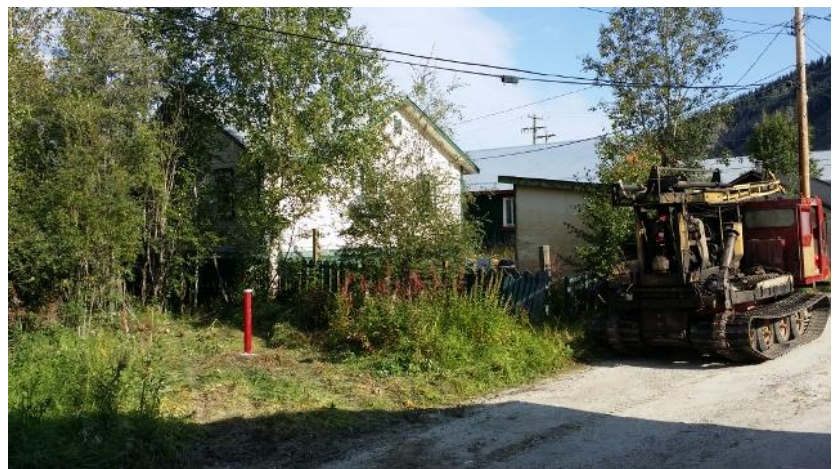
Photo # 4 (right)

Site conditions following well installation. Well on left side of photo.

A 2" diameter ABS monitoring well was installed to a depth of approximately 2.49 meters below the existing ground surface to allow for future monitoring of the local groundwater conditions.
