**Geotechnical Evaluation
Proposed Industrial Subdivision
km 353.7 RHS Klondike Highway #2
Carmacks, Yukon – 2019**

Prepared For: Yukon Government

Date : October 11th, 2019

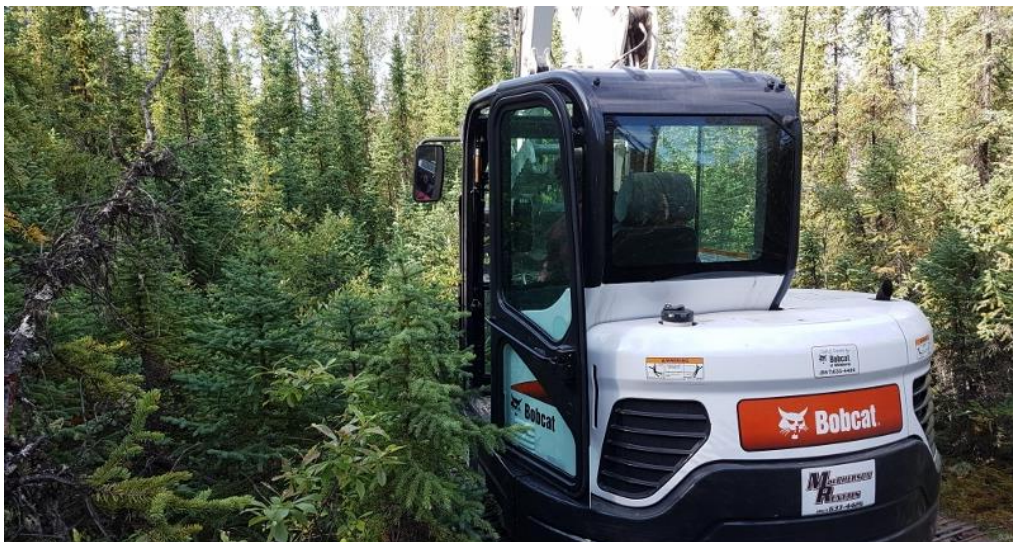
Site conditions traversing to test pit TP 2-19.

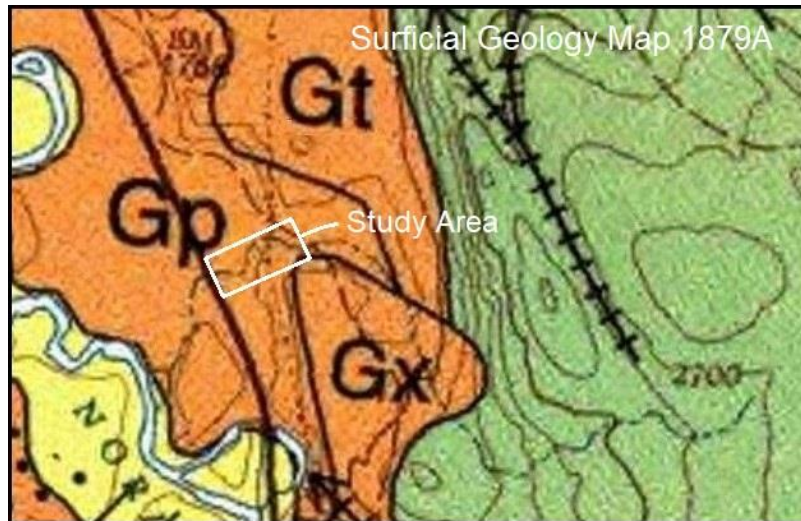
The soil deposits located within the study area are comprised of glaciofluvial plain deposits. The approximate regional distribution of these soil deposits as identified in the surficial geology map (*GSC Map 1879A*) was delineated as illustrated, below;

Glaciofluvial Plain Deposits (Gp) - (TP 3-19)

In general, the surficial geology map (*GSC Map 1879A*) described these deposits as being comprised of pebble to cobble gravels which are massive to thickly bedded and capped by sand and silt. They are planar in nature and measure between 1 meter to greater than 10 meters thick. This sequence of fine-grained sands and silt which overlay cobbly gravels were encountered in test pit TP 3-19.

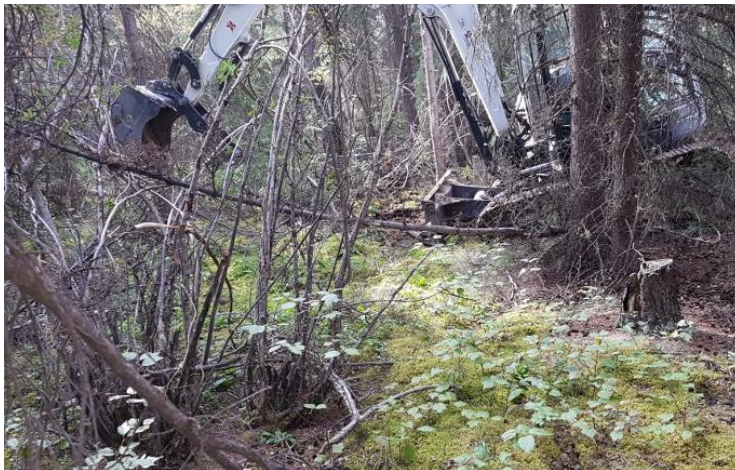
The composition of the fine-grained soil deposits varied with depth. In general, non-plastic sandy silts extended to depths of approximately 1.8 meters below the prevailing ground surface. The relative moisture content of these soils was noted to be damp (11.9%) becoming moist (18.4%) beyond a depth of 1.3 meters. Silty clays to clayey silts, which were characterized through Atterberg limit analysis as being slight plasticity, were encountered at a depth of 1.8 meters. The moisture content of these plastic soil deposits was noted to be 28.4%, indicating wet soil conditions. The hydrometer analysis indicated the silty clay to clayey silt contained 11.9% clay, 51.1% silt and 37.0% sand (by weight). The consistency of these plastic soil deposits was noted to be soft beyond a depth of 2.4 meters, suggesting the presence of a nearby groundwater table.

The underlying gravel deposit was characterized as a being a sandy silty gravel which contained 18.5% fines and the odd cobble in size to 140 mm. These soils had a moisture content of 12.8 %, indicating wet/saturated soil conditions. In a confined state, the relative density of the granular deposits would be compact. However, given their saturated condition, they were noted to be loose upon excavation.

Site conditions at test pit TP 3-19.

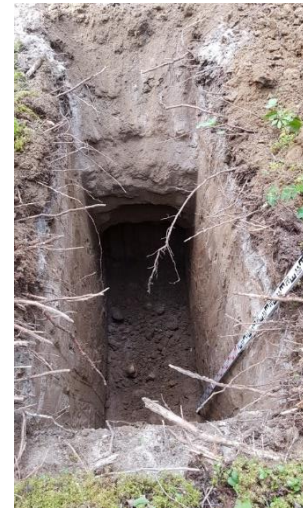
Test pit TP 3-19 soil conditions.

The above noted soils were overlain with 150 mm of organic silt and moss, 150 mm of sandy silt and 200 mm of volcanic ash.

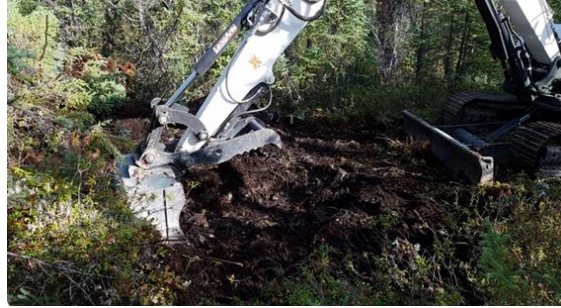
Similar soil and subsurface conditions were encountered in test pits TP 1-19 and TP 2-19. In brief, each test pit encountered permafrost comprised of black

organic silts which were overlain with approximately 100 mm of volcanic ash and approximately 250 mm of moss and rootlets. The permafrost conditions have been described in detail in Section 3.4, below. The depth of excavation in these test pits was limited to 0.7 and 0.5 meters, respectively, due to the frozen nature of the deposits.

Backfilling test pit TP 1-19.

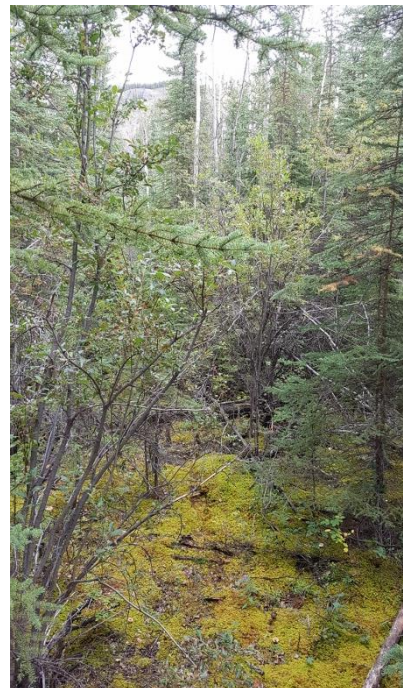
The presence of permafrost in Area C (Figure 3) is likely due to the proximity to the steep slope which is located within the sites eastern realms which limits the available amount of sunlight. The extent to which the shade may have promoted permafrost formation in Area B is unknown however portions of this region exhibits hummocky terrain and areas of thick organic moss cover which are an indication of permafrost.

Area B site conditions.

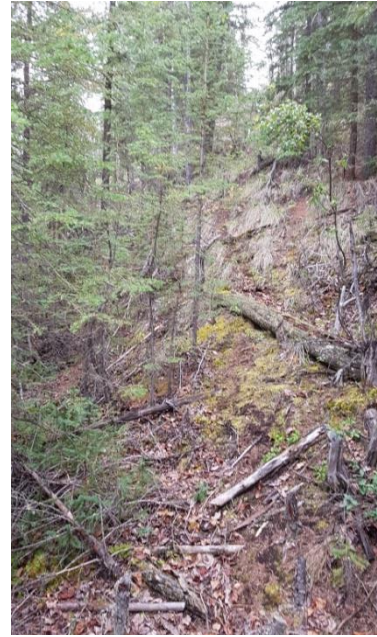
The southeastern slope measures in the order of 20 meters in height and is likely comprised of glaciofluvial ice stagnation complex deposits. The surficial geology map (*GSC Map 1879A*) classified these deposits as being

Southeastern slope conditions.

commonly comprised of a poorly to moderately sorted sand and gravel diamicton which was deposited during equilibrium phases of glacial retreat. They can contain cobble to boulder sized materials and minor amounts of silt and clay.

In brief, while there were minor indications of creep along the southeastern slope as evidenced by intermittent tree trunk and willow stalk deformation, neither of the slope exhibited any indication of slope movement which would be cause for concern.

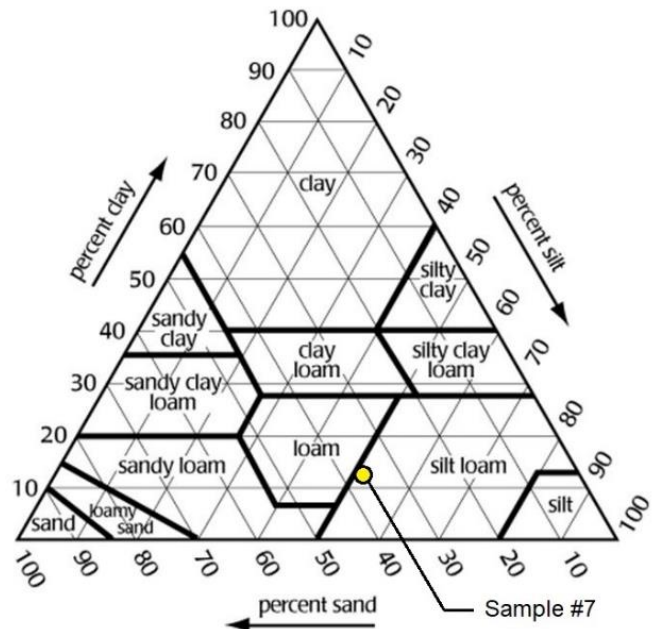
The sample was subsequently plotted on the *Soil Texture Classification Triangle* as noted in the figure, right;

Relative to the *Province of Manitoba – Onsite Wastewater Management Systems Program*, the soil sample was classified as being suitable for traditional subsurface systems. However, as the Atterberg limit analysis of the sample indicated that it exhibits slight plasticity, these soils will not likely allow for adequate percolation rates. In addition, as the presence of shallow groundwater was identified, the conditions in the study area may not be suitable to allow for septic field installation as the groundwater would be considered a nearby underlying confining layer.

Given the variability in the soils which were encountered and as required by *Yukon Health and Social Services*, site-specific assessments would need to be conducted at the time of individual lot development through percolation testing to verify the suitability of the anticipated accepting soils relative to *YG – Design Specifications for Sewage Disposal Systems*.

As the soil types and subsurface conditions will likely prevent traditional septic field construction, the use of insulated holding tanks or else raised septic fields may be required if lot/subdivision development is deemed feasible.

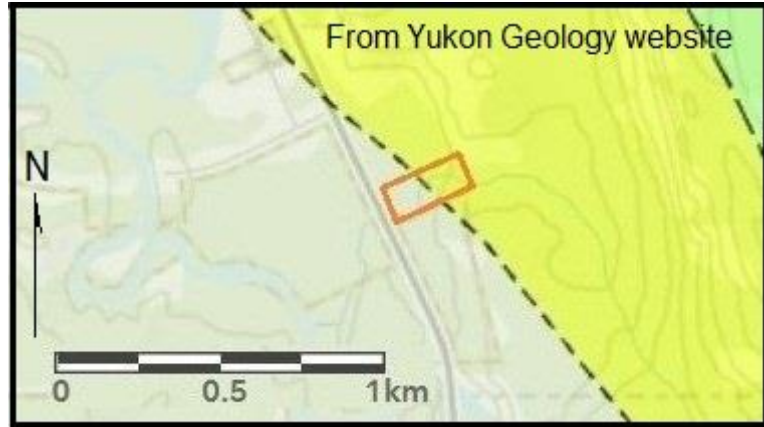
Additional consideration may be required relative the presence of an unclassified fault which bisects the central regions of the study area. The approximate location of this fault was identified in the *Yukon Geology* website as noted right;

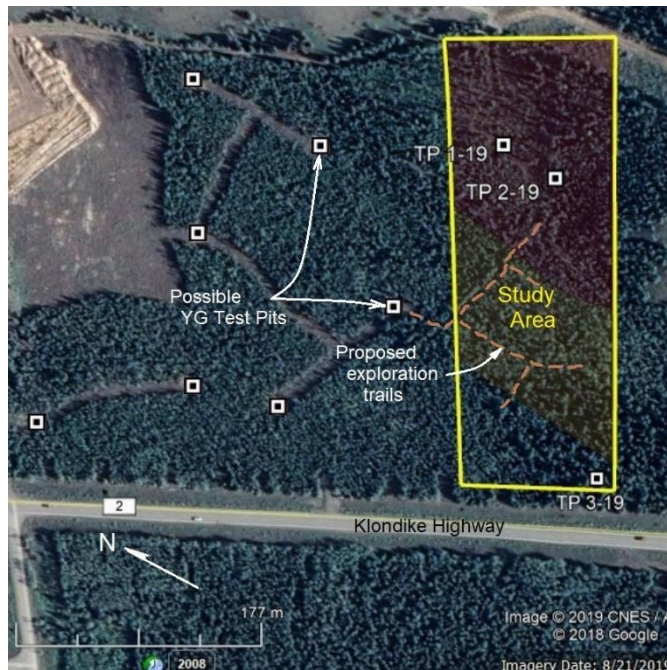
New *Google Earth* satellite imagery dated August 21st, 2019 suggest that nearby test pits (in *YG* - Disposition No.900101), which may have been recently excavated by *YG* – *Department of Highways and Public Works*, are located north of the site as illustrated in the imagery noted, right.

These test pit soil logs should be reviewed to further characterize the regional soil conditions.

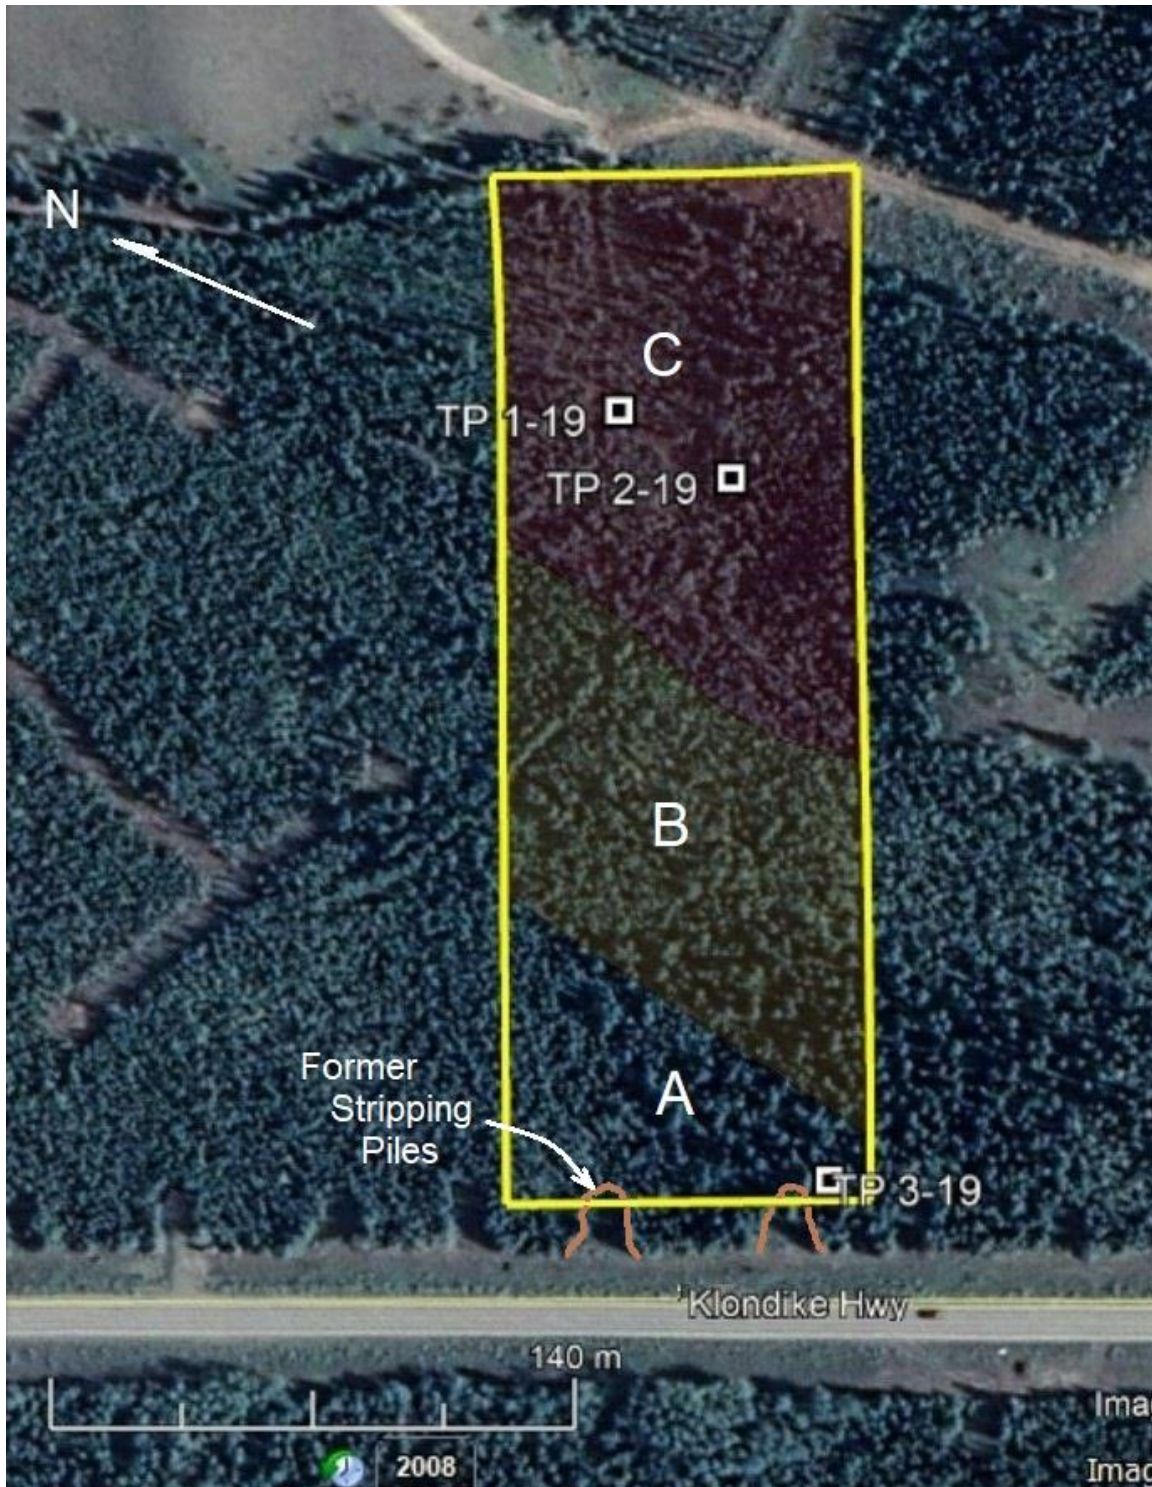
Figure 3 – Development Potential & Test Pit Locations

The work consisted of excavating three (3) test pits (TP 1-19 through TP 3-19) which were excavated at the approximate locations noted in Figure 3.

A series of stripping/grubbing piles, which are remnants from construction of Klondike Highway #2, are located along the western periphery of the site (as illustrated in Figure 3).

The development potential of the site is limited. At this stage, based upon the soil conditions which were encountered in test pit TP 3-19, it appears the western region of the site could be developed in Area A (Figure 3). However, further geotechnical evaluation would be required to determine the degree to which these thawed soil deposits extend towards the east as permafrost (which would preclude development) was encountered in Area C. The presence of the steep slopes located within the sites eastern and southeastern realms limits the amount of sunlight available to the central regions (Area B) of the study area and so the permafrost may extend into this region.

Further geotechnical evaluation would be required to better assess the study area to verify whether or not the western and central regions (Figure 3 – Areas A & B) will be suitable to allow for subdivision/lot development. The intent should be to delineate the approximate limits/distribution of the permafrost which was encountered and further characterize the depositional setting relative to the ancient/historical drainage course which appears to have flowed through the study area. Detailed foundation recommendation would need to be formulated based upon these soil and subsurface conditions. The results of the test pits, which may have been recently excavated by YG

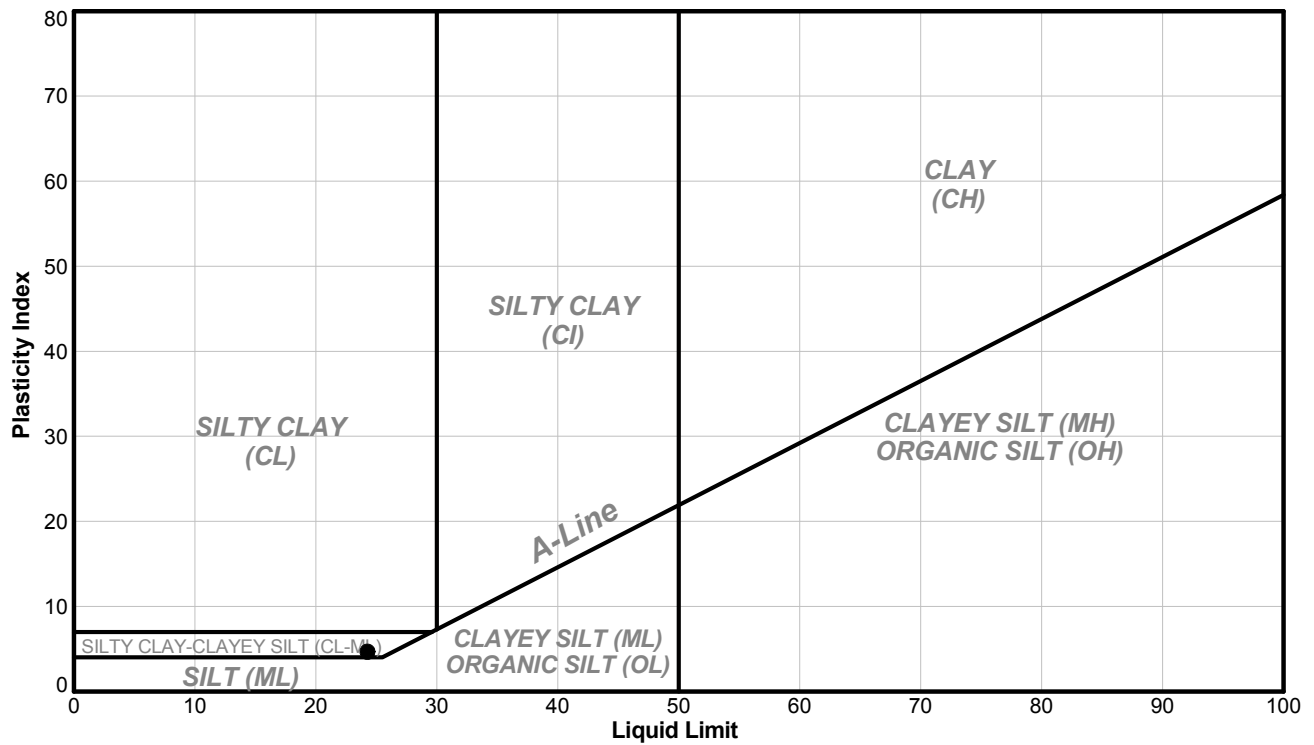
PLASTICITY CHART

Sym.	Sample Location	Sample / Specimen Number	Depth (m)	Bottom (m)	Percent Passing #40 Sieve (%)	Liquid Limit	Plastic Limit	Plasticity Index	Natural Water Content (%)	Liquidity Index
●	Industrial Site #2	TP3-19 - SA7	0.00	0.00	100	24	20	4.0	16.0	-1.0

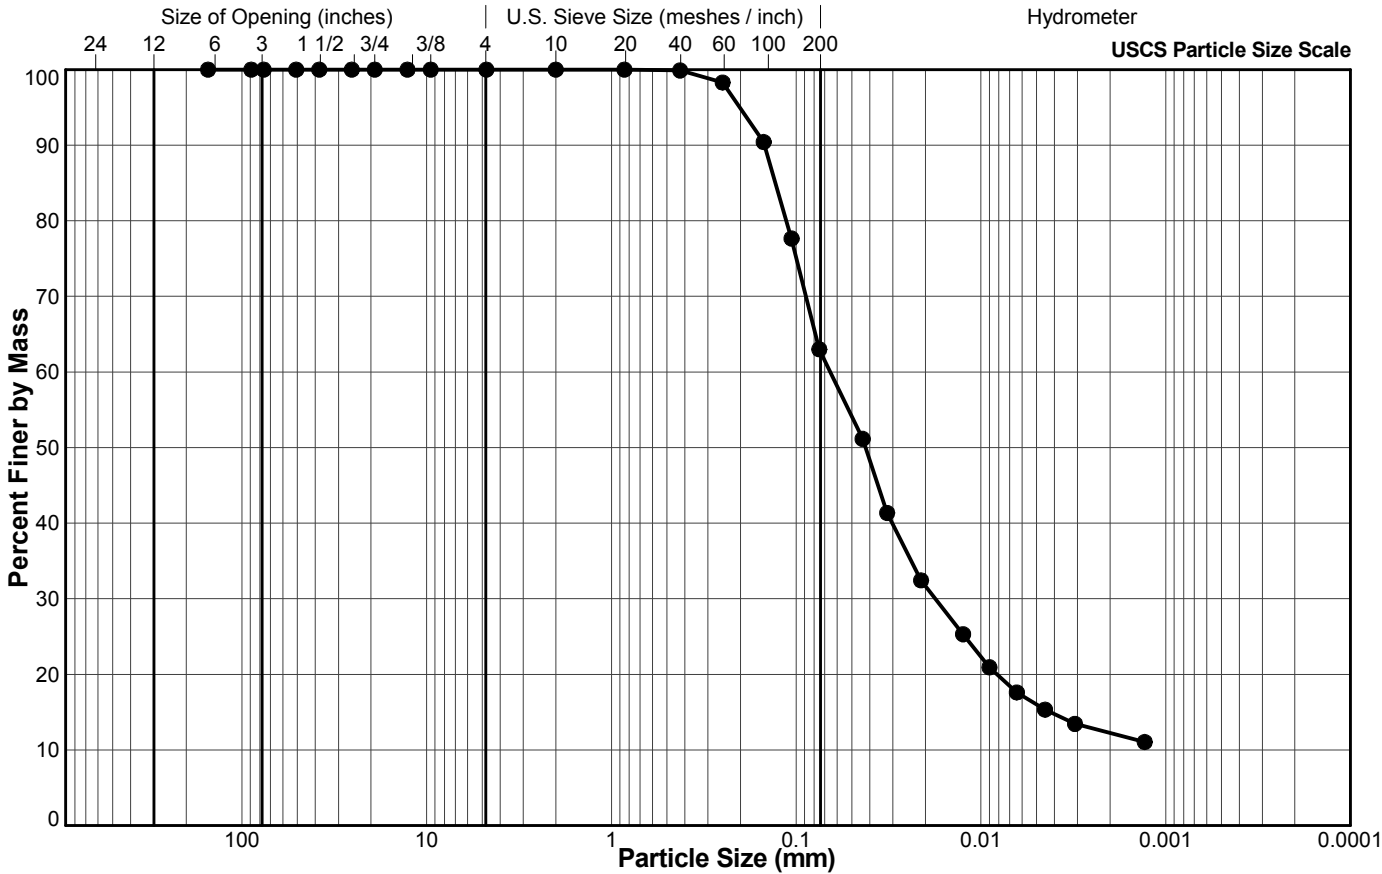
Sample Location: Industrial Site #2
Sample No.: TP3-19 - SA7
Depth (m): 2.0
Lab Schedule No.: B19-275

Sieve Size (USS)	Particle Size (mm)	Percent Passing
6"	152.4	100.0
3.5"	88.9	100.0
3"	76.2	100.0
2"	50.8	100.0
1 1/2"	38.1	100.0
1"	25.4	100.0
3/4"	19.1	100.0
1/2"	12.7	100.0
3/8"	9.5	100.0
#4 US MESH	4.75	100.0
#10 US MESH	2	100.0
#20 US MESH	0.85	100.0
#40 US MESH	0.425	99.9
#60 US MESH	0.25	98.3
#100 US MESH	0.15	90.4
#140 US MESH	0.106	77.7
#200 US MESH	0.075	63.0
	0.0437	51.2
	0.0322	41.3
	0.0211	32.4
	0.0125	25.3
	0.0090	20.9
	0.0064	17.6
	0.0045	15.3
	0.0031	13.4
	0.0013	11.0
