**Geotechnical Evaluation
Proposed Urban Lot #15 (CLSR 55659)
Carmacks, Yukon – 2019**

Prepared For: Yukon Government

Date : October 9th, 2019

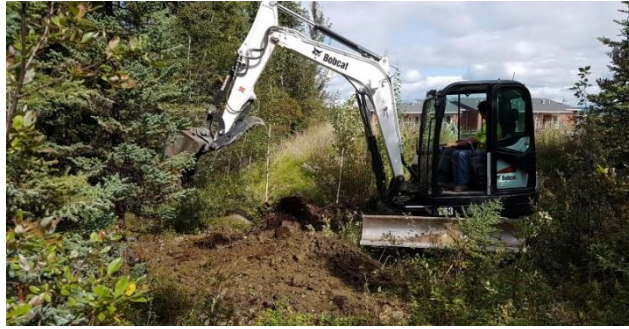
The test pits were backfilled with the excavation spoils approximately fifteen (15) minutes following completion of excavation to allow for a period of time to assess sidewall stability and potential groundwater seepage/recharge rates. The surficial organic cover, which was stockpiled separately from the excavation spoils, was subsequently utilized to cap the backfill to reduce the potential for soil erosion and promote re-vegetation.

Backfilling test pit TP 3-19.

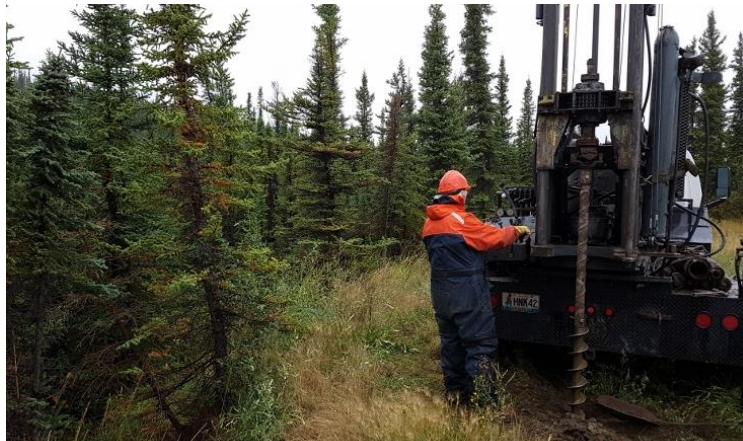
The drilling program was comprised of advancing two (2) boreholes (BH 1-19 and BH 2-19) at the approximate locations noted in Figure 3. While borehole BH 1-19 was advanced to a depth of 9.14 meters utilizing 150 mm Ø continuous flight solid-stem augers, the second borehole, BH 2-19, was advanced to a depth of 7.62 meters utilizing 200 mm Ø continuous flight hollow-stem augers. As each of these boreholes were advanced through surficial fills, these depths equate to approximately 7.54 and 6.12 meters below the prevailing original ground surface.

Drilling borehole BH 1-19.

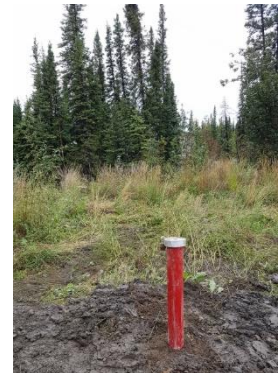
The lower 5.33 meters of the well was screened and covered with a silt sock (to minimize the influx of fines and extend the life of the well). The annular space was backfilled with an imported filter sand (conforming to NSF/ANSI 61 standards). The exception to this was the region ~0.5 meters above the screened portion of the pipe where bentonite was used to seal the annular space to the ground surface in accordance with good well installation practices. Access to

Borehole BH 2-19 well.

Measurements of a groundwater monitoring well which was installed in borehole BH 2-19 (to a depth of ~7.11 meters) revealed groundwater was located 3.02 meters below the adjacent ground surface. Considering the presence of approximate 1.5 meters of fill which overlay the site at this location, the depth of the groundwater relative to the prevailing original ground surface equates to approximately 1.5 meters.

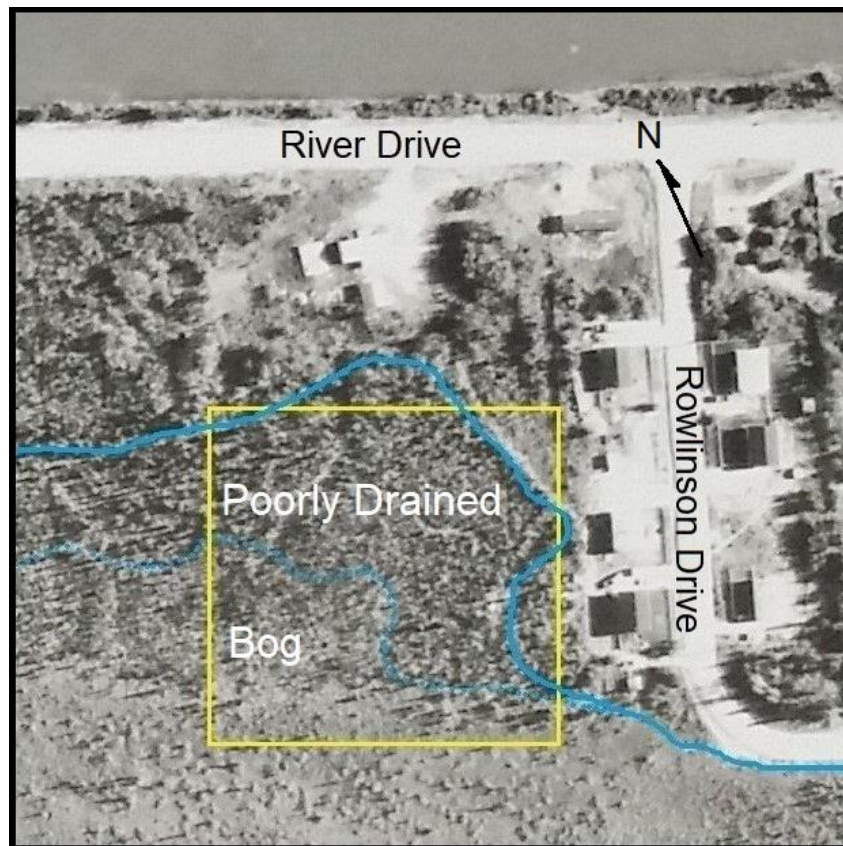
Based upon additional airphoto analysis and our field observations, it appears a bog is present within the southern realms of the lot. Poorly drained soils dominate the remainder of the lot. The approximate distribution of this terrain has been illustrated in the 1986 airphoto attached below.

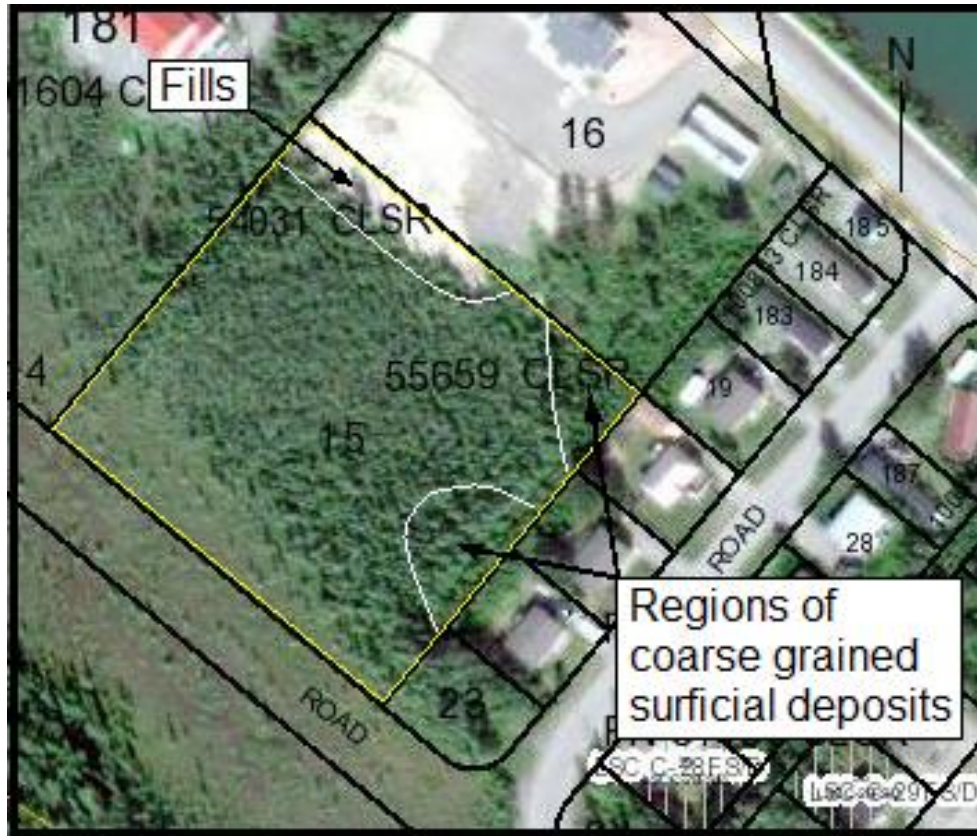
There were two regions located in the eastern realms of the study area (Areas A – Figure 3) where it appears coarser grained surficial deposits overlies the gravels. These coarse-grained deposits are likely similar in composition to the fills which cover the northern periphery of the study area. The approximate distribution of the coarse-grained surficial deposits and fills have been illustrated in the figure, below;

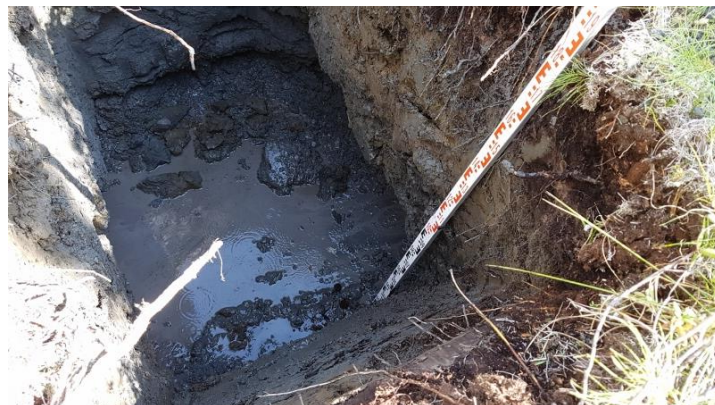
The groundwater appeared to be encountered at progressively shallower depths towards the southern limits of the site where a poorly drained (bog) region is located.

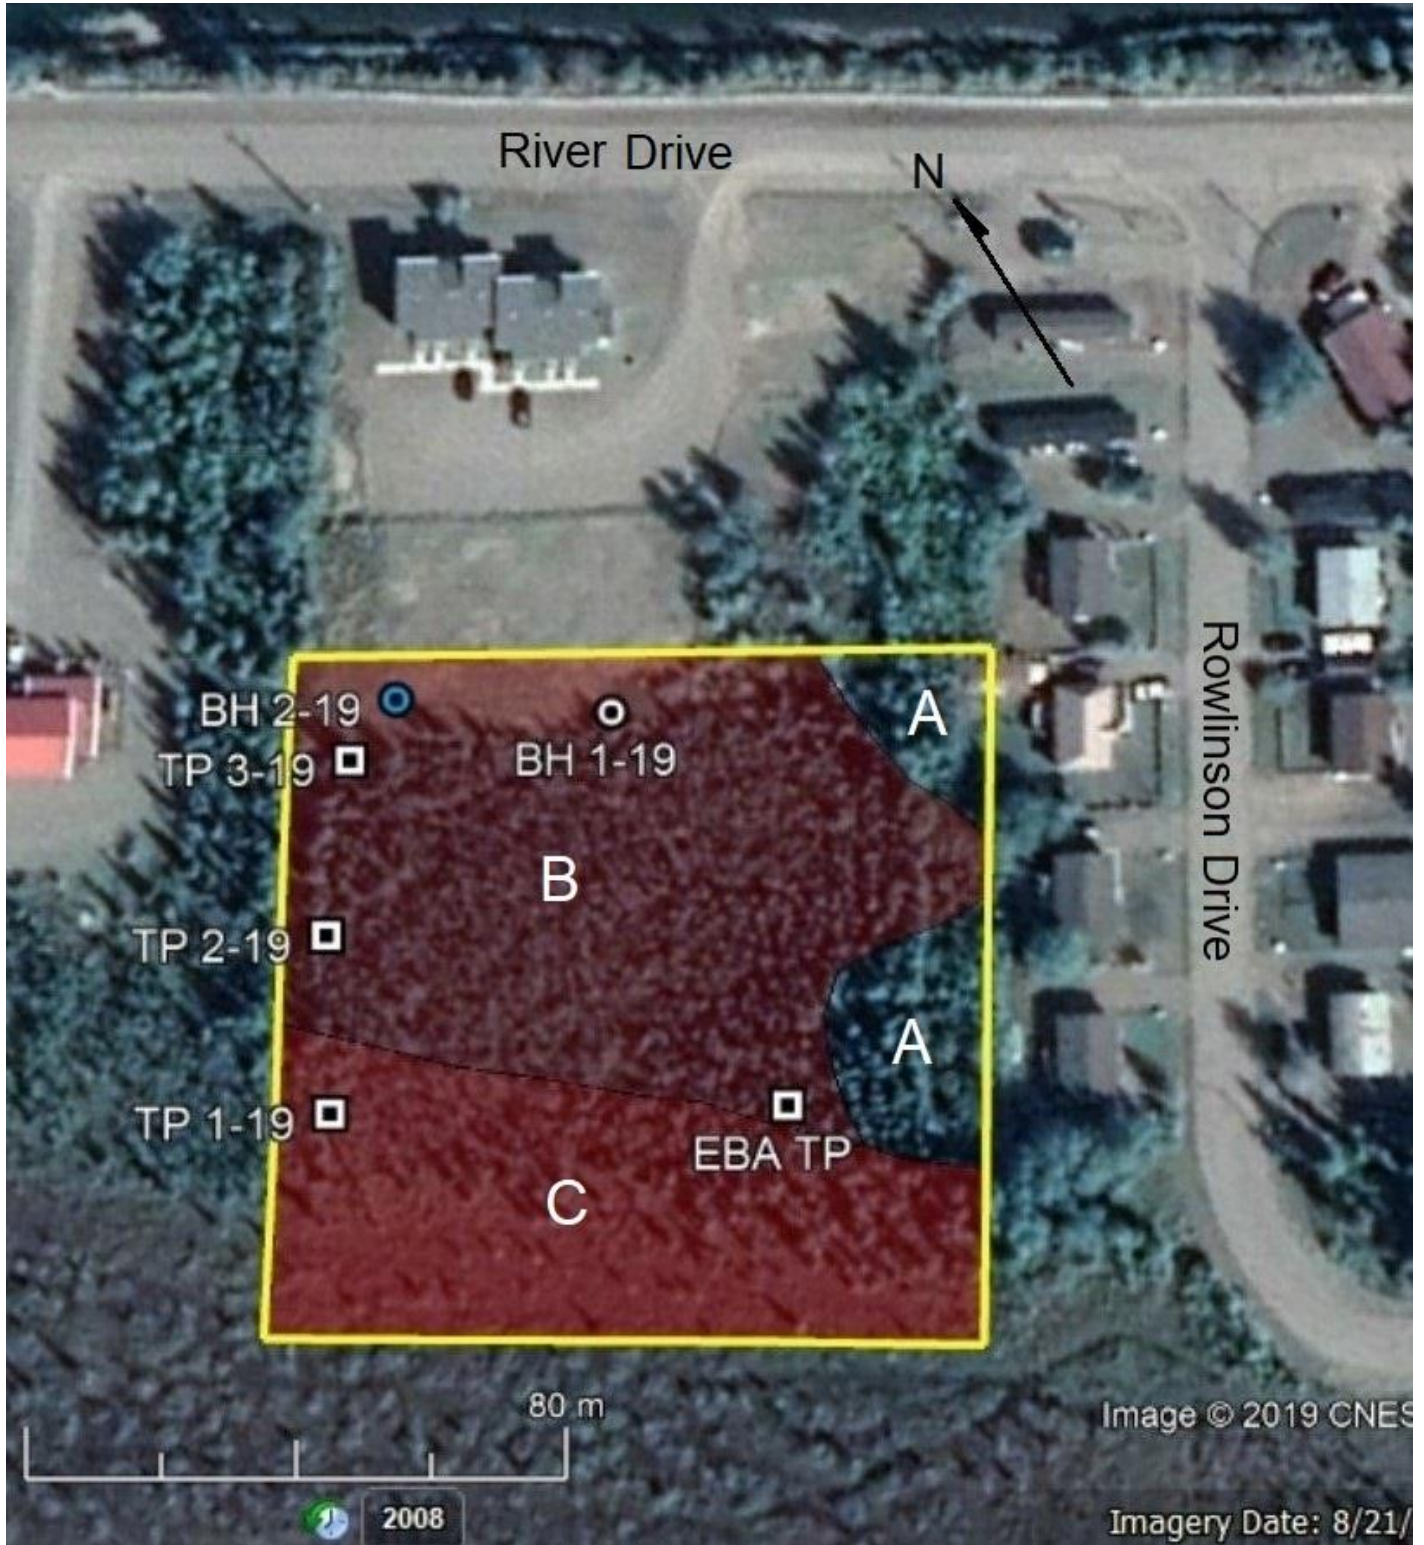
Figure 3 – Site Conditions, Test Pit & Borehole Locations

Base map from *Google Earth*- Not to Scale – Locations are approximate
Compiled by T.Dhara, P.Eng. - Sept.10th, 2019

The work consisted of excavating three (3) test pits (TP 1-19 through TP 3-19) which were excavated at the approximate locations noted in Figure 3.

As the soil conditions in Area A (Figure 3) are anticipated to be comprised of silty sandy gravels, these soils may also need to be removed as they may have poor engineering properties relative to lot development.

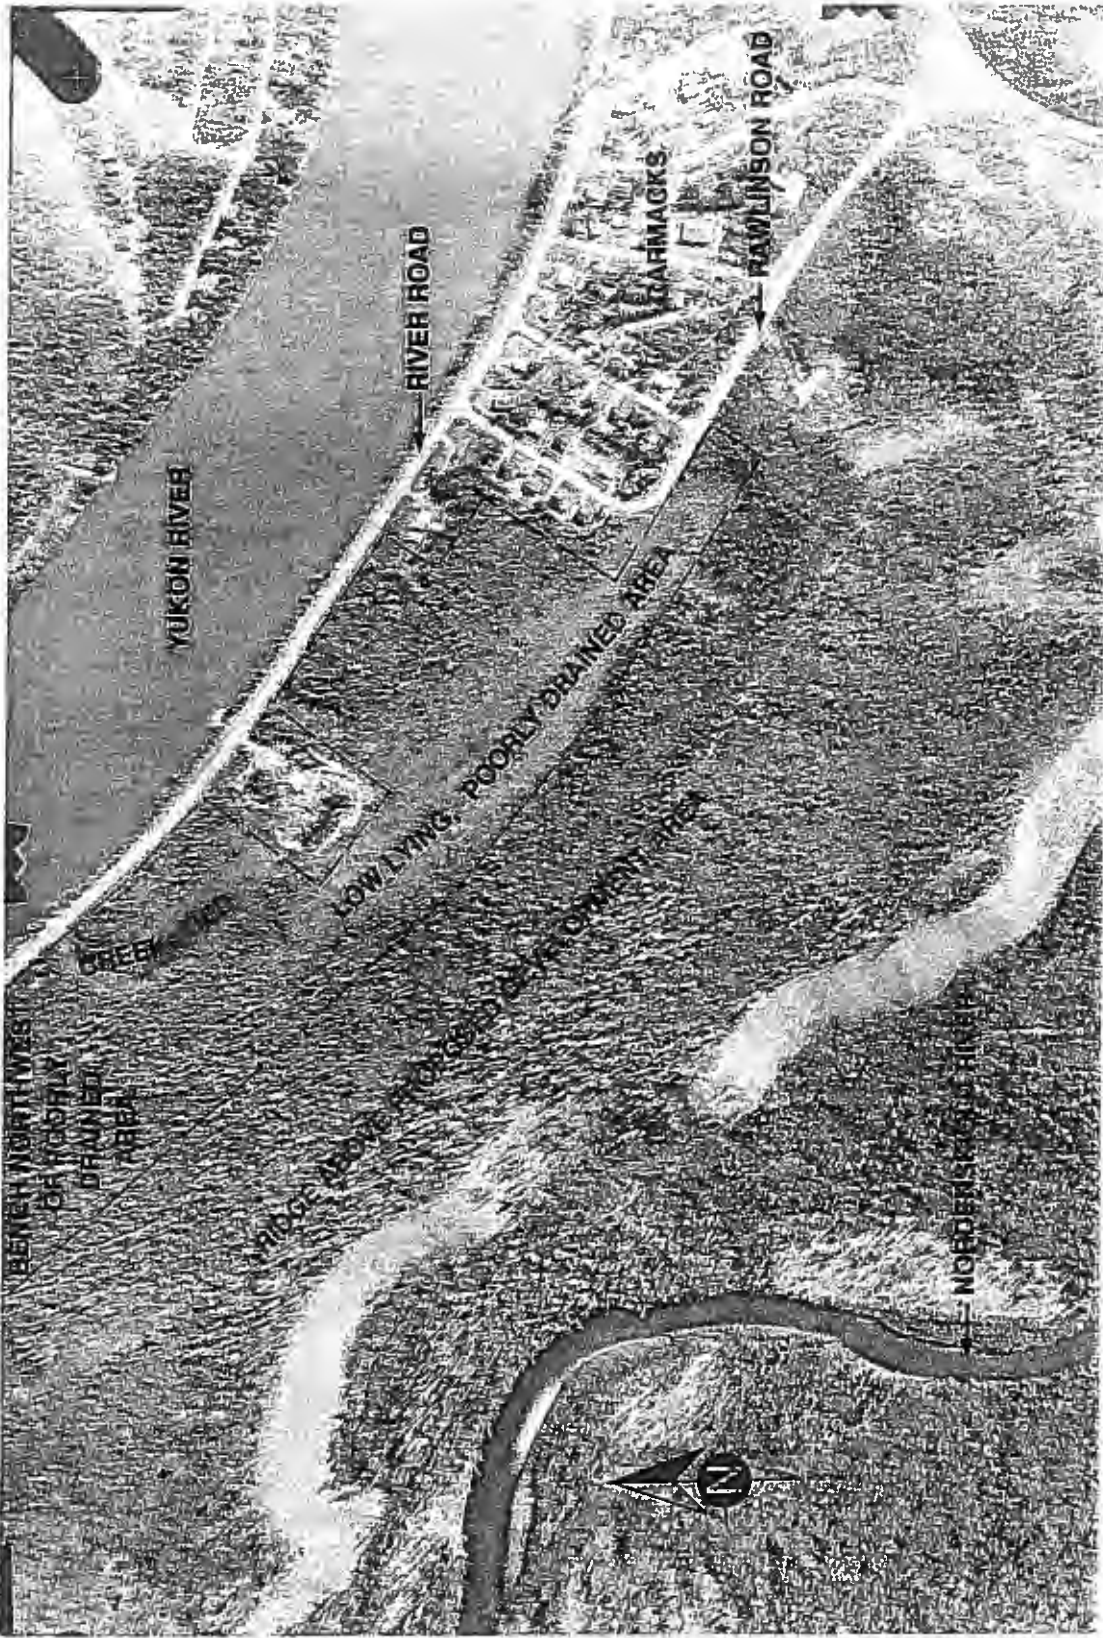
Figure 2, following, presents the various terrain features noted during air photo interpretation and the site investigation.

Generally, the subject site runs in a northwesterly direction. The physical boundaries of the site are River Road and the Yukon River at the front of the study area and the north facing toe of the ridge separating the Yukon and Nordenskiold Rivers at the back of the study area. The back half of the study area is quite typical of permafrost areas in the Yukon (characterized by the presence of thick moss ground cover and sparse, dwarf black spruce tree cover). Soil conditions in this portion of the subject site consist of up to a metre of ice rich permafrost over unfrozen but wet silts. Granular soils (gravel and sand) were noted below the silt. Groundwater was noted in each of the three testpits (TP's 1, 2 & 3) excavated in this portion of the study area. At the time of the investigation, significant glaciation of the ground surface was also noted. As well, on the airphotos utilized for this study, surface water was noted within the bermed area at the back of the developed portion of lot owned by Carl Scanlon.

The northwest end of the study area (numbered as Lot 32 on the Zoning Map included in the Inukshuk planning report) is an elevated bench. Soil conditions in this area are comprised of up to 1.0 m of silt over granular soils. This area is covered with mature spruce and poplars and appears to be well drained.

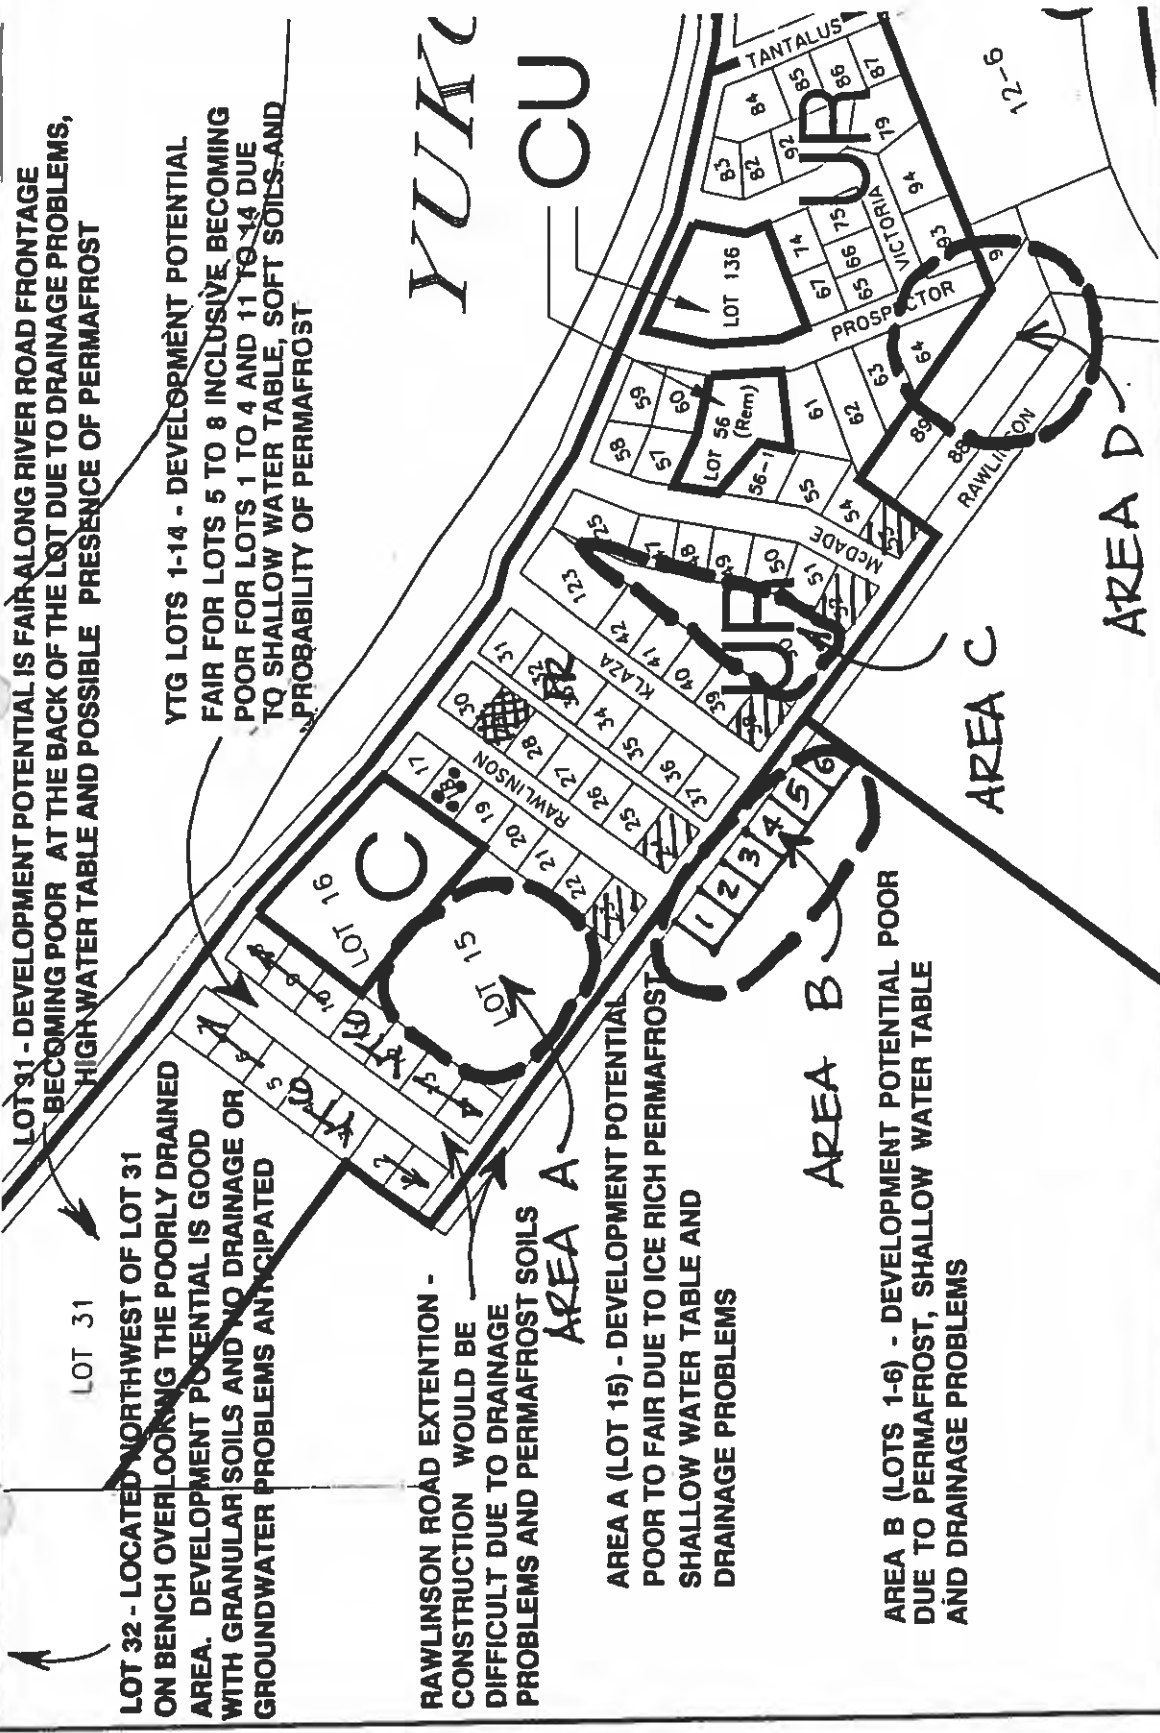
LOT 31 - DEVELOPMENT POTENTIAL IS FAIR ALONG RIVER ROAD FRONTAGE BECOMING POOR AT THE BACK OF THE LOT DUE TO DRAINAGE PROBLEMS, HIGH WATER TABLE AND POSSIBLE PRESENCE OF PERMAFROST

LOT 32 - LOCATED NORTHWEST OF LOT 31 ON BENCH OVERLOOKING THE POORLY DRAINED AREA. DEVELOPMENT POTENTIAL IS GOOD WITH GRANULAR SOILS AND NO DRAINAGE OR GROUNDWATER PROBLEMS ANTICIPATED

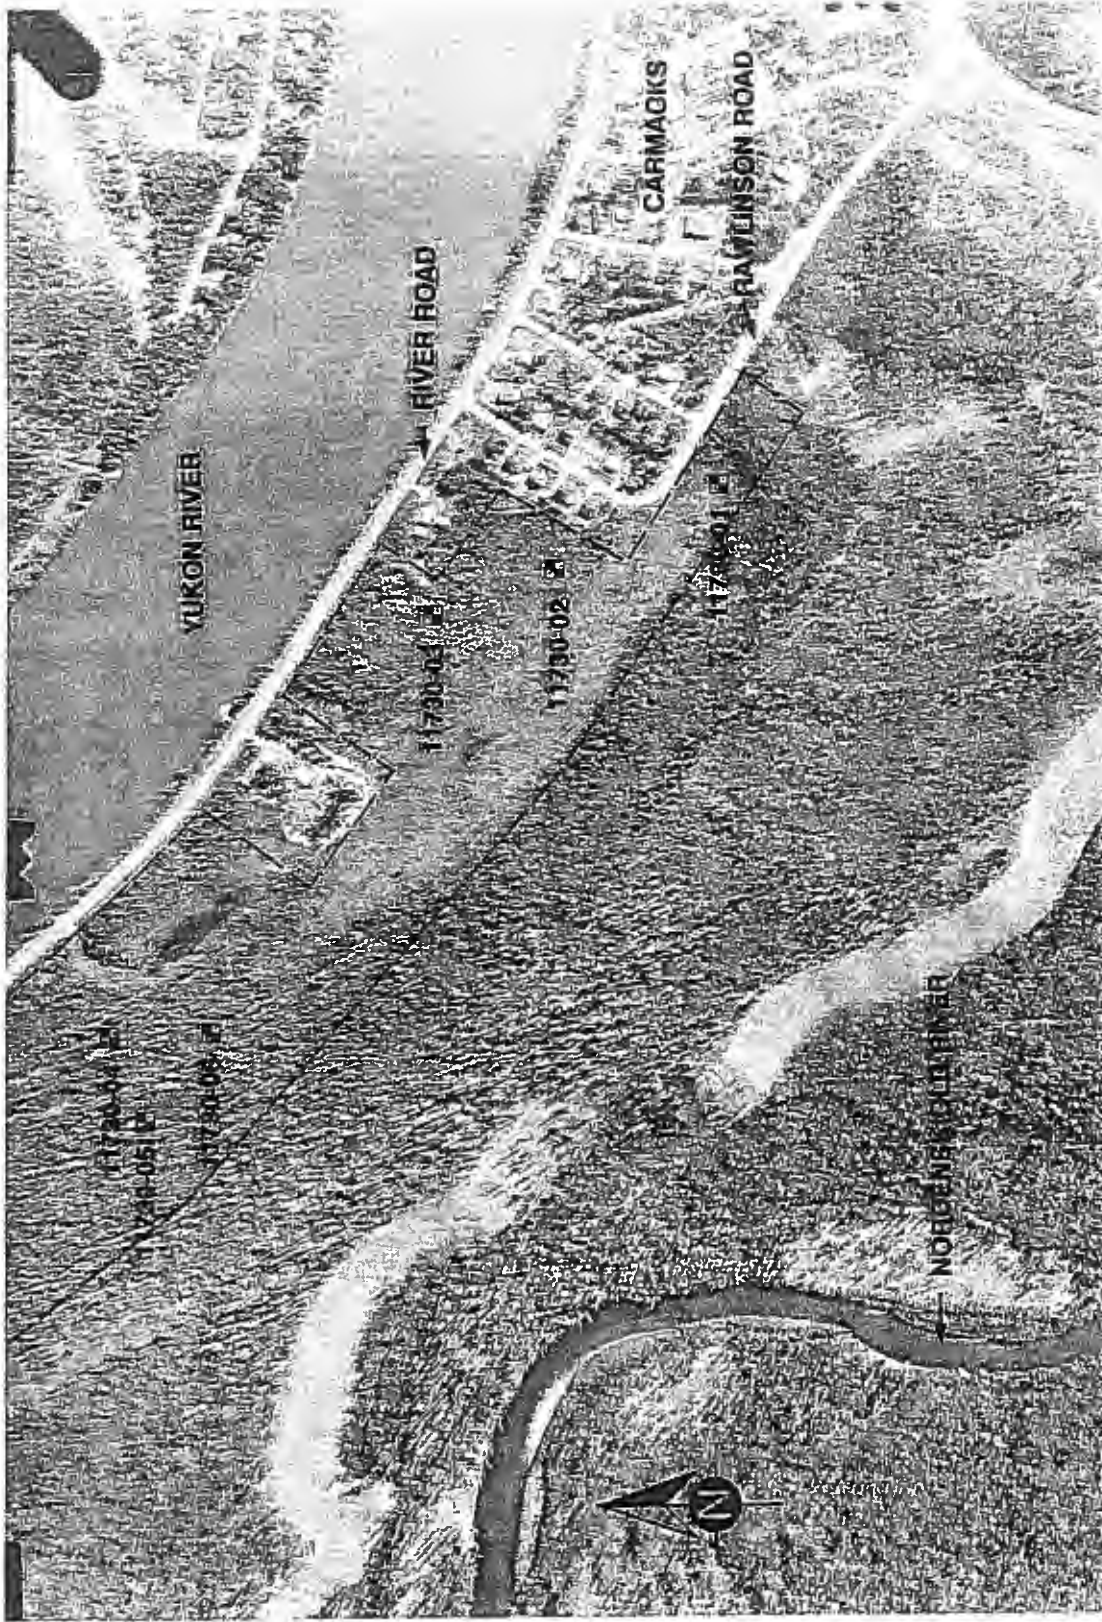
11730-A-01

Detailed soils information is presented on the testpit logs and the location of each of the six testpits is presented on Drawing 11730-A-01, attached to this letter.

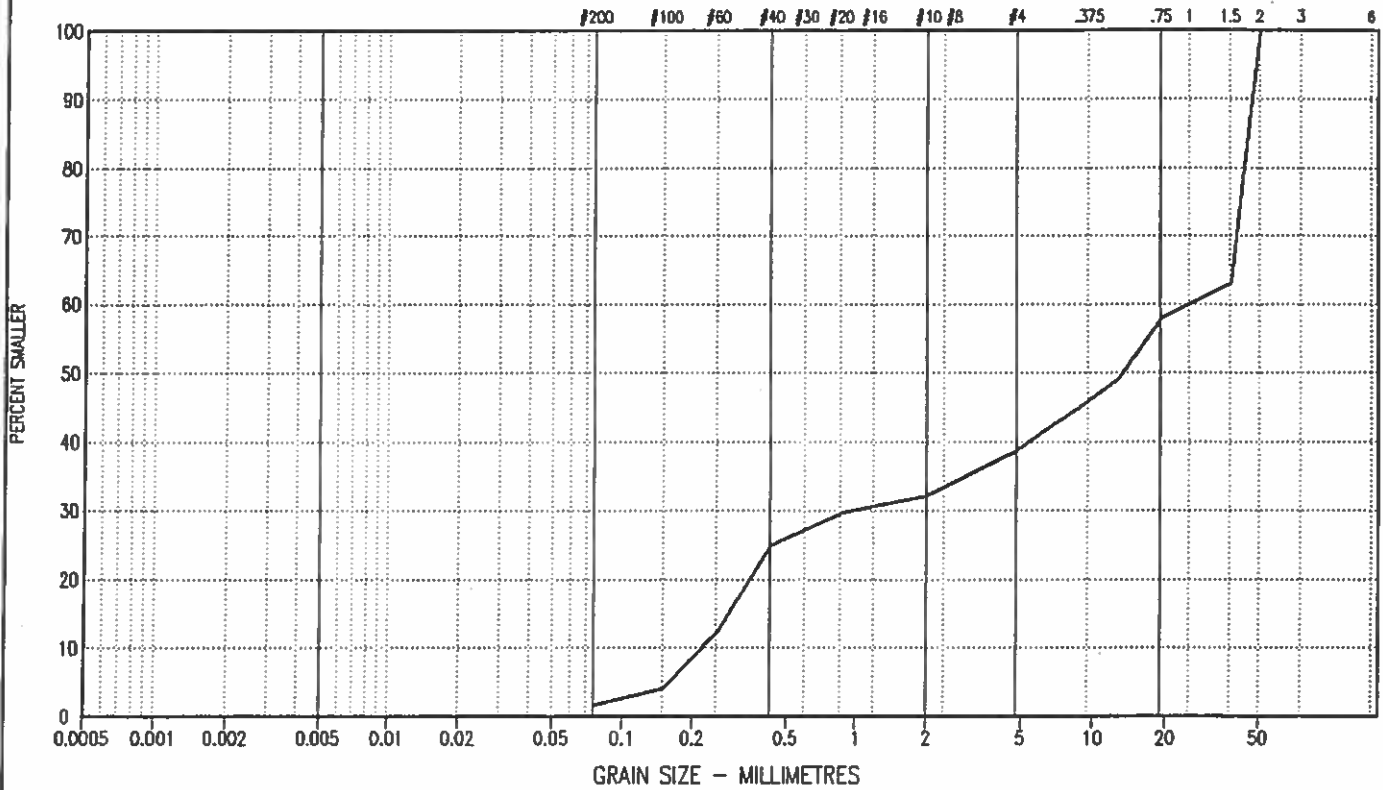
SYMBOL	BOREHOLE NUMBER	DEPTH (m)	DESCRIPTION			Cu	Cc	U.S.C
			CLAY & SILT %	SAND %	GRAVEL %			
—	11730-01	2.00 - 2.20	1.5	37.1	61.4	121.8	0.2	GP

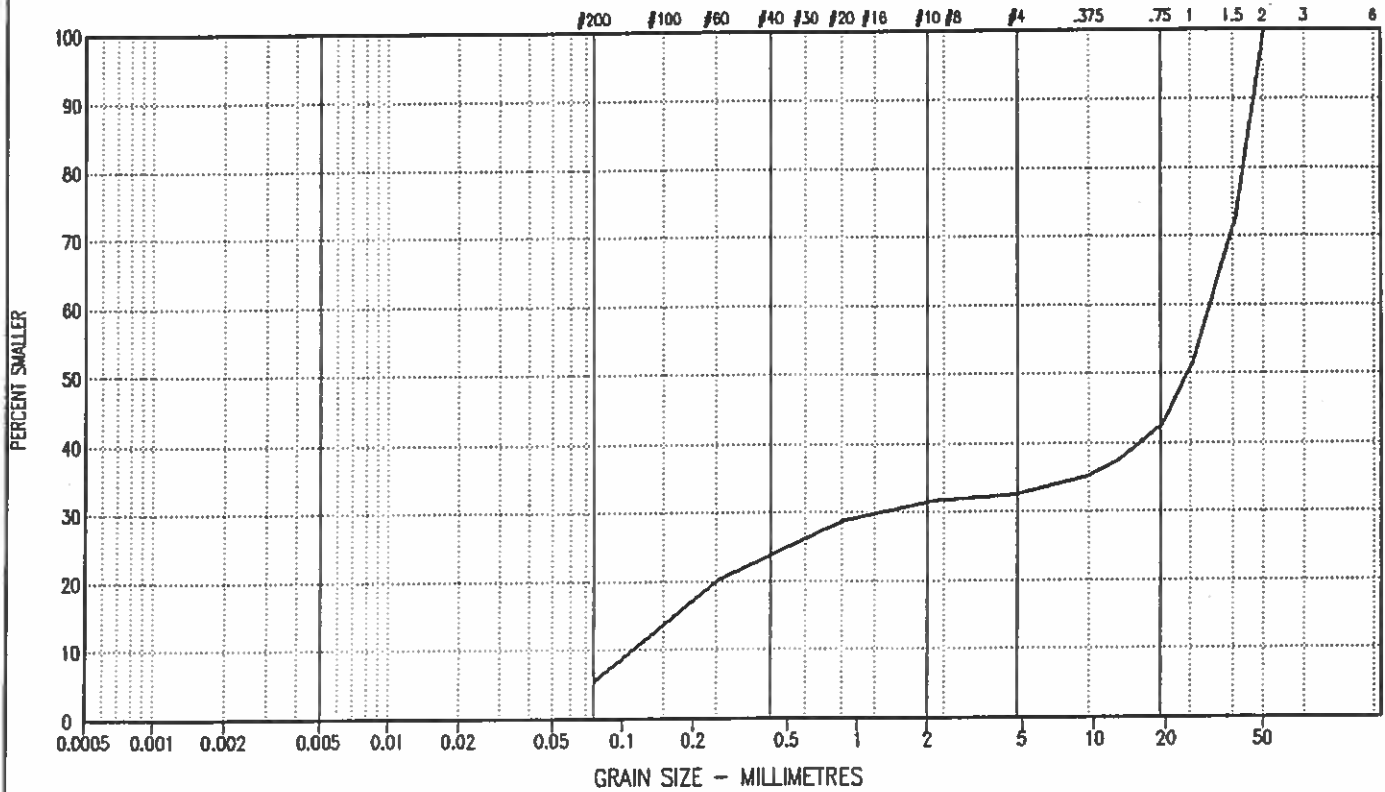
SYMBOL	BOREHOLE NUMBER	DEPTH (m)	DESCRIPTION			Cu	Cc	U.S.C
			CLAY & SILT %	SAND %	GRAVEL %			
—	11730-02	3.00 - 3.20	5.3	27.2	67.5	260.2	0.6	GP-GM

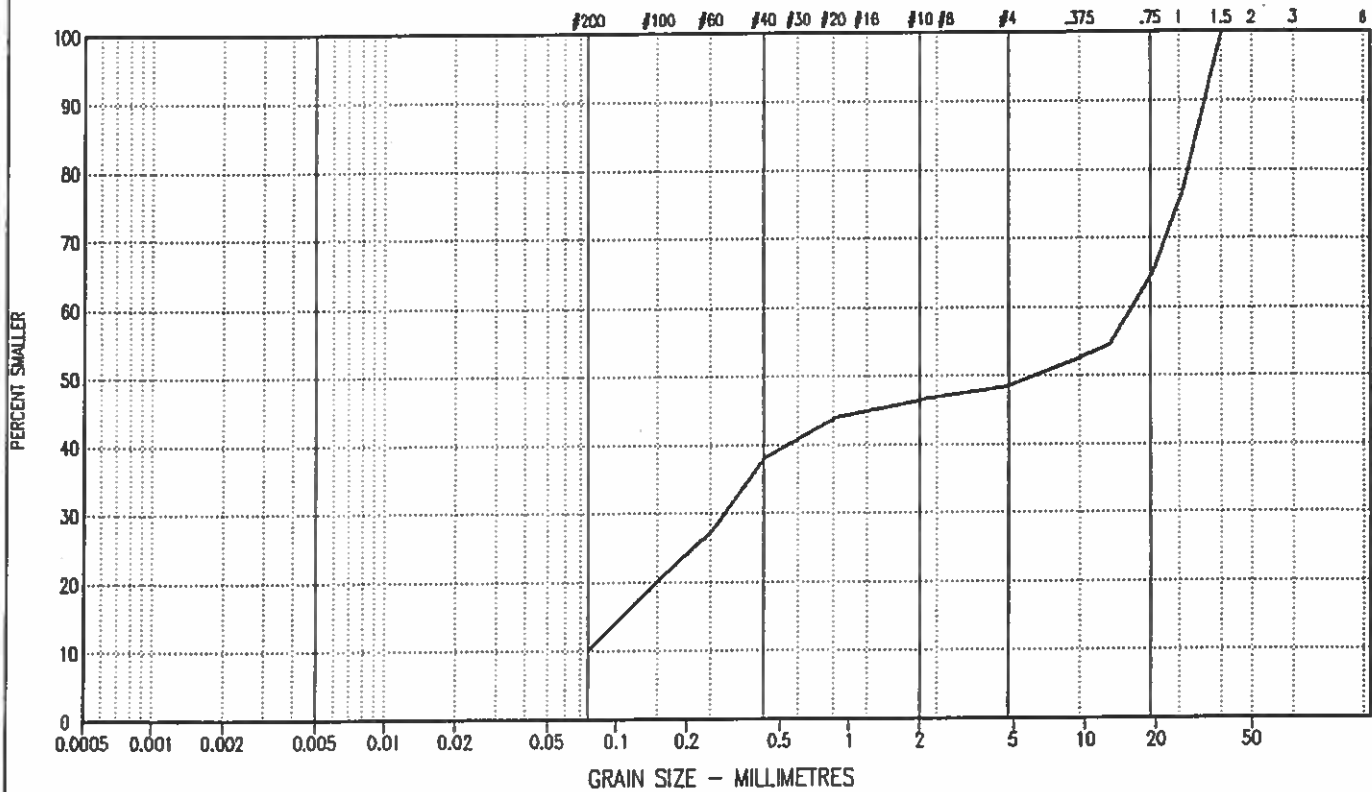
SYMBOL	BOREHOLE NUMBER	DEPTH (m)	DESCRIPTION			Cu	Cc	U.S.C
			CLAY & SILT %	SAND %	GRAVEL %			
—	11730-03	2.00 - 2.20	10.0	38.3	51.7	216.1	0.1	GP-GM

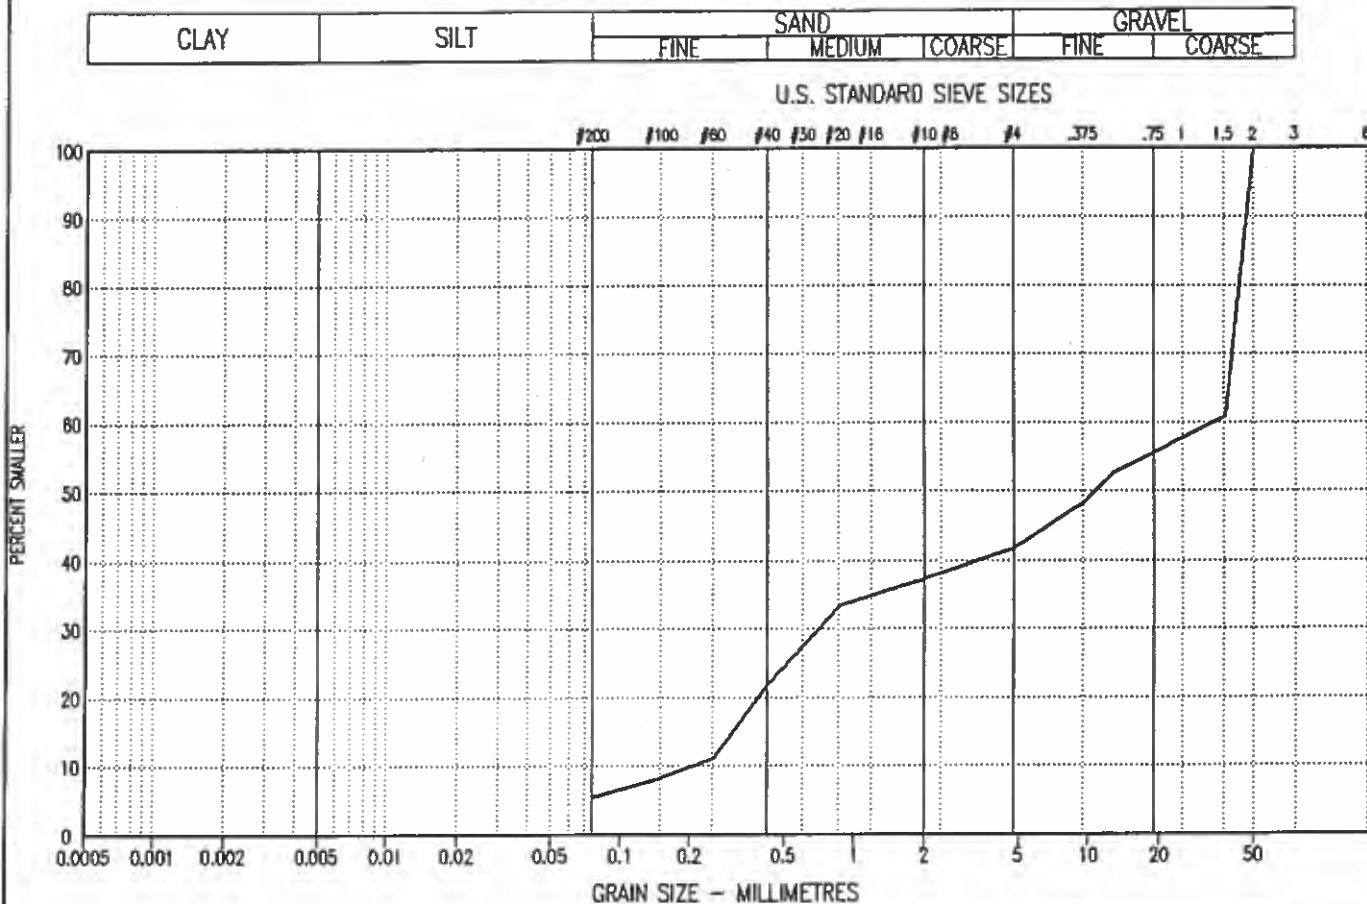
SYMBOL	BOREHOLE NUMBER	DEPTH (m)	DESCRIPTION			Cu	Cc	U.S.C
			CLAY & SILT %	SAND %	GRAVEL %			
—	11730-04	2.00 - 2.20	5.4	36.1	58.5	165.1	0.1	GP-GM

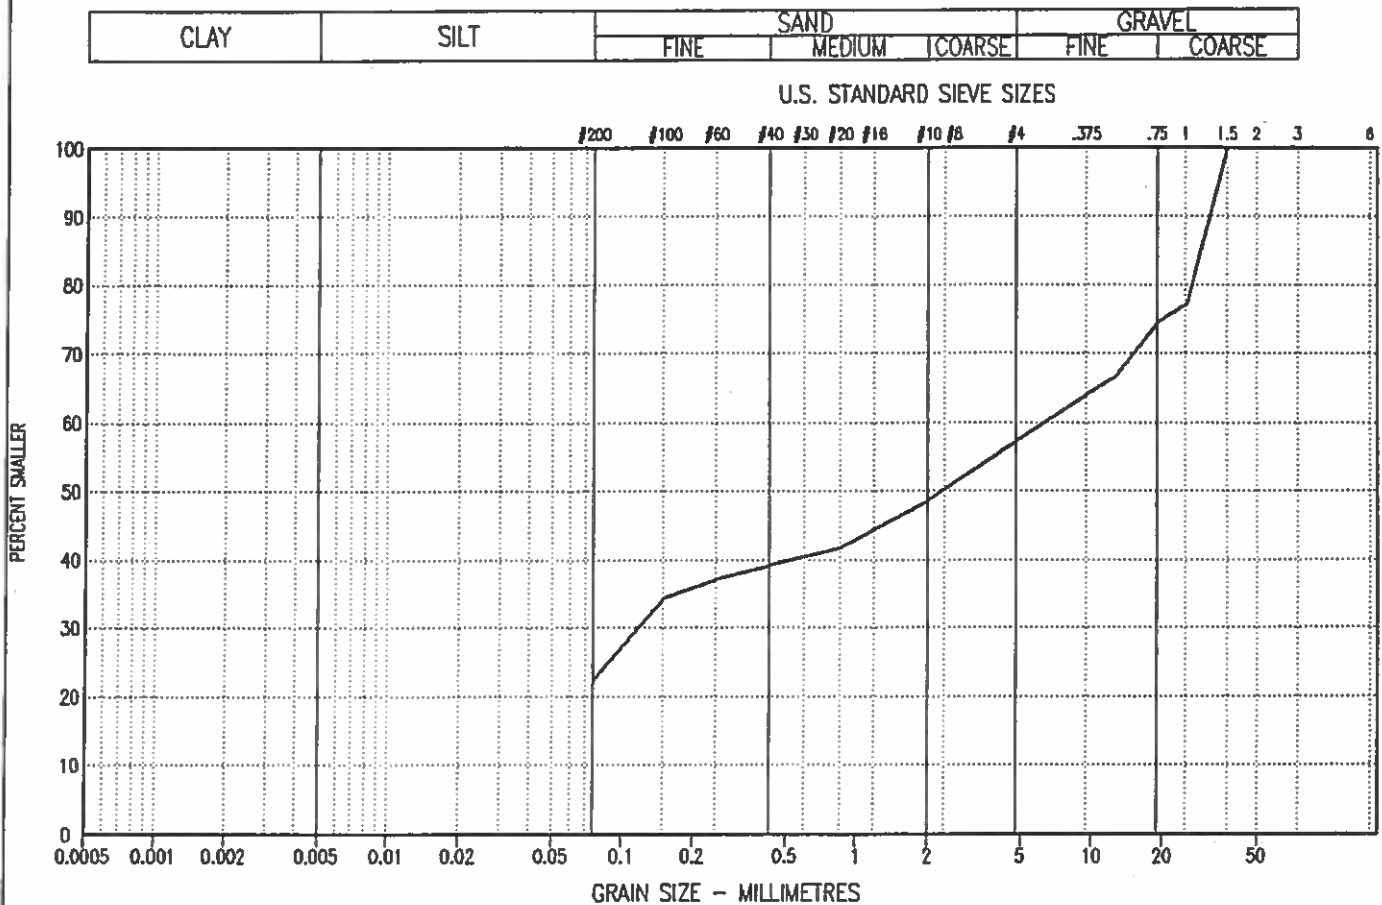
SYMBOL	BOREHOLE NUMBER	DEPTH (m)	DESCRIPTION			Cu	Cc	U.S.C
			CLAY & SILT %	SAND %	GRAVEL %			
	11730-05	1.00 - 1.20	22.3	34.7	43.0	202.4	0.1	GM

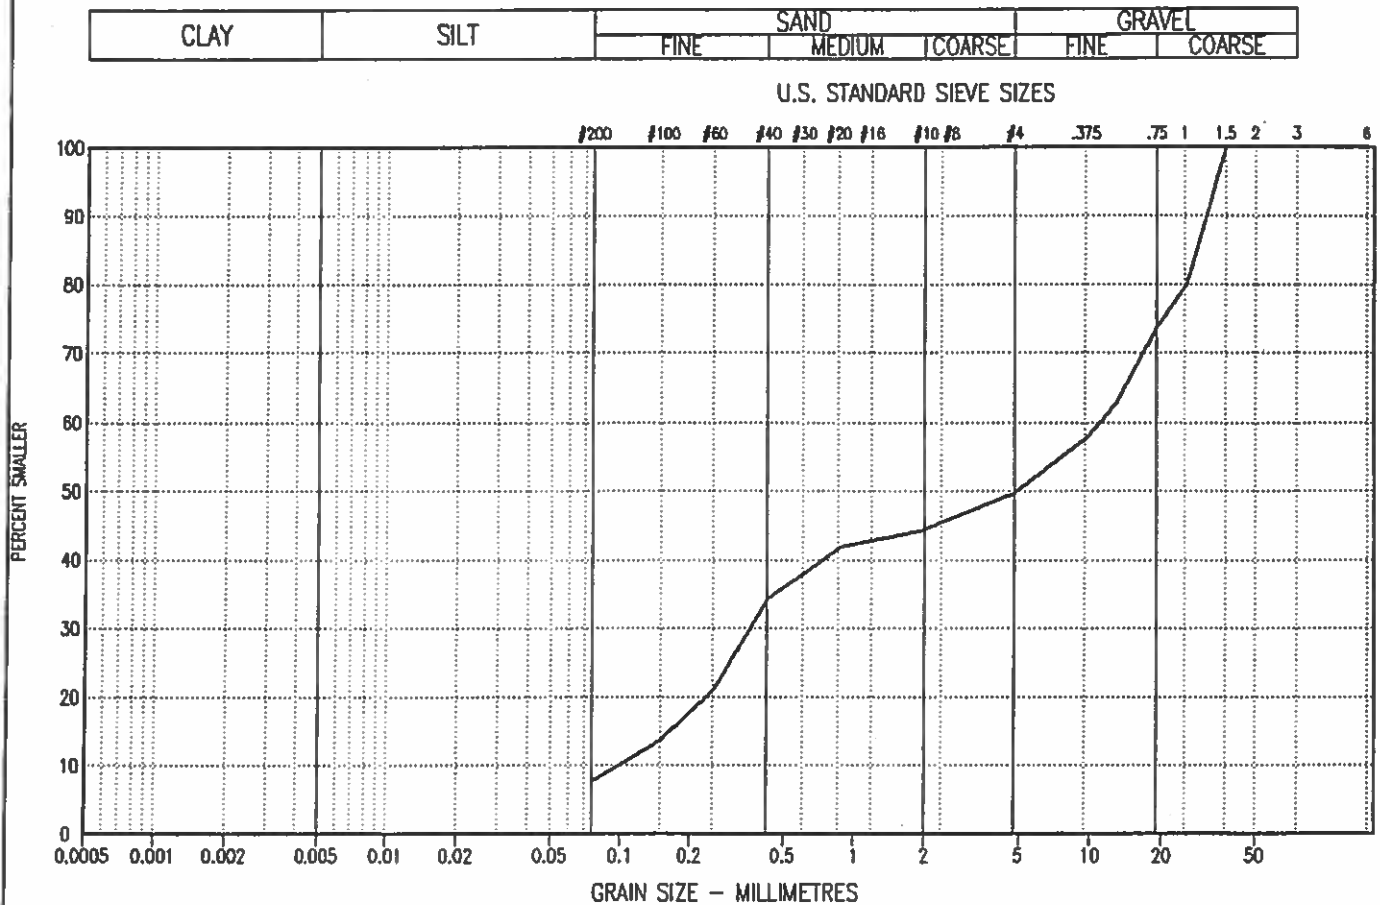
SYMBOL	BOREHOLE NUMBER	DEPTH (m)	DESCRIPTION			Cu	Cc	U.S.C
			CLAY & SILT %	SAND %	GRAVEL %			
---	11730-06	1.00 - 1.20	7.7	41.8	50.5	106.6	0.1	GP-GM

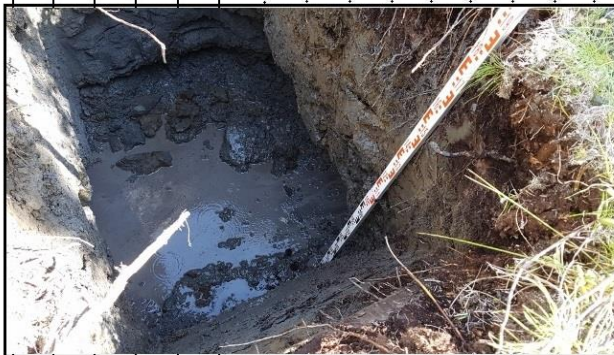
Elev. (m)	Depth		Stratigraphic Description	Field Sample					Laboratory Results (%)				USCS/NRC	Symbol	Depth (m)	
	ft	m		Type	Number	Temperature (degrees C)	Recovery %	Penetrometer (kg/cm2)	SPT 'N'	▲ - FINES	● - SAND MC	■ - GRAVEL				LL
			soft SURFICIAL ORGANICS & MOSS (300 mm)													
1			firm SANDY SILT - non-plastic, fine grained, rootlets to 0.6 m, brown some oxidation, orange-brown													
2	0.5															0.5
3		1.0														1.0
4			soft SILT trace SAND - non-plastic, fine grained, heavy oxidation, grey													
5	1.5															1.5
6			compact SANDY SILTY GRAVEL - fine to medium grained, poorly graded, cobbles in size to 150 mm, grey													
7	2.0		compact SANDY GRAVEL trace SILT - fine to medium grained, poorly graded, odd cobble in size to 150 mm, grey													
8		2.5														2.5
9																
10	3.0															3.0
11		3.5														3.5
12		4.0														4.0

Test Pit terminated @ 2.10 m below the ground surface.
 Groundwater encountered @ 1.2 m

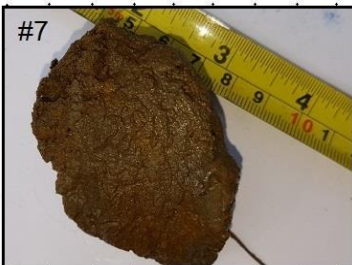
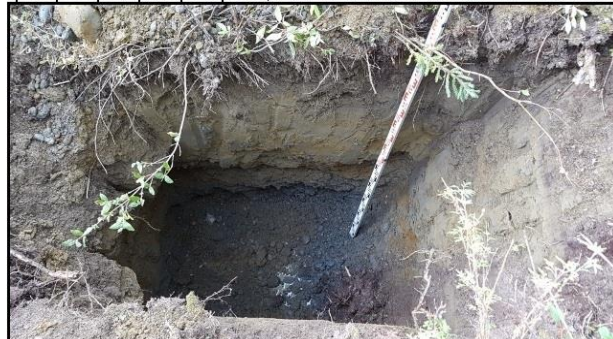
Elev. (m)	Depth		Stratigraphic Description	Field Sample					Laboratory Results (%)				USCS/NRC	Symbol	Depth (m)		
	ft	m		Type	Number	Temperature (degrees C)	Recovery %	Penetrometer (kg/cm2)	SPT 'N	▲ - FINES	● - SAND MC LL	■ - GRAVEL				PL	LL
			soft SURFICIAL ORGANICS & MOSS (200 mm)											ORG			
			firm SANDY SILT - non-plastic, fine grained, rootlets to 0.6 m, some oxidation, mottled orange-brown/grey	⊗	6	NA	NA	0.75	NA	21.4				ML	0.5		
			soft SILT trace SAND - non-plastic, fine grained, some oxidation, orange-brown	■	7	NA	NA	0.5	NA	22.8				ML	1.0		
			soft SILTY-CLAY to CLAYEY-SILT - slight plasticity, varved, heavy oxidation, grey	■	8	NA	NA	NA	NA	19.2, 29.7, 29.3, 22.2	61.1, 64.5	80.8		CL-ML	1.5		
			compact SANDY GRAVEL trace SILT - fine to medium grained, poorly graded, cobbles in size to 150 mm, grey	■	9	NA	NA	NA	NA	8.2, 13.3, 7.4				GP-GM	2.0		
			compact - as above but some SILT	■	10	NA	NA	NA	NA					GM	2.5

Test Pit terminated @ 2.40 m below the ground surface. Groundwater encountered @ 1.4 m

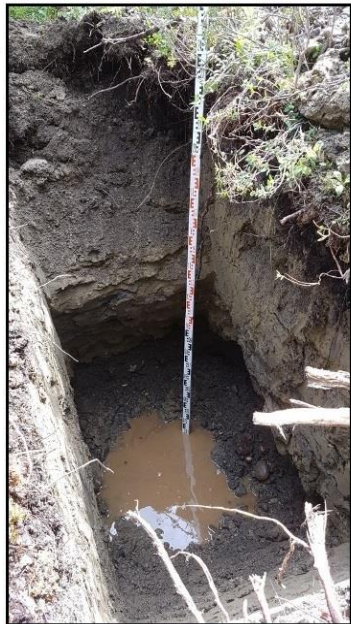
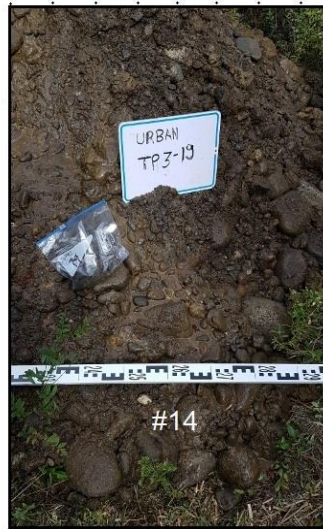
1.5	SILT - non-plastic, fine grained, heavy oxidation, grey															
4																		
5																		
6				■	13	NA	NA	0.5	NA			22.7						
		2.0	SANDY GRAVEL - fine to medium grained, poorly graded, cobbles in size to 150 mm, grey															
7																		
8				■	14	NA	NA	NA	NA	1.0		9.5	32.2		66.9

2.5	Test Pit terminated @ 2.40 m below the ground surface. Groundwater encountered @ 1.5 m															
9																		
10																		
11																		
12																		
13																		
14																		
15																		
16																		
17																		
18																		
19																		
20																		
21																		
22

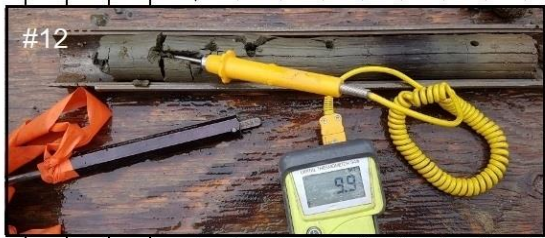
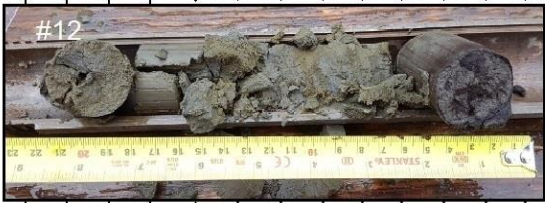
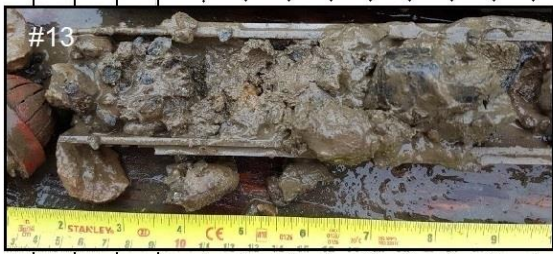
Elev. (m)	Depth		Stratigraphic Description	Field Sample					Laboratory Results (%)				USCS/NRC	Symbol	Depth (m)				
	ft	m		Type	Number	Temperature (degrees C)	Recovery %	Penetrometer (kg/cm2)	SPT 'N	▲ - FINES	● - SAND	■ - GRAVEL				PL	MC	LL	
			FILL									20	40	60	80				
1		0.5																	0.5
2		1.0																	1.0
3		1.5																	1.5
4		2.0																	2.0
5		2.5	ORIGINAL GROUND SURFACE																2.5
6		3.0																	3.0
7		3.5																	3.5
8		4.0																	4.0
9		4.5	firm SANDY SILT (40 mm) moist - non-plastic, fine grained, brown ORGANIC SILT (40 mm) trace organics, mottled grey-black SANDY SILT (370 mm) - non-plastic, trace oxidation, orange-brown/grey	12	3.4	100	0.75	12	8.5	18.3	22.8								4.5
10		5.0																	5.0
11		5.5																	5.5
12		6.0																	6.0
13		6.5	- grindy drilling																6.5
14		7.0	compact SILTY SANDY GRAVEL wet - fine to medium grained, poorly graded, grey	13	NA	56	NA	23	8.5	15.9	19.0								7.0

15		7.5																	7.5
16		8.0																	8.0
17		8.5																	8.5
18		9.0																	9.0
19		9.5																	9.5
20		10.0																	10.0
21		10.5																	10.5
22		11.0																	11.0
			SEE PAGE 2

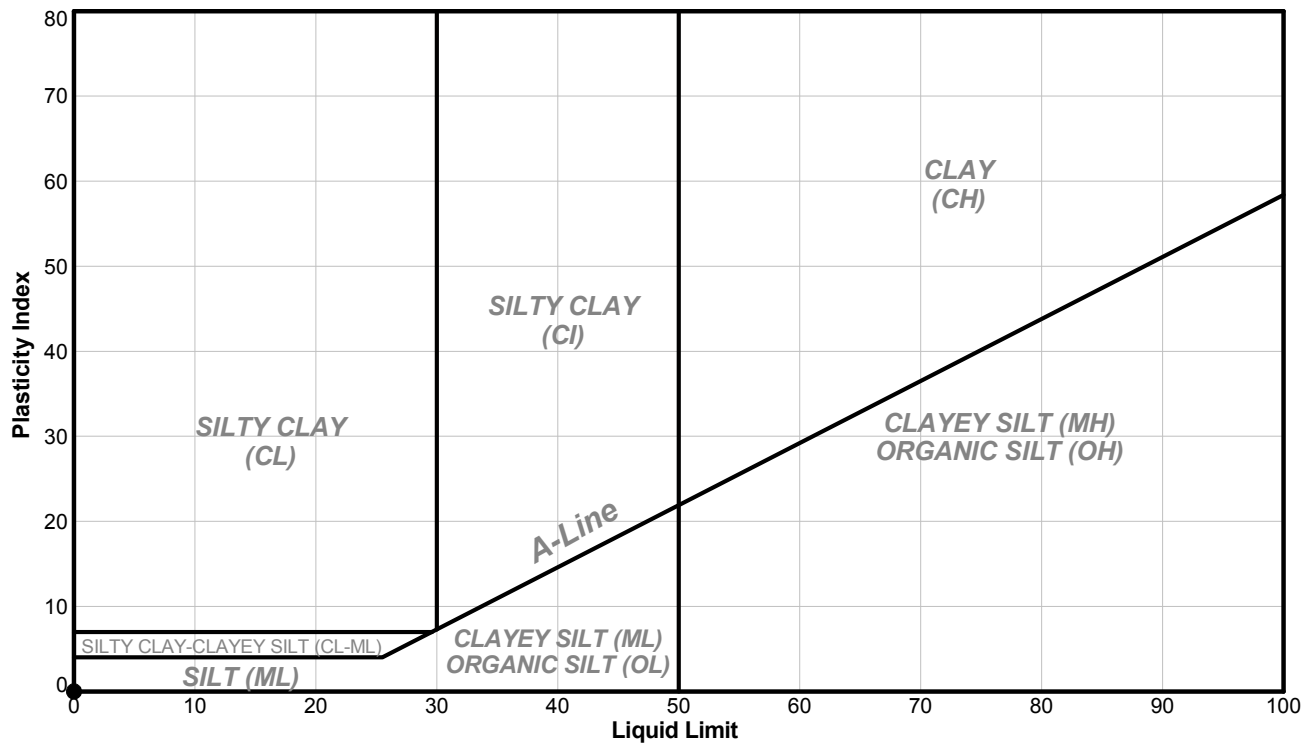
Sym.	Sample Location	Sample / Specimen Number	Depth (m)	Bottom (m)	Percent Passing #40 Sieve (%)	Liquid Limit	Plastic Limit	Plasticity Index	Natural Water Content (%)	Liquidity Index
●	Urban Lot #15	TP1-19 - SA3	0.00	0.00	ND	NP	NP	NP	14.8	NP
