**Geotechnical Evaluation
Proposed Urban Lot #15 (CLSR 55659)
Carmacks, Yukon – 2019**

Prepared For: Yukon Government

Date : October 9th, 2019

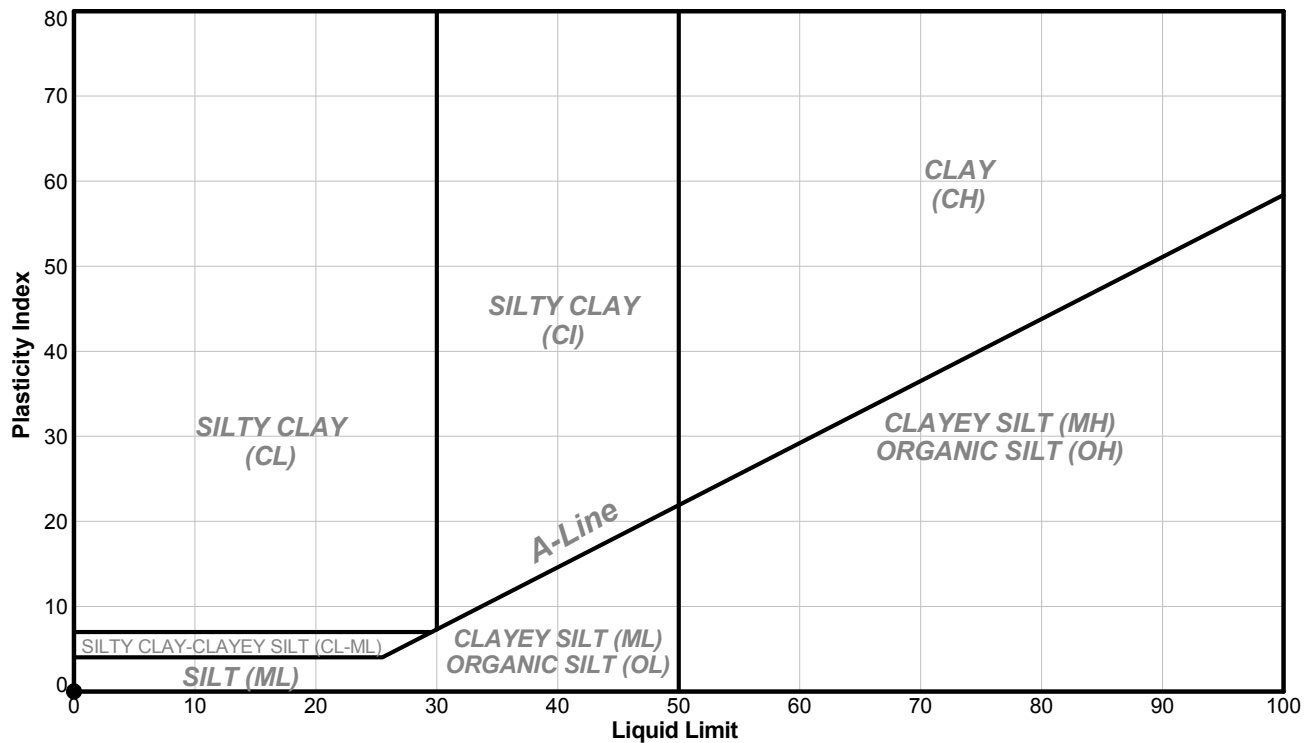
Sym.	Sample Location	Sample / Specimen Number	Depth (m)	Bottom (m)	Percent Passing #40 Sieve (%)	Liquid Limit	Plastic Limit	Plasticity Index	Natural Water Content (%)	Liquidity Index
●	Urban Lot #15	TP2-19 - SA7	0.00	0.00	ND	NP	NP	NP	18.1	NP

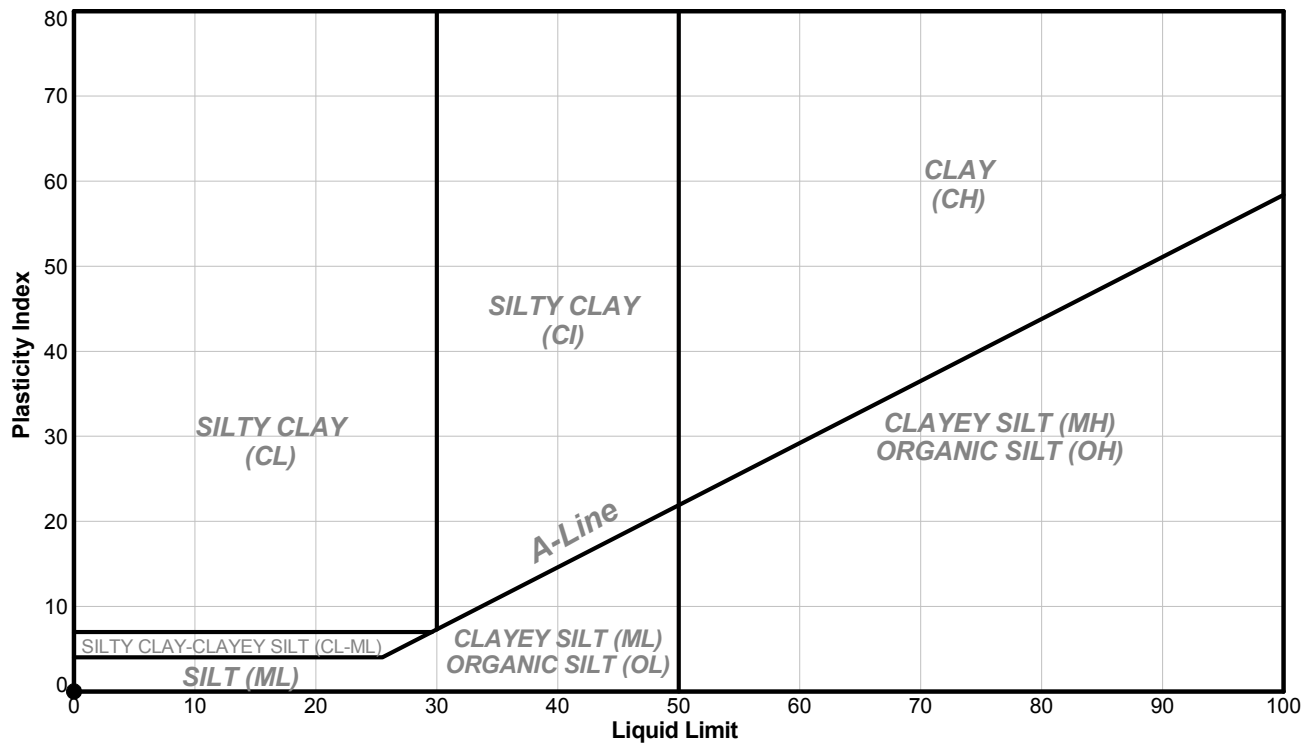
Sym.	Sample Location	Sample / Specimen Number	Depth (m)	Bottom (m)	Percent Passing #40 Sieve (%)	Liquid Limit	Plastic Limit	Plasticity Index	Natural Water Content (%)	Liquidity Index
●	Urban Lot #15	TP3-19 - SA13	0.00	0.00	ND	NP	NP	NP	14.6	NP

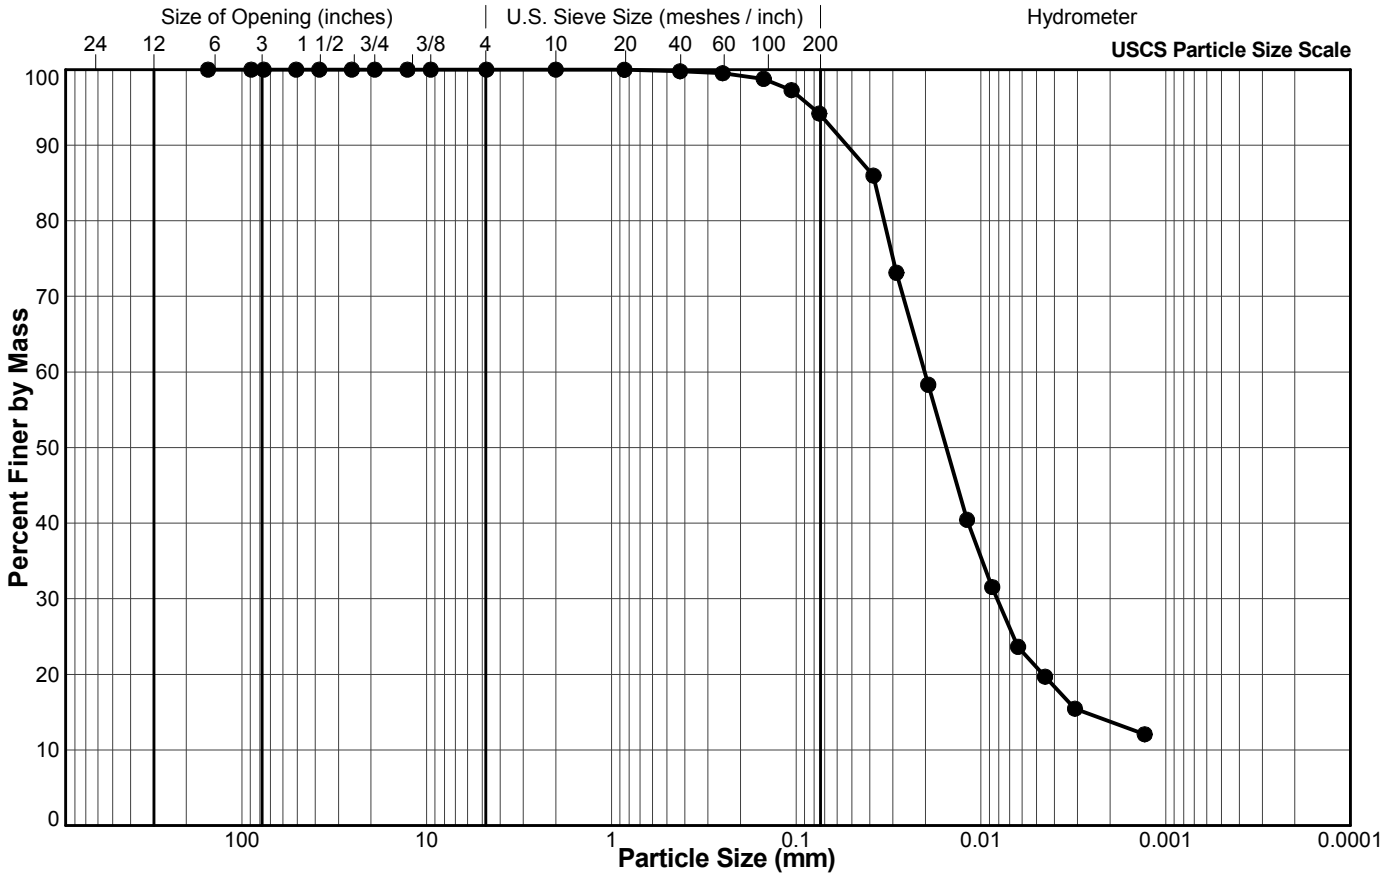
Sample Location: Urban Lot #15
Sample No.: TP2-19 - SA8
Depth (m): 1.6
Lab Schedule No.: B19-275

Sieve Size (USS)	Particle Size (mm)	Percent Passing
6"	152.4	100.0
3.5"	88.9	100.0
3"	76.2	100.0
2"	50.8	100.0
1 1/2"	38.1	100.0
1"	25.4	100.0
3/4"	19.1	100.0
1/2"	12.7	100.0
3/8"	9.5	100.0
#4 US MESH	4.75	100.0
#10 US MESH	2	100.0
#20 US MESH	0.85	100.0
#40 US MESH	0.425	99.8
#60 US MESH	0.25	99.5
#100 US MESH	0.15	98.8
#140 US MESH	0.106	97.3
#200 US MESH	0.075	94.2
	0.0382	86.0
	0.0287	73.1
	0.0193	58.3
	0.0119	40.4
	0.0087	31.5
	0.0063	23.6
	0.0045	19.7
	0.0031	15.5
	0.0013	12.1

The fine-grained alluvial floodplain deposits were generally classified as silts which contained varying amounts of clay, sand and gravel. While the majority of these fine-grained deposits were characterized as being non-plastic (as determined through Atterberg limit analysis), silty clay to clayey silt soils which exhibited slight plasticity was noted in test pit TP 2-19 (Sample No.8). This sample contained 13.4% clay as determined through hydrometer analysis.
