GEOTECHNICAL INVESTIGATION

SOUTH ACCESS PUBLIC QUARRY

WHITEHORSE, YUKON

REPORT NUMBER: 8002-222

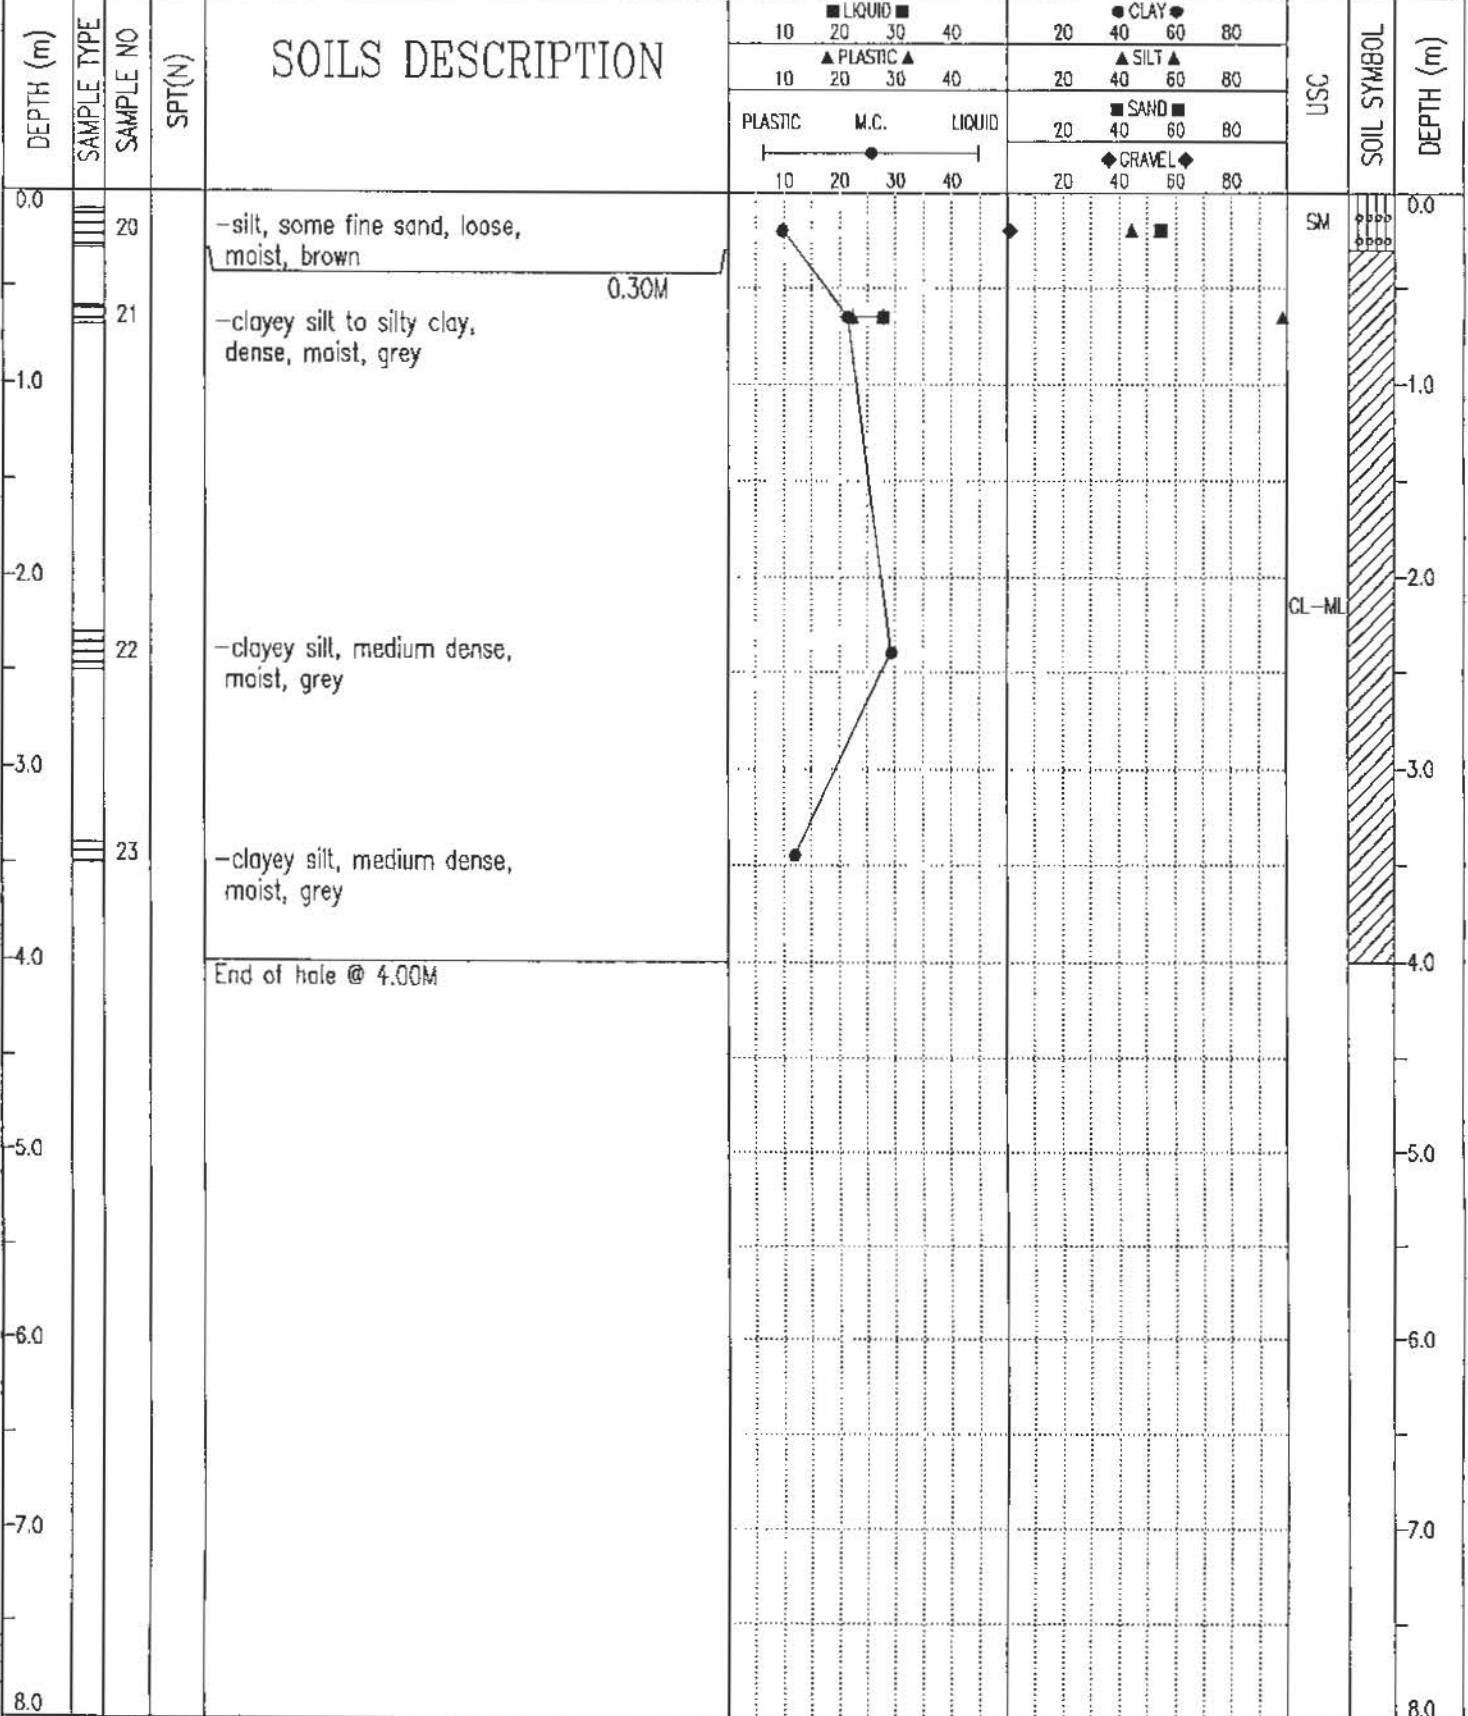
LOGGED BY: AB MK
REVIEWED BY: WCK
Fig. No: 5

COMPLETION DEPTH: 4.0 m
COMPLETE: 92/06/08

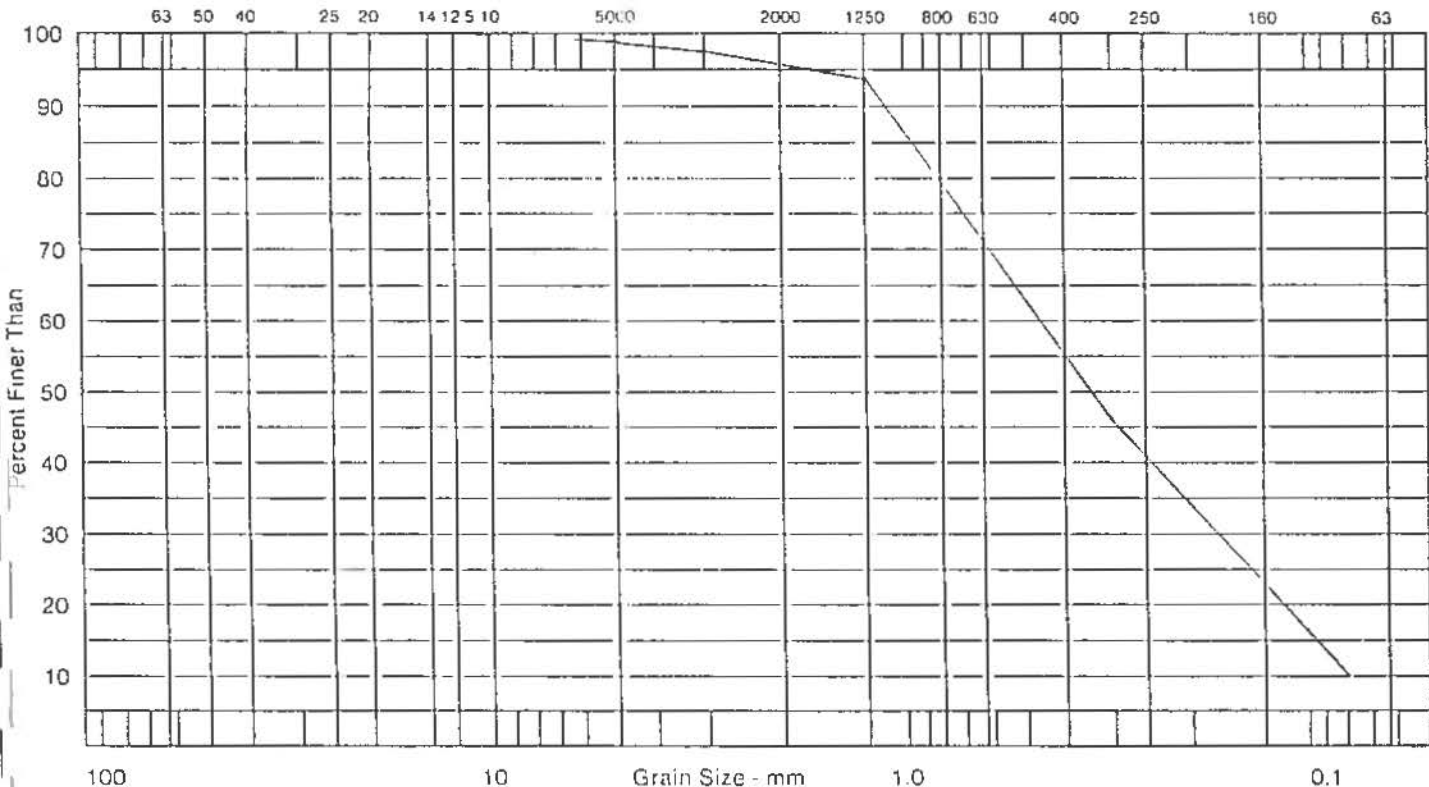
Sample: 1 Depth: 0.1-0.2m Client: YTG, C&T Services, Transportation Eng'
 Location: _____ Project: Geotechnical Investigation South Access
 Made by: AB Job No.: 8002-222
TP135-92 Date: 1992/06/15
 CK'd by: WCL

Sand, SW-SM

Gravel 1.1%

Sand 88.8%

Silt 10.1%

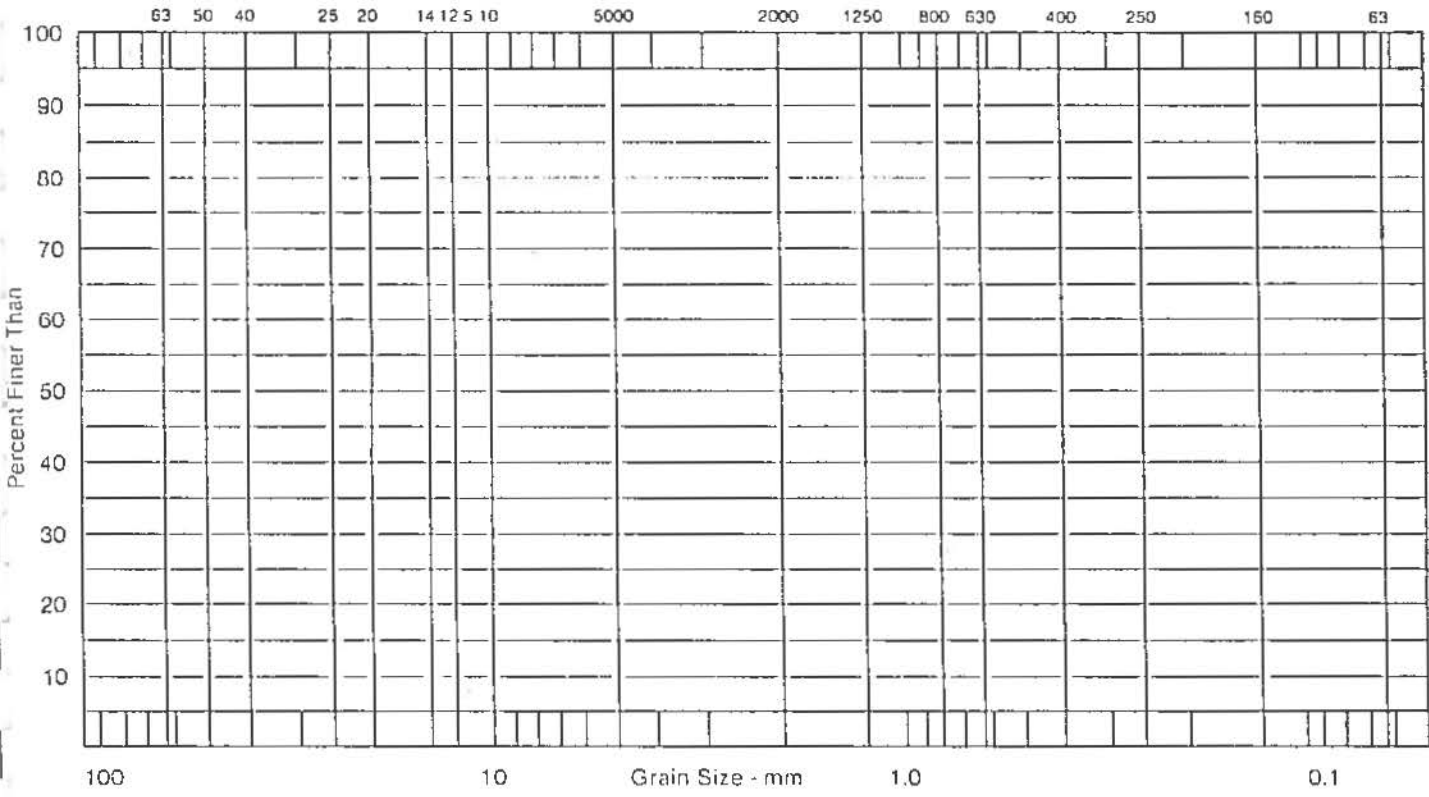
Sample: 3 Depth: 1.5-1.65m Client: YTG, C&T Services, Transportation Eng'
 Location: TP135-92 Project: Geotechnical Investigation South Access
 Made by: AB Job No.: 8002-222
 Ck'd by: WCL Date: 1992/06/15

Description of Sample _____
silt, ML

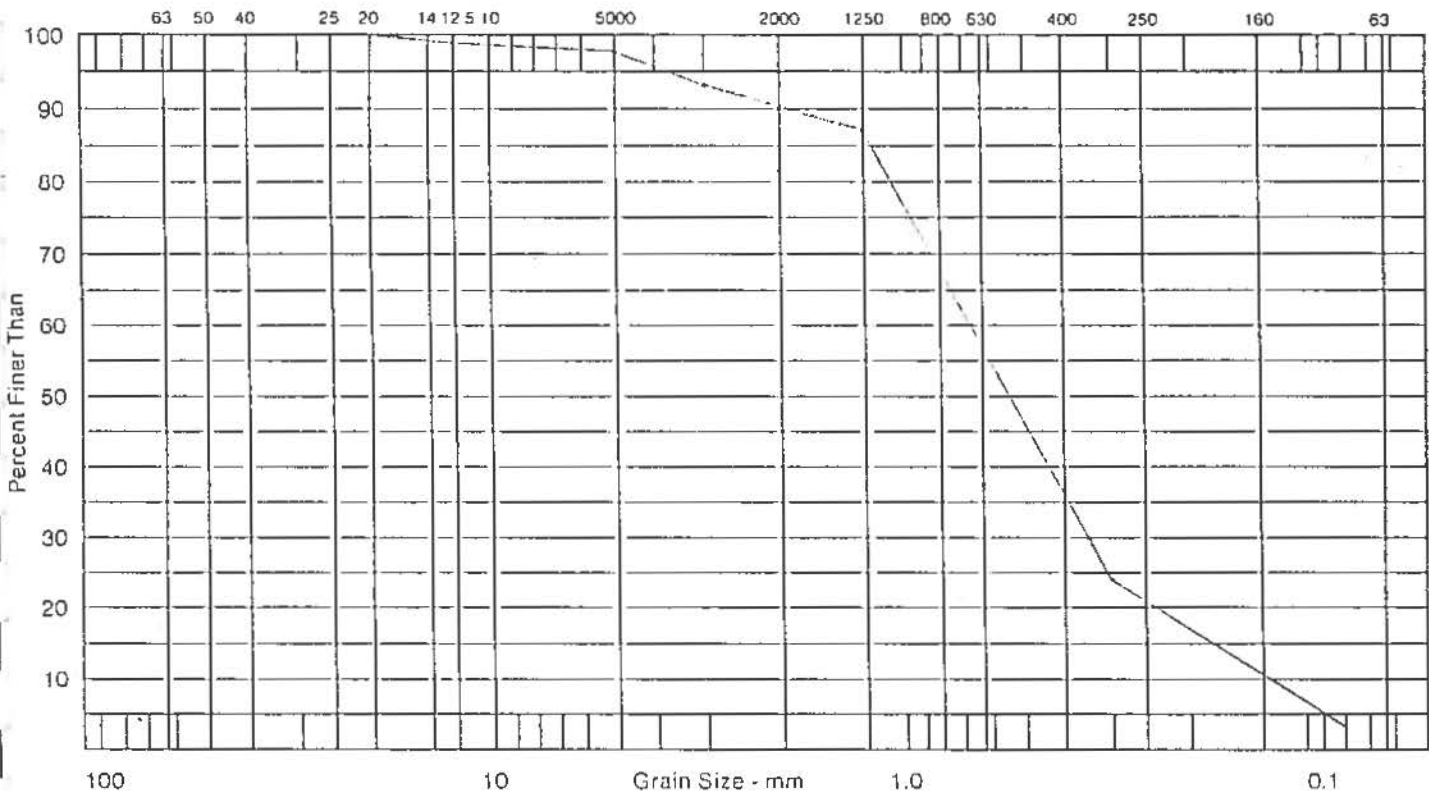
Client: YTG, C&T Services, Transportation Engⁿ
 Project: Geotechnical Investigation South Access
 Sample: 6 Depth: 0.4-0.5m Made by: AB Job No.: 8002-222
 Location: TP#36-92 Made by: WCC Date: 1992/06/15

Sand, SP

Gravel 2.4%
Sand 94.0%
Silt 2.8%

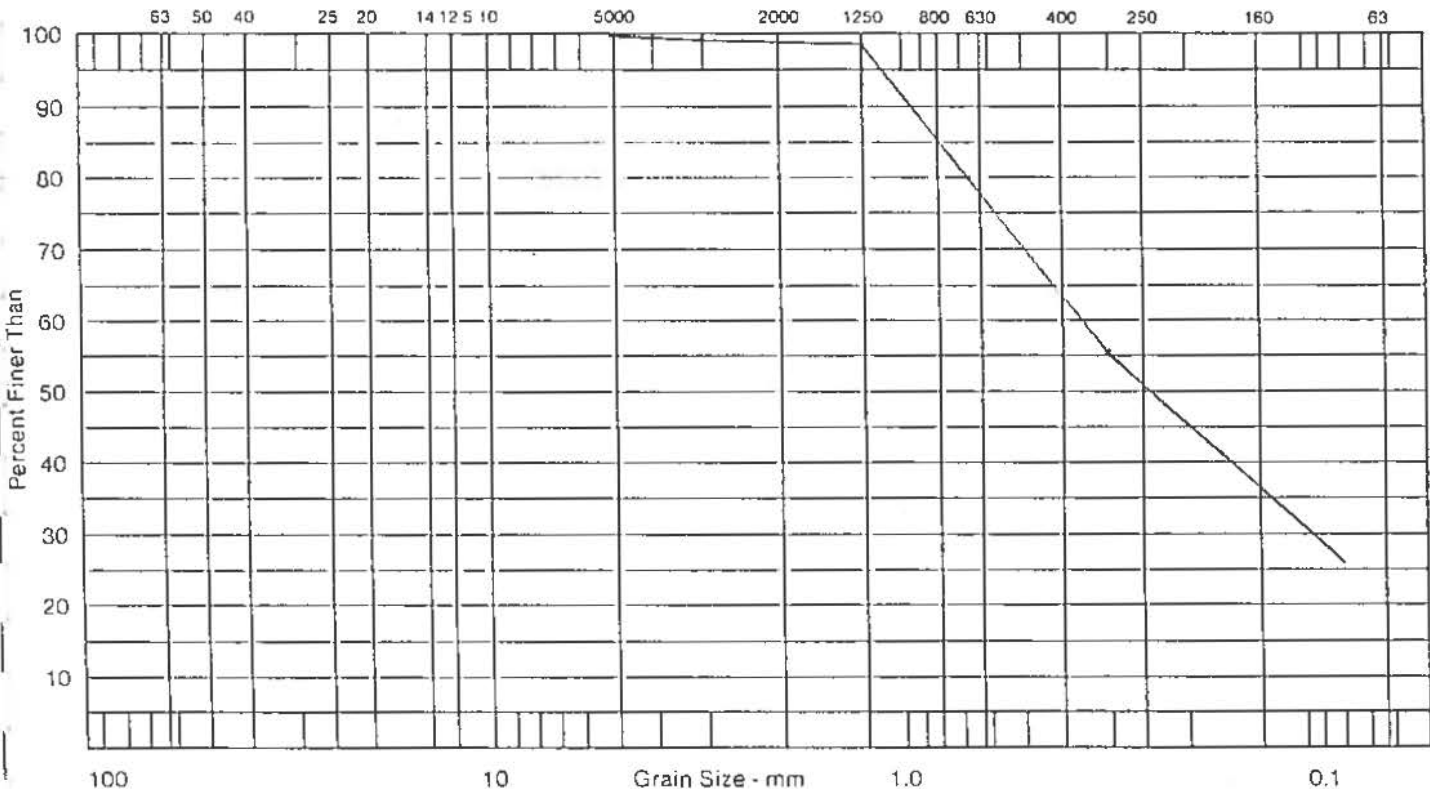
Client: YTG, C&T Services, Transportation Eng'
 Project: Geotechnical Investigation South Access
 Sample: 10 Depth: 0.3-0.45m Made by: AB Job No.: 8002-222
 Location: _____ Ck'd by: WCC Date: 1992/06/15
TP#37-92

Silty sand, SM

Gravel 0.2%

Sand 78.3%

Silt 26.0%

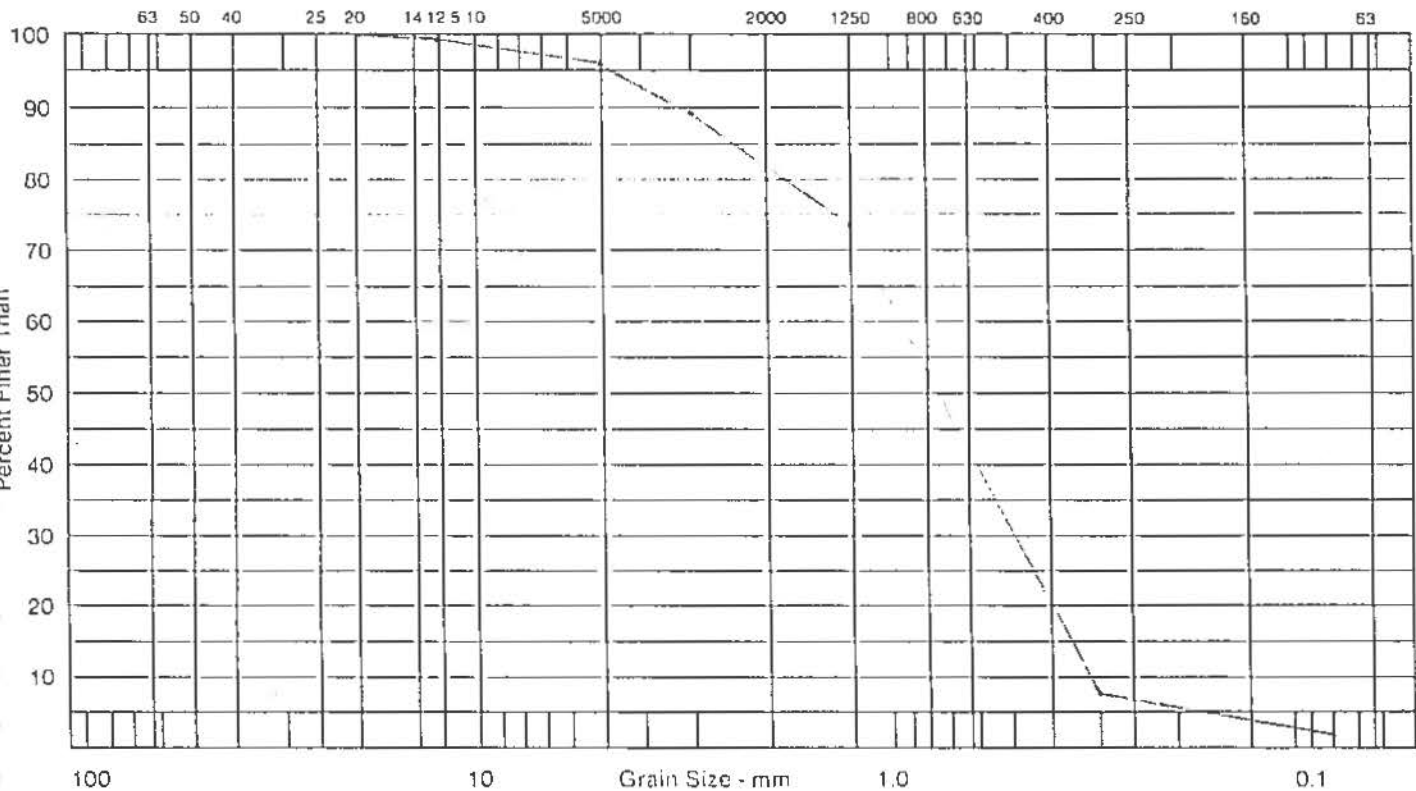
Client: YTG, C&T Services, Transportation Eng'
 Project: Geotechnical Investigation South Access
 Sample: 11 Depth: 0.65-0.75m Made by: AB Job No.: 8002-222
 Location: _____ Ck'd by: WCL Date: 1992/06/15
TP#37-92

Sand, SP

Method of Preparation _____ Dry _____ Washed **X**
 Remarks _____
Gravel 4.3%
Sand 94.8%
Silt 0.9%

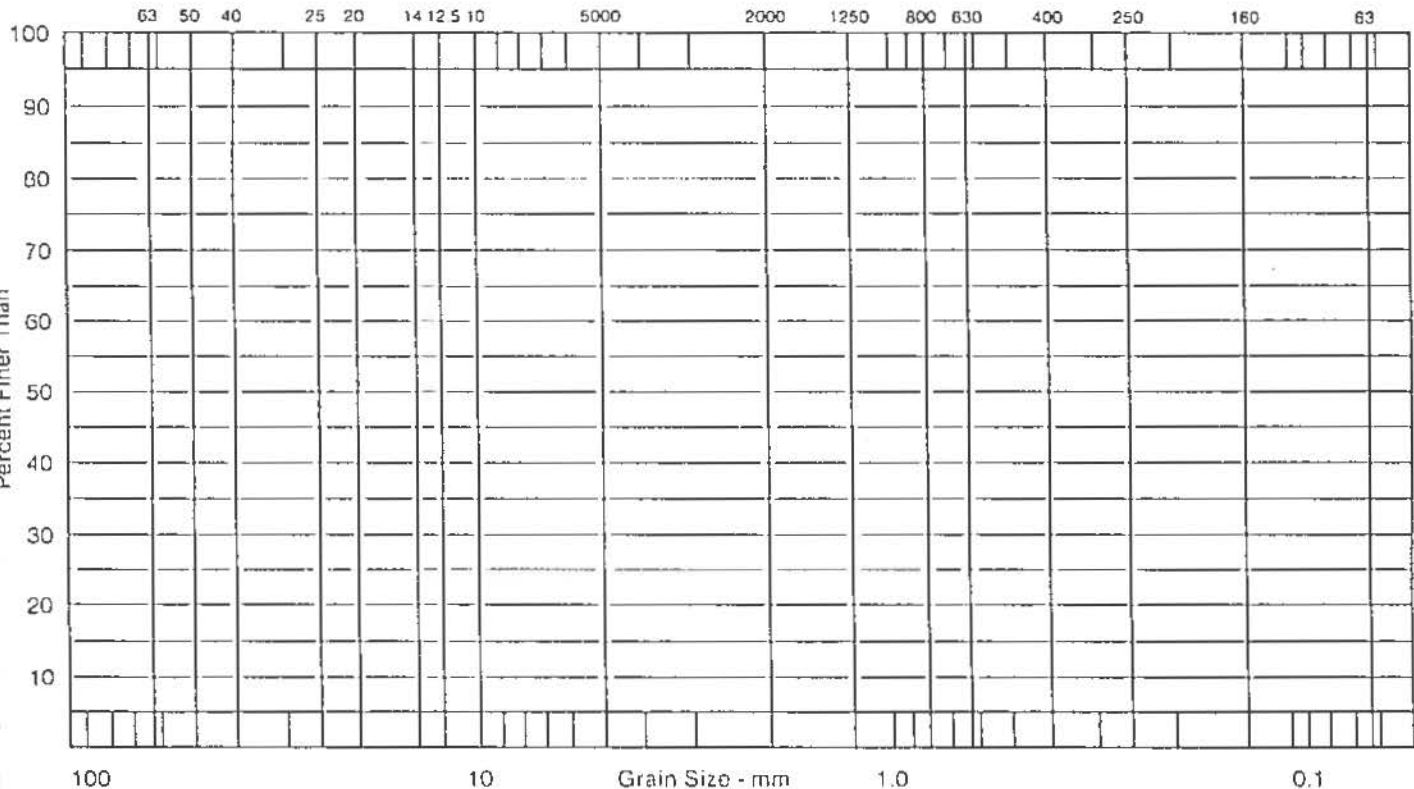
Client: YTG, C&T Services, Transportation Eng'
 Project: Geotechnical Investigation South Access
 Sample: 12 Depth: 1.0-1.2m Made by: AB Job No.: 8002-222
 Location: _____ Ck'd by: WCIL Date: 1992/06/15
TP#37.92

Silt ML-CL

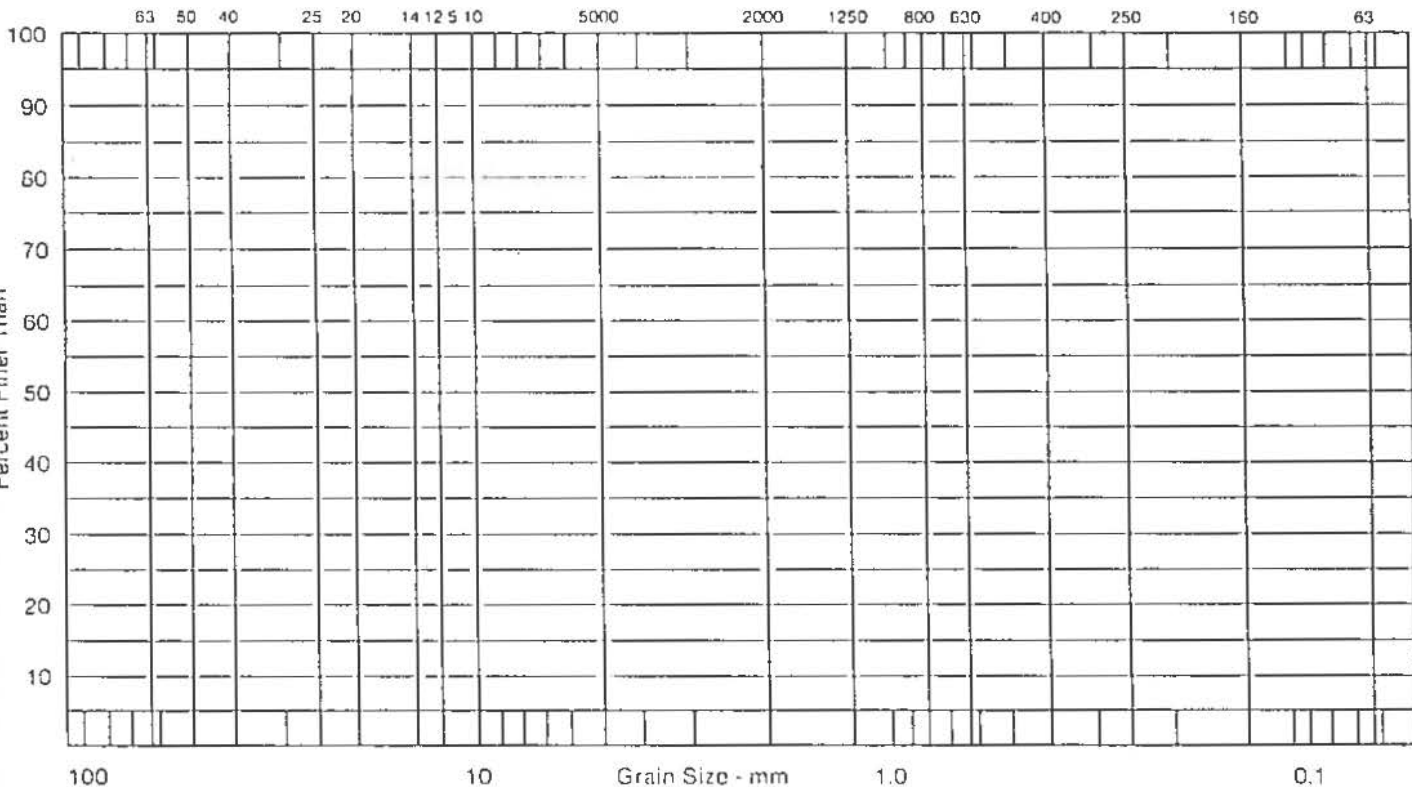
Client: YTG, C&T Services, Transportation Eng'
 Project: Geotechnical Investigation South Access
 Sample: 17 Depth: 1.2-1.3m Made by: AB Job No.: 8002-222
 Location: _____ Ck'd by: WCK Date: 1992/06/15
TP138-92

silt, ML

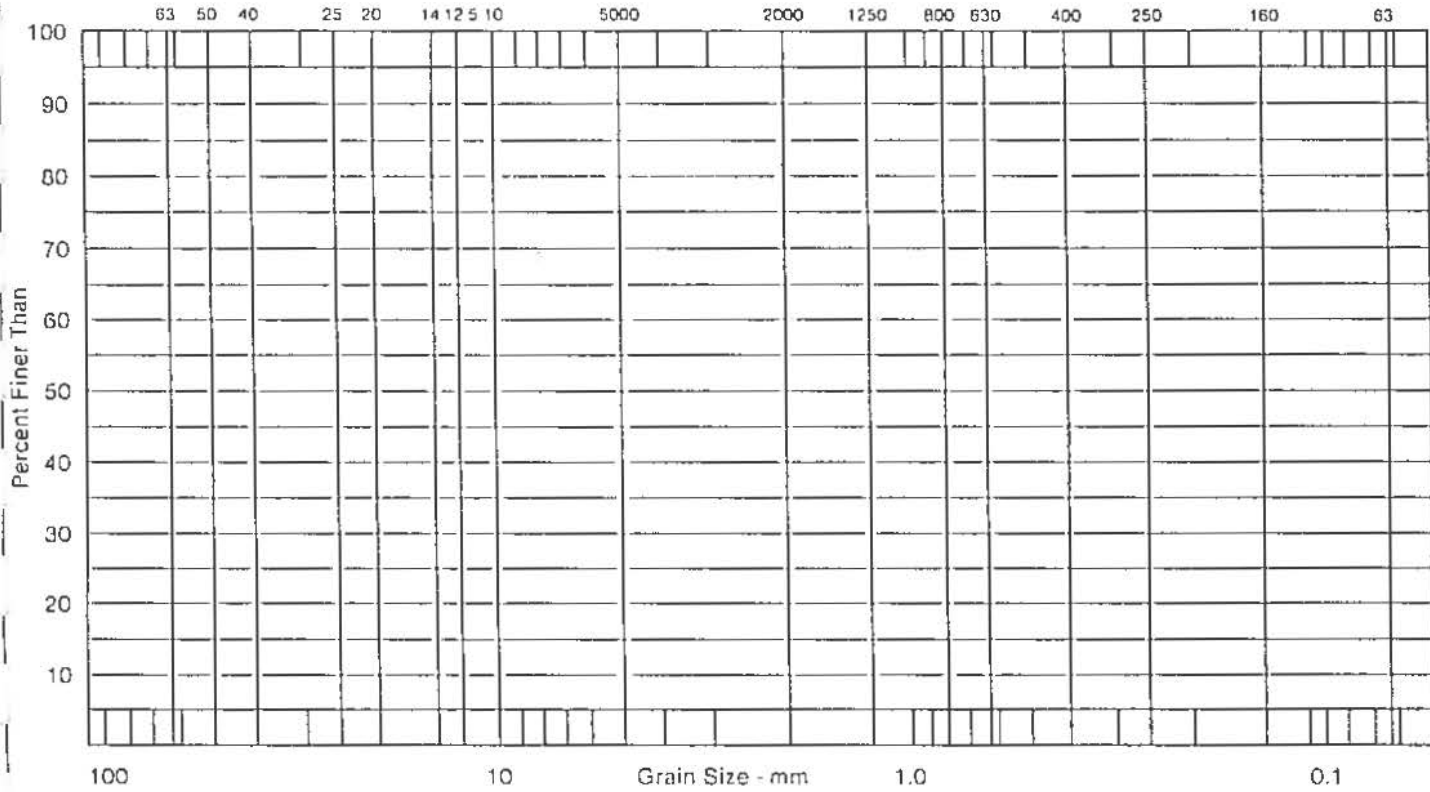
Client: YTG, C&T Services, Transportation Eng'
 Project: Geotechnical Investigation South Access
 Sample: 21 Depth: 0.6-0.7m Made by: AB Job No.: 8002-222
 Location: TP#39-92 CK'd by: WCU Date: 1992/06/15

Silt ML-CL

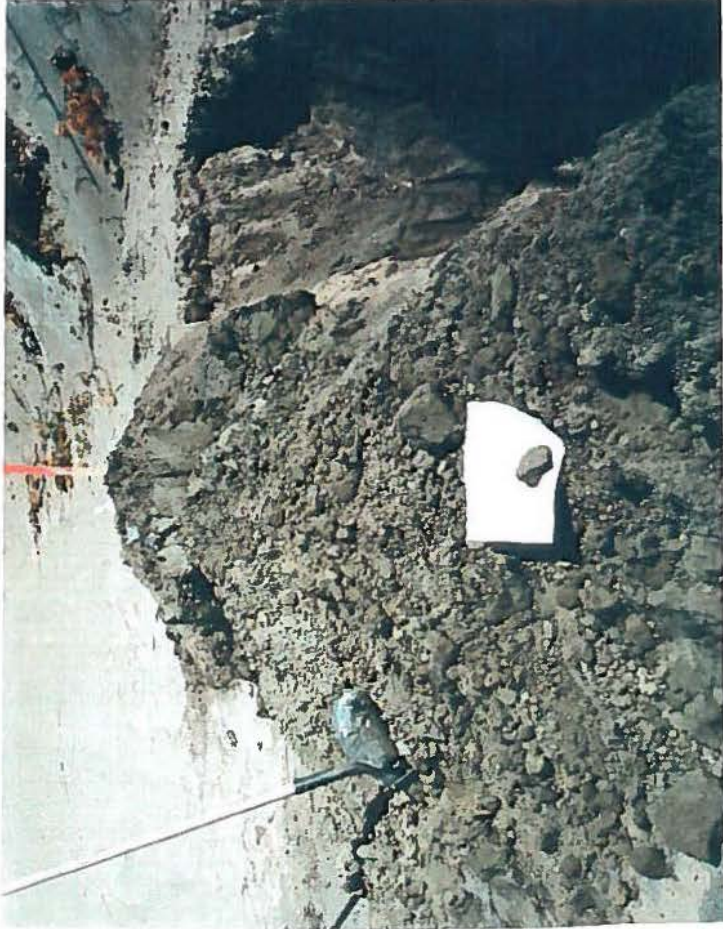
Photo # 2 TP# 36-92

PHOTOGRAPH #	DESCRIPTION
1	-Test Pit 35-92, sample spill piles
2	-Test Pit 36-92, sample spill piles
3	-Test Pit 37-92, sample spill piles
4	-Test Pit 38-92, sample spill piles
5	-Test Pit 39-92, sample spill piles
6-9	-Panoramic view of site
