**ROCK SLOPE ENGINEERING DESIGN
Sheep Mountain Rock Cut
Km 1705 Alaska Highway #1
March 2006**

**ROCK SLOPE ENGINEERING DESIGN
SHEEP MOUNTAIN ROCK CUT
KM 1705, ALASKA HIGHWAY
YUKON**

**Transportation Engineering
Geotechnical Services**

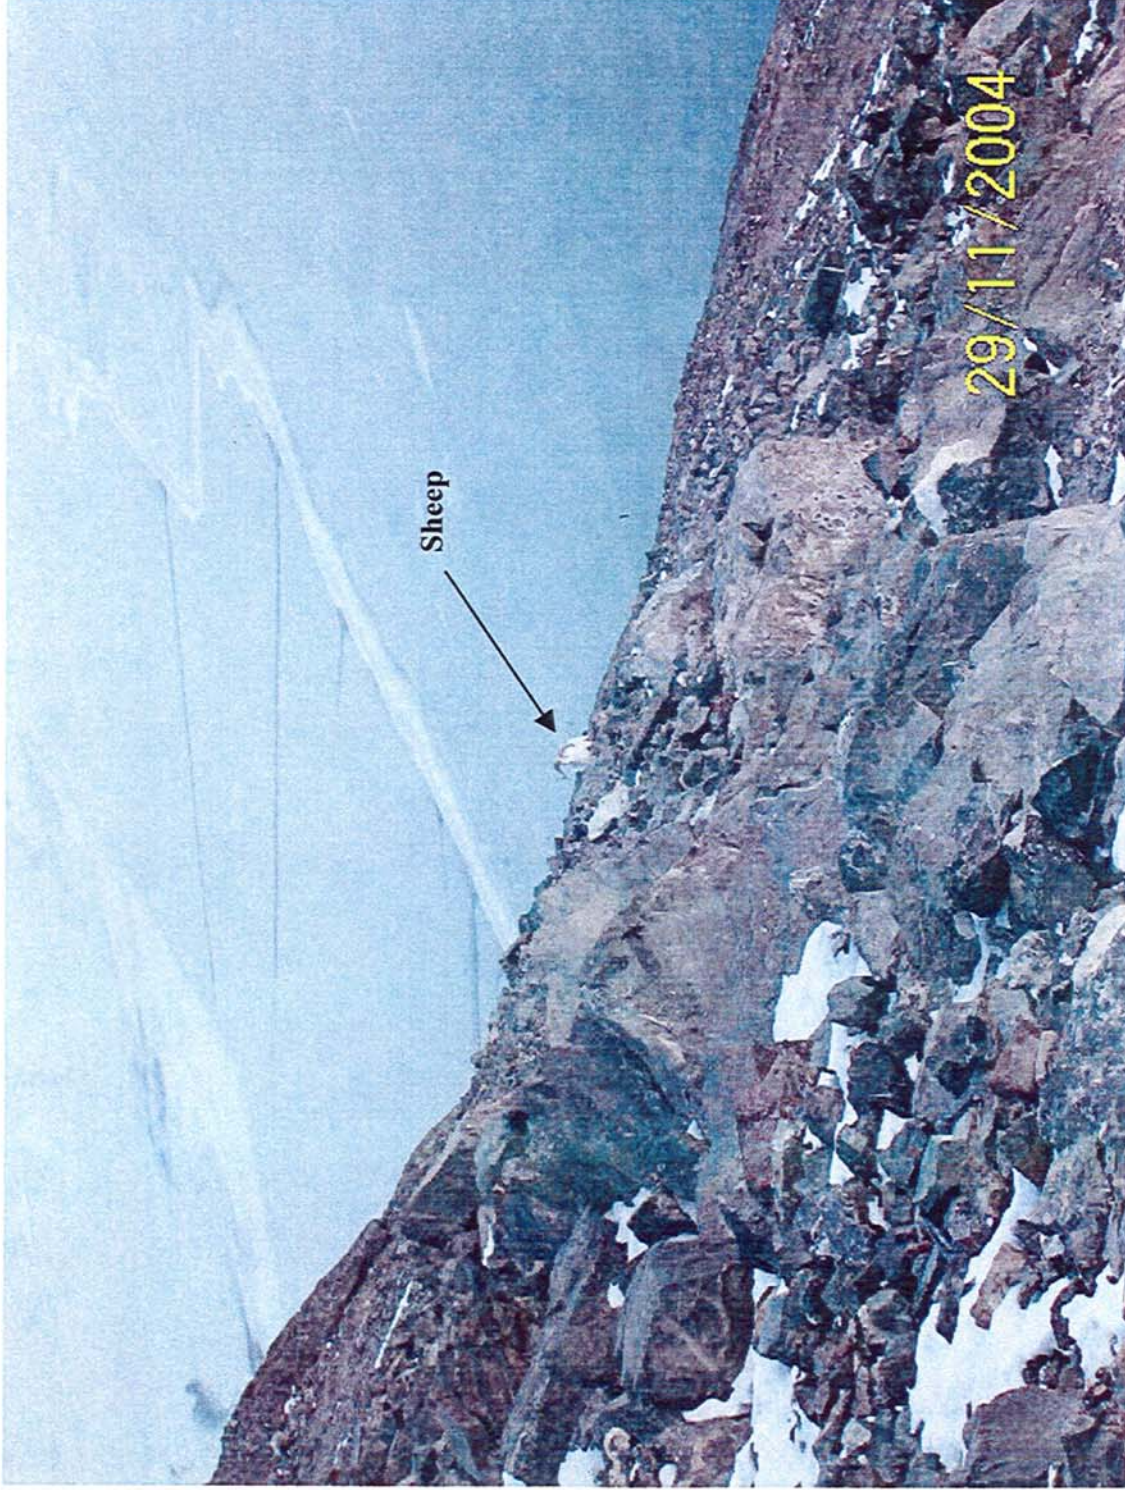
Photo 2: Moderately steep gradient slopes of colluvium and bedrock upslope of existing highway rock cut.

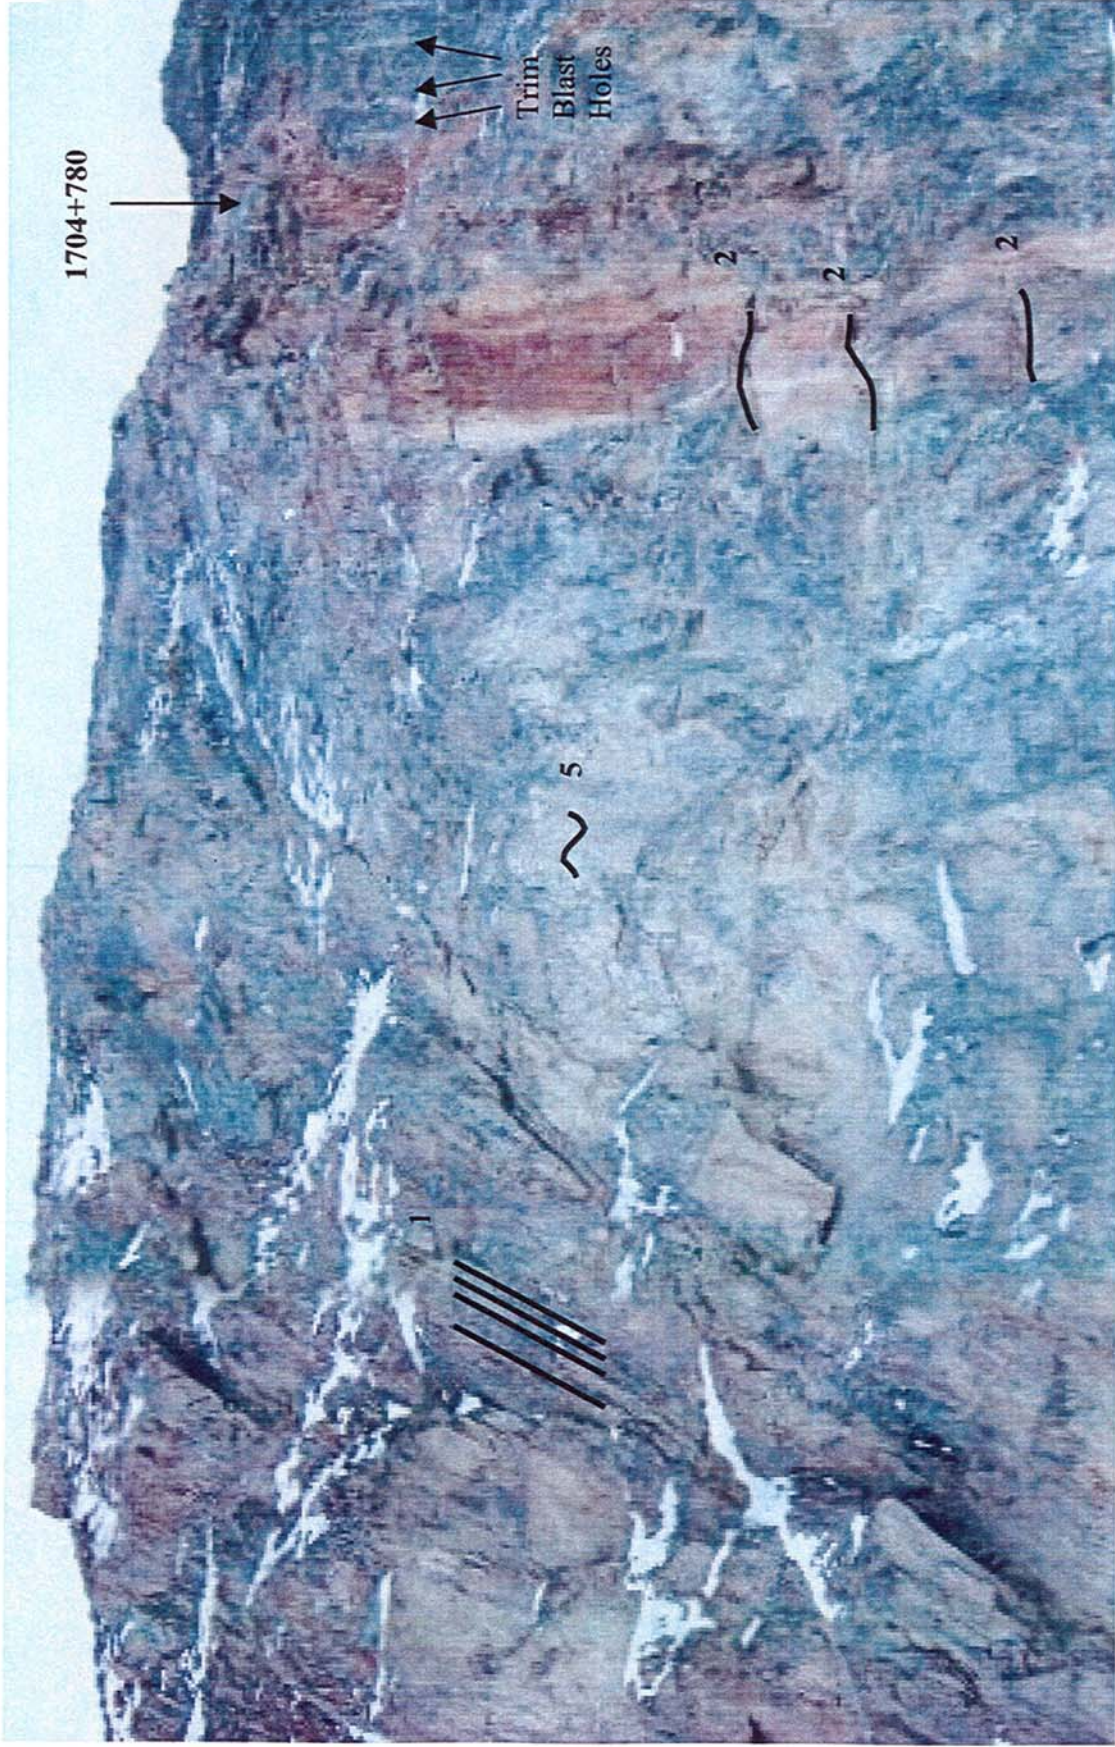
Photo 4: Structural Domain 2 (Quartzite) with selected joint sets highlighted. Note traces of small diameter trim blast holes spaced at approximately 0.8 m apart.

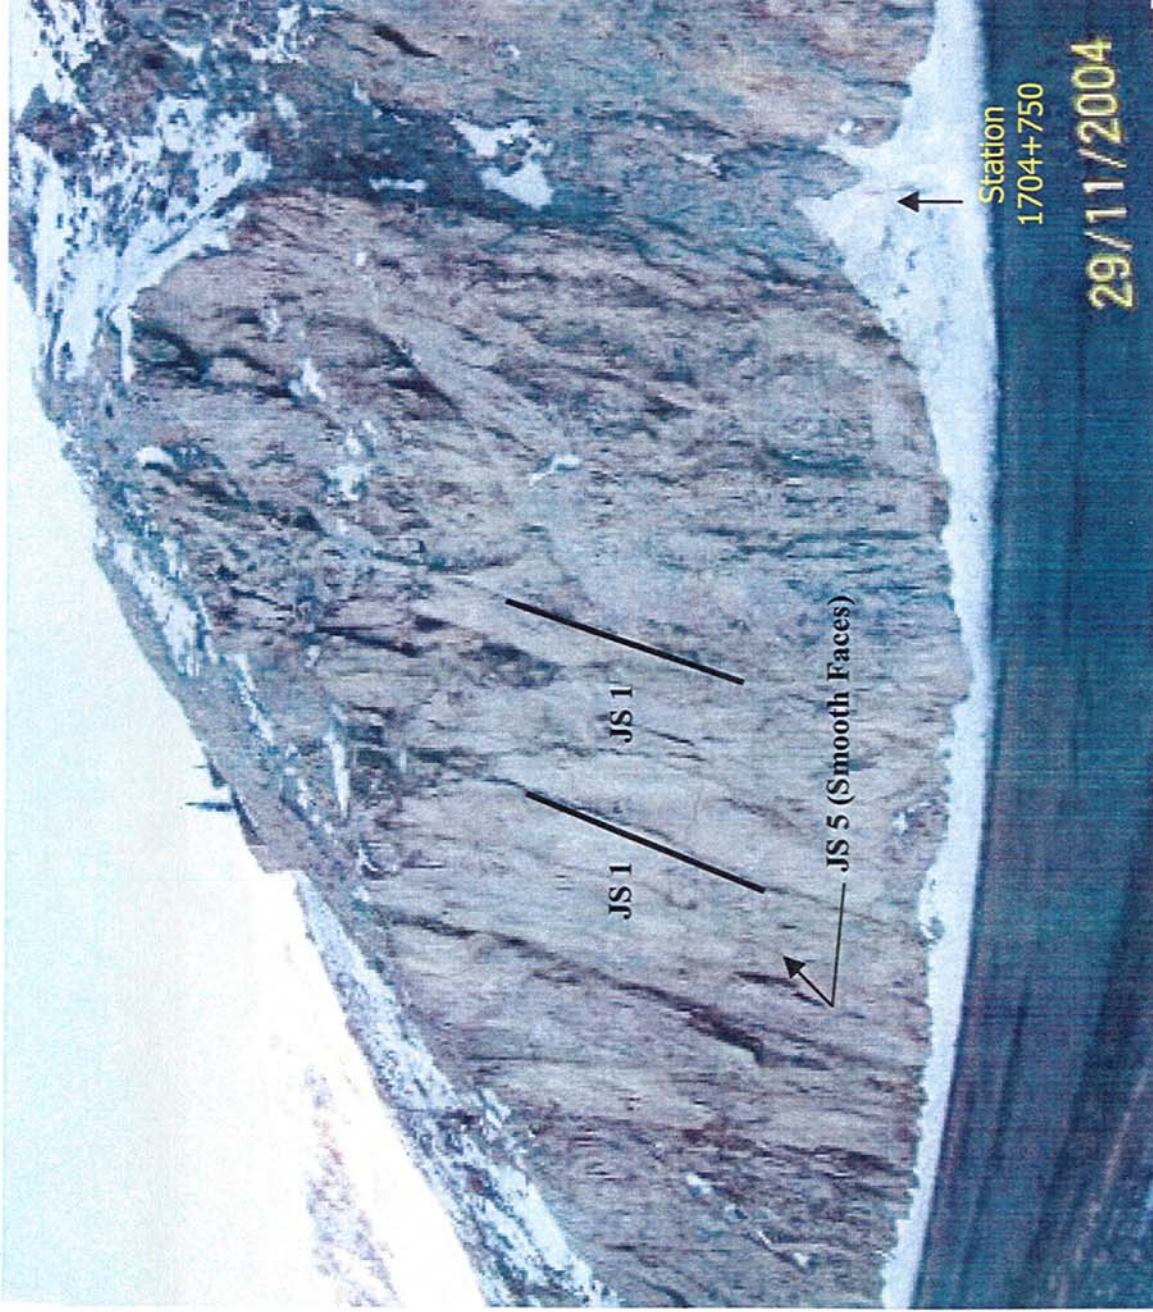
Photo 7: Locally pronounced joints of Joint Sets 1 and 5 in the quartzite in Design Sector 2.

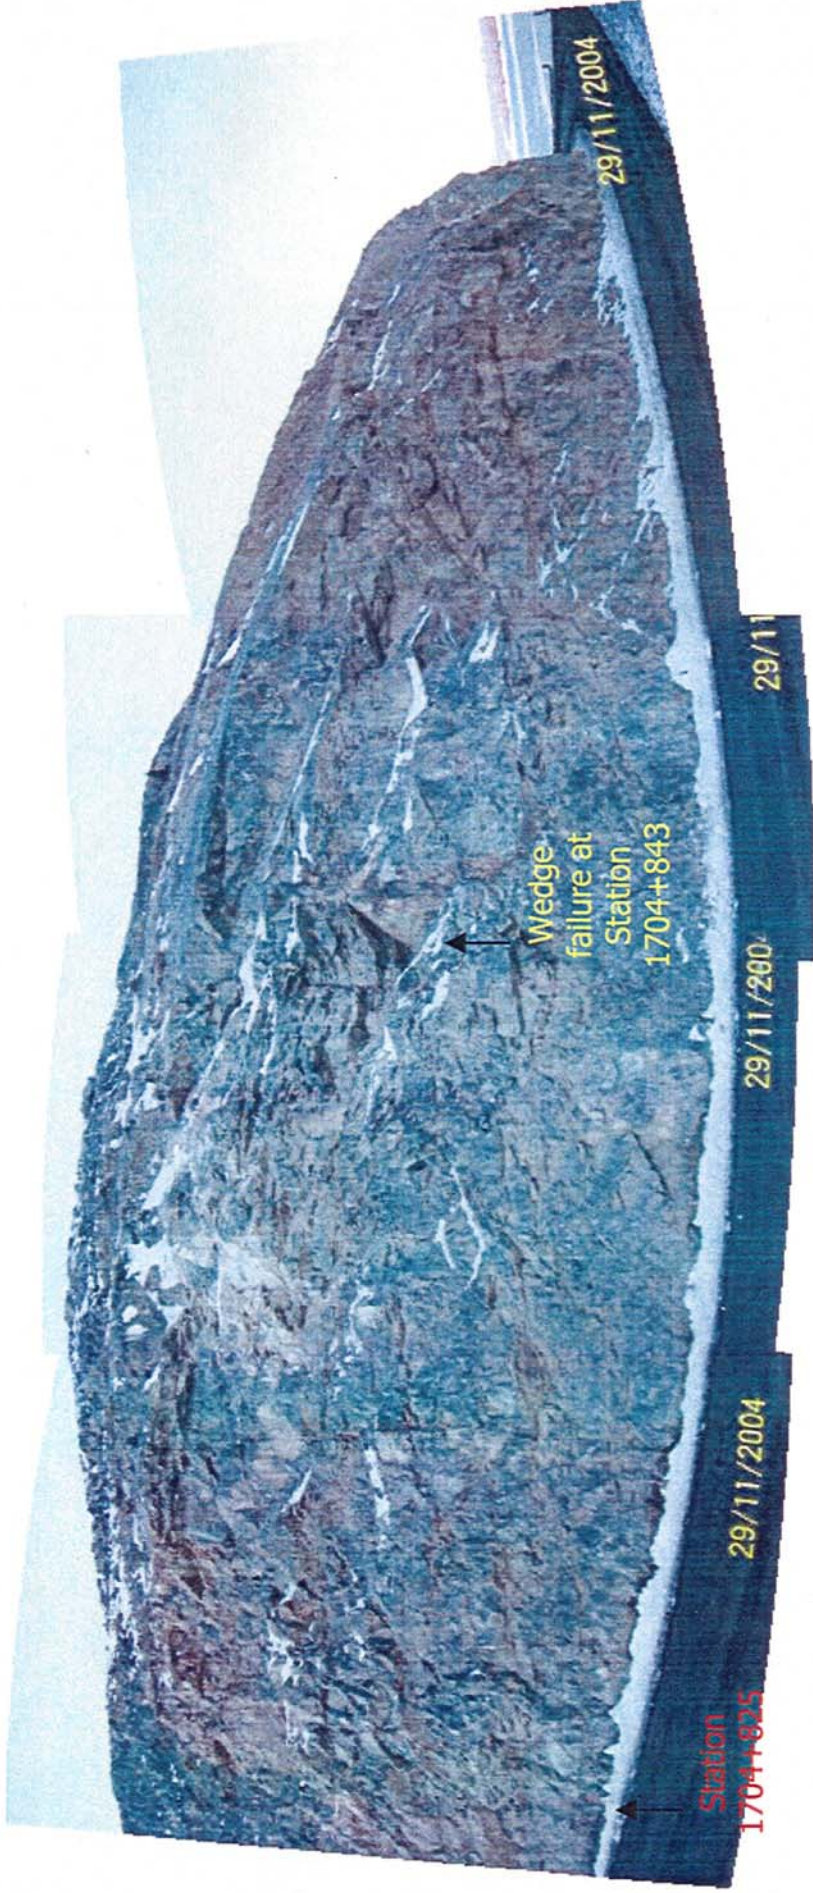
Photo 8: Typical exposure of the meta-volcanics in Design Sector 3.
