PROJECT CONSTRUCTION REPORT
PROJECT NO. 85-9207
CONTRACT NO. 86-1137-01

EQUIPMENT RENTAL,
DEMPSTER HIGHWAY GRADE REPAIR
km 8.5 to km 50.9
DEMPSTER HIGHWAY (NO. 8) N.W.T.

EBA ENGINEERING CONSULTANTS LTD.
EDMONTON, ALBERTA

December, 1986

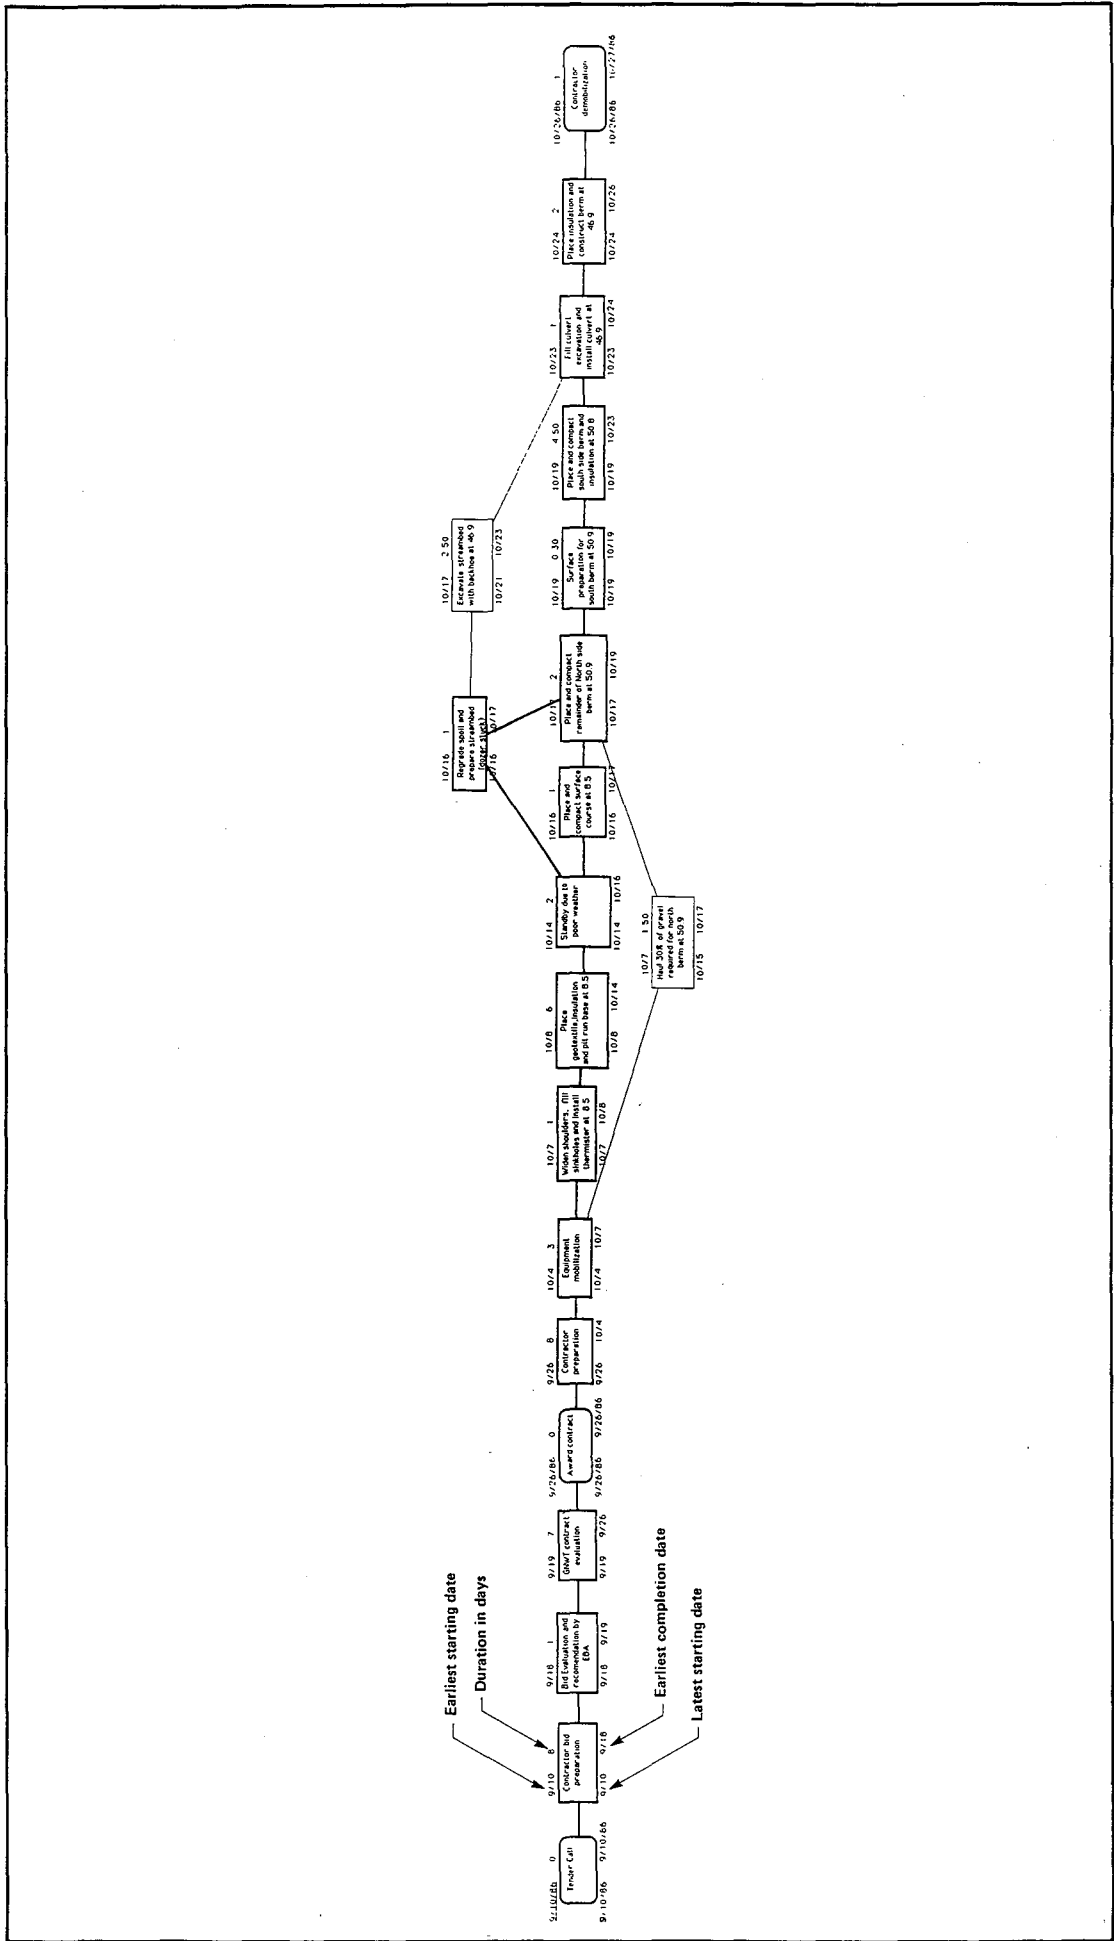
FIGURE 1.1 DEMPSTER HIGHWAY GRADE REPAIRS AS BUILT SCHEDULE

The principal activities carried out, and their corresponding dates are presented on Figure 1.1. The first site repaired was the site of a subgrade collapse located at km 8.5. Repairs at km 8.5 consisted of placement of synthetic insulation on the existing road grade and a buildup of the grade by addition of 550 mm of granular fill. The insulation was underlain by a heavy, woven geotextile and thermistor cables were installed to monitor ground temperature below the insulation.

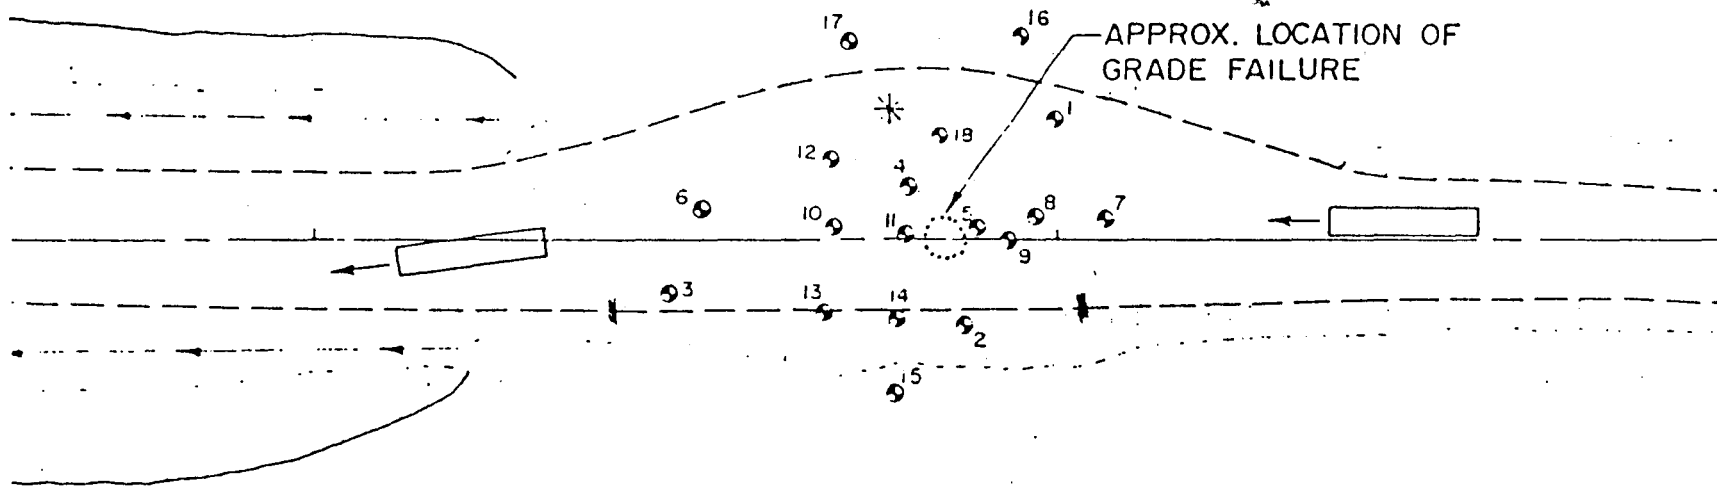
SITE PLAN AND BOREHOLE LOCATIONS
 ACCIDENT SITE
 km 8.5, DEMPSTER HIGHWAY, N.W.T.

A total of eighteen boreholes were drilled at the site. Figure 1 shows the borehole location. A thermistor cable was installed in Borehole No. 15 (Figure 2) which is off the highway embankment. One set of ground temperatures was measured on 85-10-21. The information on this borehole represents the ground temperature condition in the natural terrain near the site, which is useful for model calibration with respect to climatic input parameters.

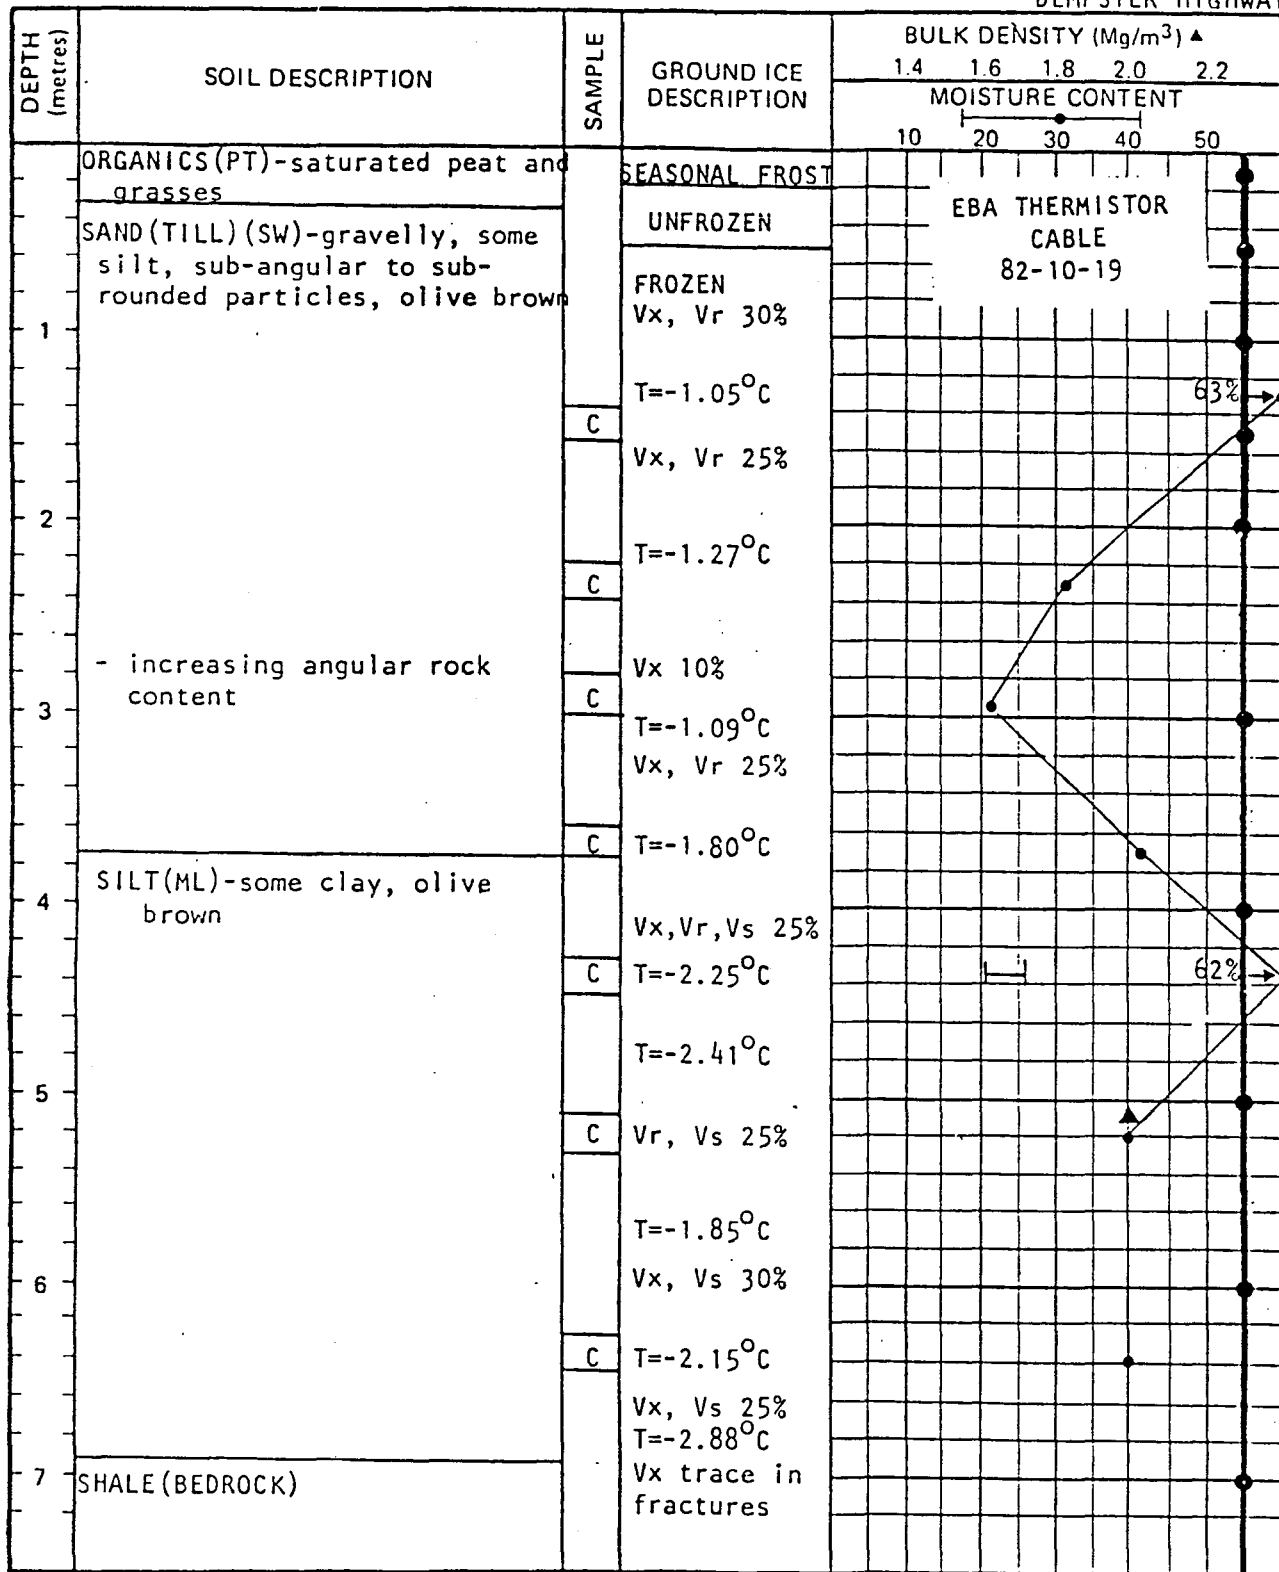
BOREHOLE No.
15
PAGE 1 OF 2

SFC. ELEVATION (m)	DATE DRILLED 1985-10-12
COMPLETION DEPTH (m) 8.9	LOGGED BY JRT
DRILLING RIG CME 750	LOCATION km 8.5 (NWT)

DEPTH (metres)	SOIL DESCRIPTION	SAMPLE	GROUND ICE DESCRIPTION	BULK DENSITY (Mg/m ³) ▲				
				1.4	1.6	1.8	2.0	2.2
				MOISTURE CONTENT				
				10	20	30	40	50
8	SHALE (BEDROCK)		FROZEN Vx trace in fractures					
9	END OF HOLE (Auger refusal)							
10	NOTE: EBA Thermistor cable 82-10-19 installed in this borehole.							
11								
12								
13								
14

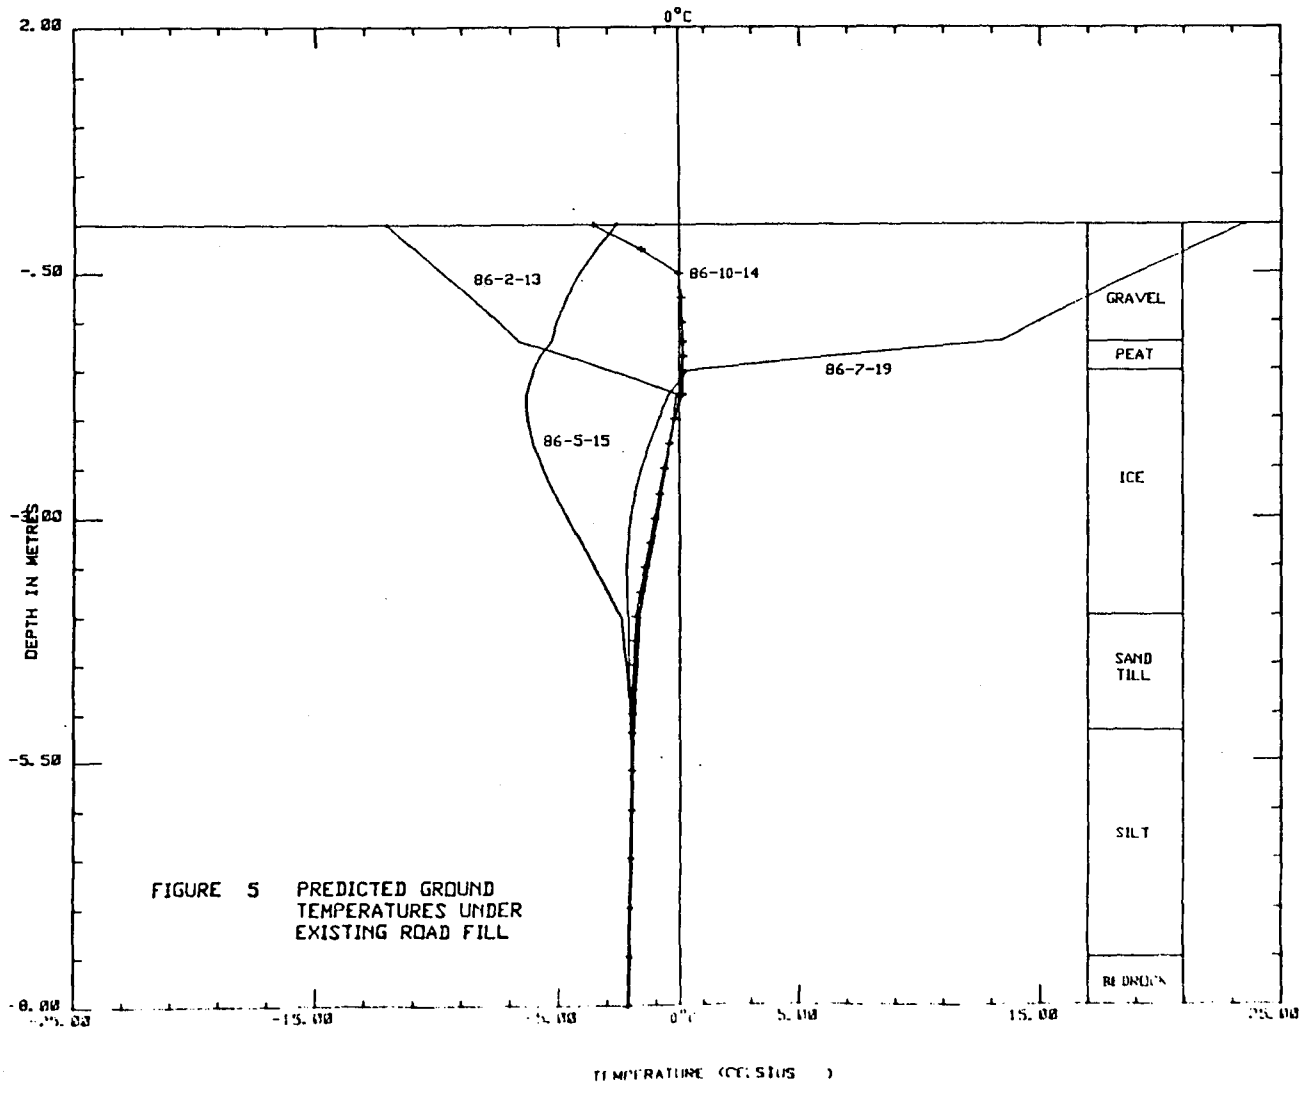
FIGURE 5 PREDICTED GROUND TEMPERATURES UNDER EXISTING ROAD FILL

4551bh05d01- Dempeter Highway B.H. 5 Analysis (NO Insulation/gravel)
 TEMPERATURES AT X= .00 SECTION

Borehole No. 5 (Figure 2) is believed to represent the worst soil condition at the site based on the available data. This borehole is therefore selected as the design case for the thermal analyses. The soil profile consists of 1.25 m of gravel fill overlying a thin layer of organic soil (0.3 m). Beneath the organic soil lies an ice layer of 2.5 m in thickness. The objective of placing a 50 mm insulation board over the existing road surface is to contain the seasonal thaw depth within the existing roadfill so as to prevent future thermal degradation in the natural terrain beneath the roadfill.

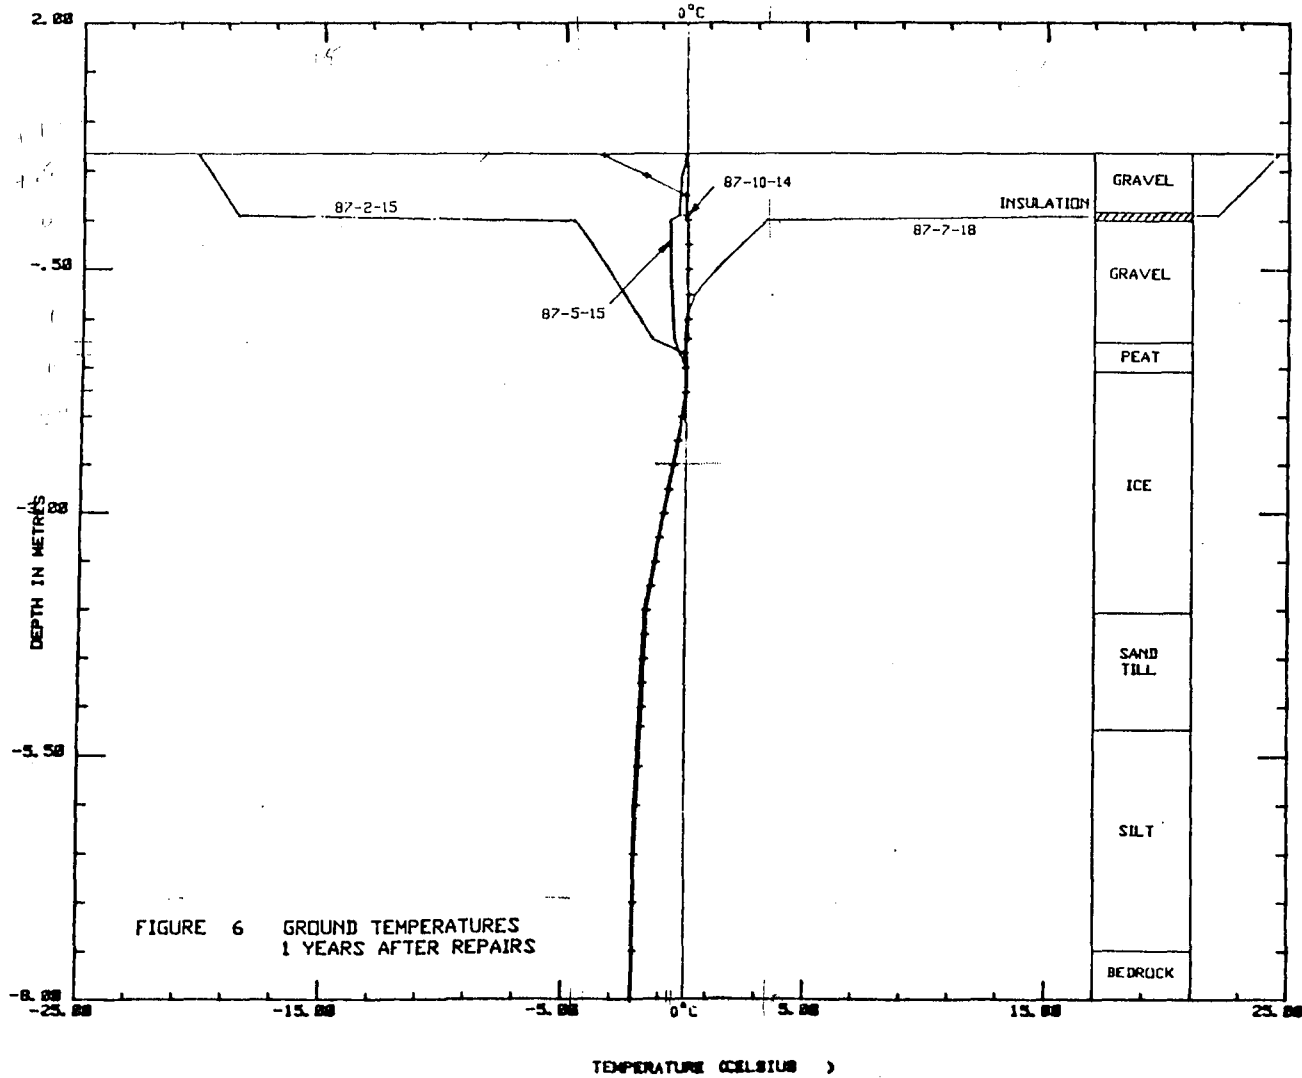
FIGURE 6 GROUND TEMPERATURES
 1 YEARS AFTER REPAIRS

4551bh05d04- Dempeter Highway B.H. 5 Analyse 10 yrs. run
 TEMPERATURES AT X= .00 SECTION

To simulate the construction sequence, a 50 mm insulation board is placed on top of the existing road surface, and covered by an additional 0.6 m roadfill. Figures 6 and 7 present the predicted ground temperatures one year and ten years after remedial construction. The results show that thermal degradation under the road fill has been arrested (Figure 6), and the ground temperatures cool with time (Figure 7). The ground temperature variations beneath the road fill are shown in Figure 8. A steady-state is reached in about 3 years after construction.

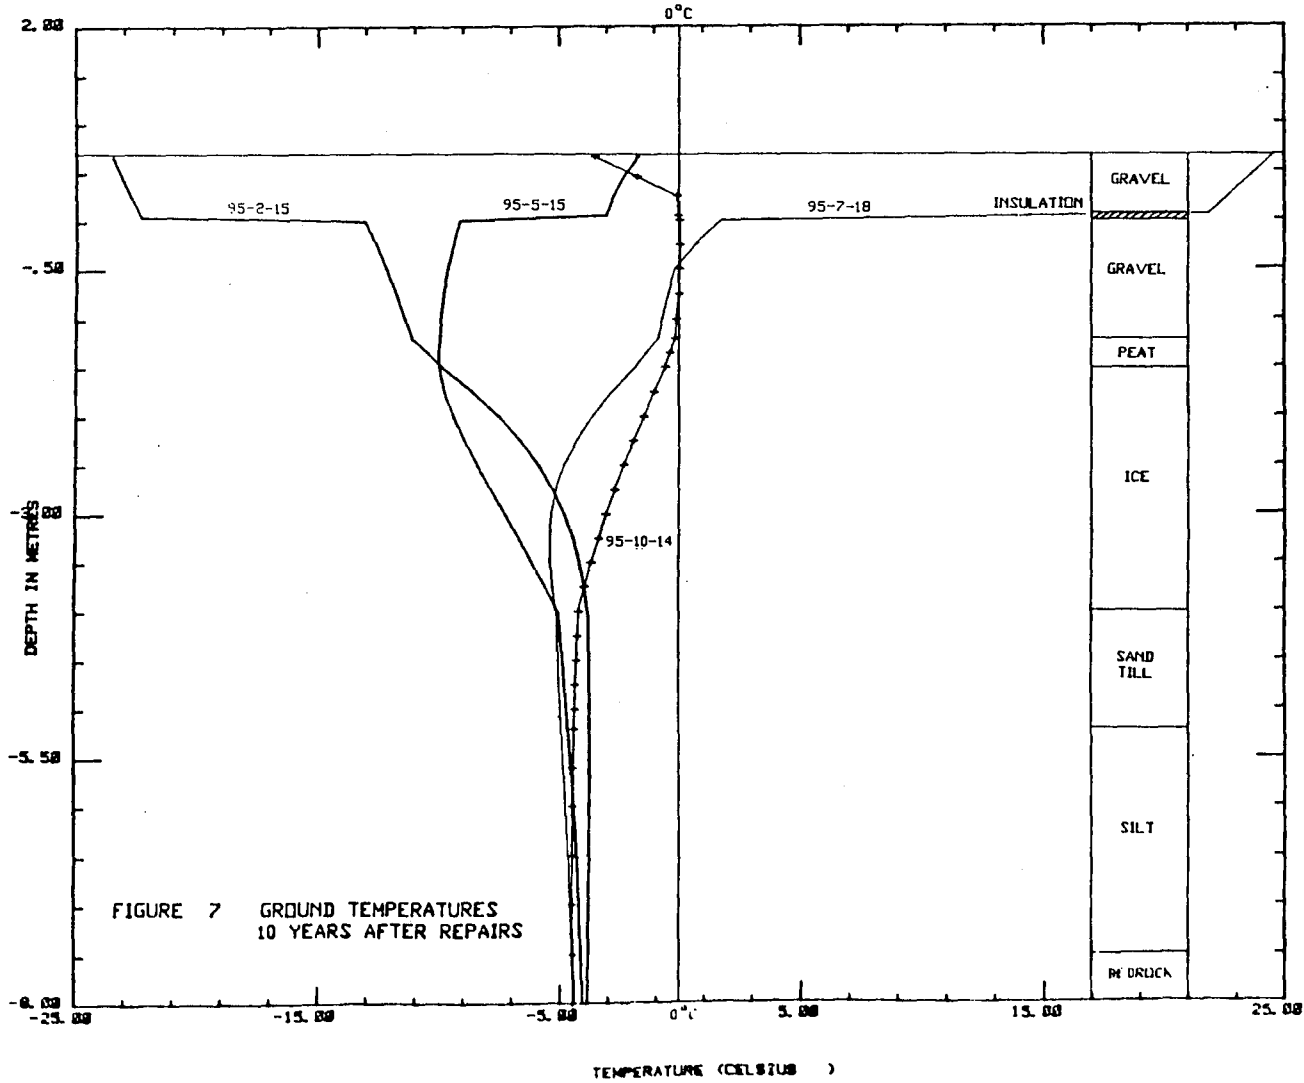
4551bh05d04- Dempeter Highway B.H. 5 Analysis 10 yrs. run
 TEMPERATURES AT X= .00 SECTION

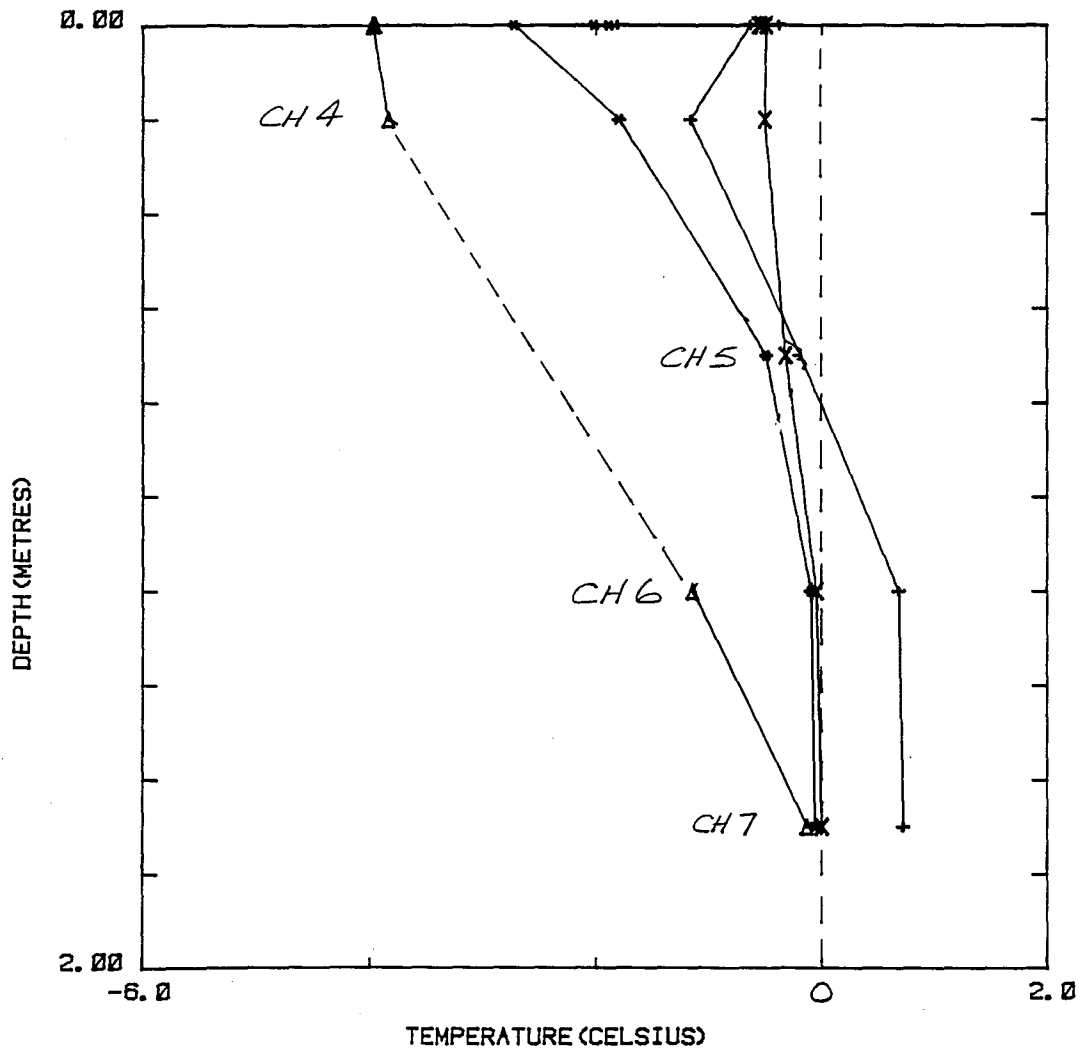
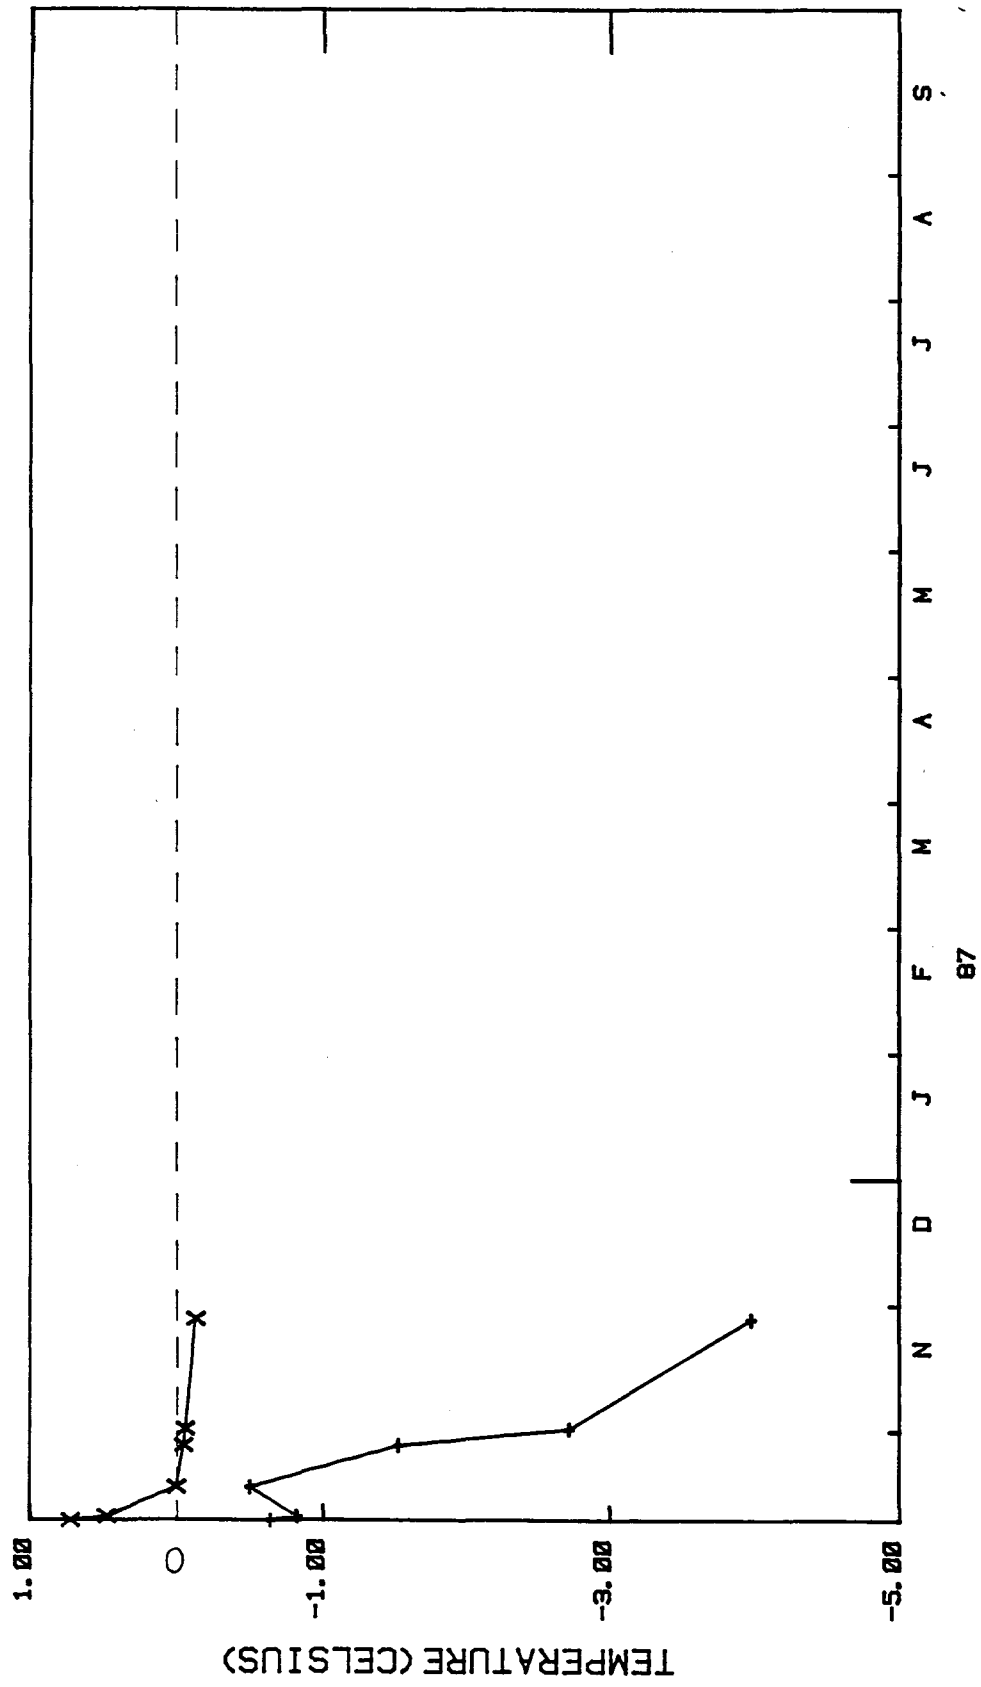
THERMISTOR NUMBER 0660

DATE INSTALLED 86-10-9

+	86-10-9
x	86-10-17
*	86-10-31
Δ	86-11-27

+ 0.00 METRE DEPTH
 X 1.70 METRE DEPTH

A program to monitor ground temperatures below the insulation layer was recommended and implemented to verify performance of the system. Installation of two thermistor cables on October 9 and data collected to date is presented in Appendix B. As-built drawings that adequately represent the design developed for km 8.5 are included in Appendix A.

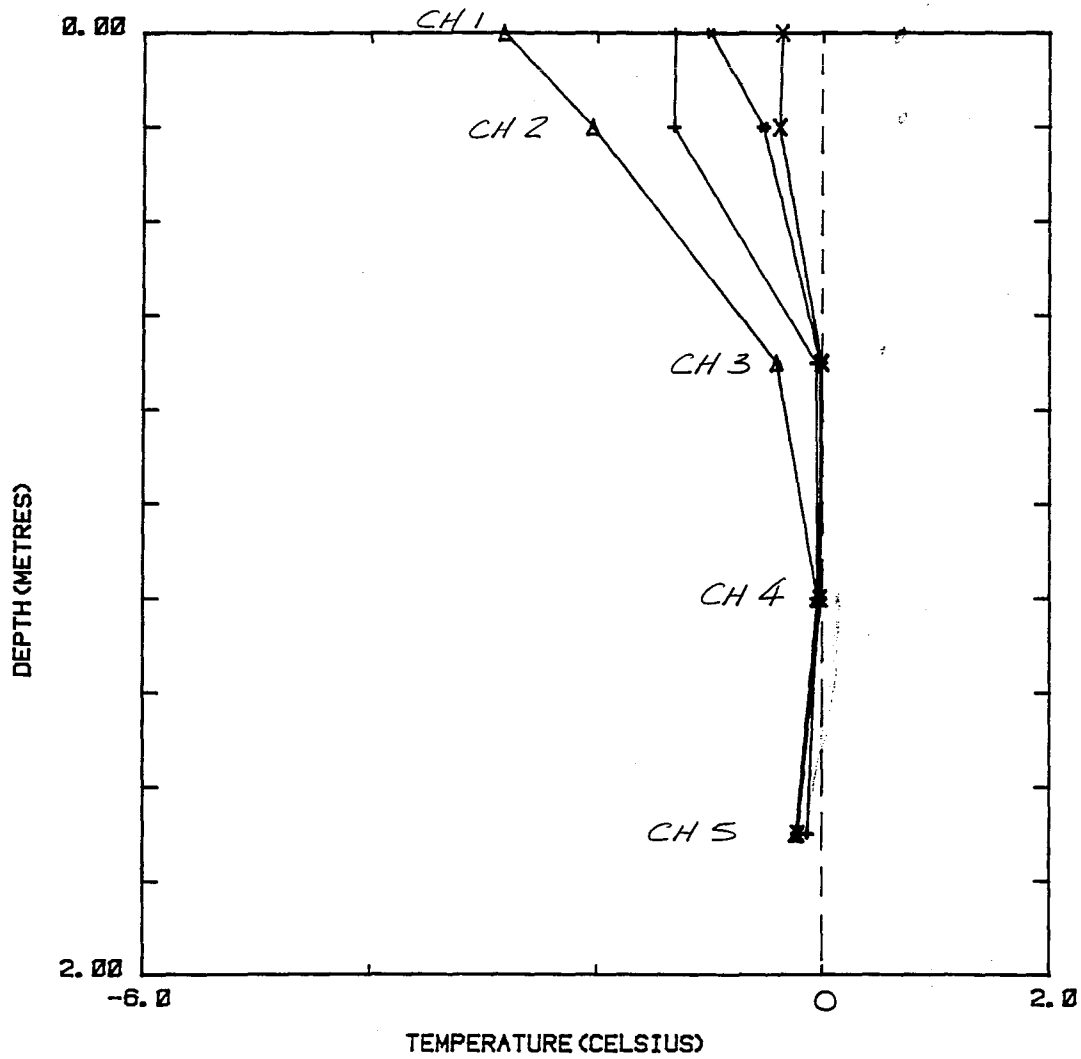
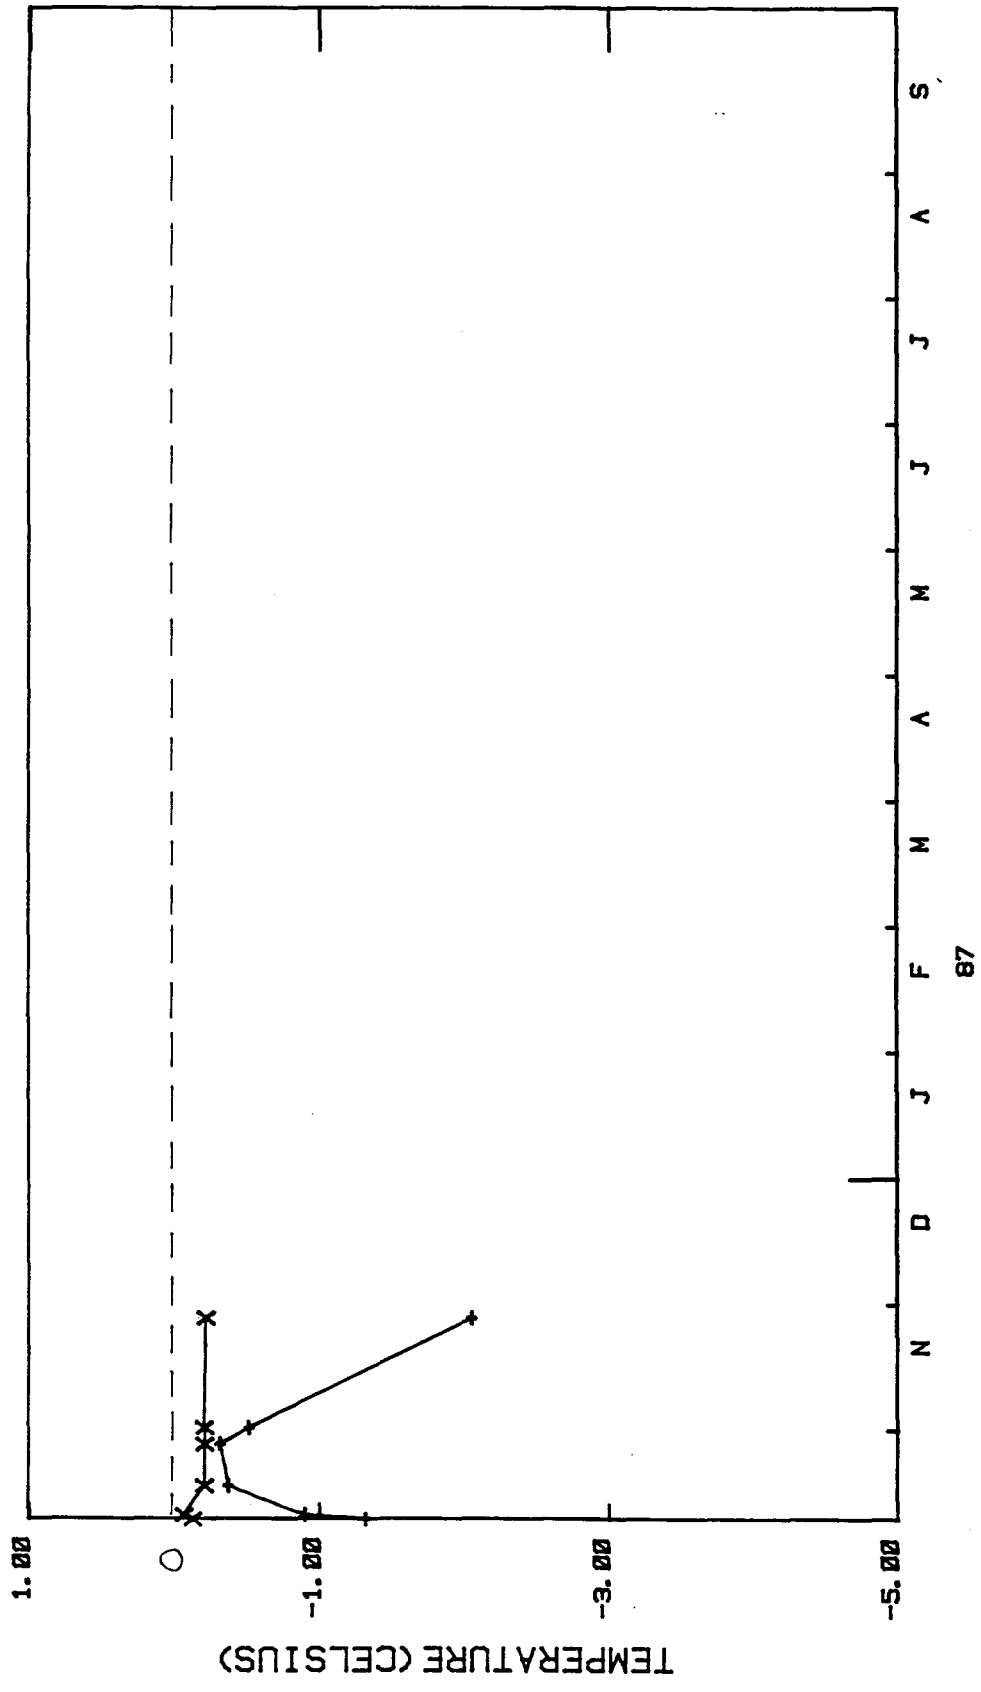
THERMISTOR NUMBER 0661

DATE INSTALLED 86-10-9

- + 86-10-9
- x 86-10-17
- * 86-10-31
- A 86-11-27

+ 0.20 METRE DEPTH
 x 1.70 METRE DEPTH

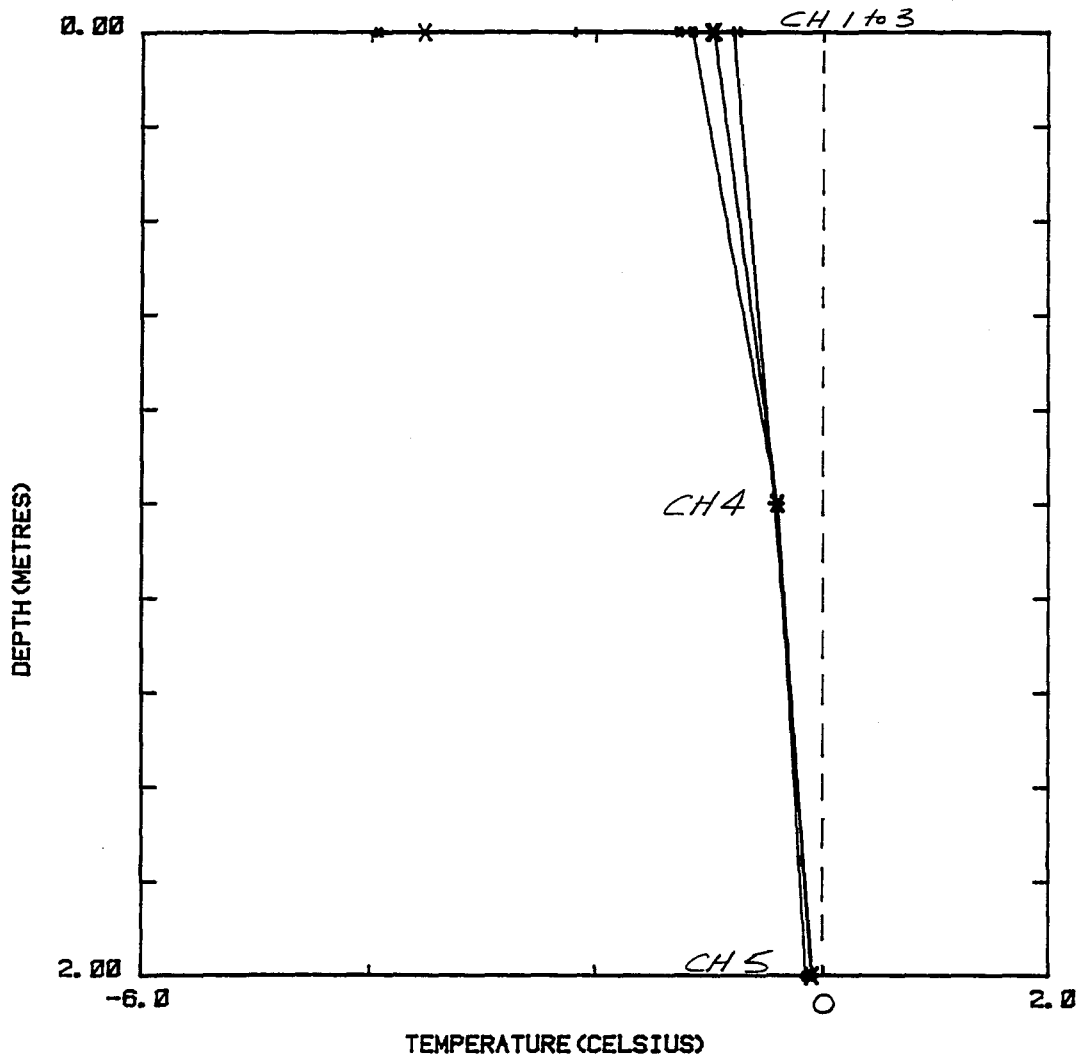
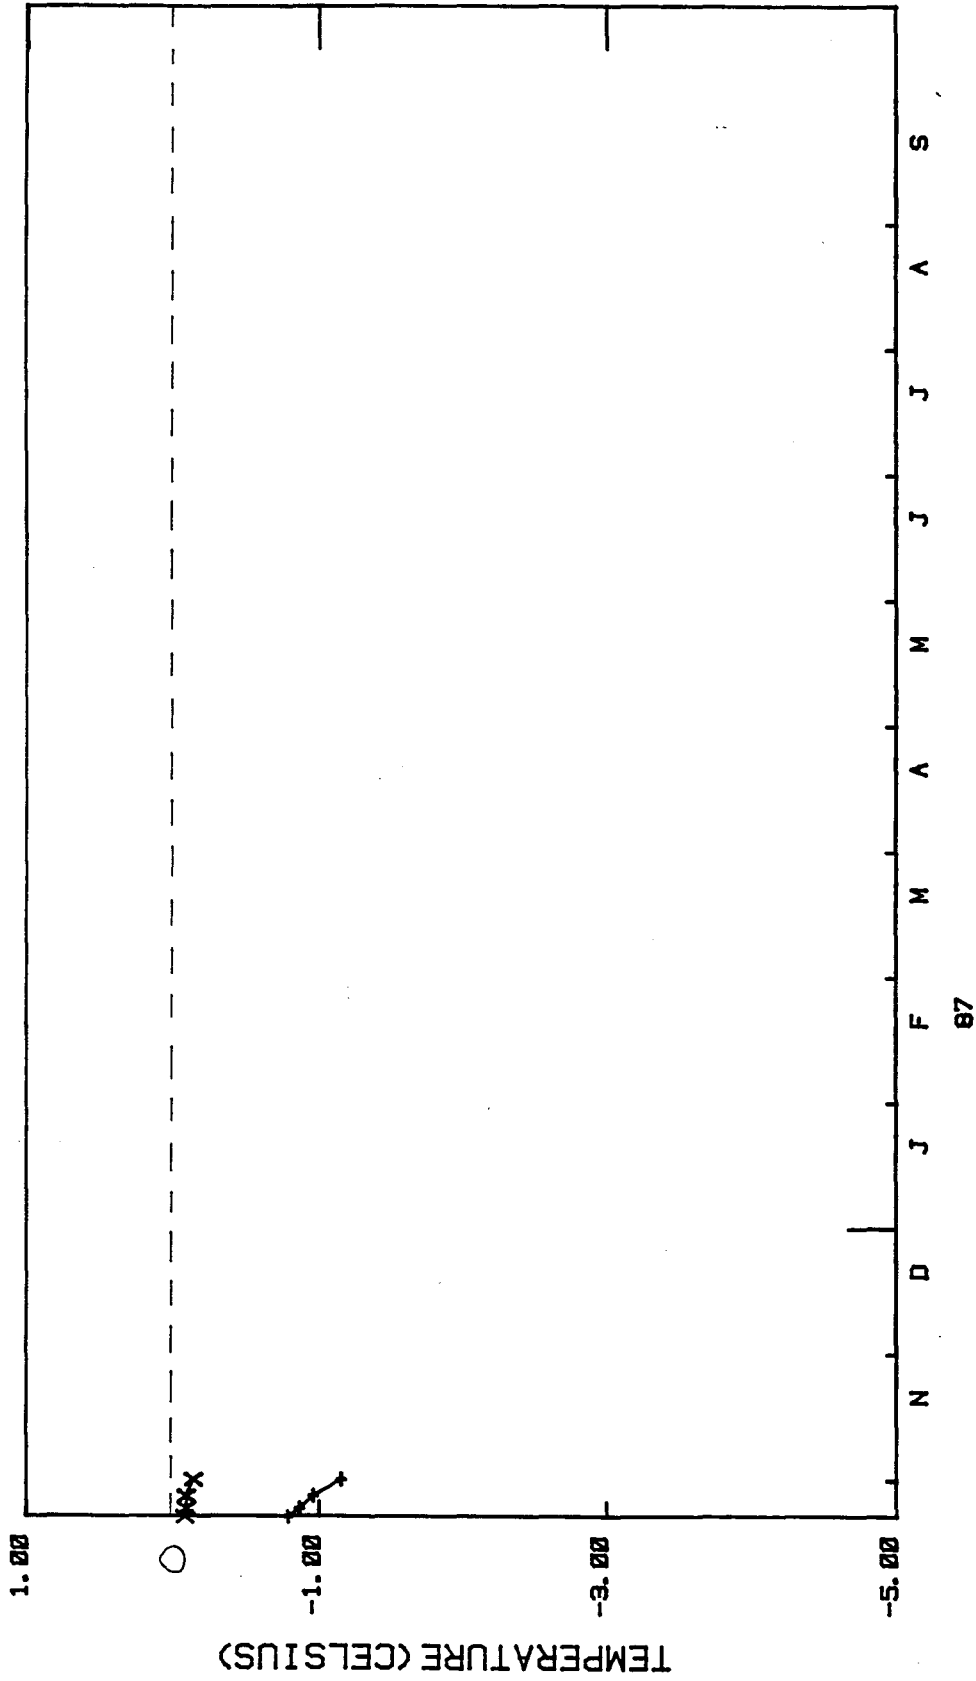
THERMISTOR NUMBER 0662

DATE INSTALLED 86-10-22

+ 0.00 METRE DEPTH
 X 2.00 METRE DEPTH

buttress the slope of the existing embankment. At km 50.9, a thermistor cable located beneath the toe insulation will allow monitoring of the effectiveness of the berm at arresting progressive thaw of the permafrost.

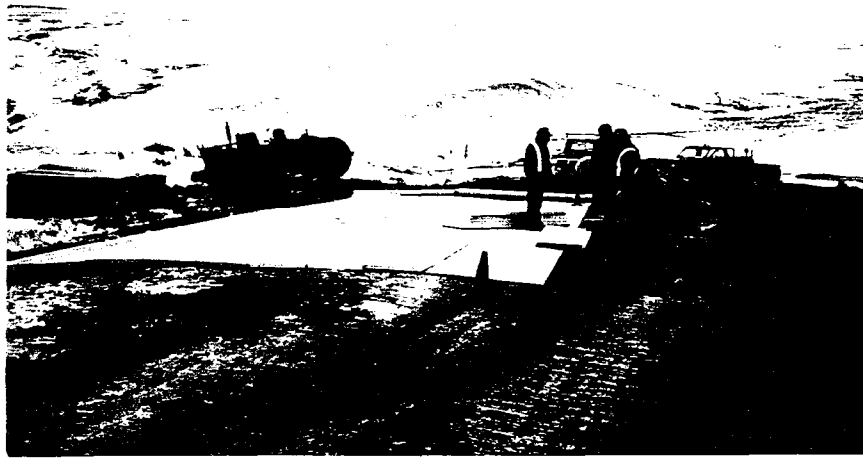
KM 8.5 PLACING GEOTEXTILE AND 50 mm
INSULATION IN RIGHT LANE -
LOOKING WEST

At km 8.5 construction repairs were initiated by regrading approximately 60 m of highway and prepare the surface for placement of geotextile and insulation. During regrading, two holes were drilled in the subgrade at the backfilled sinkhole location and thermistor cables were installed. The subgrade buildup was started on the right lane by first placing Propex I-996 geotextile on the leveled road surface. HI 60, rigid 50 mm polystyrene insulation, was placed directly on the geotextile. The joints of adjacent rows of insulation were staggered to prevent gaps from occurring during placement of the overlying gravel fill. The gravel was placed in 200 mm lifts and compacted by driving loaded gravel trucks over each lift until no more wheel ruts appeared. The vibratory drum roller was used when it was serviceable. Traffic was diverted to the right lane once all geotextile, insulation and the first lift of compacted fill were in place. The left lane was constructed in the same fashion. The final 200 mm lift was placed and compacted and prepared for the topping course. A topping course of crushed gravel was placed in one 150 mm lift. Grading was completed with a grader and compaction was accomplished using a vibratory compactor. The final measurements and quantities, and details of the thermistor cable configuration are presented on Drawing No. 1 in Appendix A.

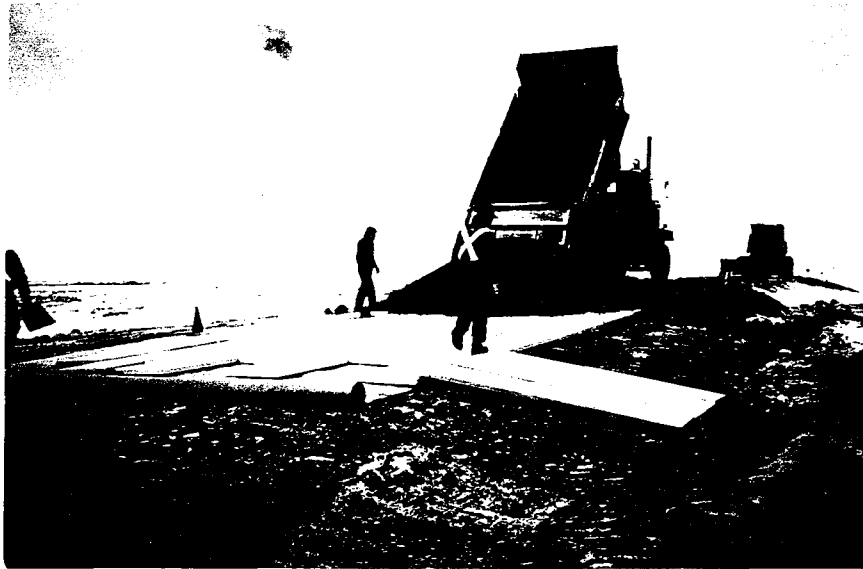
KM 8.5 PLACING LIFT OF FILL OVER GEOTEXTILE
AND INSULATION IN RIGHT LANE -
LOOKING EAST

Placement of the insulation was easily attained. Minor sliding of the insulation during the fill covering process was reduced by carefully directing the dozer operator. In some areas minor gaps (less than 300 mm) between boards of insulation exist. The plans and specifications were complete with only minor discrepancies. It was observed; however, that some of the profiles varied from those on the drawing.

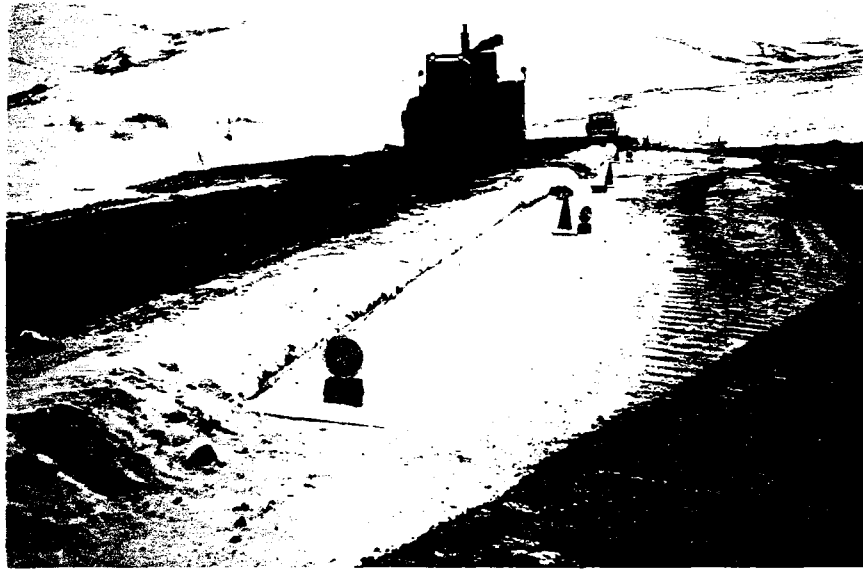
KM 8.5 FIRST LIFT OF FILL OVER GEOTEXTILE
AND INSULATION ON RIGHT
LANE - LOOKING WEST

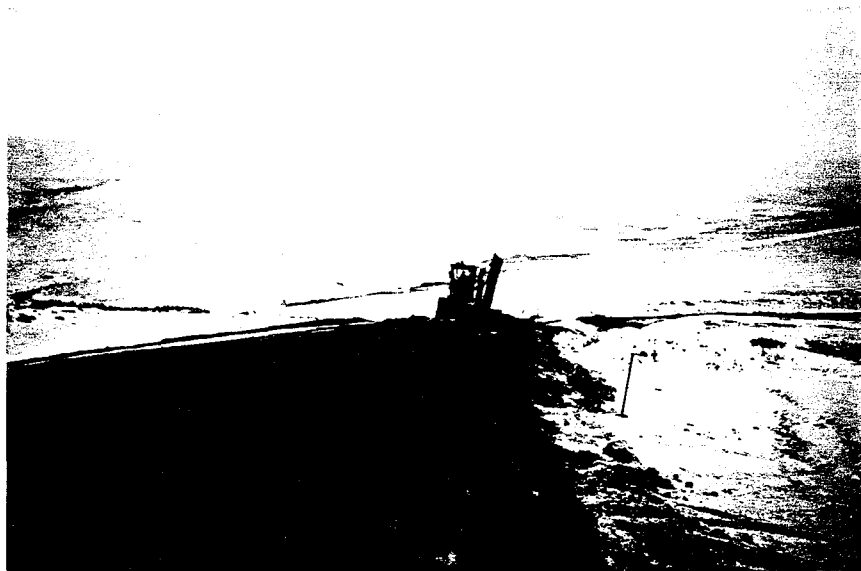
KM 8.5 FINAL SHAPING OF SURFACE TOPPING
COURSE - LOOKING WEST

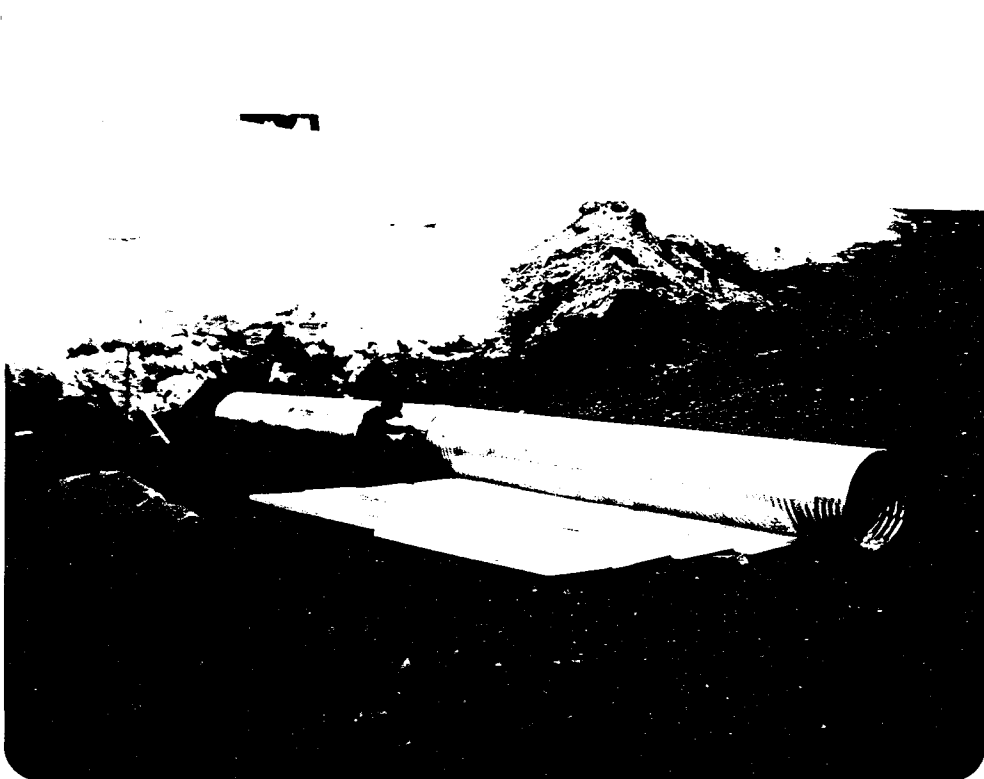
KM 46.9 INSTALLATION OF CULVERT EXTENSION
AND PORTION OF 50 mm INSULATION

The culvert foundation pad at km 46.9, could not be constructed as specified on the design drawings. Frozen ground was encountered in the middle of the excavation for the extension and proved to be too difficult to remove. The unfrozen ground in the culvert extension excavation was extremely soft and a backhoe was required to complete the excavation. The dozer was initially used, but became stuck in the soft silt and clay. An approximate profile showing the lobe of frozen ground remaining below the culvert extension is included on the as-built drawing, for km 46.9, in Appendix A.

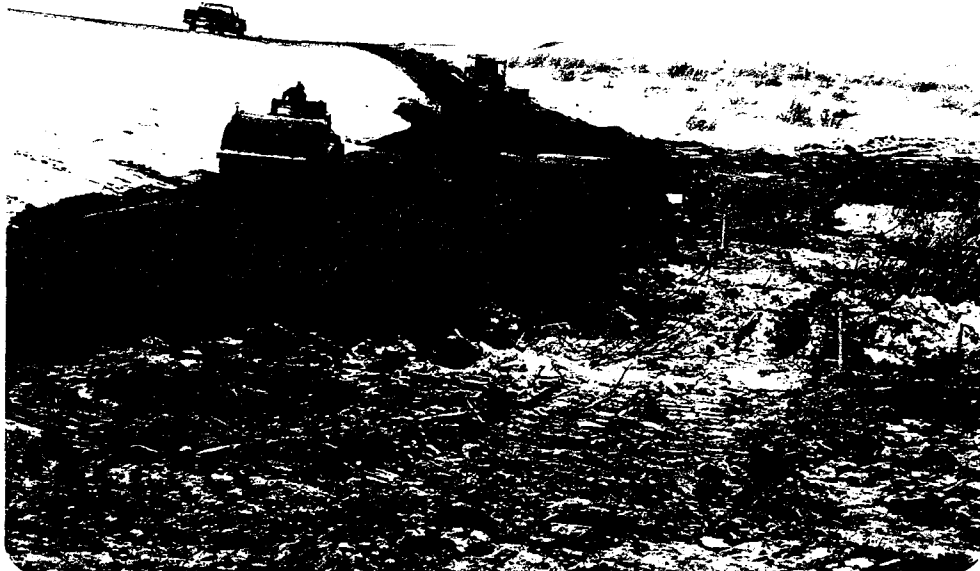
KM 46.9 PLACING FILL AT TOE BERM

At km 46.9 construction of the toe berm commenced by constructing an access ramp to the toe berm area, on the south side of the highway. A 12 m extension to the existing culvert was necessary prior to fill placement. Approximately 1.5 m of soft silty clay was excavated from beneath the culvert extension and replaced with granular fill. Several old spoil piles, located at the toe of the slope, were removed from the toe berm site and leveled in an area southeast of the toe berm.
