PROJECT CONSTRUCTION REPORT
PROJECT NO. 85-9207
CONTRACT NO. 86-1137-01

EQUIPMENT RENTAL,
DEMPSTER HIGHWAY GRADE REPAIR
km 8.5 to km 50.9
DEMPSTER HIGHWAY (NO. 8) N.W.T.

EBA ENGINEERING CONSULTANTS LTD.
EDMONTON, ALBERTA

December, 1986

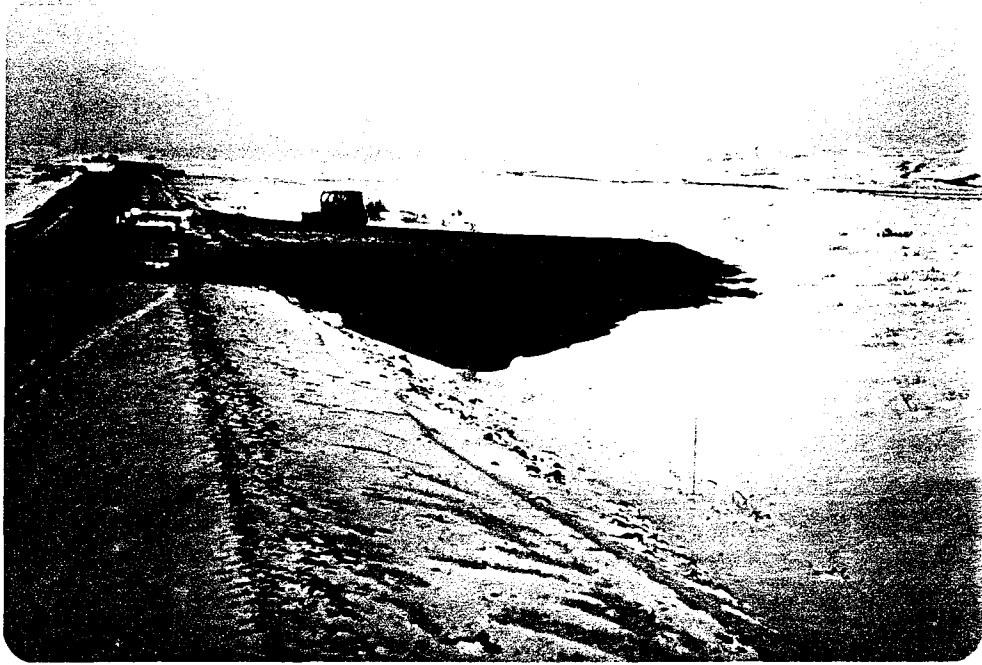
KM 50.9 PLACING FILL AT NORTH SIDE OF
HIGHWAY - LOOKING WEST

At km 50.9 it is likely that additional fill will be required in the old pond area on the north side of the highway. Fill was placed over the snow and ice in the pond. Some settlement did occur during fill placement; however, more settlement is expected. Fill should be added to prevent ponding once settlement occurs in the spring. Reshaping along the toe of the new berm, on the south side of the highway, may be necessary in the spring once the snow melts. The final shaping of the berm took place during blizzard conditions and consequently, areas requiring levelling may have been missed because they were covered with snow. A thermistor cable was installed beneath the insulation, and it was recommended that temperature readings be taken each month for the first year and the readings forwarded to EBA.

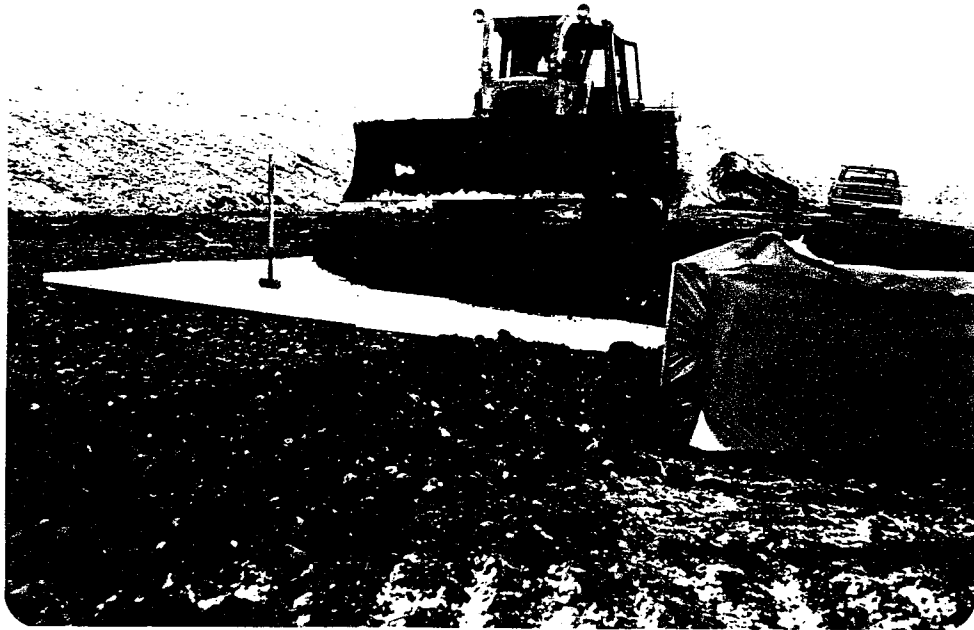
KM 50.9 PLACING LIFT OF FILL OVER
50 mm INSULATION

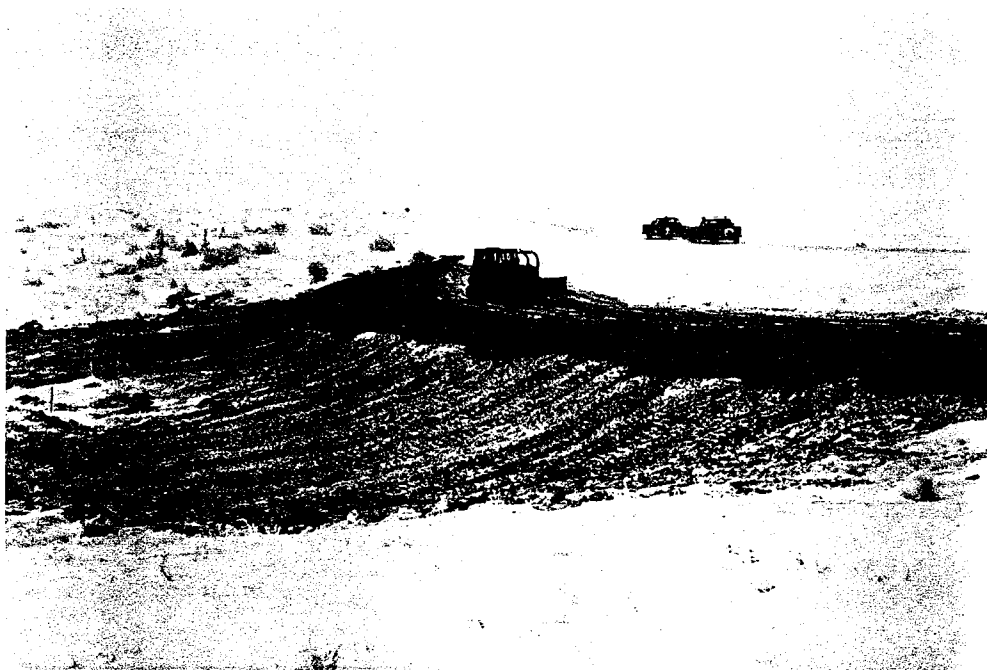
KM 50.9 FINAL SHAPE OF TOE BERM
SOUTH SIDE OF HIGHWAY
LOOKING WEST
