**GEOTECHNICAL SERVICES  
ROCK QUARRY INVESTIGATION  
km 134.5 Dempster Highway # 5  
Yukon, 1998**

**REPORT NO: 8002-251**

**June 16, 1998**

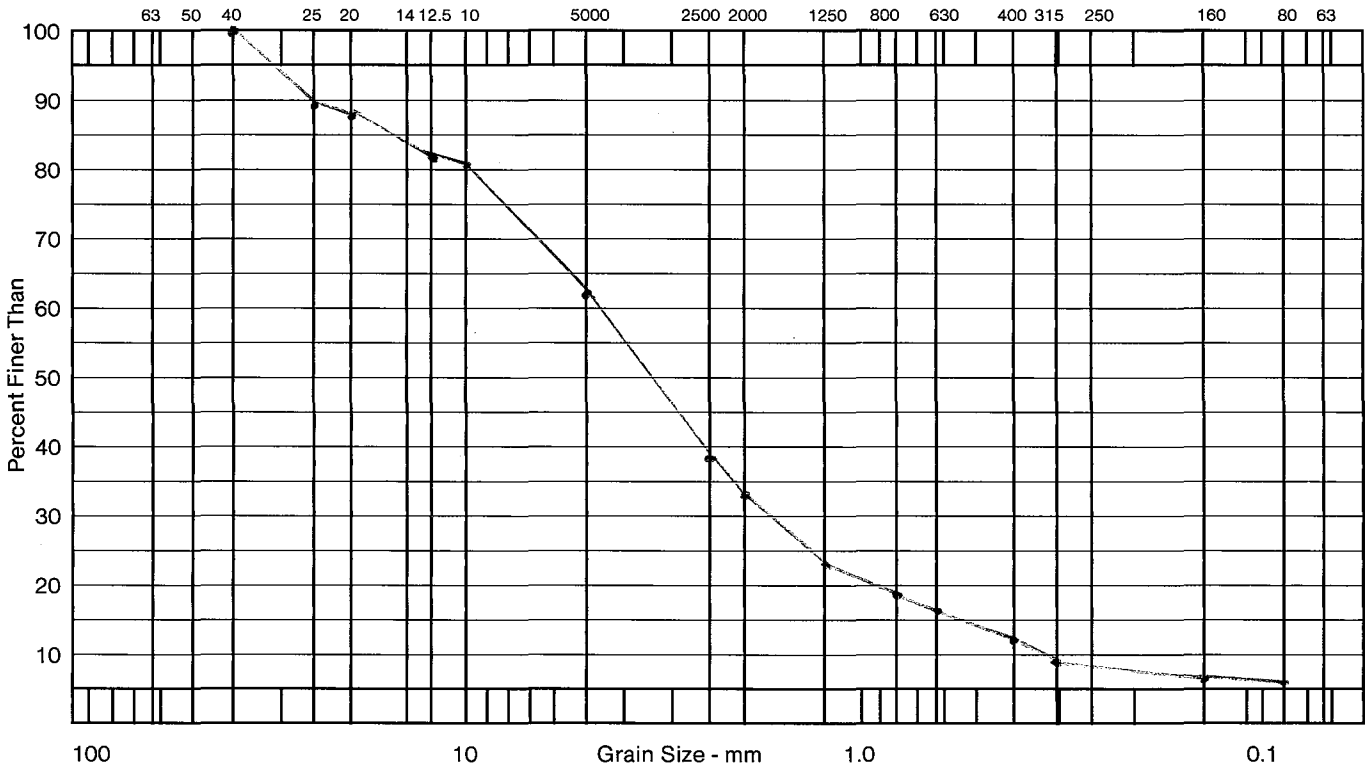
Description of Sample \_\_\_\_\_ Method of Preparation \_\_\_\_\_ Dry \_\_\_\_\_ Washed X  
 Remarks \_\_\_\_\_  
Gravelly sand - trace to some silt  
SM  
 Time of Sieving \_\_\_\_\_ Min. 15  
 Gravel: 37.6%  
 Sand: 56.8%  
 Fines: 5.6%  
 Moisture: 9.4%

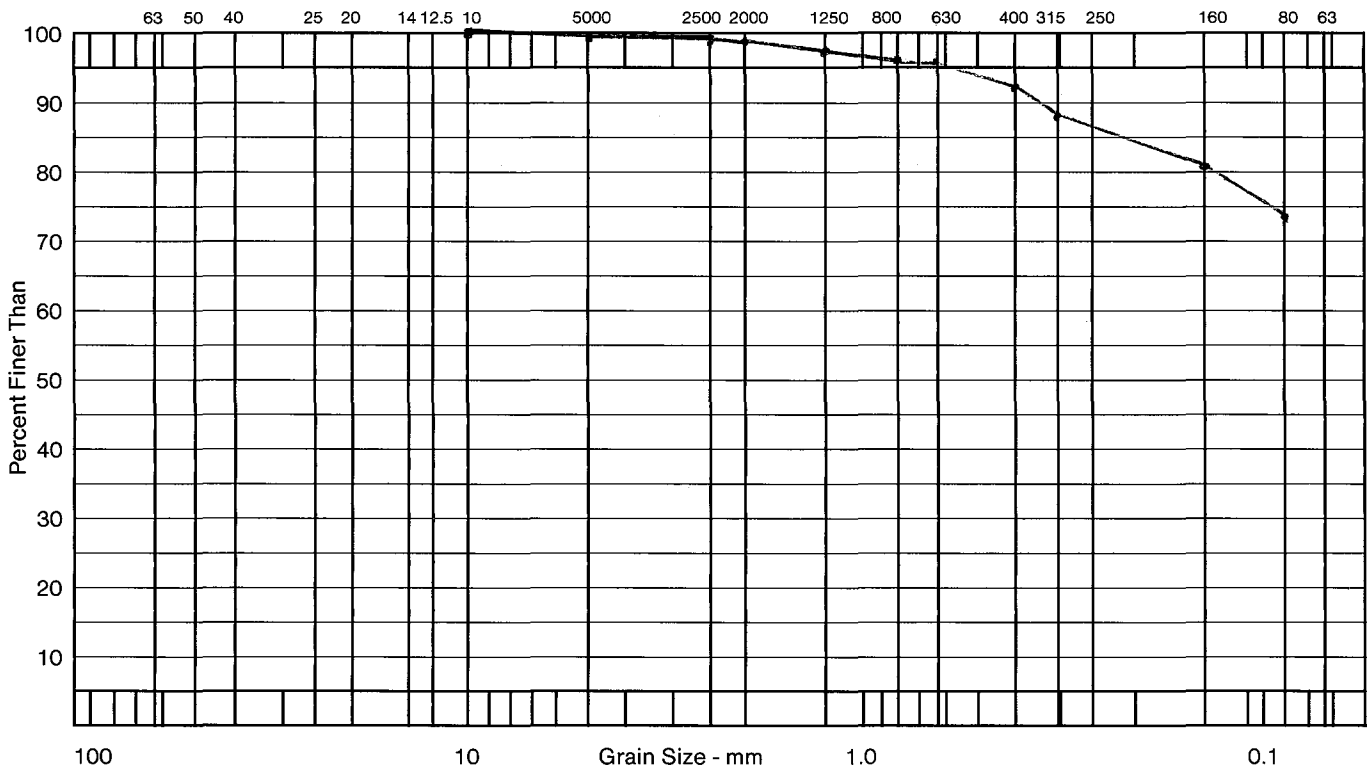
Description of Sample Sandy silt Method of Preparation \_\_\_\_\_ Dry \_\_\_\_\_ Washed  ML  
 Remarks Gravel: 0.4%  
Sand: 25.4%  
Fines: 74.2%  
Moisture: 38.1%  
 Time of Sieving \_\_\_\_\_ Min. 15

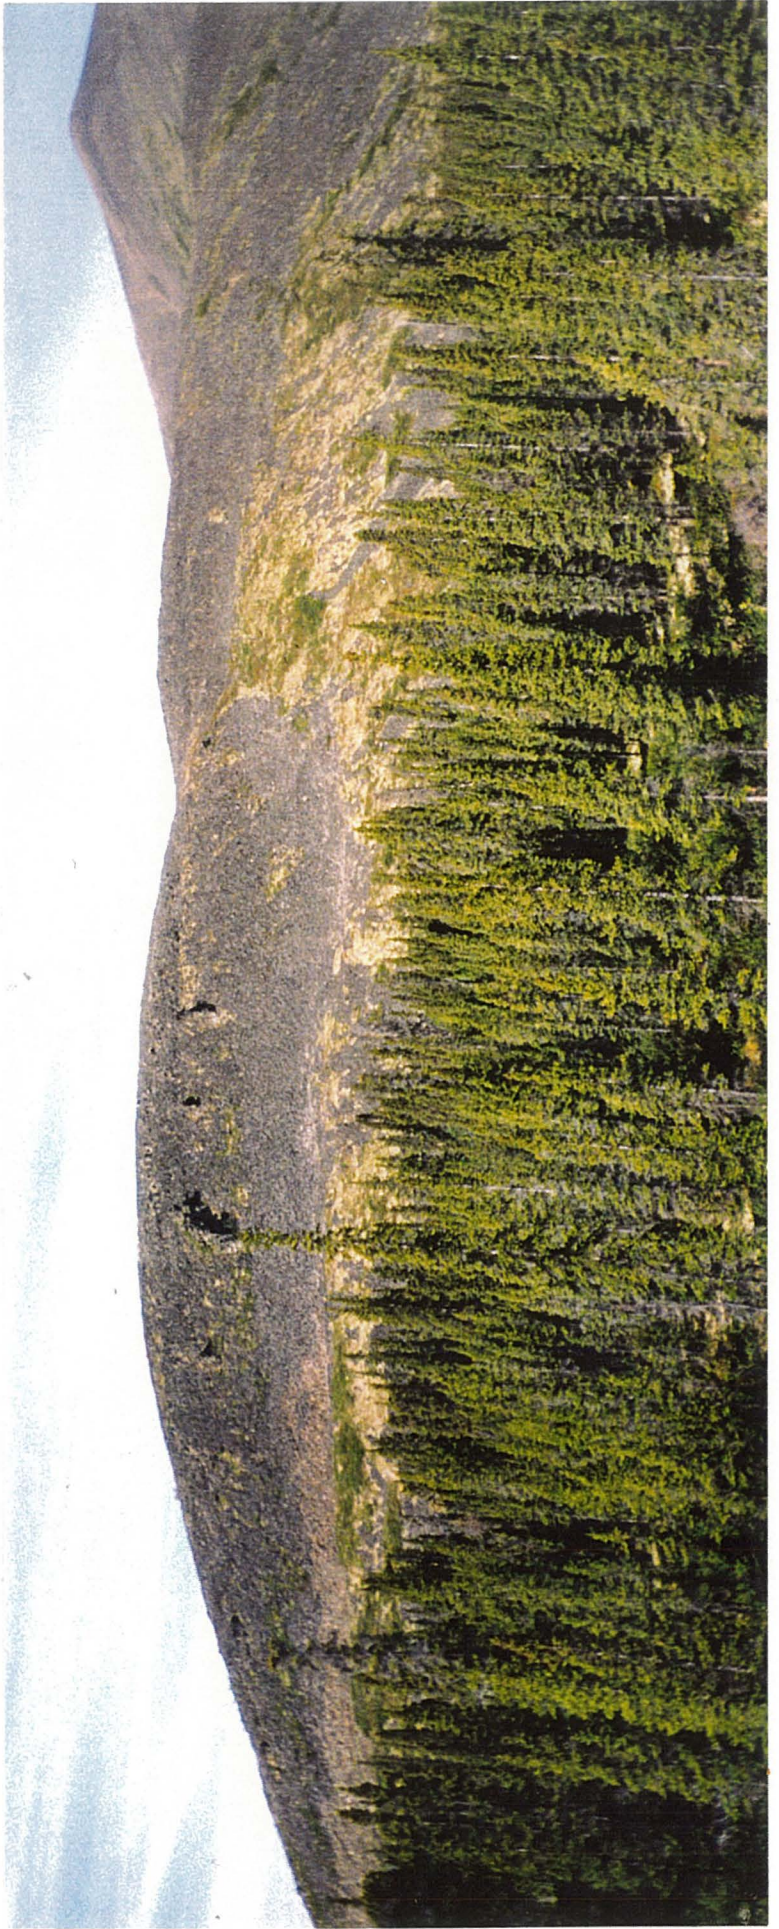
Photo # 1 - Below

A limited amount of vegetation along the exposed slope was noted as shown in photo # 1-98. Traversing west across mid-slope, very limited vegetation was encountered until approximately 175 meters into the site. At this location, lichen and a limited amount of moss was encountered. At 380 meters into the site, established grasses, shrubs and mosses were encountered to the western edge

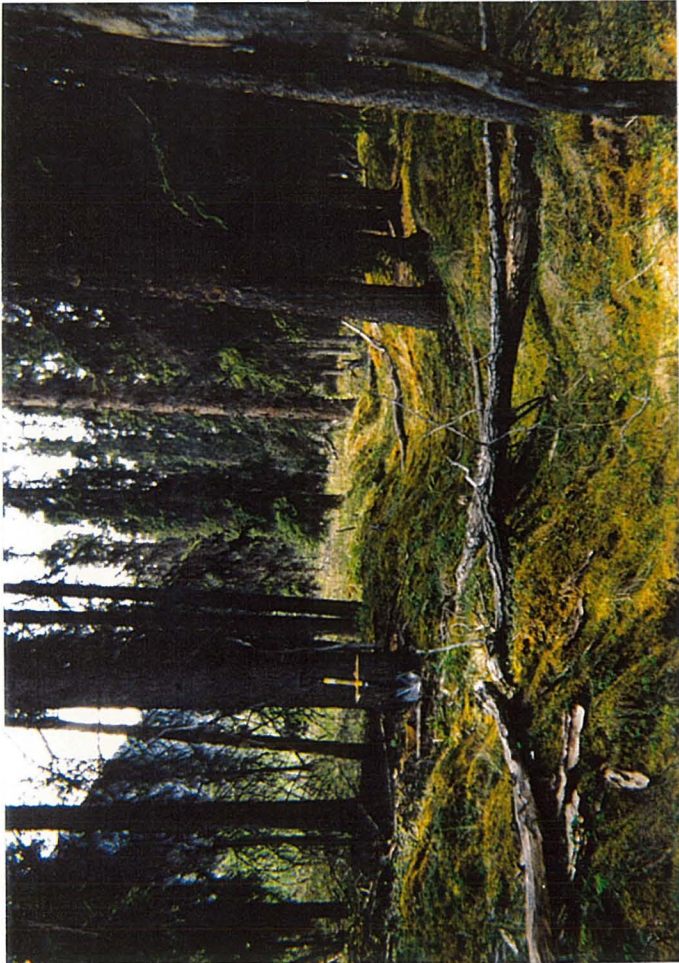
Photo # 2 - Left

of the site. Vegetation along the eastern portion of the lower terrace consisted of similar vegetation. Vegetative conditions along the western portion of the lower terrace consisted of sphagnum and free standing water over frozen materials extending to unknown depths. A sparse to medium dense ancient growth pine forest, with a surficial organic mat (approximately 0.2 meters thick) and odd bush, was located within the alluvial fan as shown in photo # 2-98.

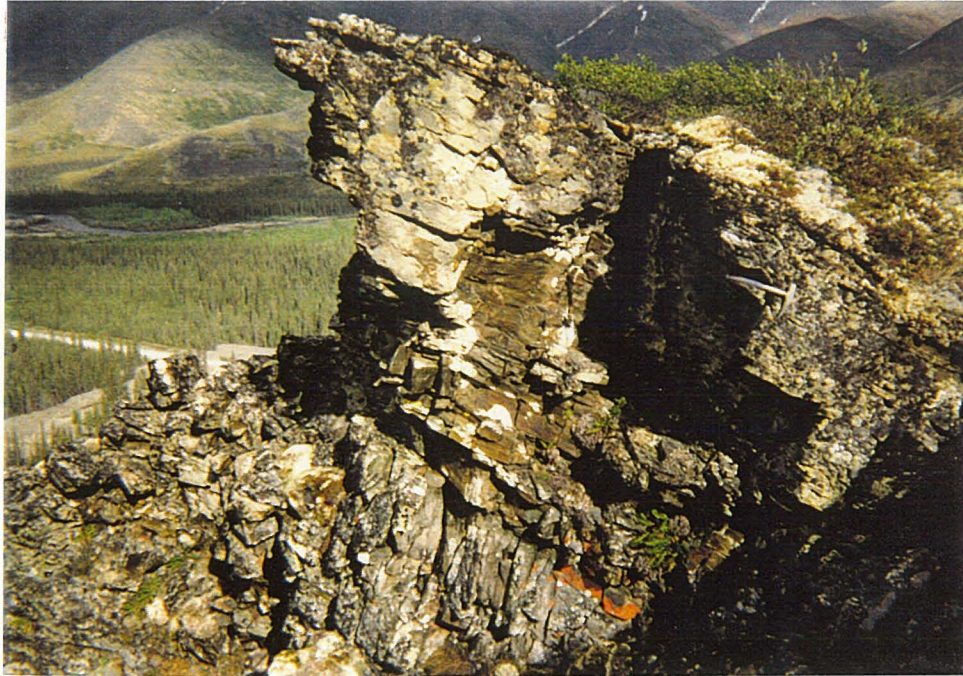
**Photo # 3**

All the rock outcrops noted near the top of the slope appeared to be comprised of slate. The outcrops were commonly bedded with discontinuities propagating both vertically and horizontally, as shown in photos # 3-98 & # 4-98. From field observations, it was noted that the most commonly oriented joint set were those striking approximately east-west and dipping to the south at approximately 18 to 30 degrees. Joints spacing in some locations was as frequent as 1 per 0.005 meters with 0.2 meters being nominal. Infilling was not observed at the site with the exception of toppling failures where the infilling consisted of voids near the surface with a small amount of detritus at the base of the fracture. Three major discontinuities were recognized within the rock outcropping forming a block jointed structure. Generally the steep sloping faces of the outcrops had strikes east/west and dips ranging from 70 to 90 degrees to the north. The top surface of the block joints generally had strikes east/west with dip angles ranging from 18 to 30 degrees to the south. The exposed eastern and western faces of the outcrops had southern strikes (+/- 15 degrees) with dips approximately vertical.
