GR-05-034

Dempster Highway Aggregate Survey, km 193 - km 347

EXECUTIVE SUMMARY

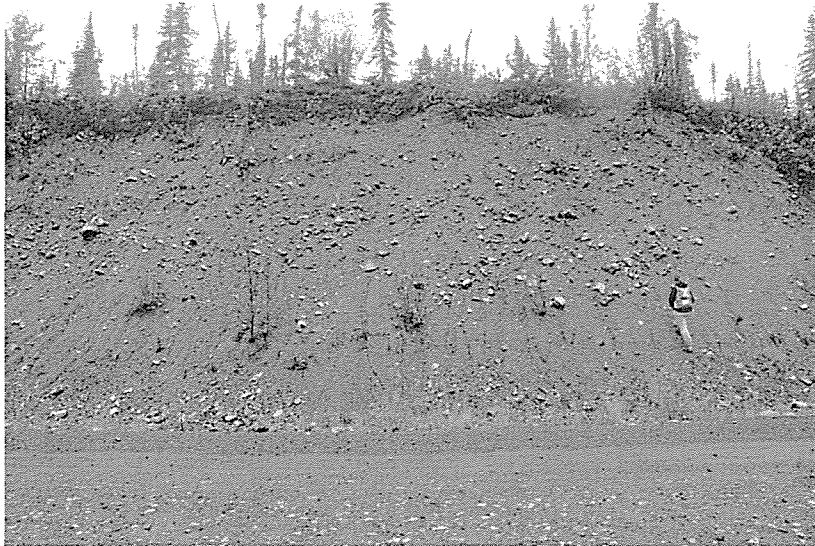
Figure 5: Reid aged (At2) terrace at km 193.3.

Intermediate terrace ranging from 2-3 m's to ~10 m above road (Figure 5).

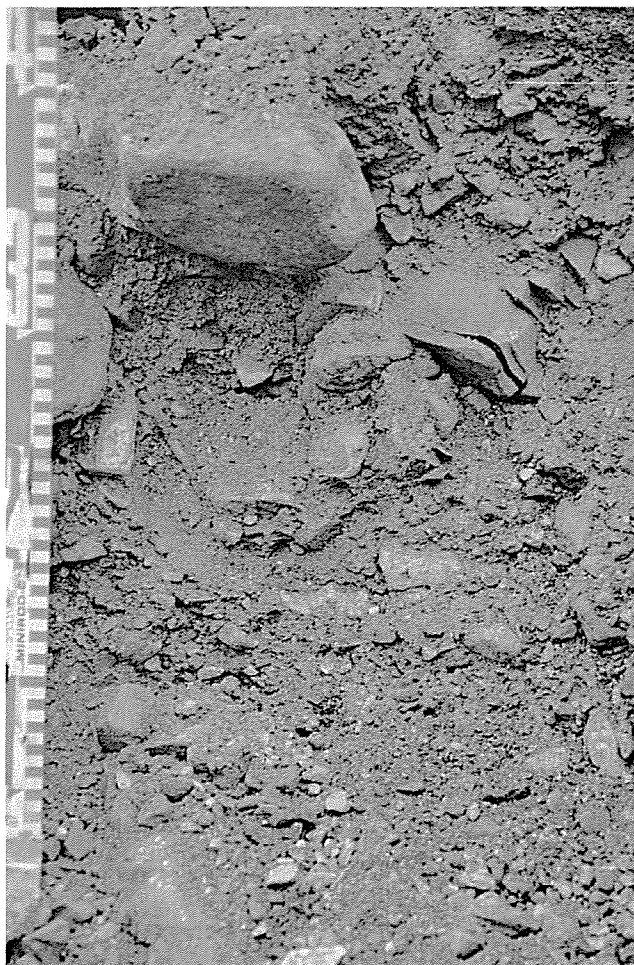
Figure 6 Detail of Gravel at km 193.3.

Bouldery Gravel (Figure 6)

Clasts subangular to subrounded with low sphericity. Numerous boulders present, dominantly cobbles and pebbles. Matrix medium to coarse sand.

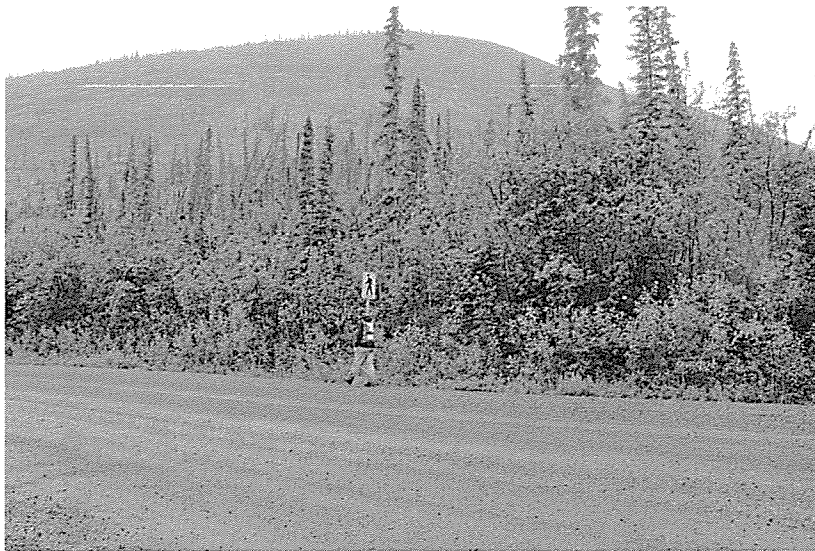
Figure 7: Likely a gravelly alluvial fan at km 199.

Treed surface ~10 m about river (Figure 7). Likely a gravelly alluvial fan. This surface would be underlain by sand and gravel and if aggregate is required in this area, it would be worth a test pit.

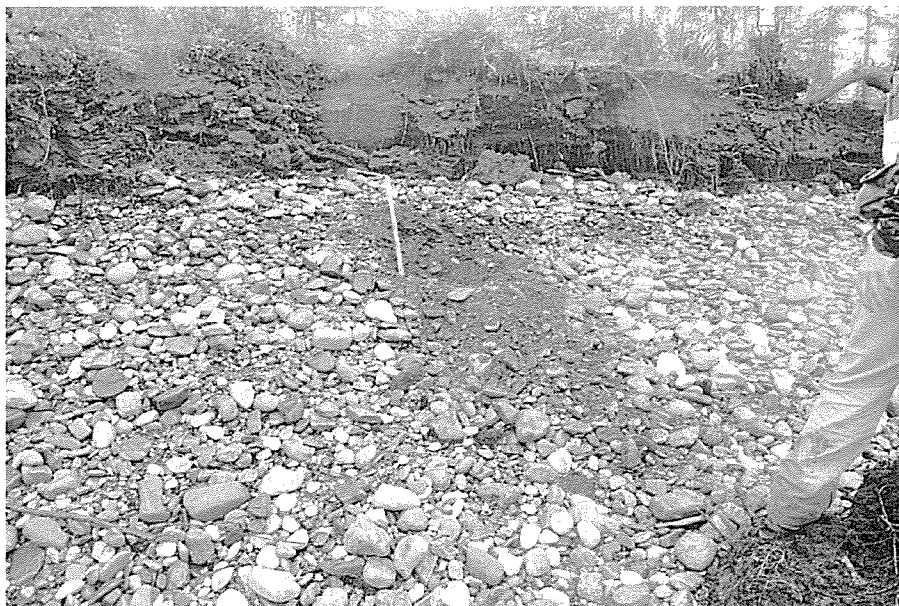
Figure 8: Exposure of gravel just below surface of low terrace approximately 4 m above river level.

Exposure in River bank (Figure 8) should reflect material under terrace.

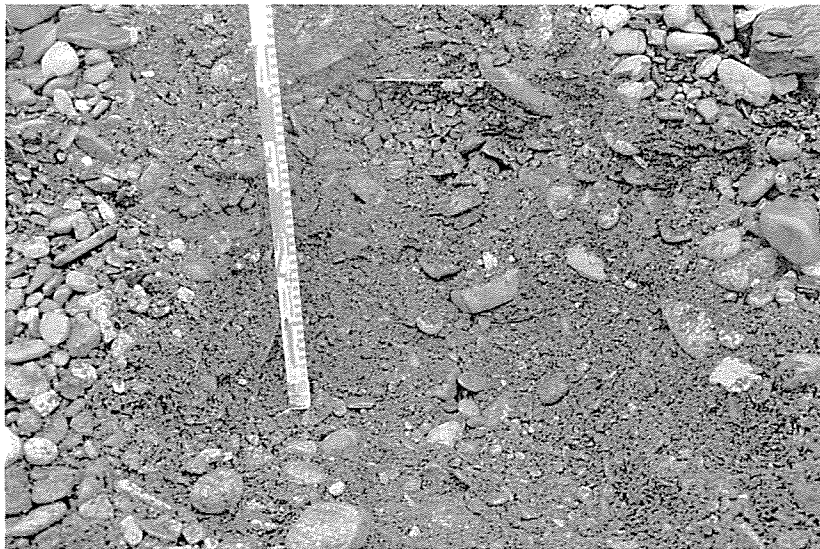
Figure 9: Detail of gravel in low, 4 m terrace at km

Pebbly gravel with a sandy granule matrix (Figure 9). Clasts subrounded, some platy, pebbles to cobbles with most clasts being in the small pebble range. Good mix of lithologies so would be good durable aggregate

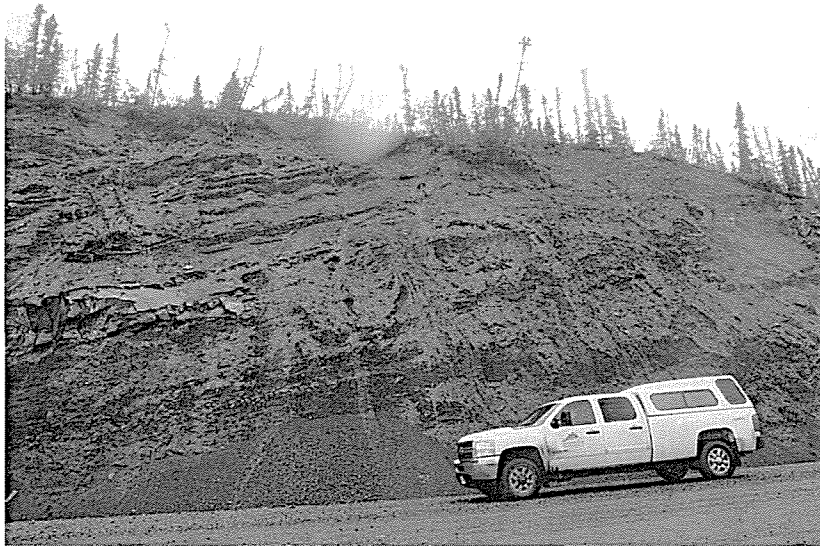
Figure 10. High terrace at km 221.6 mapped as Reid glaciation (At2)

High terrace mapped as Reid (glaciation before the last) glaciofluvial outwash (At2). Most of terrace exposed in roadcut is bedrock (Figure 10) with gravel of ~2 m on top. Access to gravel may be difficult.

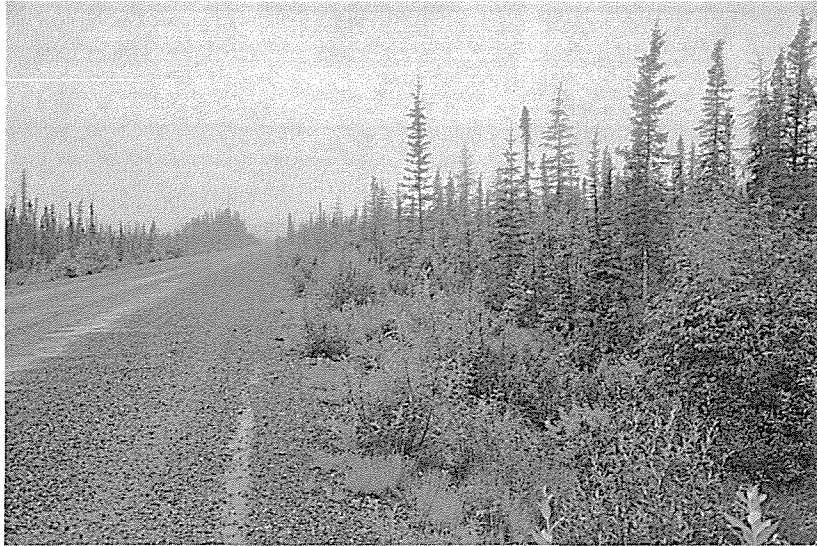
Figure 11: Large, low terrace surface that will be underlain by sand and gravel.

Large terrace surface (Figure 11). No exposures but sand and gravel will be under.

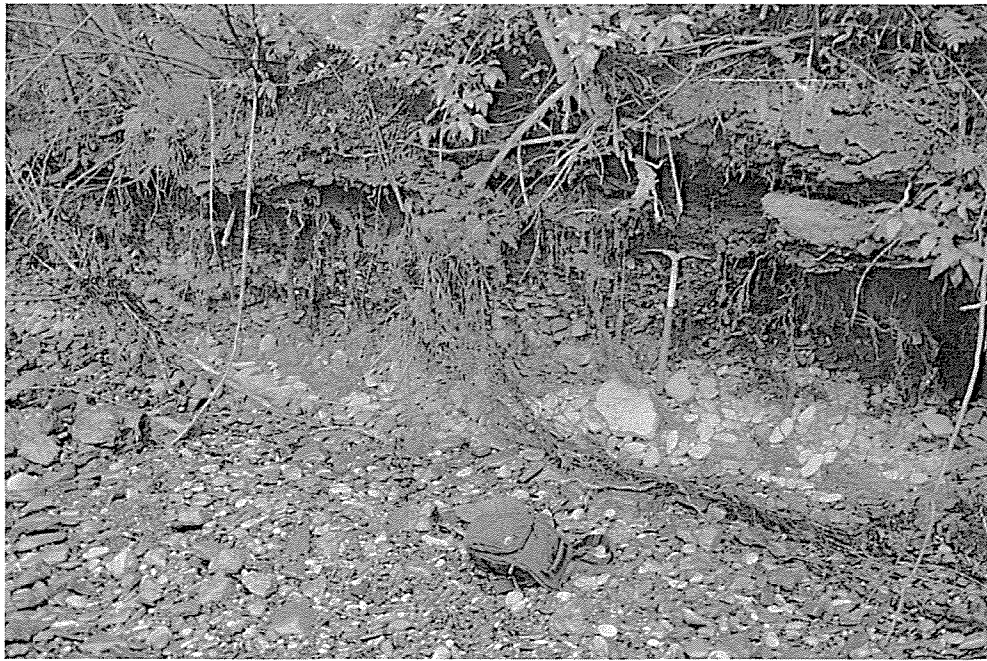
Figure 12: Exposure of gravel along river at km 228. Pick is ~60 cm long.

Exposure along river ~1 m of imbricate gravel (Figure 12). This is a window into the sediments that makes up terrace surface from km 221-224. Gravel is dominantly sub-rounded pebbles with a sandy granule matrix (Figure 13). Clasts appear competent.

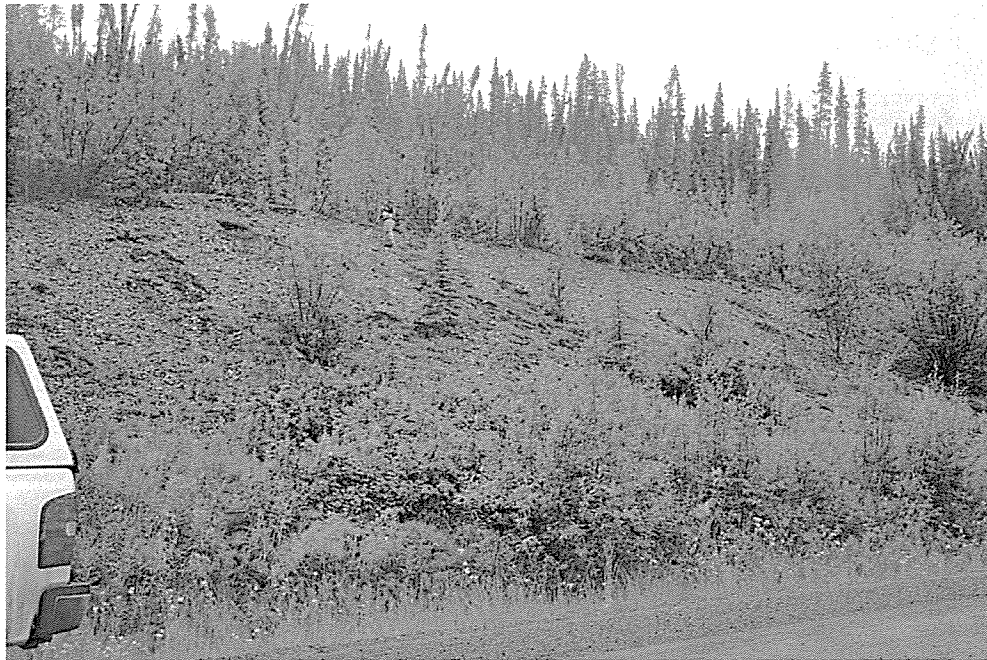
Figure 14: Small gravel terrace at km 242

Terrace ~9m above road (Figure 14). Not sure of extent back into slope, may only be 4 m, gravel exposed for at least 160 m along road.

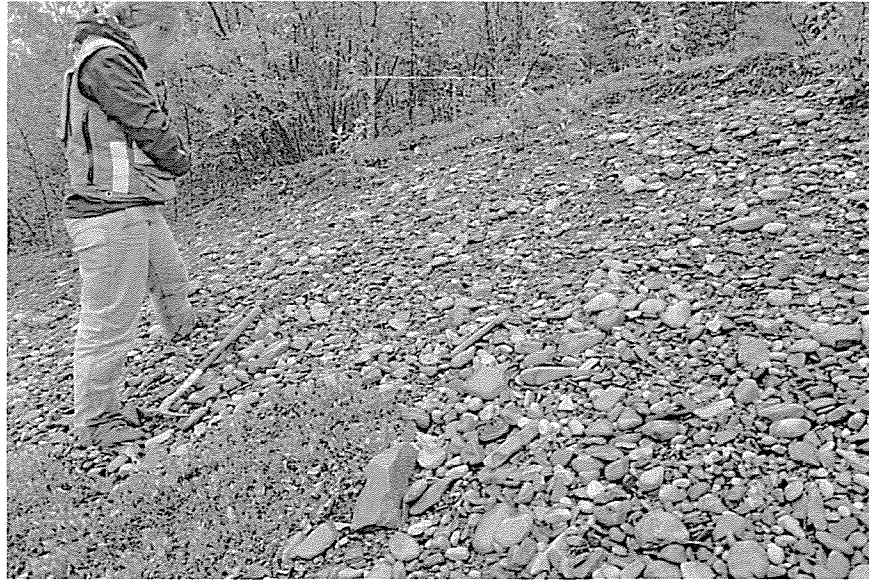
Figure 15: Gravel exposed in terrace at km 242.

Gravel: Clasts pebble to cobble, subrounded, some platy average size 1-2 cm, medium to coarse sand matrix (Figure 15). Clasts look competent - sandstone, siltstone and limestone. L.C. covered but >3-4 m thick.

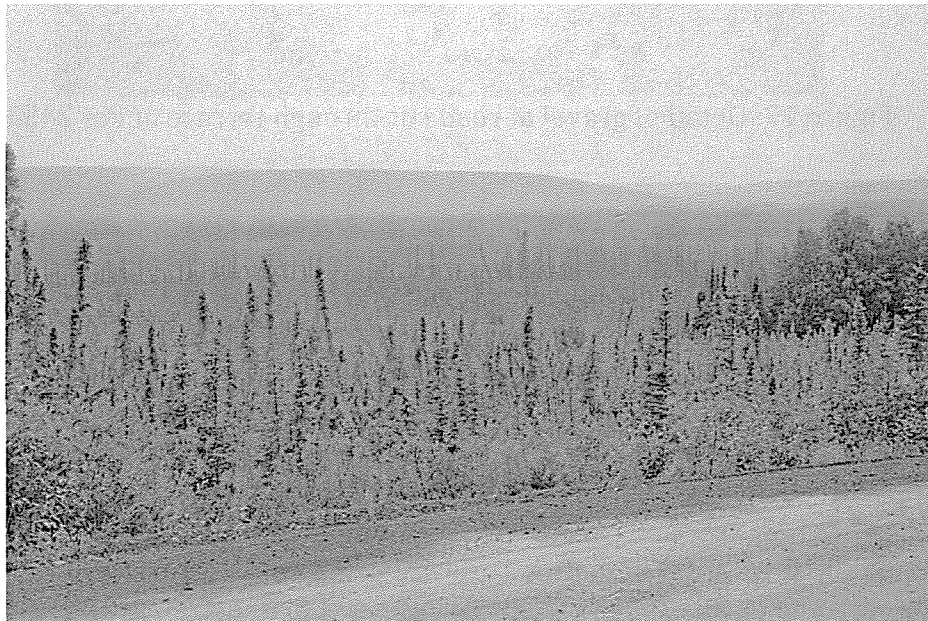
Figure 16: Large terrace at km 245.8.

The only potential gravel source associated with the highest priority area is just as the road starts to climb out of the Ogilvie valley at km 245.8. Here a large terrace feature contains gravel. The size of the terrace indicates a large source, but because many of the clasts are sandstone, the durability of the crushed aggregate would have to be evaluated.

Large alluvial terrace, likely associated with small creek coming in from hillslope.

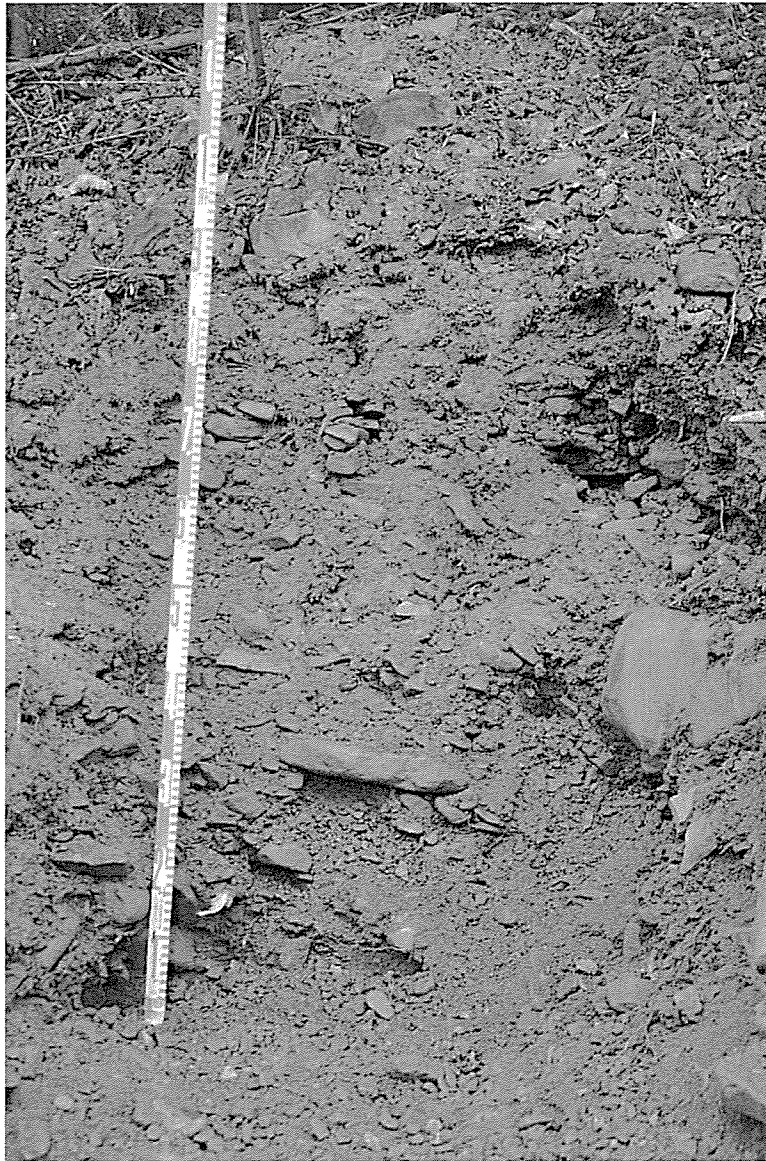
Figure 17: Detail of gravel at road cut through terrace at km 245.8.

Gravel, lower contact covered but at least 3 m thick. Clasts pebble to boulders up to 3—40 cm, average size ~ 3-4 cm, subrounded but majority platy. Most are sandstone, matrix dominantly sand. Weak horizontal stratification with silty-sandy matrix zones and some open work granules and very small pebble layers.

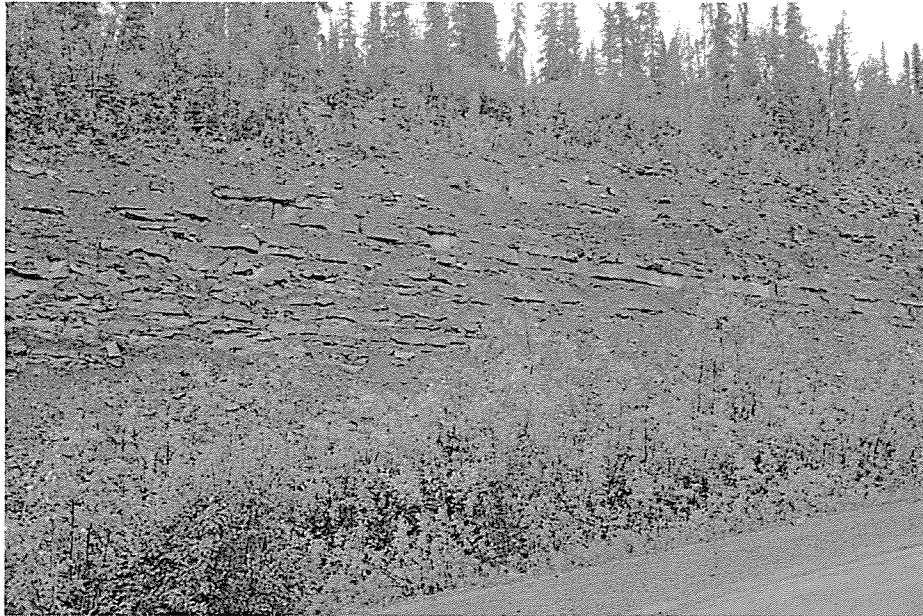
Figure 18: Outcrop at km 251.1.

Outcrop ~12 m high and ~200 m long (Figure 18)

High outcrop interstratified siltstones and sandstones.

Fine - grained (0.18-0.3 mm) immature sandstone. Grains are dominantly subrounded with lesser amounts of sub-angular. Lithology is a mix of quartz, feldspar and dark lithic

fragments. The rock is poorly lithified with grains able to be rubbed off with finger. Cement is orange and likely siderite. Porosity is quite high and no visible reaction to HCl.

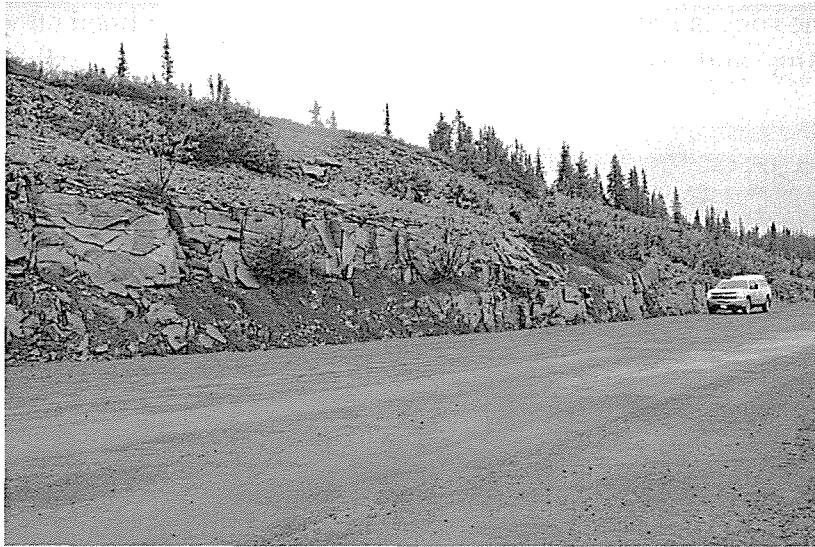
Figure 19. Sandstone outcrop at km 272.8

Sandstone outcrop at side of road (Figure 19)

This outcrop contains interbedded sandstone and siltstones. The more regressive siltstones would not make a good crushed aggregate. As the sandstone is poorly lithified it may not make good crushing aggregate either.

Fine - grained (0.18-0.3 mm) immature sandstone. Grains are dominantly subrounded with lesser amounts of sub-angular. Lithology is a mix of quartz, feldspar and dark lithic fragments. The rock is poorly lithified with grains able to be rubbed off with finger.

Cement is orange and likely siderite. Porosity is quite high and no visible reaction to HCl.

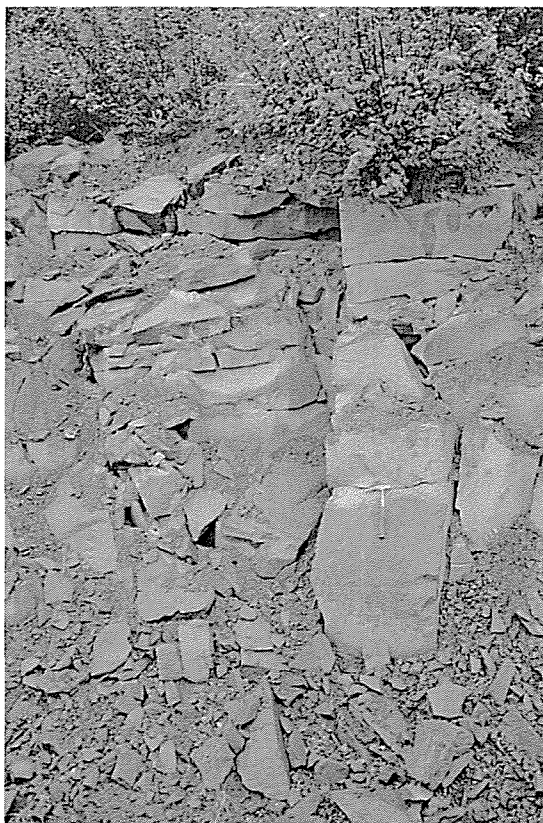
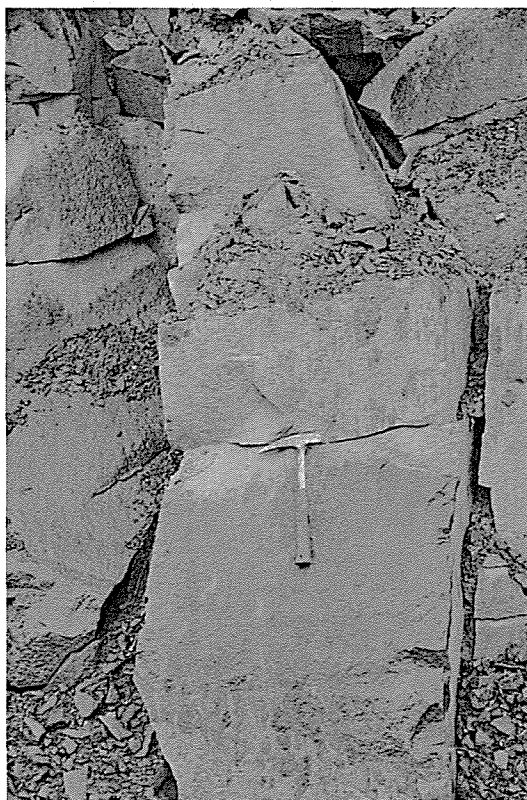
Outcrop alongside of road. Thickly bedded sandstone up to 7-8 m high (Figure 20, 21).

Majority of outcrop is fine to medium grained immature sandstone (0.125 -0.3 mm) with some areas being medium to coarse grained (0.35-0.7 mm) with areas of very coarse sand and granules (1.0 mm-4 mm). Grains are approximately equal amounts of subrounded sub-angular. Lithology of grains are a mix of quartz, feldspar and dark lithic fragments, some of which are chert. Sandstone is poorly lithified with grains able to be rubbed off with finger. Cement is orange and likely siderite. Porosity is quite high and no visible reaction to HCl.

Figure 20: Detail of outcrop at km 273.5. Rock hammer for scale.

Figure 21: Detail of thickly bedded sandstone.

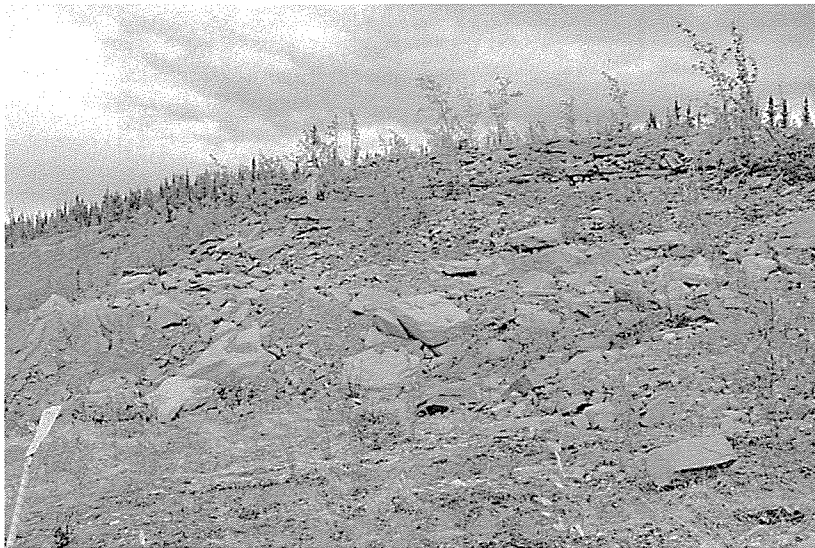
Figure 22: Bedrock exposed in old crushing site at km 333.4.

Old crushing site, bedrock exposed (Figure 22)

Immature carbonaceous sandstone.

It is a medium grained (0.3-0.5 mm) immature sandstone. Grains are dominantly sub-angular with lesser amounts of subrounded and angular. Grains are a mix of quartz, feldspar and dark lithic fragments. Sandstone is poorly lithified with grains able to be rubbed off with finger. Cement is orange and likely siderite. Porosity is quite high and no visible reaction to HCl. Organic material present

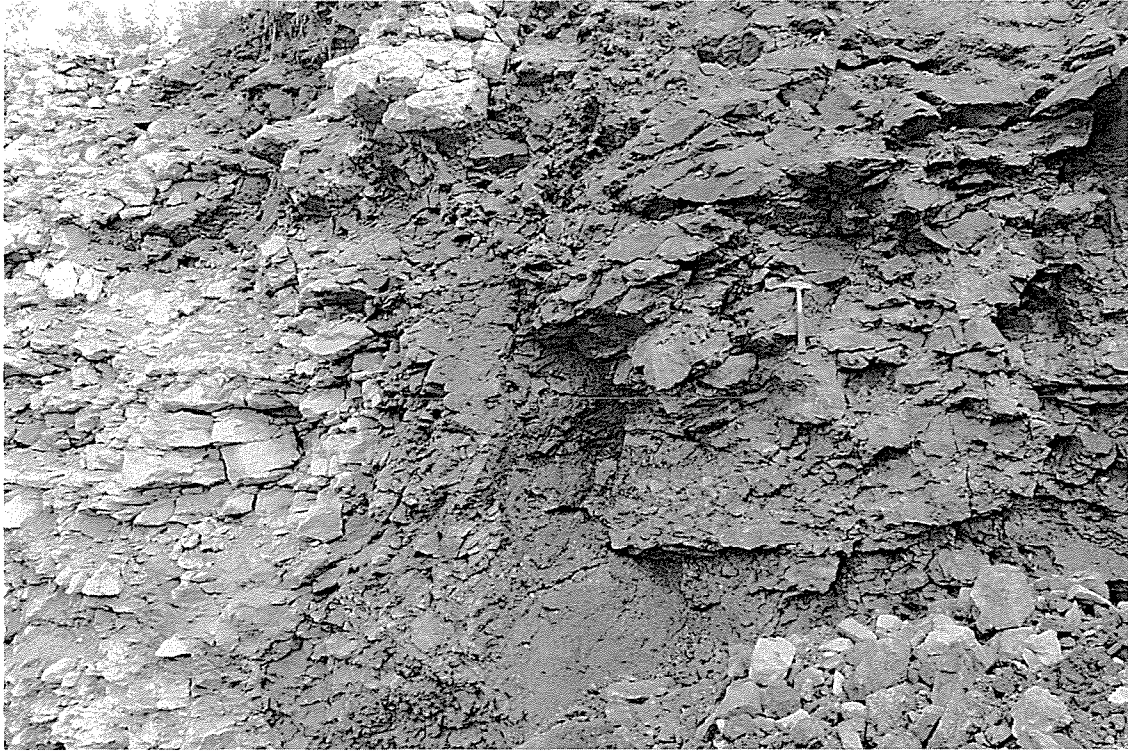
Figure 23: Fresh exposure at crushing site.

Active crushing site (Figure 23)

Recent blasting has exposed a variety of sedimentary rock types: conglomerate, breccia and sandstone.
