The Role of Permafrost in the 2002 Ten Mile Creek Debris Torrent, Yukon, Canada

Introduction

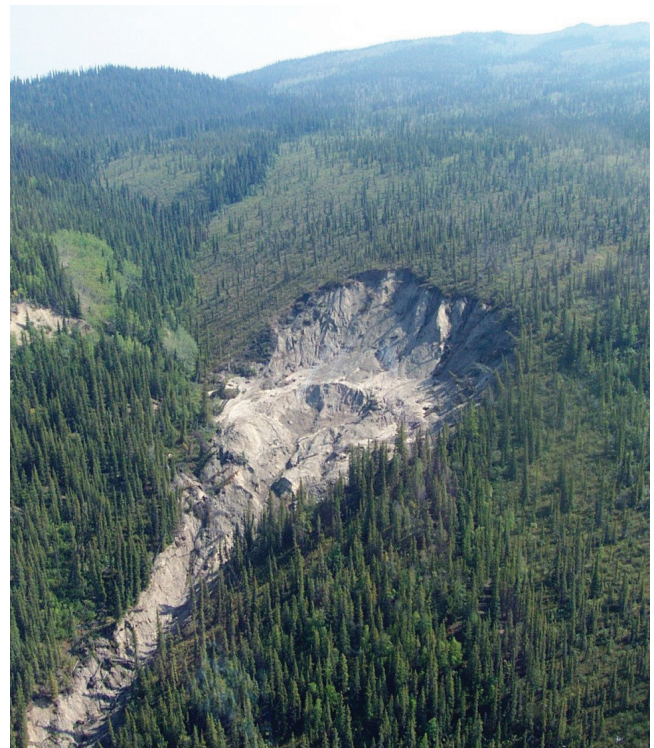
The landslide left a bowl-shaped scar up to 160 m wide and 100 m long with a steep headwall 12–31 m high (Fig. 1). Springs flow from the base of a secondary slump scar in the floor of this bowl. Following the initial failure, an ensuing debris torrent descended 500 m in elevation and traveled 4.7 km down the narrow v-shaped valley of Ten Mile Creek. The main debris lobe came to rest after crossing the South Klondike Highway, clogging its culvert and filling the adjacent ditch with debris. Superelevation measurements taken on a channel bend in the runout zone indicate that the torrent traveled at a maximum velocity of 11 m/s (40 km/hr) with a peak discharge of 1300 m³/s.

Figure 1. Aerial view of landslide source zone showing debris torrent channel exiting at lower left corner. Maximum height of the headwall is 31 m and the bowl is approximately 160 m wide.

DC resistivity surveys conducted in 2006 suggest that permafrost is up to 5 m thick on the gentle north-facing slope behind the landslide headwall, and up to 15 m thick on the steeper north-facing slope adjacent to the landslide source zone (Fig. 1). The resistivity surveys also confirmed the absence of permafrost in the landslide headwall, implying that rapid lateral thaw has occurred since the failure occurred in 2002.
