GEO Québec
2015

Monitoring permafrost conditions along the Dempster Highway

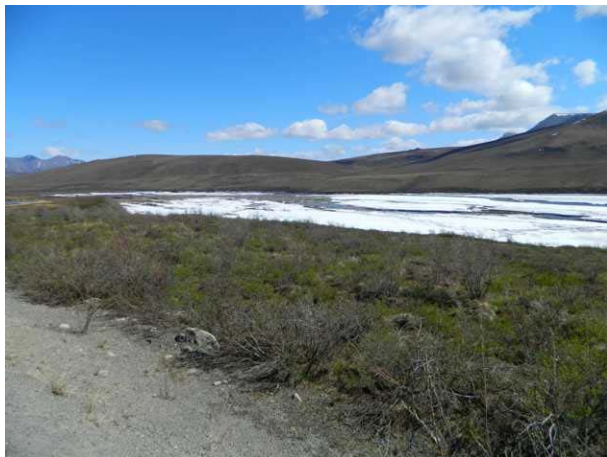
Figure 2. Blackstone River near Chapman Lake, showing extensive river icing, May 2014.

from km 85 to 130, and in other tundra areas. Icings are common in the discontinuous permafrost section. Extensive sheets of river icing develop in the Blackstone and North Klondike river channels (Figure 2) (Hu and Pollard 1997).

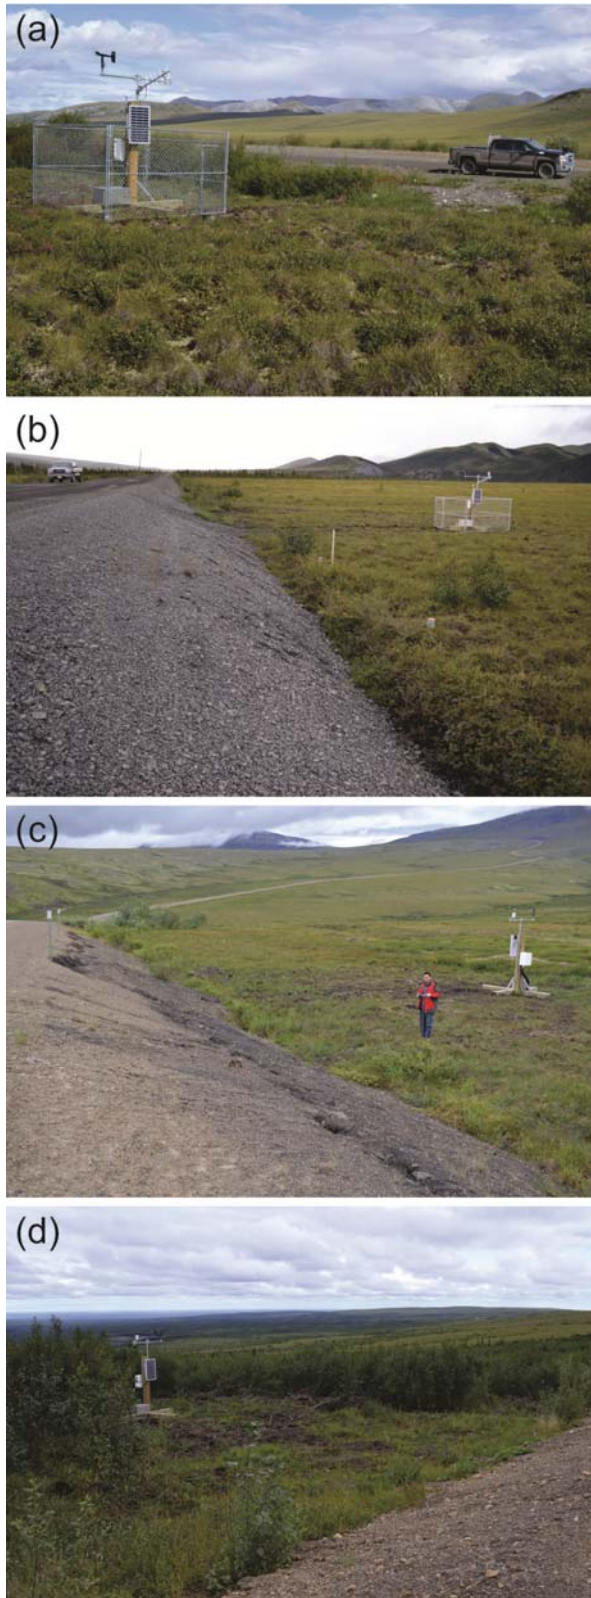
Figure 3. Permafrost monitoring sites along the Dempster Highway, late July 2014. (a) Chapman Lake airstrip; (b) Glacier Creek; (c) Territorial border; (d) Midway airstrip.

Site 1 is in the northernmost portion of the Blackstone Uplands, where the road follows the broad Blackstone River valley (Figure 3a). The site is north of the glacial limit (Beierle 2002). A gravel pit 1 km south of the airstrip indicates the surficial materials are mostly glaciofluvial outwash, covered by a veneer of silt. The site has well developed networks of ice-wedge polygons. These are outlined at the ground surface by slight depressions in the moss and lichen surface vegetation. Numerous willow bushes have grown adjacent to the road at the toe of the embankment. In 2005-2010, ground temperatures were measured with HOBO H-008 miniature data loggers and TMC6-HA sensors at three locations in this flat valley floor, about 500 m from the site. T_p at 1-m depth at the three sites were -4.7, -4.5, and -5.0 °C (Burn et al. 2015). The glaciofluvial terrace surface at the site is about 30 m above the Blackstone River, which flows north, subparallel to the road, about 200 m to the east.

Site 2 is 15 km north of the Arctic Circle crossing, at the foot of the western escarpment of Richardson Mountains (Figure 3b). The road runs across the slope at the site. The vegetation cover is dominated by mosses and lichens, with few bushes. The ground was not glaciated, so the gentle gradient of the lower slopes is the result of colluvial deposition continuing over millennia. Ice-wedge polygons are apparent, but their form is muted, with little development of bounding ridges and troughs.

Site 3 is on the NWT side of the territorial border (Yukon km 465) in the high Richardson Mountains (Figure 3c). It is near the location of a serious accident caused by collapse of the roadbed following thermal erosion of an ice wedge beneath the embankment. The site is on a slope descending westwards. The area is covered by dwarf birch bushes growing in mosses and lichens. The area was not glaciated, so the surficial materials are dominantly the result of colluvial processes. Bedrock exposures are visible from the road, but not at the precise location of the monitoring site. In June 2014 a large frost blister was examined on the south side of the road near the site, indicating the efficacy of water movement through the active layer at this site.

Site 4 is in Peel Plateau (Figure 3d), within the area glaciated by the Laurentide Ice Sheet. The region is underlain by extensive deposits of buried glacier ice. The rolling terrain is covered by shrub tundra, and dense alder thickets have grown alongside the highway since it was built in the 1970s (Gill et al. 2014). Tills cover much of the region (Lacelle et al. 2013). Permafrost in the Peel Plateau is remarkably warm for a tundra environment in the western Arctic (O'Neill et al. 2015a).

A weather station was erected at the field installations, 15 m from the toe of the embankment (Figure 3). This station includes Campbell Scientific HC2-S3-L air temperature and relative humidity sensors, and an anemometer and wind direction sensor (RM Young 05103AP-10-L). Data from these atmospheric sensors and the thermistors are collected by a Campbell Scientific CR1000-55 data logger via a multiplexer board (AM 16/32B XT). Weather data are stored on an hourly basis; ground temperatures are collected every four hours. As from early June 2014, data from sites 1 and 2 have been relayed by GOES satellite to a server in Whitehorse. Data are stored at sites 3 and 4 until collected.

Surface disturbance during drilling was minimal at sites 2 and 3, and moderate at site 1, where two attempts were required for completion of the installation (Figure 3). Disturbance was greatest at site 4, due to the need to clear alders and other bushes (Figure 3d).

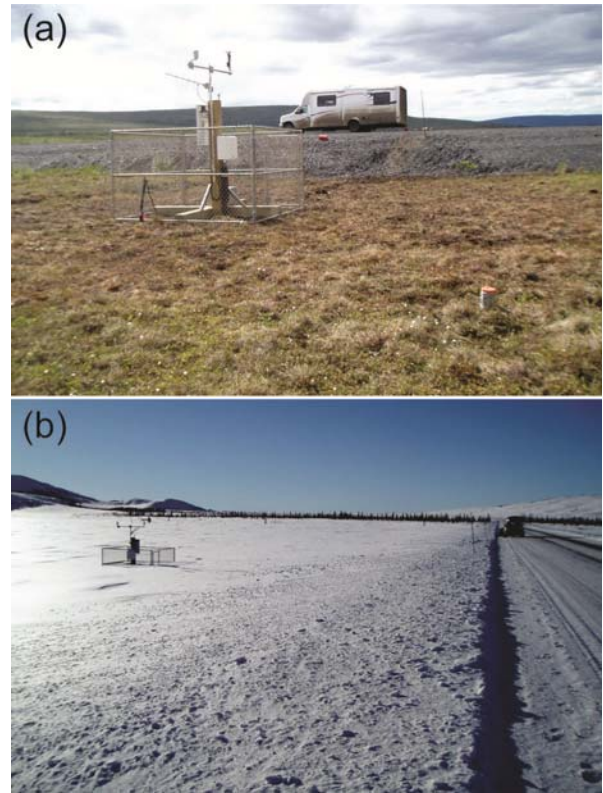
Figure 4. Site 2 shown (a) in summer and (b) in winter to illustrate the accumulation of snow beside the road embankment.

The embankment height is variable between the sites, being least at site 1 and greatest at site 4 (Table 2). Snow accumulation along the embankment slope is evident in Figure 4, which presents views of the embankment at site 2 in summer and winter.

Permafrost is sustained at site 2, but has been warmed at depth beneath the road and toe, due to the deep snow banks that accumulate on the side slopes (Figure 4) (Table 5). The field site appears to be located away from thermal disturbance associated with the embankment. The site is exemplary because it demonstrates (1) overall warming of permafrost by the road; (2) relatively cold conditions in the embankment; (3) relatively warm conditions at the toe.

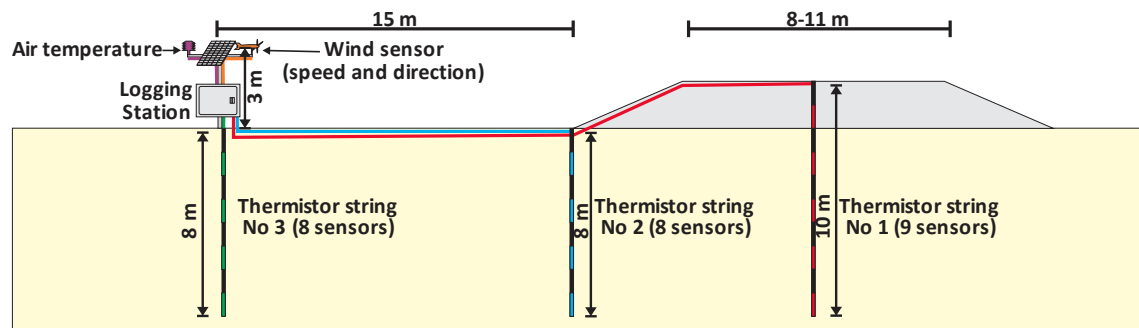
Figure 5. Schematic diagram of drill holes and meteorological equipment at each site.

The four monitoring sites were established in late November and December 2013. At the highway centerline, holes were drilled to reach 10 m below grade. At the toe and at the undisturbed ("field") sites, the nominal intentional depth was 8.5 m. The holes were drilled by Marl M4CT and Sandvik Marlin M5 rigs. Surficial materials and any unfrozen ground were penetrated by auger, but in frozen ground a 4-inch CRREL barrel was used. Cores were retrieved with the CRREL barrel, but only grab samples were recovered when drilling with the auger. The ground materials retrieved from the holes were logged, with some samples returned to Whitehorse for laboratory examination. Grain-size and moisture content analyses were by Tetra Tech EBA. A one-inch, capped PVC tube was installed in the holes as casing for thermistor cables. The holes were backfilled with dry sand. Figure 5 is a schematic diagram of the installation at the sites.

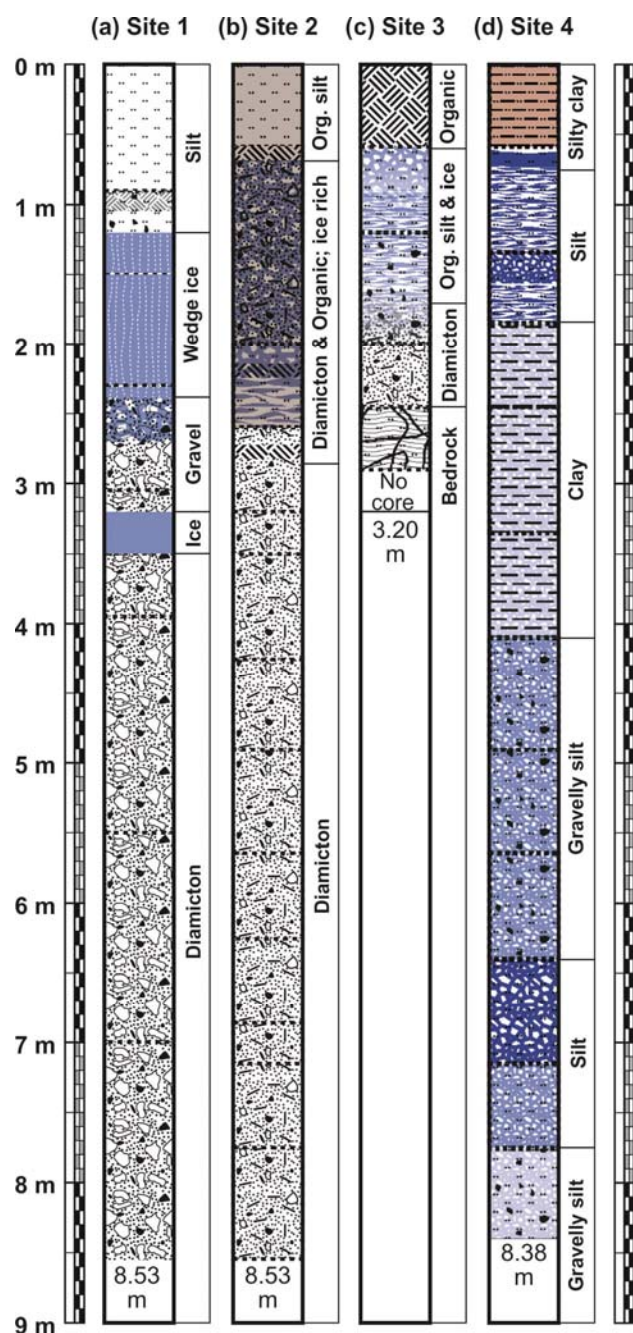
Figure 6. Representative stratigraphy of boreholes drilled in undisturbed ground (field) at the monitoring sites. The base of permafrost at site 1 is at approximately 7 m depth.

Table 3 presents a summary of ground materials at each site. Excess ice was encountered in the uppermost 3.5 m of the field borehole at each site. The stratigraphy of these boreholes is presented in Figure 6. Full stratigraphic data, including photographs of retrieved core, are in Northern Climate ExChange (2014).

Ice-poor gravelly diamicton is overlain at the site by a layer of ice-rich organic silt and clay (Mod. USC - CL), 1 – 2 m thick (Figure 6b). The diamicton is interpreted as a colluvial deposit that originated from the nearby slopes of Richardson Mountains (Figure 3b). The restriction of ice enrichment to the uppermost 3.5 m suggests that the excess ice is associated with permafrost aggradation during deposition of the fine-grained materials. Excess ice content in this material ranged from 20 – 50 %. Wedge ice was recovered in the toe borehole. The organic content of the upper 2 m indicates burial by surface deposition or cryoturbation.

Schist bedrock is close to the surface at this site. The lower surficial material is dominantly weathered rock. Ice-rich sediment and massive ice were found in the near surface (Figure 6c). The materials are sand and silt sized at the surface (Mod. USC - ML), becoming coarser with depth (MH), reaching gravel size. The ice is a combination of wedge ice, intrusive ice, and aggradational ice. Excess ice contents of 25 – 52% were measured in the ice-rich material, but relatively few samples were collected due to the shallow holes.

The terrain is covered by diamicton (till), dominated by silt and clay with numerous stones (Figure 6d). Some beds of clay and silty clay were encountered in the drill holes (Mod. USC - Cl), but samples of diamicton tested also contained up to 10% gravel. It is ice-rich throughout, with excess ice contents of up to 57%, but generally in the range of 40 – 50 %. No massive icy bodies were encountered in the drill holes.

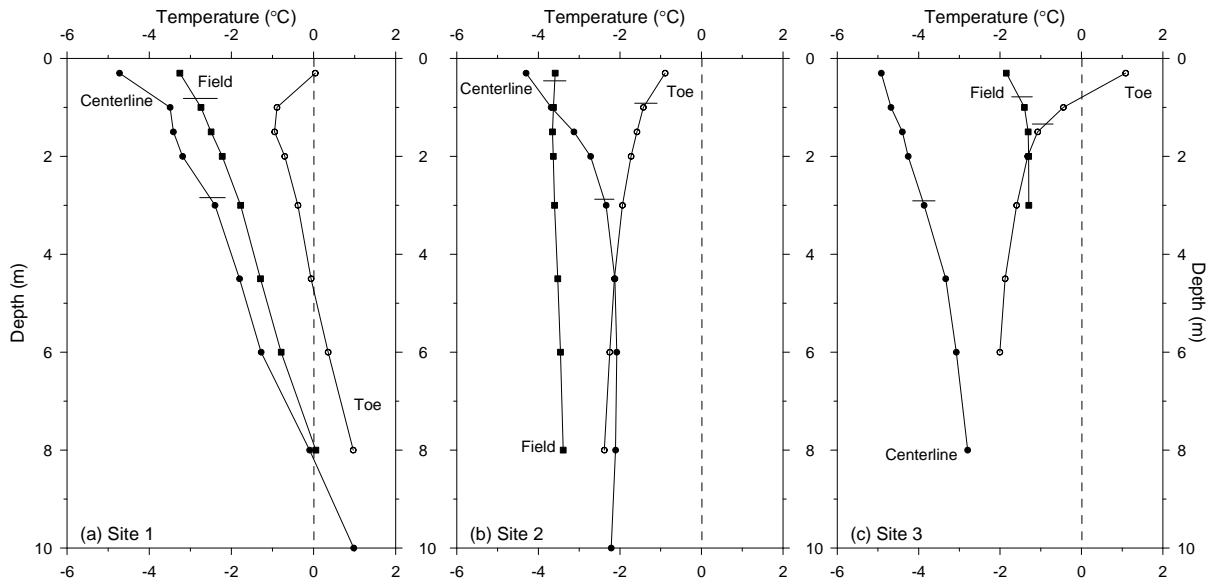
Figure 7. Annual mean temperature profiles from sites 1 – 3 for 1 Mar. 2014 – 28 Feb. 2015. Thaw depths are indicated by a horizontal line at each site. Maximum temperatures were > 0 °C throughout the profile at the toe location of site 1.

from a full year of observations, but the information for site 4 is interpreted from only 3 months' data. There is considerable other thermal information from Peel Plateau that is consistent with these values (e.g., O'Neill et al. 2015a, b). Figures 7a-c present mean annual ground temperature profiles from the field, toe and embankment profiles at sites 1-3, and Table 5 presents snow depths measured at sites 1-4 in mid-March 2015. We note several general characteristics: (1) ground temperatures are highest at the toe in association with a snow bank that accumulates there each winter; (2) the temperatures at the centerline are cooler at the surface than in the field sites; (3) the temperature profile of the embankment appears to converge at depth with the profile from the toe.

Bedrock was encountered near the surface at site 3, reducing the depths at which ground temperatures have been measured. The embankment at centerline is relatively cold at the site (Figure 7c), but the similarity between conditions at the toe and field sites suggests that the influence of the snow bank created by the road extends away from the embankment (Table 5). Permafrost appears to be degrading at the toe, as indicated by annual mean temperature above 0 °C
