**NORTH FORK ROSE CREEK REMEDIATION,  
FARO MINE COMPLEX, YUKON**

**PHASE 1A SITE INVESTIGATION**

**FINAL**

PROJECT NO.: 1085-007-02  
DATE: June 19, 2015  
DOCUMENT NO.:

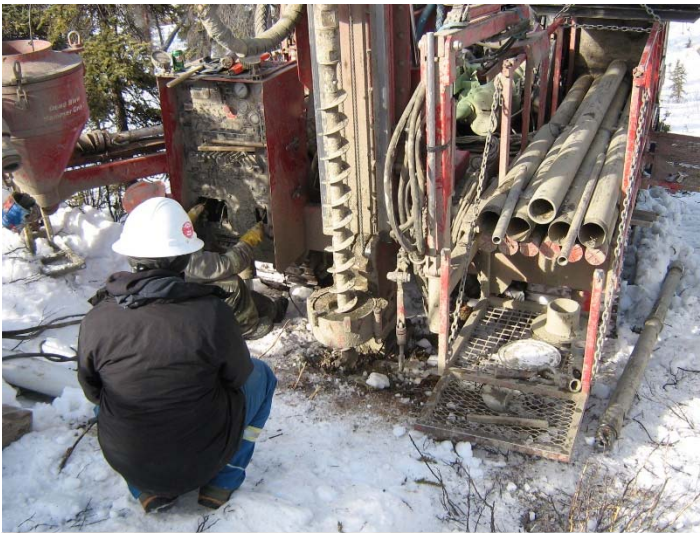
**Photo 11.**

**Typical drilling activity**

- Photo is from CH15-107-MW014
- April 18, 2015
- Photo provided by CH2M Hill

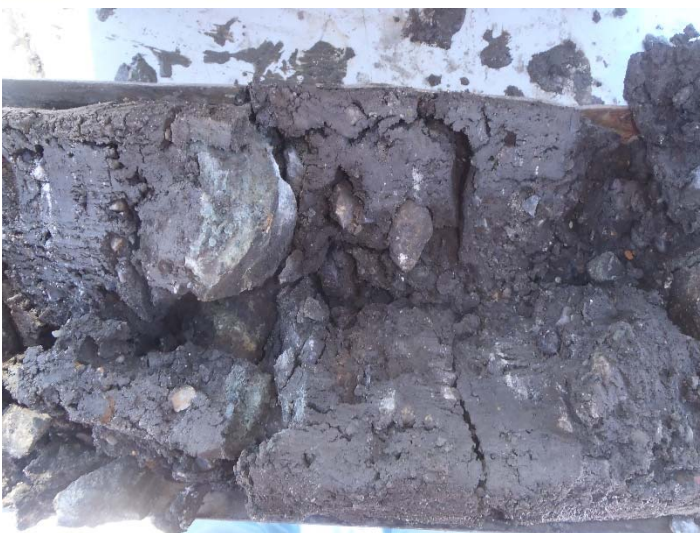
**Photo 12.**

**Typical till material**

- Photo is from 6.0 m depth in CH15-107-MW012
- Sample from CRREL barrel
- April 23, 2015

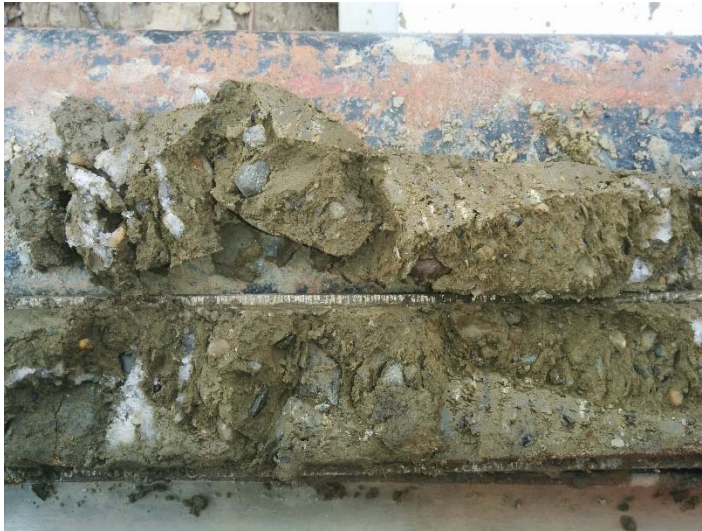
**Photo 13.**

**Typical glaciofluvial material**

- Photo is from 6.2 m depth in CH15-107-MW014
- Sample from SPT barrel
- April 18, 2015

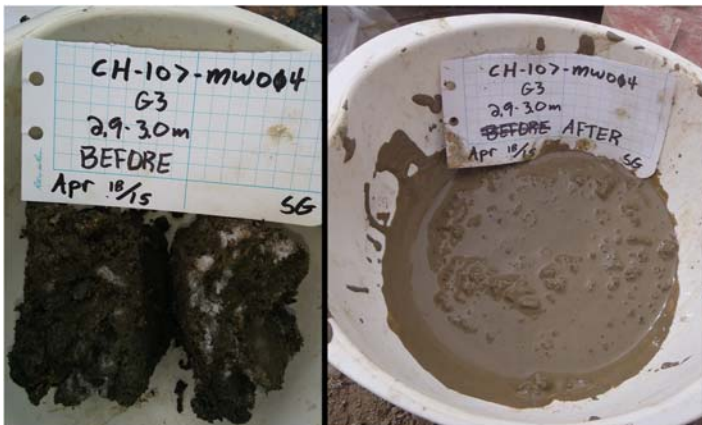
**Photo 14.**

**Typical ice-rich glaciofluvial sample, estimated 25-30% visible ice content**

- Left side shows soil immediately after drilling
- Right side shows same material after being exposed to 3°C ambient temperature for 3 hours with no mechanical disturbance between photos
- Photo is from 2.9 m depth in CH15-107-MW014
- Sample from CRREL barrel
- April 18, 2015

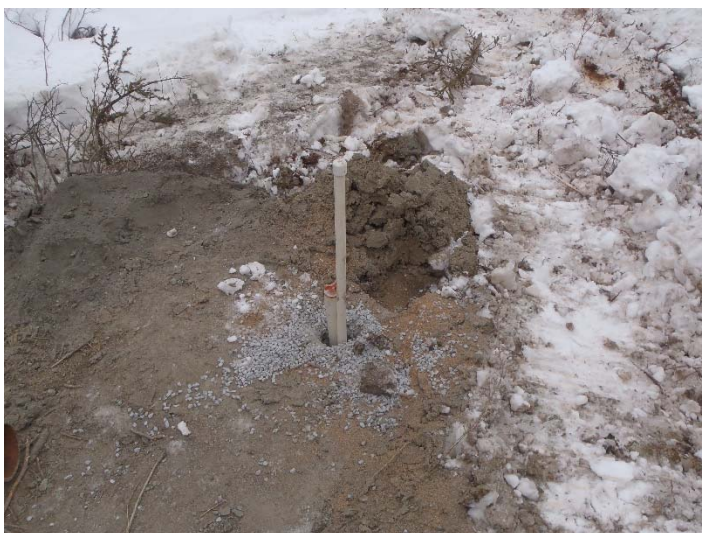
**Photo 15.**

**Example of typical standpipe and thermistor casing installation before monument placement.**
