October 28, 2008

EBA File: W14101020

**Subject: Geotechnical Evaluation – Dome Road
Subdivision Expansion - Dawson City, Yukon**

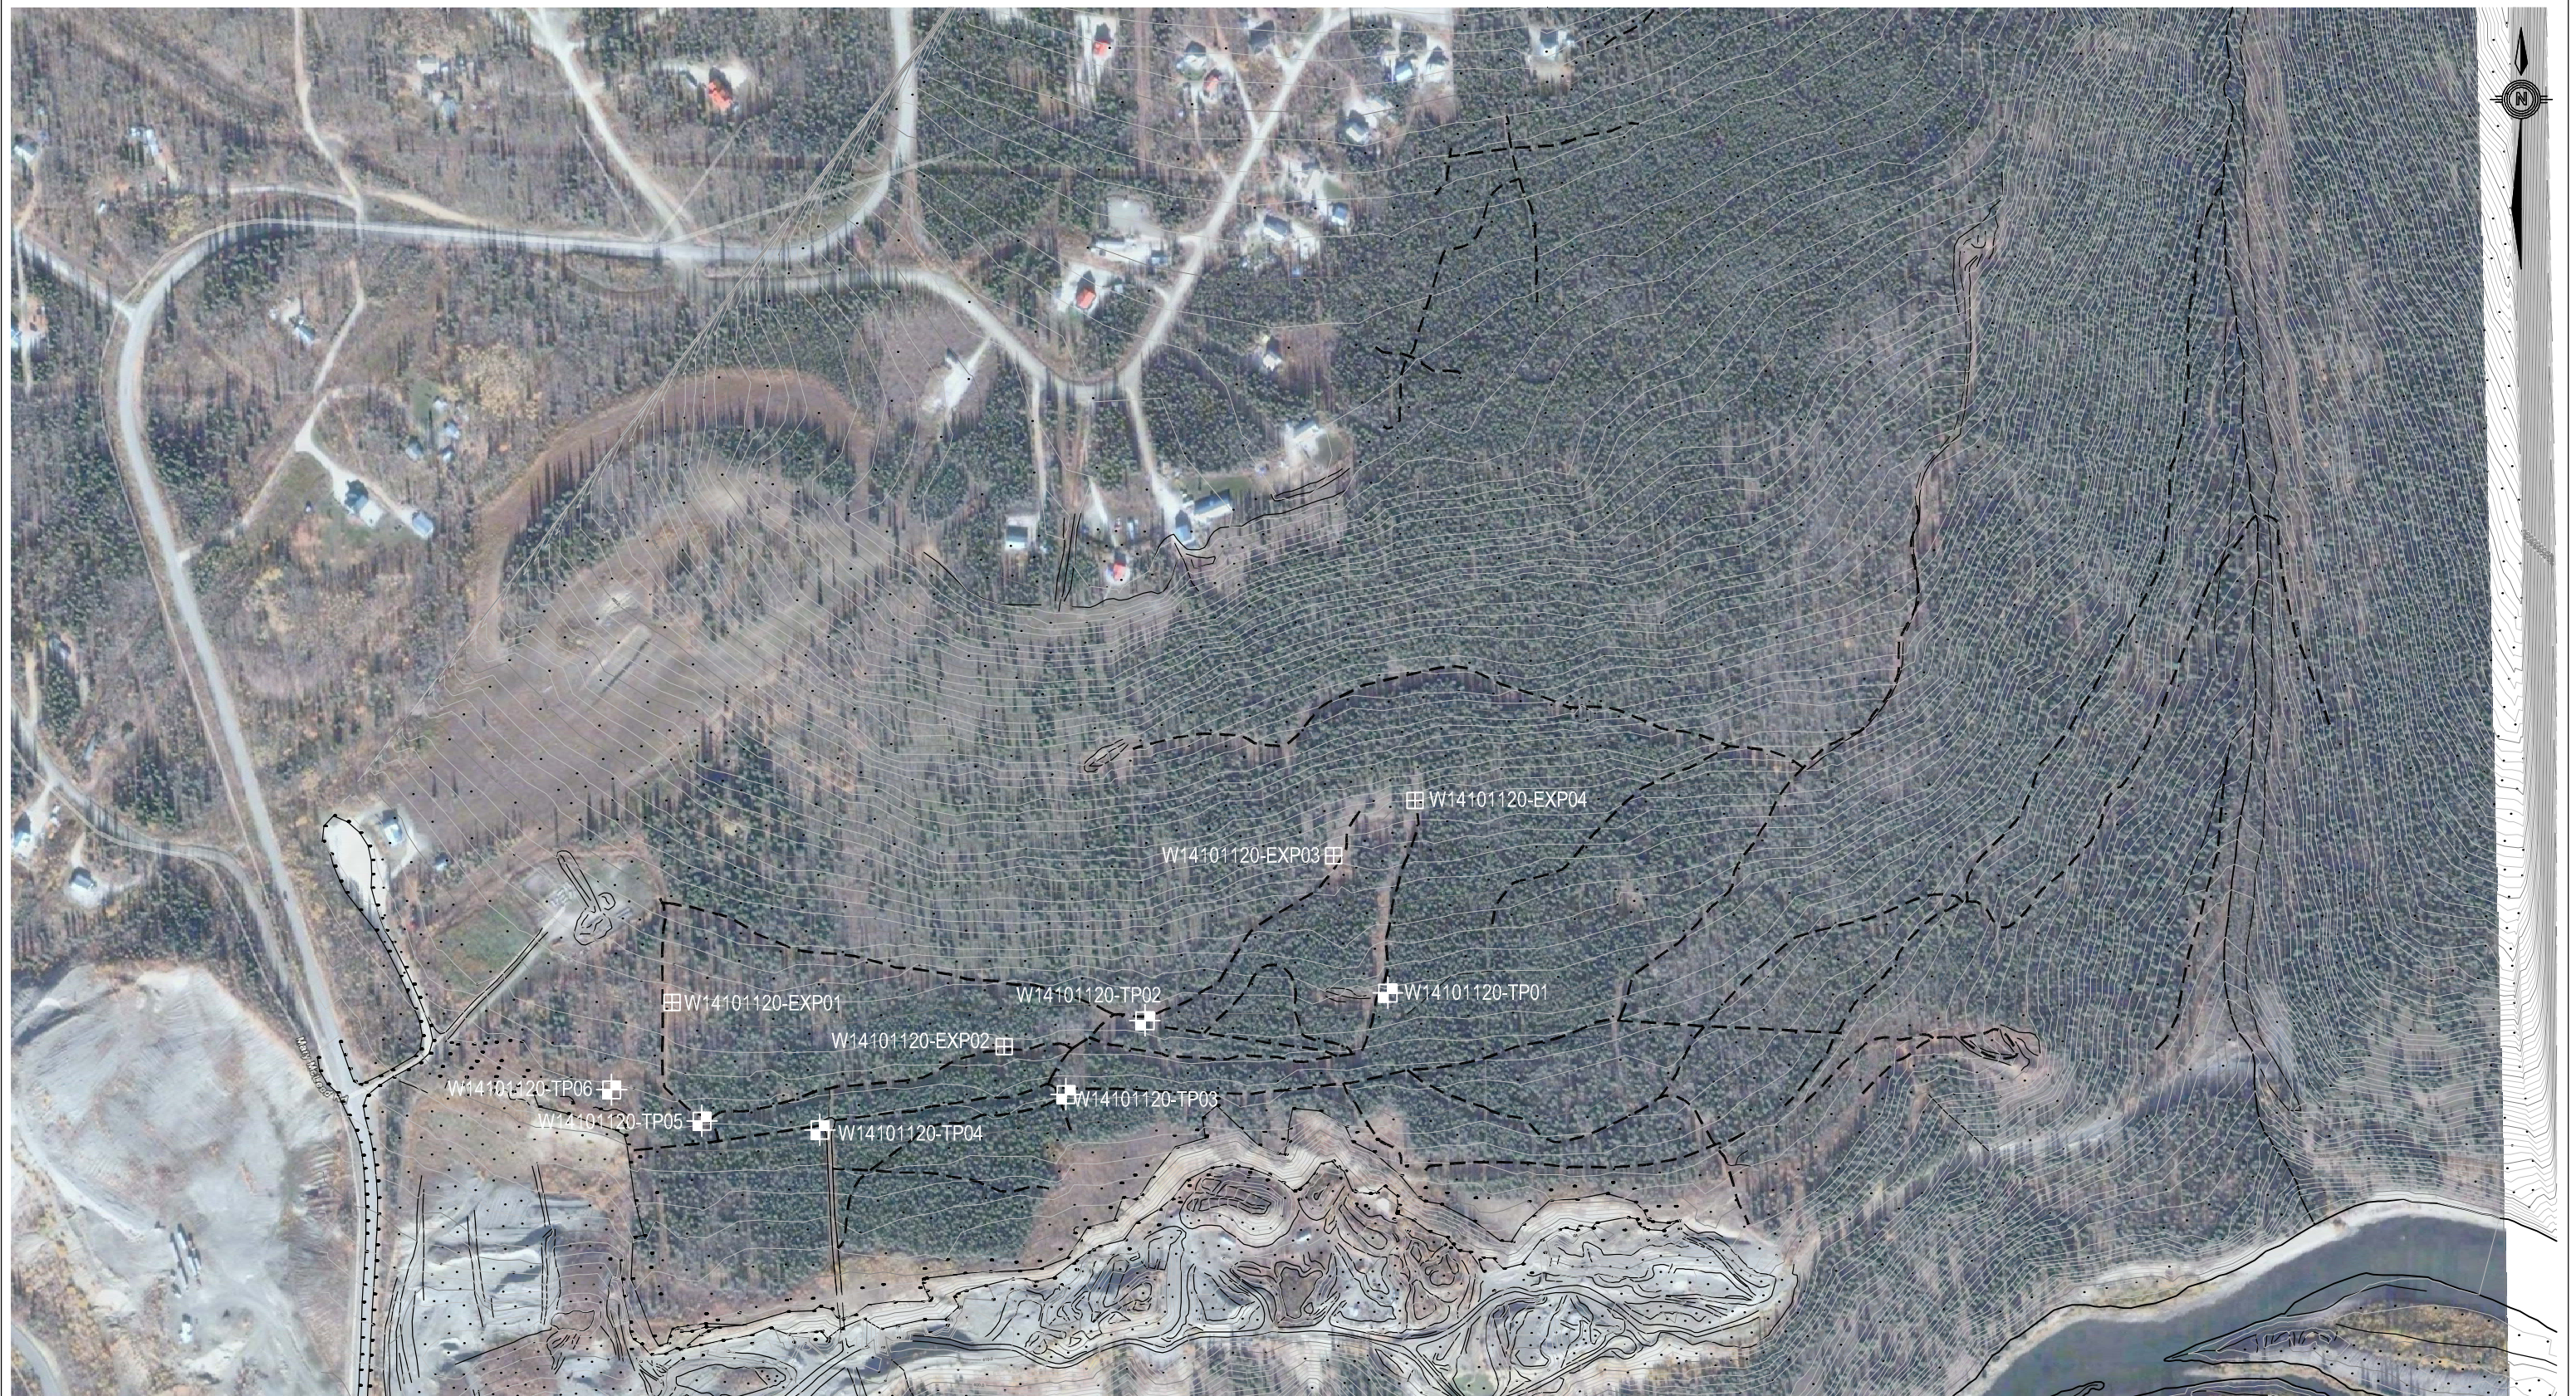
C:\Whitehorse\Drawings\Drawings\City Area\W14101120 Dome Road Res Expansion\E08006.dwg [FIGURE 1] September 18, 2008 - 10:58:17 am (BY: JAMES BU'YCK)

Geotechnical conditions are described in the following section. Testpit locations and the locations of four of the exposures used for evaluation purposes are presented on Figure 1. Detailed testpit logs and associated laboratory testing report forms are presented following Figure 1 in Appendix A of this report.

- LEGEND**
- ⊕ TESTPIT LOCATIONS
 - ⊞ EXPOSURE LOCATIONS

- Fine grained soils were encountered in Testpits W14101120-TP03, -TP04, -TP05 and -TP06, from surface to the 3.2 m testpit termination depth. These testpits were excavated along the cross country ski trail closest to the crest of the cut-slope overlooking the placer mining area. In addition, permafrost (Nbn – non-visible; not excessively wet when thawed) was encountered at 2.0 m in -TP03; 2.5 m in -TP04 and 2.9 m in -TP05. A percolation test was performed in testpit W14101120-TP05. In the near surface fine grained soils (0.3 m to 0.6 m), a 60 minute per 25 mm percolation rate was measured, suggesting that the fine grained soils along the down gradient portion of the site are not be conducive to on-site sewage disposal system construction.

- Colluvial soils (soil matrix is sandier and has angular rock fragments of various sizes distributed throughout) were noted in Testpits W14101120-TP02 and -TP04, as well as the old exploration testpits (labelled as exposures -EXP01, -EXP02, -EXP03 and -EXP04 on Figure 1). The thickness of the colluvial veneer in the testpits and exposures, where colluvium was noted, was variable (between 1.2 m and greater than 3.0 m). Two percolation tests were performed in the colluvial soils in testpits W14101120-TP01 and -TP02 between 0.3 m and 0.6 m and acceptable percolation rates of 12 minutes per 25 mm and 18 minutes per 25 mm were measured in Testpits W14101120-TP01 and -TP02 respectively.

- Depth to bedrock is quite variable throughout the study area. Bedrock was not encountered in any of the testpits excavated during the current evaluation; however, it was noted in exposure W14101120-EXP04. As mentioned in the April, 2008 Terrain Evaluation report, the transition with the steeper, up-gradient portion of the study area, depth to bedrock could be a development concern.
