# CONTRASTING BEHAVIOUR OF TWO RECENT, LARGE LANDSLIDES IN DISCONTINUOUS PERMAFROST, LITTLE SALMON LAKE, YUKON, CANADA

Ryan R. Lyle<sup>1</sup>, D. Jean Hutchinson<sup>2</sup> & Panya S. Lipovsky<sup>3</sup>

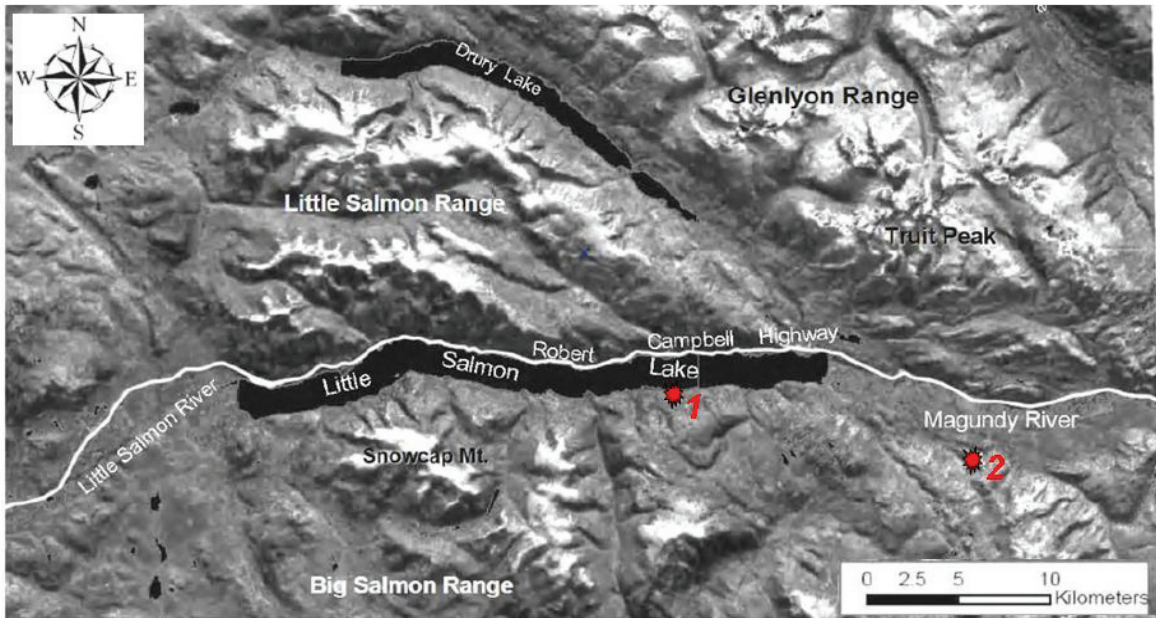
**Figure 2:** Physiography of the Little Salmon Lake area. Select landslide locations: 1 – YT Landslide and 2 - Magundy River Landslide.

Little Salmon Lake is located in south-central Yukon as shown on Figure 1. The area is located between the villages of Carmacks and Faro, and is bisected by the Robert Campbell Highway. A satellite image shown in Figure 2 shows some of the key physiographic features of the area. The Yukon Plateaus region is a broad uplands area consisting of rolling hills and some mountain ranges (Ward and Jackson, 2000). The Little Salmon Lake area contains some of the highest peaks on the Plateaus with elevations exceeding 1700 m. Little Salmon Lake lies at 609 m elevation. The Little Salmon Lake valley occupies a glacially scoured and over-deepened U-shaped valley (Campbell, 1967) that is approximately 33 km long and 2 km wide.

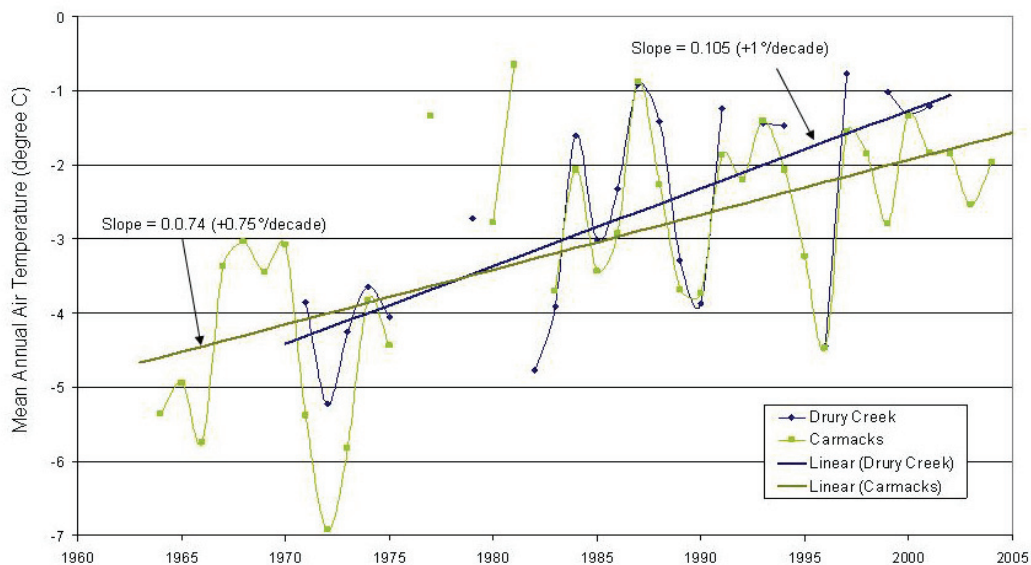
**Figure 3:** Climate data for Drury Creek, and Carmacks (data from Environment Canada, 2005).

The Little Salmon Lake area is within the sub-arctic continental climate zone, which is characterized by long, cold winters, short, warm summers, low relative humidity, and low to moderate precipitation. The general climatic conditions are illustrated in Table 1, which shows the 1970-2000 climate normals for the meteorological stations in Faro and Carmacks (see Figure 1 for station locations). There is also a meteorological station at Drury Creek Highway Maintenance camp, located near the outlet of Drury Creek into Little Salmon Lake. However, Environment Canada does not calculate climate normals for this station. A temporal plot of average annual temperature for the Carmacks and Drury Creek meteorological stations is shown

in Figure 3. The apparent warming trend illustrated by the Carmacks station data is even more apparent in the limited data from the Drury Creek station. These data show the climate warming trends noted by Serreze et al. (2000).

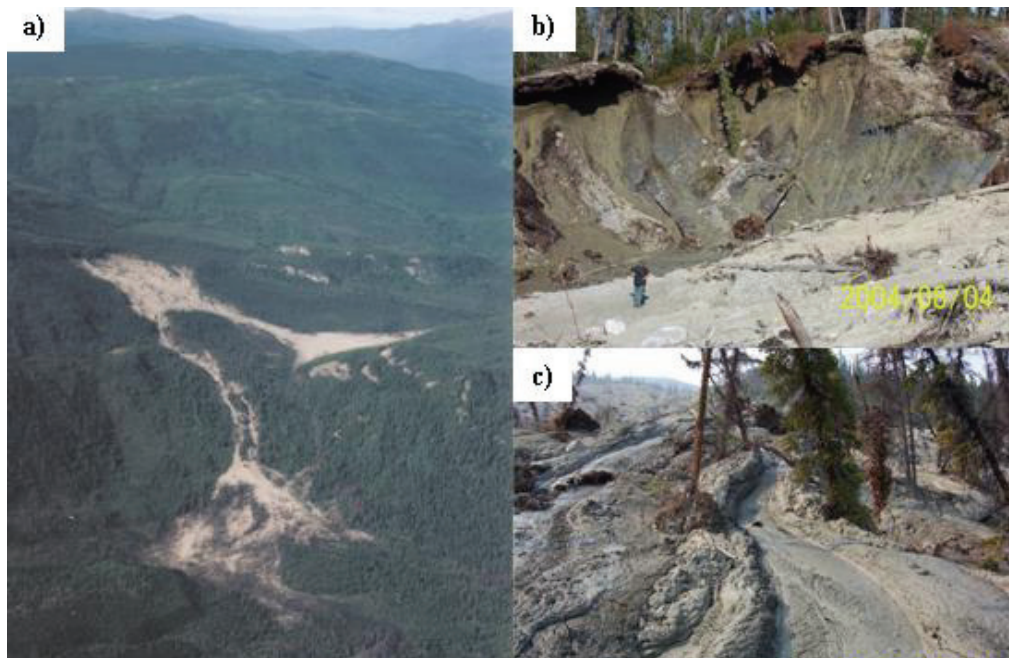
**Figure 4:** Magundy River Landslide: a) overview looking south (top scarp is 350 m wide, elevation change from top scarp to depositional is about 350 m) b) active thaw slump area (note 2<sup>nd</sup> author for scale); and c) active debris flow (channel width is approximately 1 m across).

The debris flow has eroded two substantial channels, each having a distinct depositional area (Figure 4a). Two surficial units, exhibiting similar texture, are exposed in the landslide: a colluvial layer of variable thickness overlying denser glacial diamicton (till). The colluvium

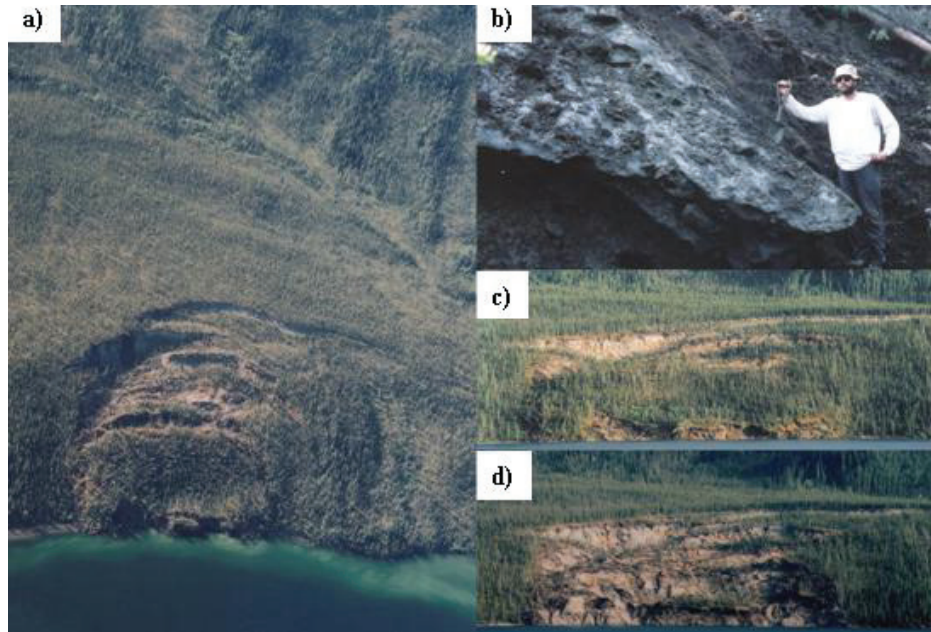
**Figure 6:** YT Landslide: a) overview, looking south (Aug. 2004); b) massive ice in sediments exposed in landslide scarp (first author for scale); c & d) overview photos, looking south from across Little Salmon Lake. Note the changes between photo (c) taken on Aug. 3, 2004, and photo (d) taken on Aug. 2, 2005. Upper scarp in photos a, c & d is approximately 350 m long.

Figure 7 shows some hypothetical failure planes (dashed lines) along a cross section through the landslide. The curved upper scarps, and pattern of deformation noted on old airphotos, indicate that the landslide is moving in a generally rotational sense. However, the movement noted between the 2004 and 2005 field seasons (Figure 6c,d) indicates a more translational
