Satellite Monitoring of Permafrost Instability — Validation, Evaluation and Evolution

R-07-018-402 v.2.0

Prepared for:
European Space Agency

December 2007

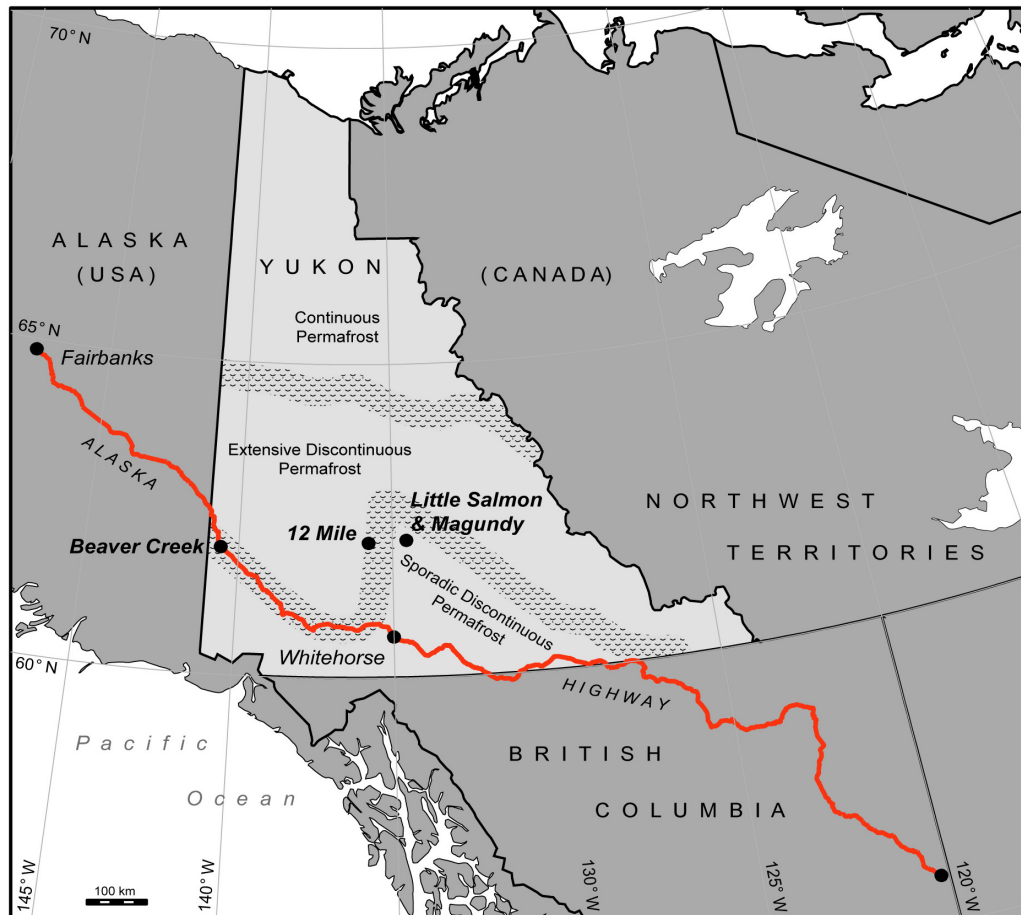
Figure 4 Location map showing regional context of permafrost and study sites within Yukon Territory. Hatched areas represent boundaries between generalized permafrost zones (after Heginbottom, 1995).

Permafrost is defined as ground which has been frozen year-round for at least 2 years. All five study sites are located in southern Yukon Territory near the southern boundary of the extensive discontinuous permafrost zone in North America (Figure 4). In the extensive discontinuous permafrost zone, 50-90% of the surface is underlain by permafrost of variable thickness and ice-content. Near the southern margin of this zone, permafrost is typically less than 15 m thick, and its temperature is generally warmer than -1°C . For this reason, it is more susceptible to degradation than the colder and thicker

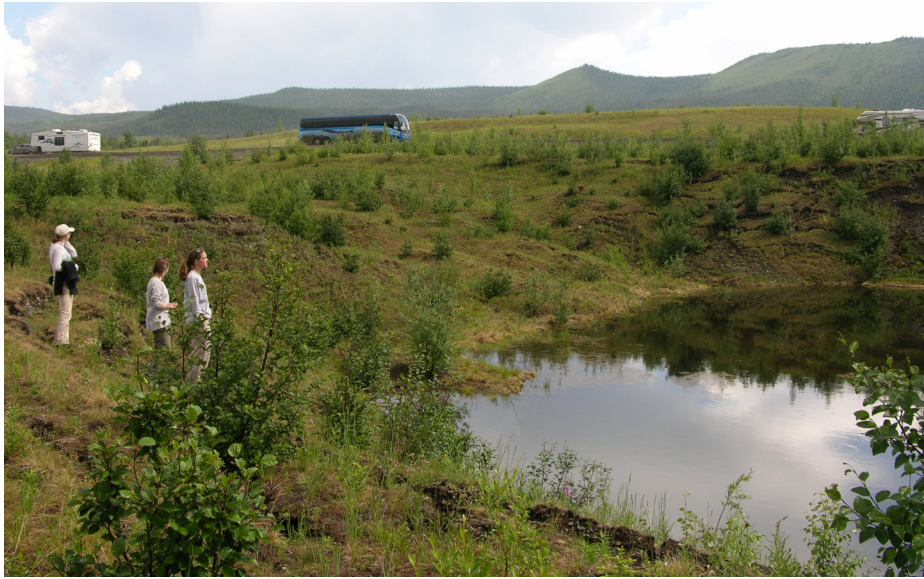
Figure 5 Thermokarst ponds occur along both sides of the Alaska Highway (in background) at this location 50 km south of Beaver Creek. The ground surface here used to be level before gravel was stripped from the surface for road construction in the early 1990's.

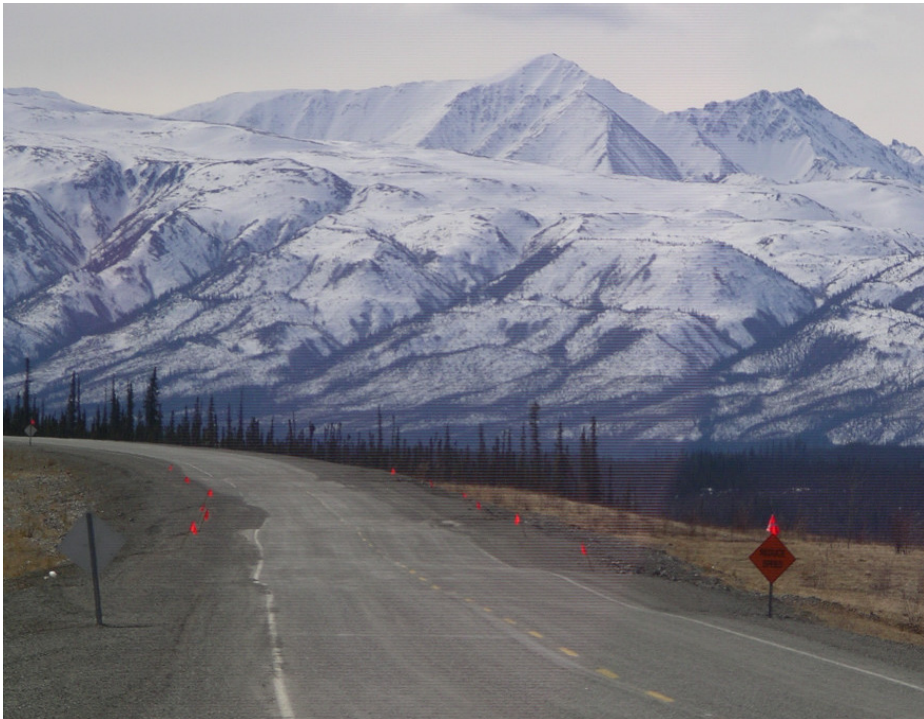
Figure 6 Subsidence along the Alaska Highway due to permafrost degradation, 50 km south of Beaver Creek.

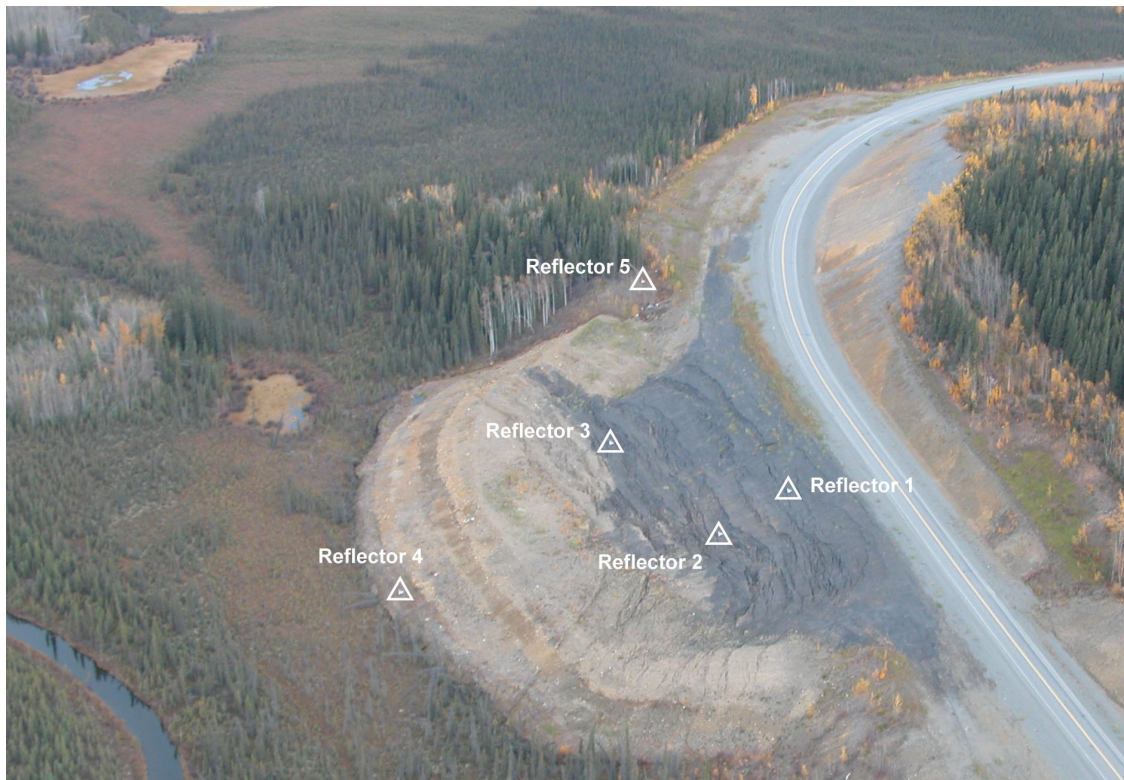
Figure 7 Embankment failure due to permafrost degradation at Beaver Creek, Site 1, along the Alaska Highway.

The position of this site at the base of a bedrock slope is a common setting for ground ice to form due to the convergence of groundwater flow into fine-grained valley bottom sediments (Rampton et al., 1982). Boreholes in the embankment revealed between 2.8 and 3.7 m ice-rich silt beneath 8-12 m of gravel fill (Paine and Associates, 1997b). Thaw of this ice is likely being accelerated by a number of factors including disruption of an underground creek at toe of failure, water ponded by the grabens, and thermal heat transfer from dark-coloured fill (Paine and Associates, 1997b).

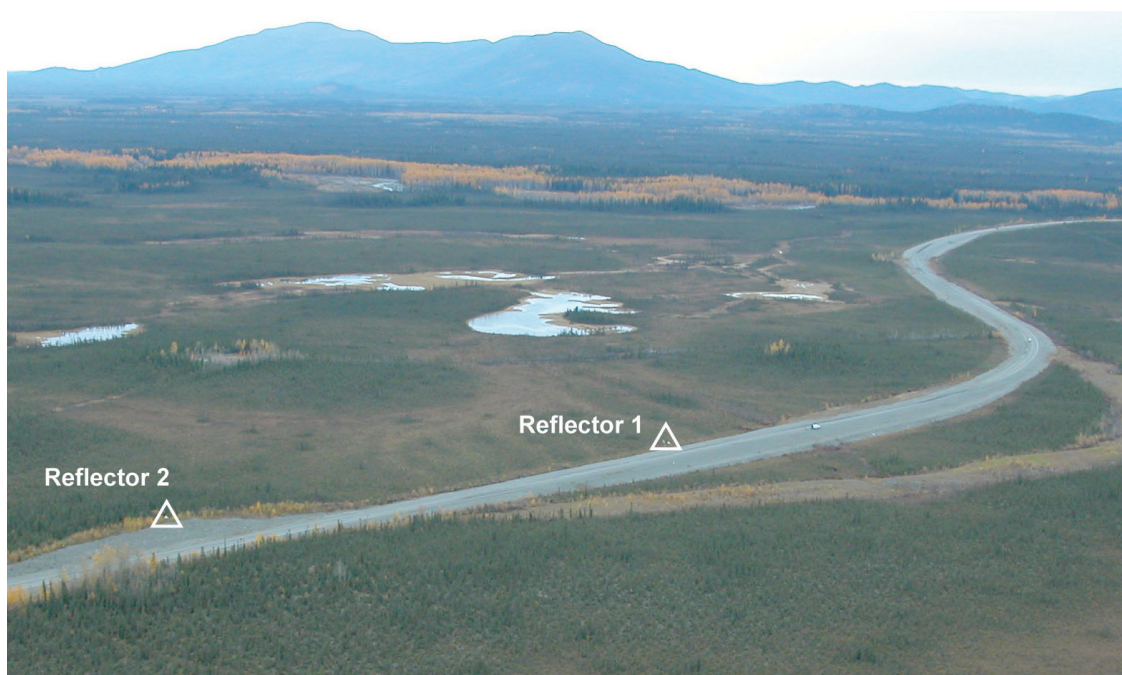
Figure 8 Oblique aerial photograph of the stretch of the Alaska Highway monitored at Beaver Creek Site 2. The distance between reflectors 1 and 2 is 370 m.

The width of the paved highway and its gravel stabilization berms is approximately 40 m; within this corridor, which is entirely unvegetated, the InSAR coherence was expected to be reasonable. The coherence in the poorly-drained sparsely forested swamp adjacent to the highway depends on the amount of surface water and vegetation change throughout the summer.

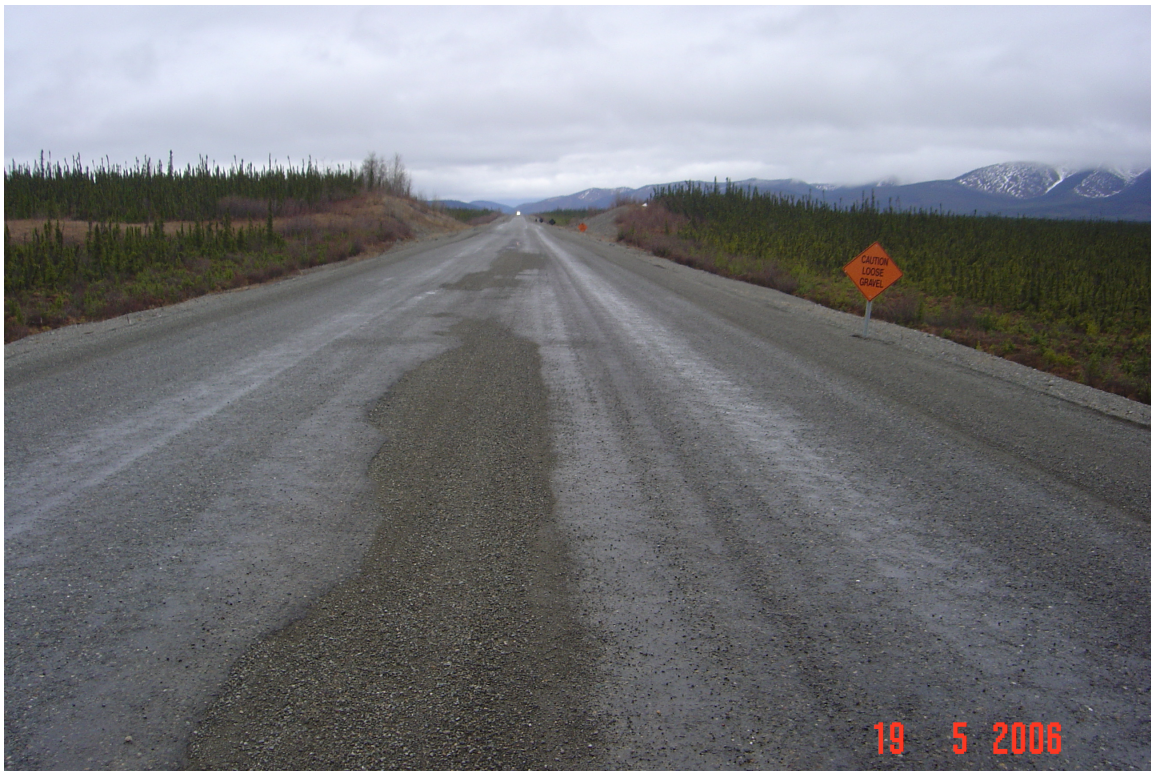
Figure 9 Patched cracks in the road are evidence of thaw settlement along the Alaska Highway at Beaver Creek, Site 2.

Since 1997, the Yukon Department of Highways has been monitoring ground temperatures down to a depth of 10 m at this site. Three separate thermistors were installed: one beneath the highway centre line, one in the stabilization berm, and one adjacent to the highway in natural ground. Using these data, the thermal performance of the highway was analyzed in detail by Dore (2005). He reported that ground temperatures were rising beneath the highway centerline and berm as a result of highway construction, despite local cooling climatic trends in the area between 1997 and 2003. He also determined that greater amounts of warming were occurring beneath the berm than beneath the centerline and that the road appears to induce thawing of the underlying ice-rich ground. This would likely lead to the large number of longitudinal cracks that continually develop in the road surface (as shown in Figure 9) each year.

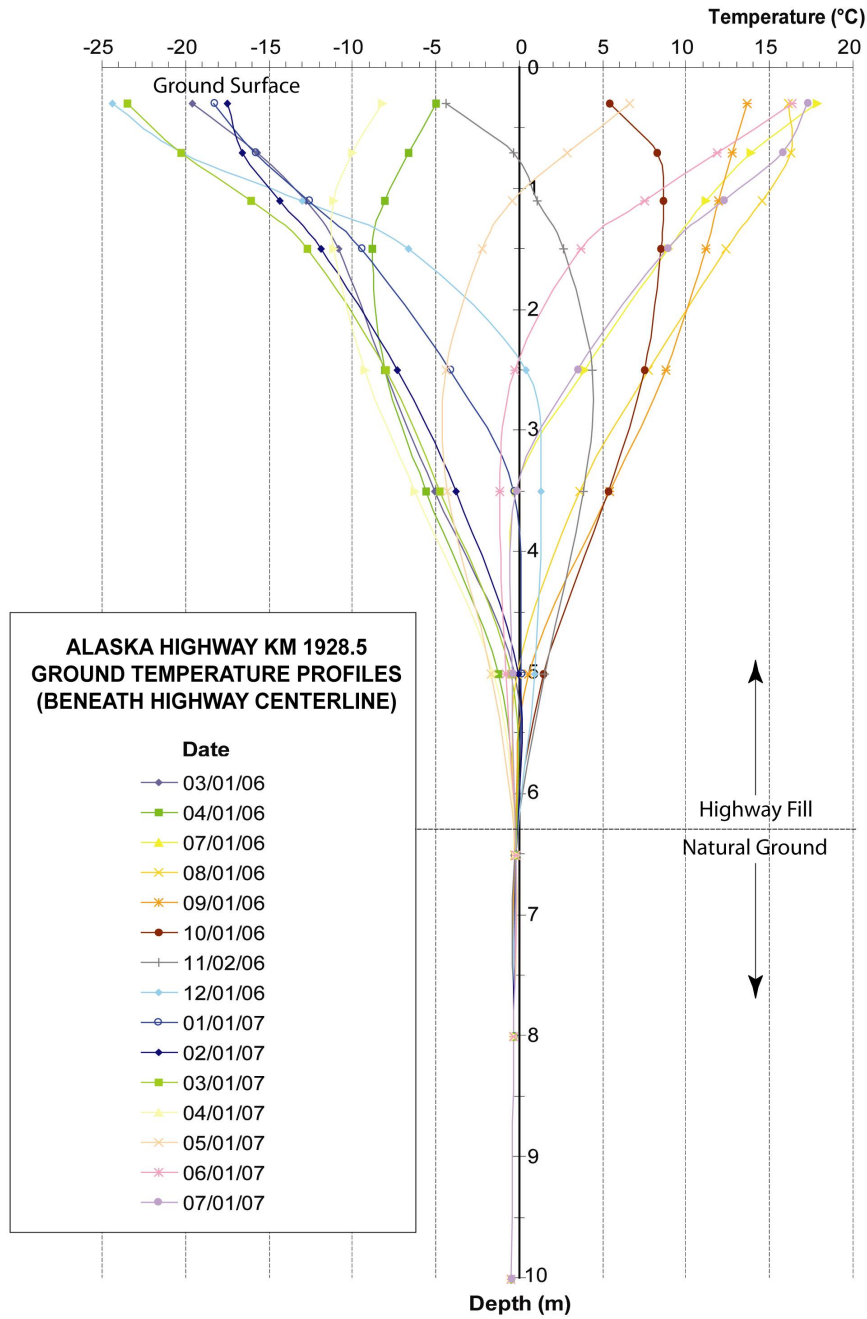
Figure 10 Ground temperature profiles between March 2006 and July 2007 beneath the centerline of the Alaska Highway at km 1928.5.

Ground temperature profiles generated from the Yukon Department of Highways thermistor strings for between March, 2006 and July, 2007 are shown in the following pages (Figure 10, 11 and 12). Several interesting facts are observed in these figures.

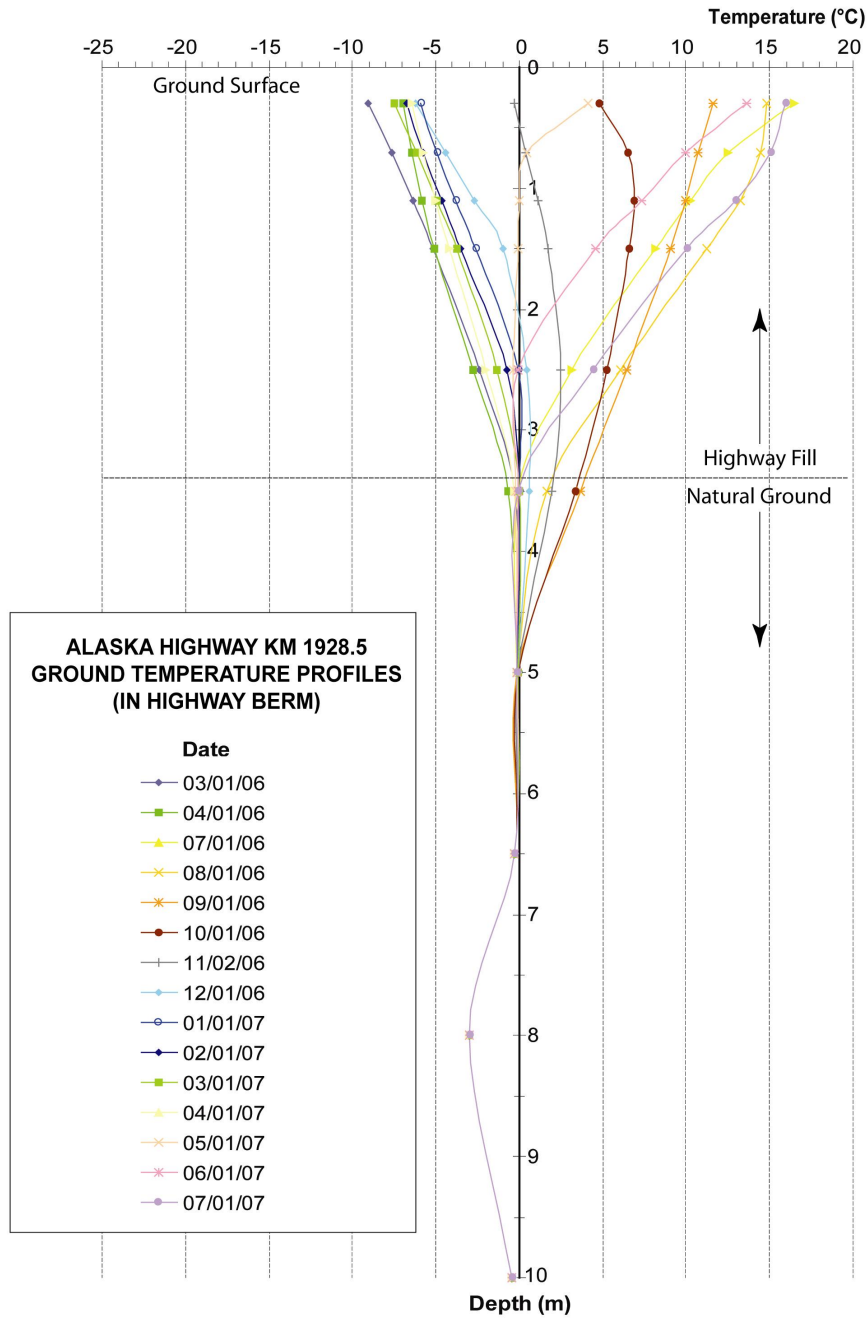
Figure 11 Ground temperature profiles between March 2006 and July 2007 beneath the stabilization berm for the Alaska Highway at km 1928.5.

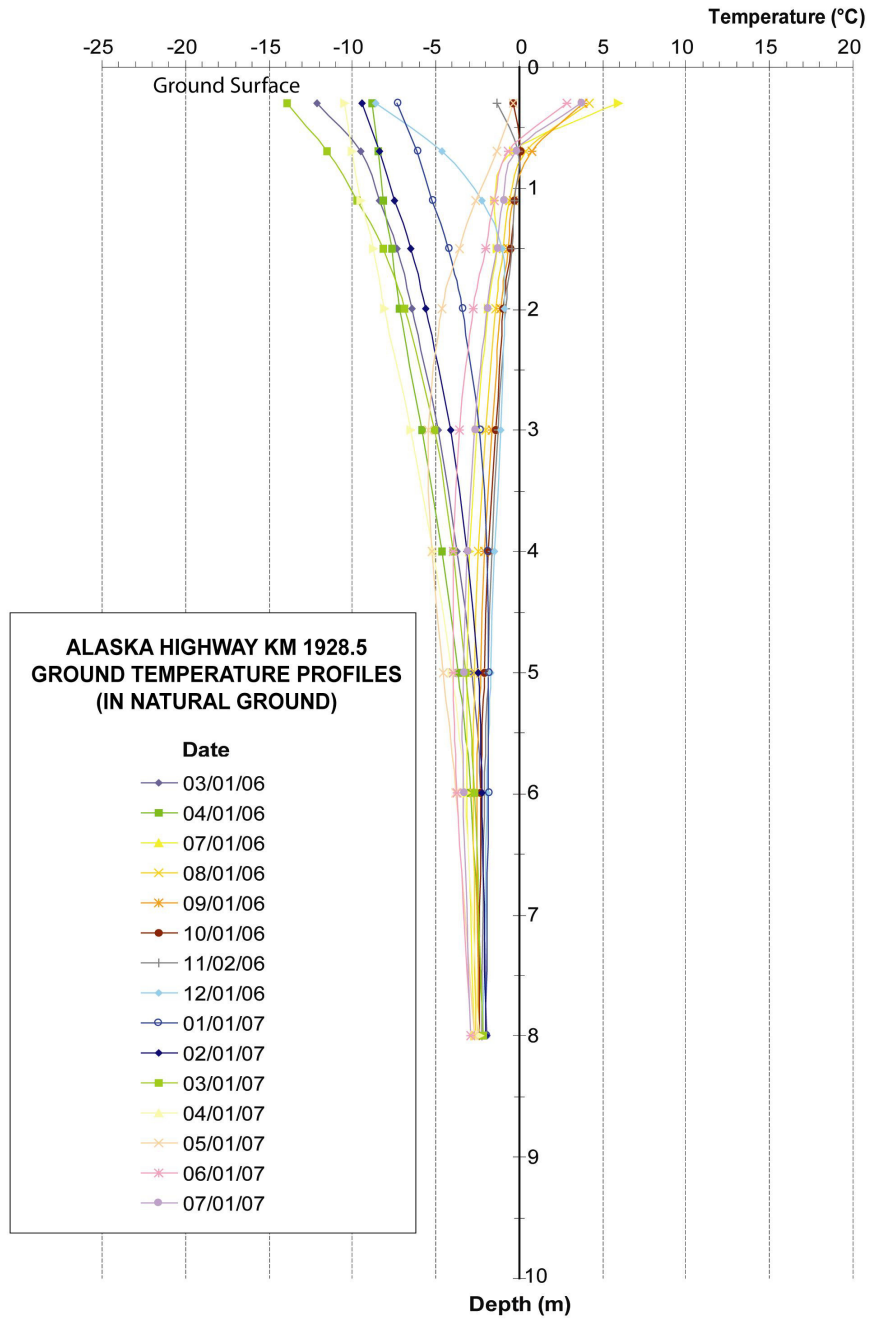
Figure 12 Ground temperature profiles between March 2006 and July 2007 in natural ground adjacent to the Alaska Highway at km 1928.5.

In Figure 12, ground temperatures are shown for the “natural” site, located 20 m from the toe of the highway berm in the undisturbed muskeg (Paine and Associates, 1997a). The active layer thickness portrayed in this figure is approximately 0.8 m thick. While the ground beneath this always remains frozen year-round, the temperature still fluctuates a few degrees at 8m depth.

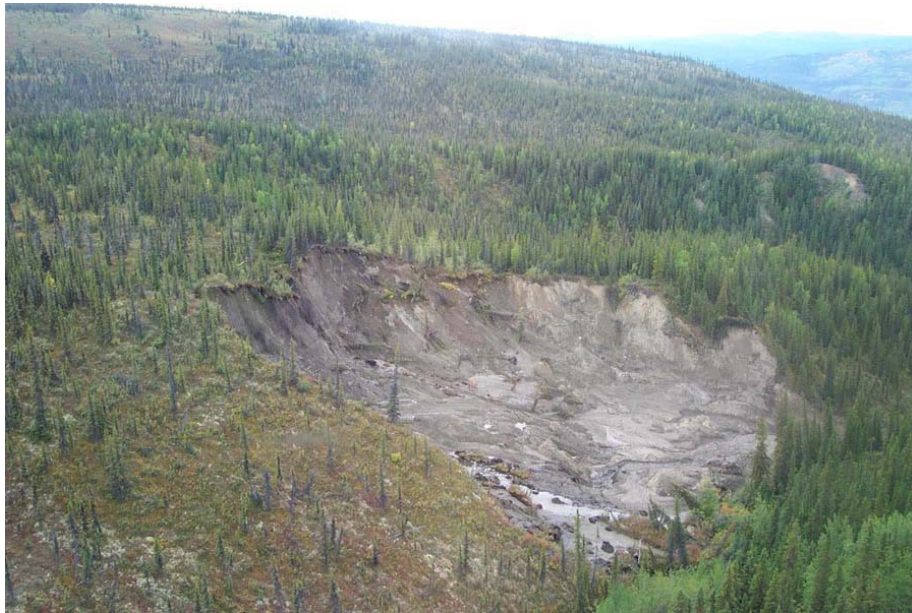
Figure 13 Bowl-shaped source zone for the 12-Mile Slope site landslide (photo taken May 20, 2006). The bowl is 115 m wide and the headwall is 12-30 m high.

Since the original failure in 2002, ongoing activity has been occurring at this site. Permafrost exposed in the steep headwall has been actively thawing in the summer months (June to September), causing parts of the headwall to gradually retreat. Thawed material from this retrogression accumulates at the base of the headwall, while slide debris from the original failure continues to settle and shift. This continued activity has had ongoing downstream impacts on highways maintenance, water quality and salmon habitat.

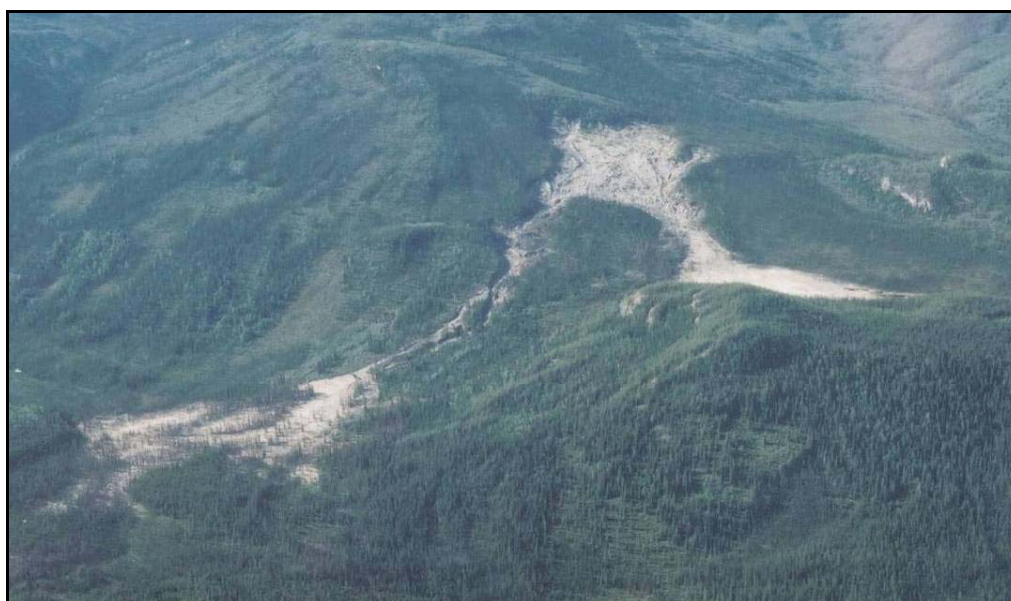
Figure 14 The Magundy Slide retrogressive thaw failure is comprised of three main components: the squarish source zone at the top of the slide (350 m wide), the smaller west fan deposition zone at the mid-right of the photo, and the larger east fan deposition zone in the lower left of the photo.

One of the most interesting features of this slide is its rapid rate of growth, as interpreted from analysis of air photos, satellite imagery and GPS surveys (Lyle, 2006). The landslide started in 1996 as a small groundwater piping failure less than 10 m wide. Subsequent activity has followed the typical sequence documented for retrogressive thaw flows. The initial disturbance exposed massive ground ice to the air. The exposed ice-rich material quickly thawed, releasing large amounts of water which has carried the debris up to 2 km down into the Magundy River valley bottom. The debris is transported in highly viscous mud and debris flows which have the appearance of lava flows. These flows travel on very gentle slopes due to the high moisture content provided from the thawing massive ice. The ongoing process has caused steady retreat of steep headscarps and accumulation of debris on the two distinct depositional fans visible in Figure 14.

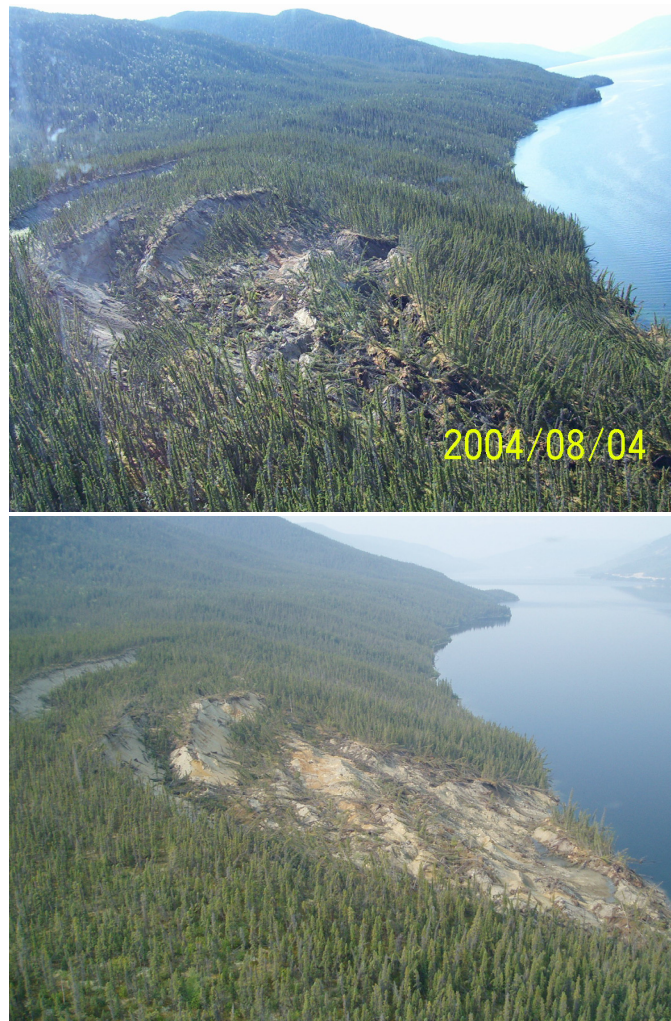
Figure 15 Translational ground movement at the Little Salmon Lake Slide between August 2004 (top photo courtesy of R. Lyle) and August 2005 (bottom photo courtesy of A. von Finster).

The Little Salmon Lake site is located at 62°21'04" N latitude and 134°30'42" W longitude. The slide is 350 m wide, and the elevation difference between the top of the scarp and the lake is 100 meters. As shown in Figure 15, several large rotational slump blocks have displaced up to 20 m along multiple steep scarps. The largest scarp, which forms the upper boundary of the slide, developed first some time before 1989. Between 1989 and 1998 an additional scarp developed just below the upper one. Then between 1998 and 2004, two more major scarps developed further down the slide. Between 2004 and 2005, the largest amount of movement occurred when the lower half of the slide moved translationally into the lake and disappeared (Figure 15).

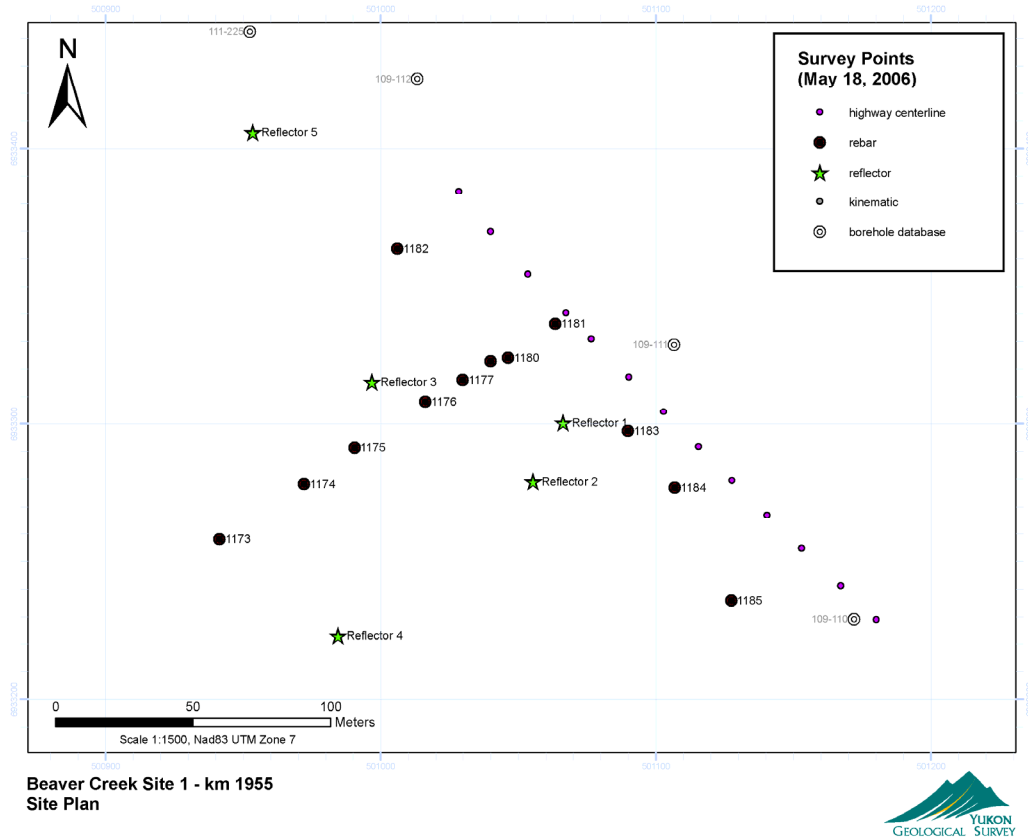
Figure 17 Locations of the reflectors and survey monuments at Beaver Creek, Site 1

Five radar corner reflectors were installed to ensure that, at a minimum, point measurements of ground motion could be made at this site. Four radar reflectors were placed on the active part of the slope, with an additional one installed to the northwest outside the active slide zone on ground that was assumed to be stable. The reflectors were anchored by driving three 50 mm diameter metal support posts into the ground as far as possible (approximately 50 cm). The photograph in Figure 16 shows reflectors 1 and 2 (in the distance) installed near the centre of the slope. The locations of the radar reflectors and the rebar monuments are shown in Figure 17.

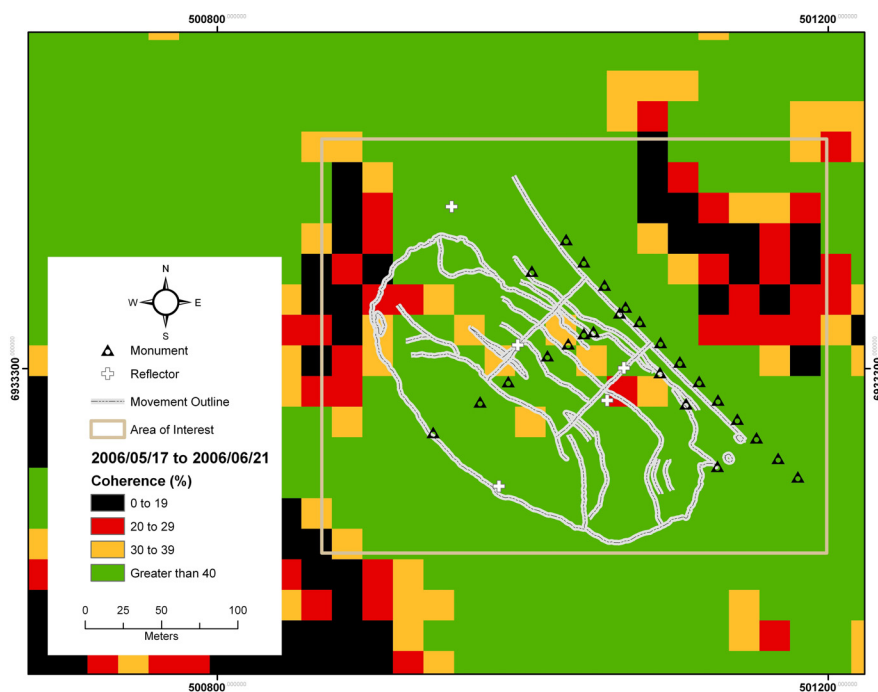
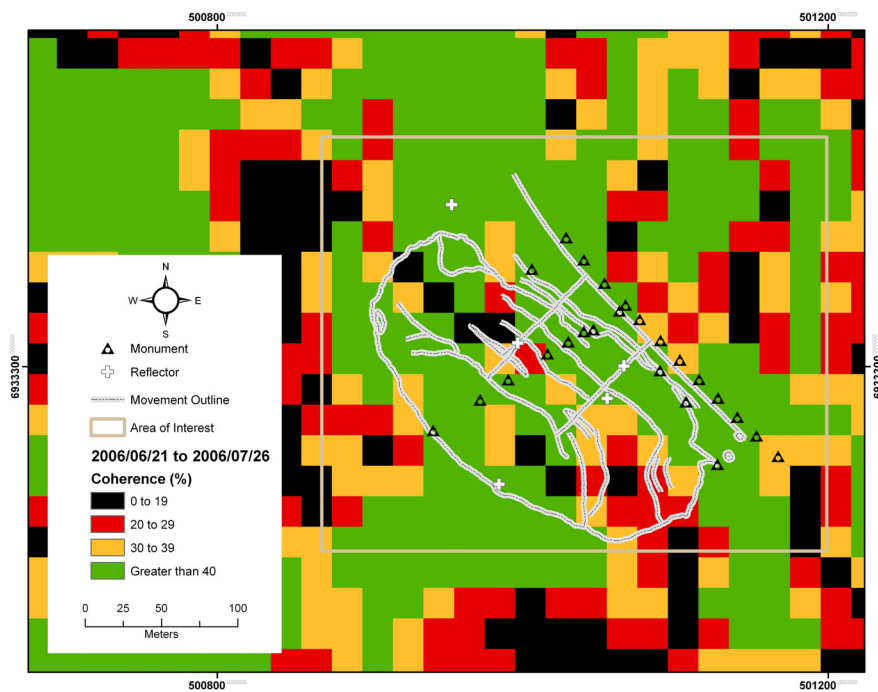
Figure 18 Coherence map derived from ENVISAT data for Beaver Creek site 1 (May 17 to June 21, 2006).

Figure 19 Coherence map derived from ENVISAT data for Beaver Creek site 1 (June 21 to July 26, 2006).

Figure 20 Coherence map derived from ENVISAT data for Beaver Creek site 1 (July 26 to August 30, 2006).

In general the coherence maps suggest that ground movement estimates can be derived from these image pairs using traditional interferometric techniques. It should be noted that the areas of low coherence – likely caused by variation in soil moisture content - for the June to July image pair (Figure 19) will cause phase unwrapping problems which will negatively effect the movement estimates derived from this data. Conversely the image pair for July to August displays very good coherence which results in more reliable estimates of ground motion results.

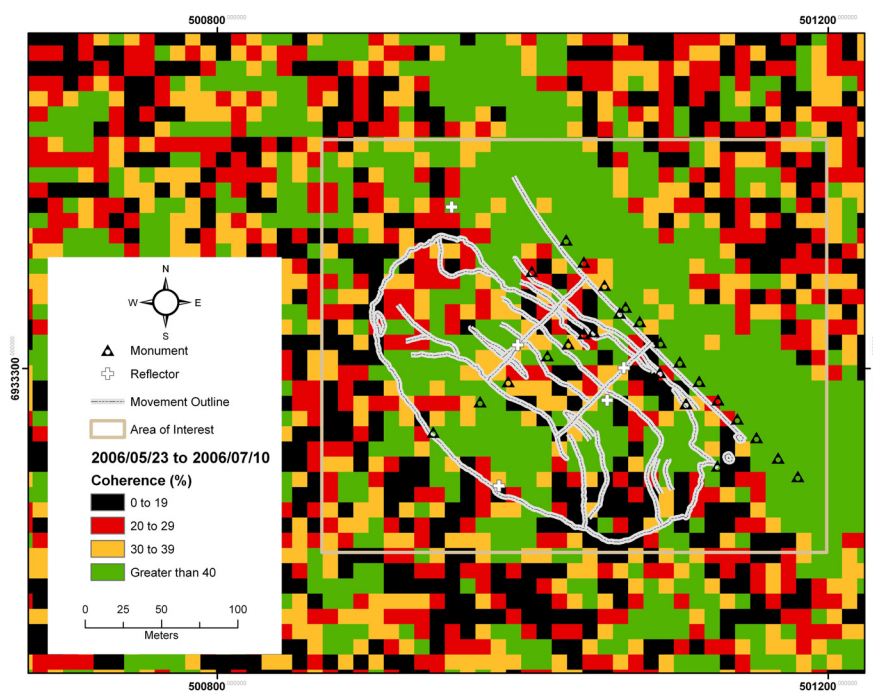
Figure 21 Coherence map derived from RADARSAT data for Beaver Creek site 1 (May 23 to July 10, 2006)

Figure 22 Coherence map derived from RADARSAT data for Beaver Creek site 1 July 10 to August 03, 2006)

Figure 23 Coherence map derived from RADARSAT data for Beaver Creek site 1 (August 03 to August 27, 2006)

Figure 24 Coherence map derived from RADARSAT data for Beaver Creek site 1 (August 27 to September 20, 2006)

Figures 21 through 24 show the variation of the RADARSAT coherence at Beaver Creek site 1, kilometer post 1955. These figures clearly show the interspersion of good coherence ($> 30\%$) and poor coherence ($< 30\%$). This type of coherence pattern makes phase unwrapping challenging and likely introduces errors in ground motion estimates when phase unwrapping errors occur. The radar reflector data from these image pairs however provide useable phase data from the coherent point targets. This phase data was used to estimate ground movement values as opposed to traditional InSAR processing techniques. See Section 2.5 for these results.

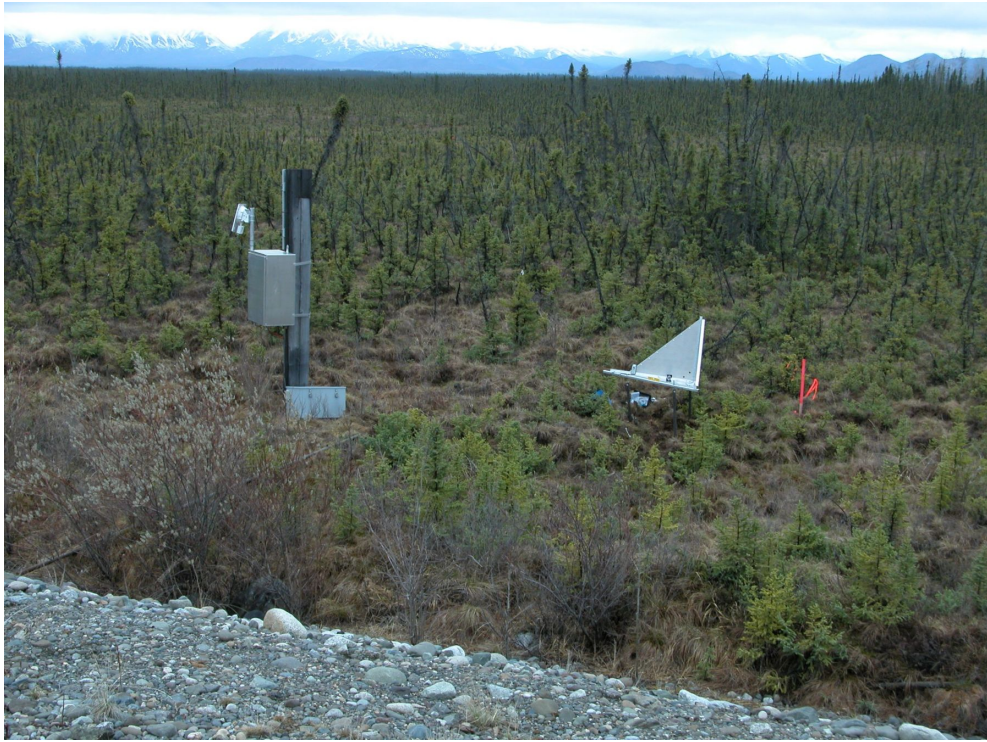
Figure 30 Radar reflector (to the right) and pre-existing data logger (to the left) used to monitor ground temperatures beneath and adjacent to the Alaska Highway at Beaver Creek, Site 2

This highlights the challenge with anchoring reflectors in permafrost terrain where thaw settlement is a desired phenomenon for SAR detection. If thaw settlement is what one is attempting to detect, the reflector needs to be either anchored in the active layer, or somehow anchored to the ground surface to reflect this movement. It should not be anchored deeper down in the permafrost which would never thaw, and hence would not reflect any settlement movement. However, it is difficult to anchor the posts in a medium that freezes and thaws seasonally due to the inherent changes in volume and moisture in this layer.

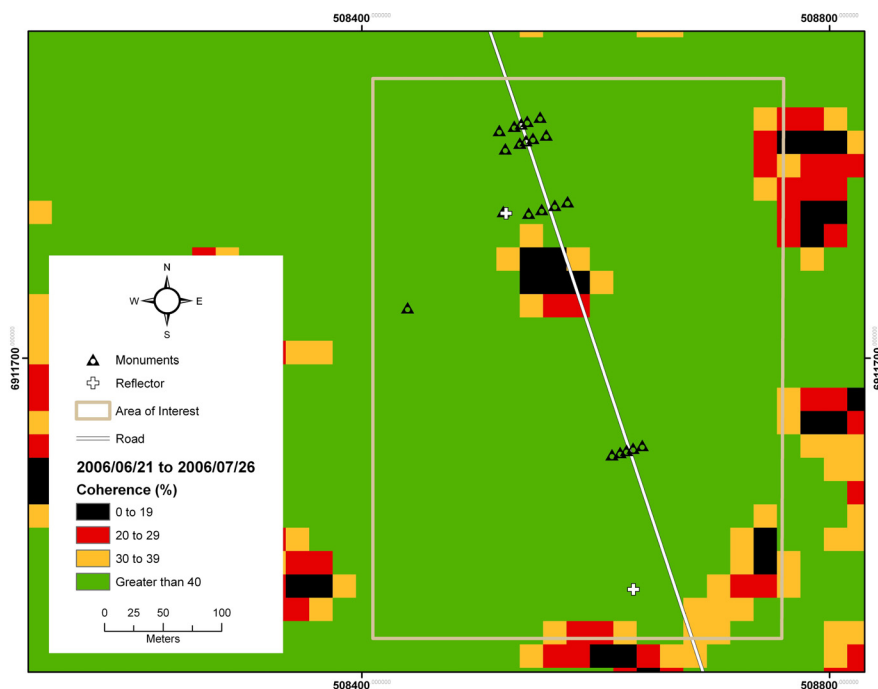
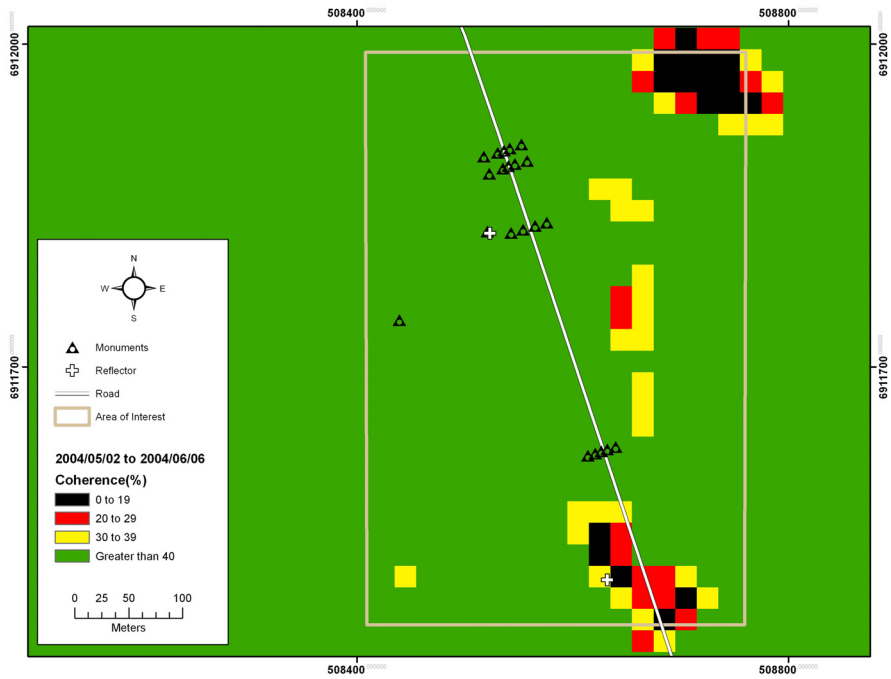
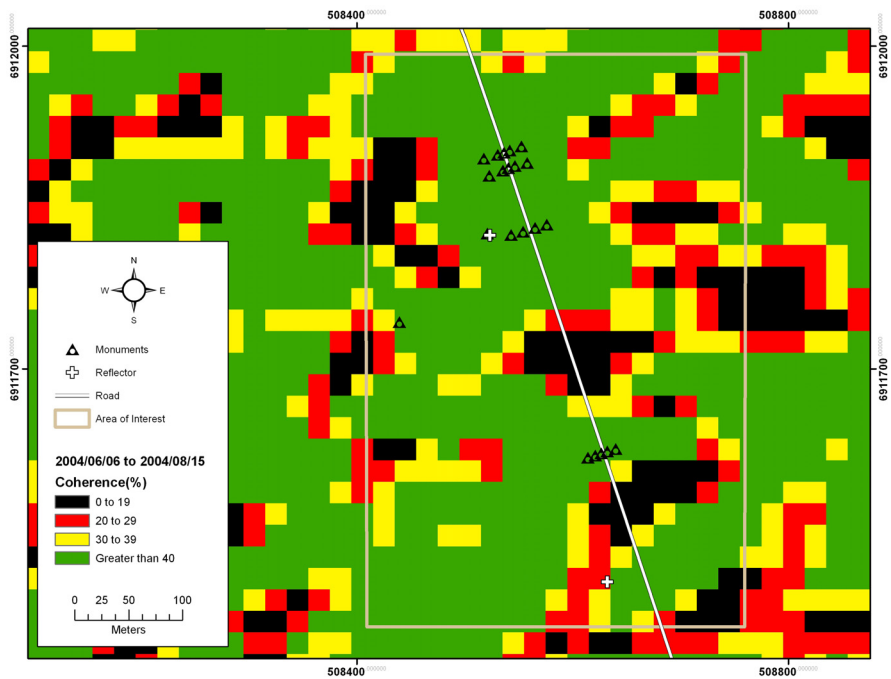
Figure 32 Coherence map derived from ENVISAT data for Beaver Creek site 2 (May 17 to June 21, 2006)

Figure 33 Coherence map derived from ENVISAT data for Beaver Creek site 2 (June 21 to July 26, 2006)

Figure 34 Coherence map derived from ENVISAT data for Beaver Creek site 2 (July 26 to August 30, 2006)

Figure 35 Coherence map derived from ENVISAT data for Beaver Creek site 2 (May to June 2004)

Figure 36 Coherence map derived from ENVISAT data for Beaver Creek site 2 (June to August 2004)

Figure 37 Coherence map derived from ENVISAT data for Beaver Creek site 2 (August to September 2004)

It is also interesting that the coherence is very good between nearly all image pairs in the well-vegetated (stunted spruce forest / muskeg) and very-poorly drained natural ground adjacent to the highway. The ground surface in this area is covered by patches of moss 20-30 cm thick, interspersed with grass tussocks and occasionally small water-filled depressions. The ground beneath the organic material typically only thaws to a depth of approximately 10 cm each summer. Because the active layer is so thin and thaws so slowly, surface moisture may only change by very minor amounts throughout the summer, and vegetation also grows extremely slowly.

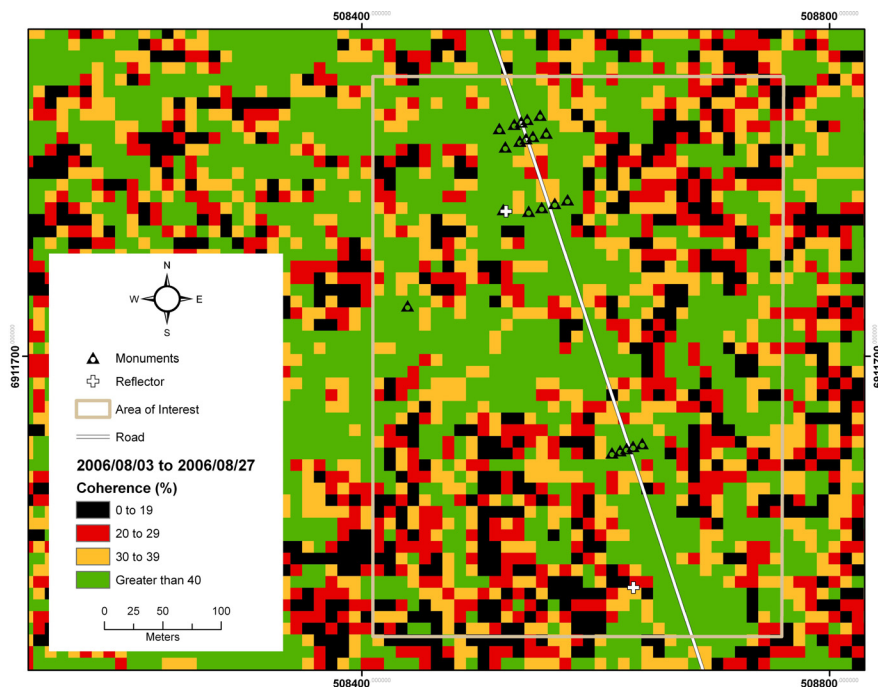
Figure 38 Coherence map derived from RADARSAT data for Beaver Creek site 2 (May 23 to July 10, 2006)

Figure 39 Coherence map derived from RADARSAT data for Beaver Creek site 2 (July 10 to August 03, 2006)

Figure 40 Coherence map derived from RADARSAT data for Beaver Creek site 2 (August 03 to August 27, 2006)

Figure 41 Coherence map derived from RADARSAT data for Beaver Creek site 2 (August 27 to September 20, 2006)

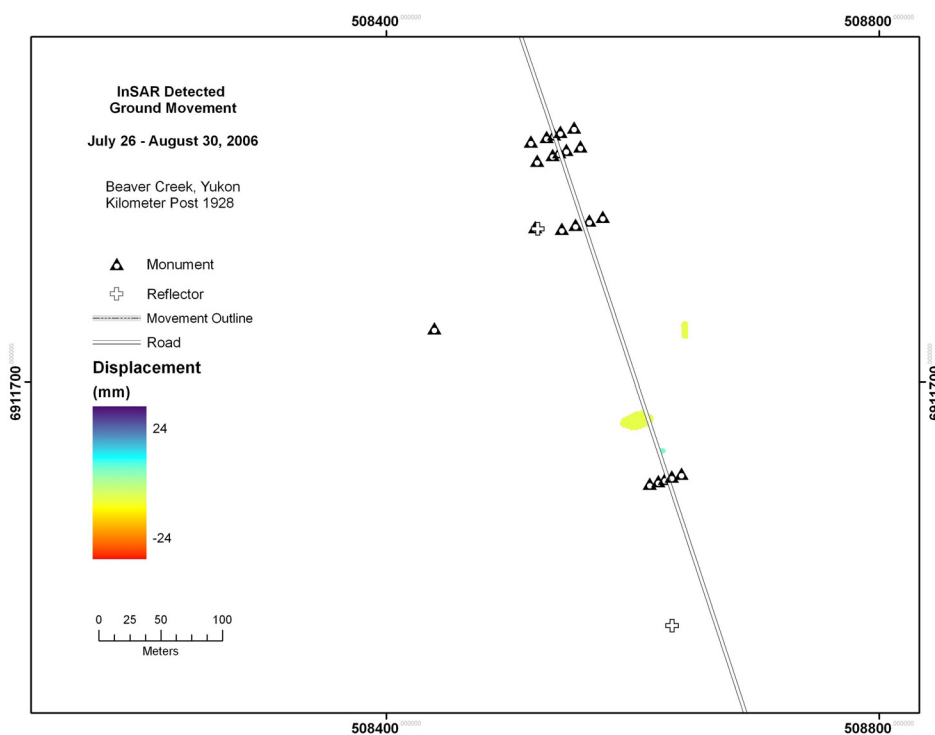
Figure 42 Movement map derived from ENVISAT data (May 17 to June 21, 2006)

Figure 43 Movement map derived from ENVISAT data (June 21 to July 26, 2006)

Figure 44 Movement map derived from ENVISAT data (July 26 to August 30, 2006)

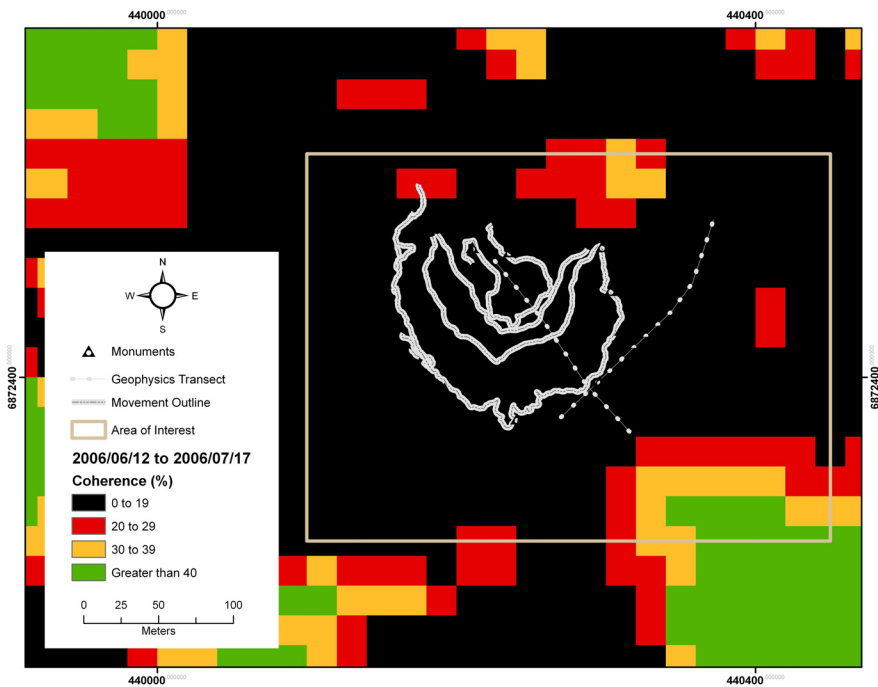
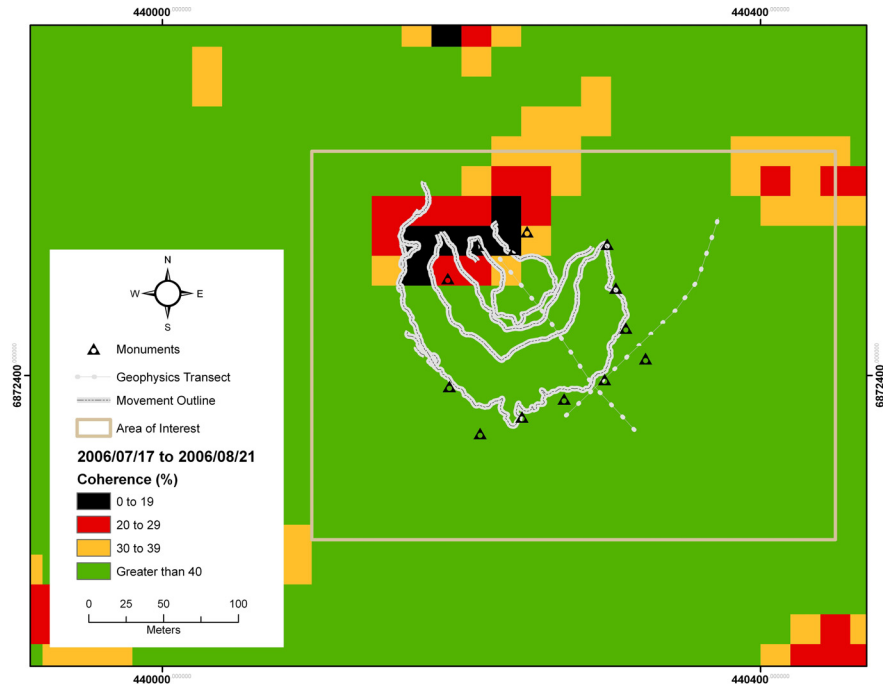
Figure 48 Coherence map derived from ENVISAT data for 12 Mile Slope (May 08 to June 12, 2006)

Figure 49 Coherence map derived from ENVISAT data for 12 Mile Slope (June 12 to July 17, 2006)

Figure 50 Coherence map derived from ENVISAT data for 12 Mile Slope (July 17 to August 21, 2006)

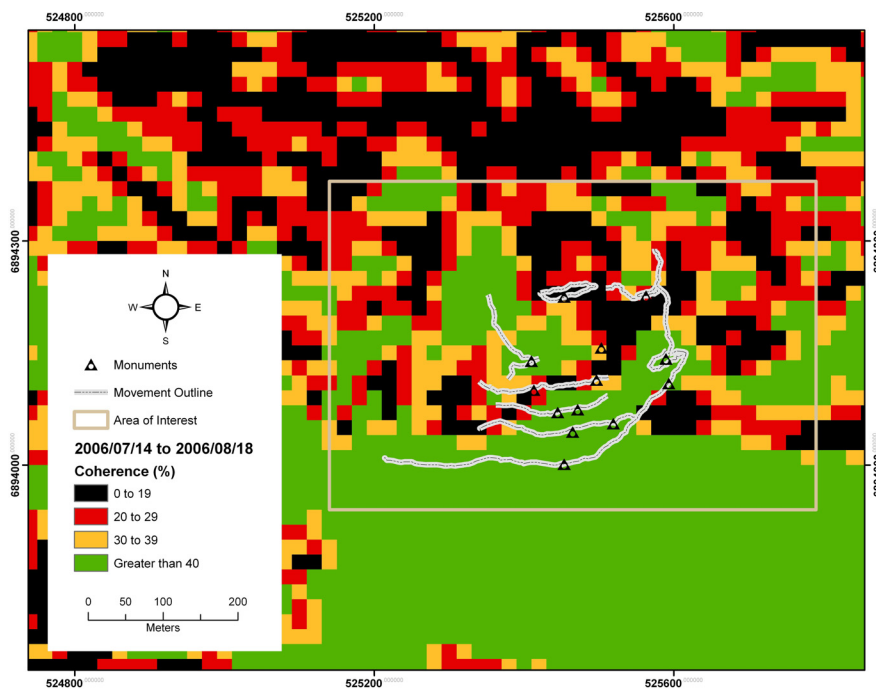
Figure 54 Coherence map derived from ENVISAT data for Little Salmon Lake (May 05 to June 09, 2006)

Figure 55 Coherence map derived from ENVISAT data for Little Salmon Lake (June 09 to July 14, 2006)

Figure 56 Coherence map derived from ENVISAT data for Little Salmon Lake (July 14 to August 18, 2006)

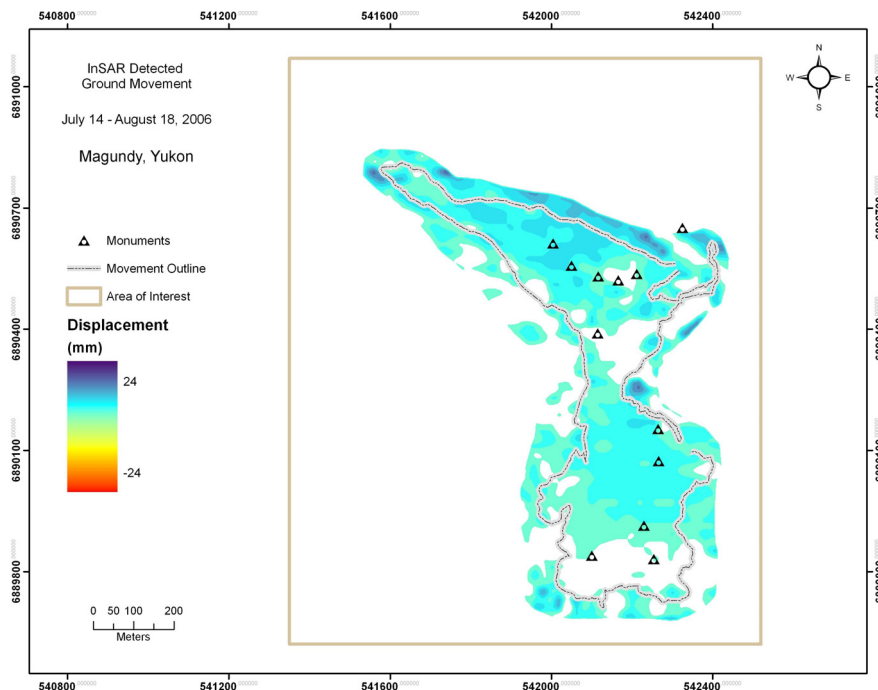
Figure 60 Movement map derived from ENVISAT data (July 14 to August 18, 2006)
