Satellite Monitoring of Permafrost Instability — Validation, Evaluation and Evolution

R-07-018-402 v.2.0

Prepared for:
European Space Agency

December 2007

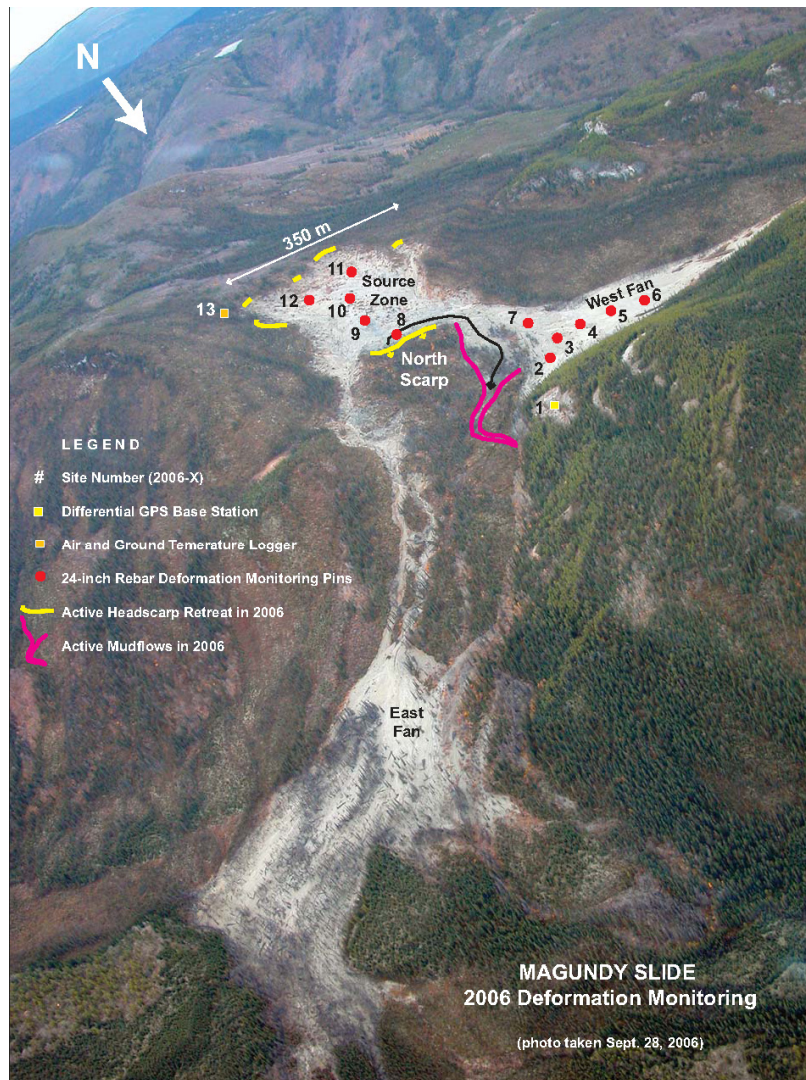
Figure 62 Deformation monitoring at the Magundy River Slide in 2006 (note that the horizon is rotated about 45° counter clockwise in this image)

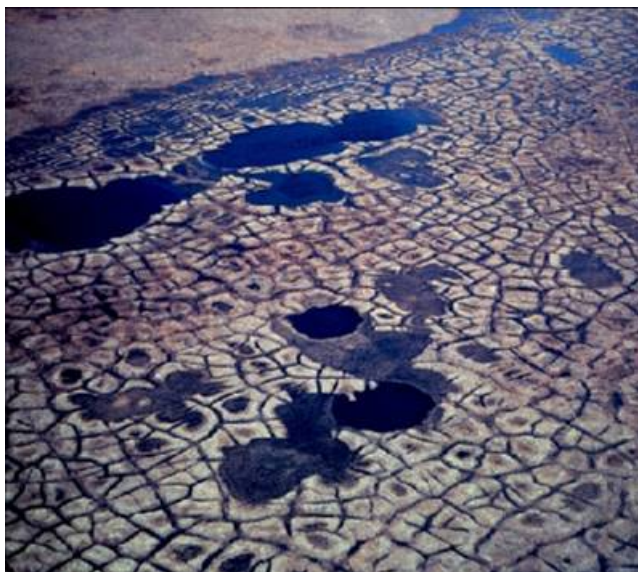
Figure 64 Patterned ground in permafrost terrain

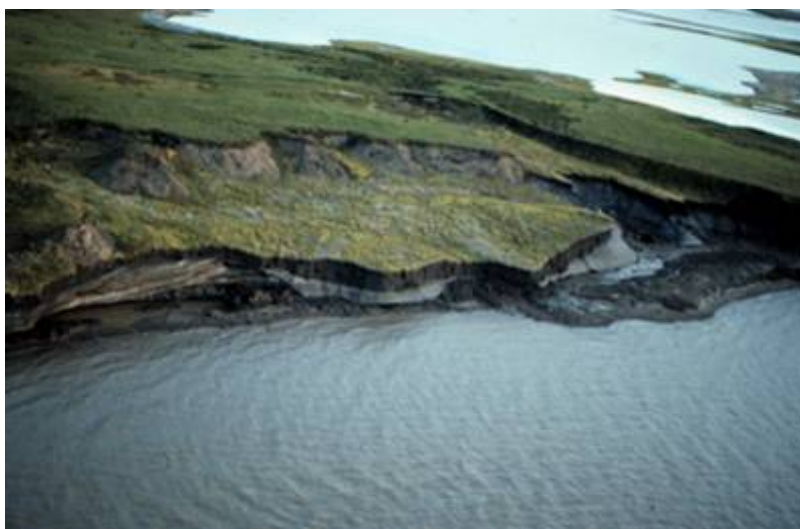
Figure 65 Slope instability (block failure) in permafrost terrain

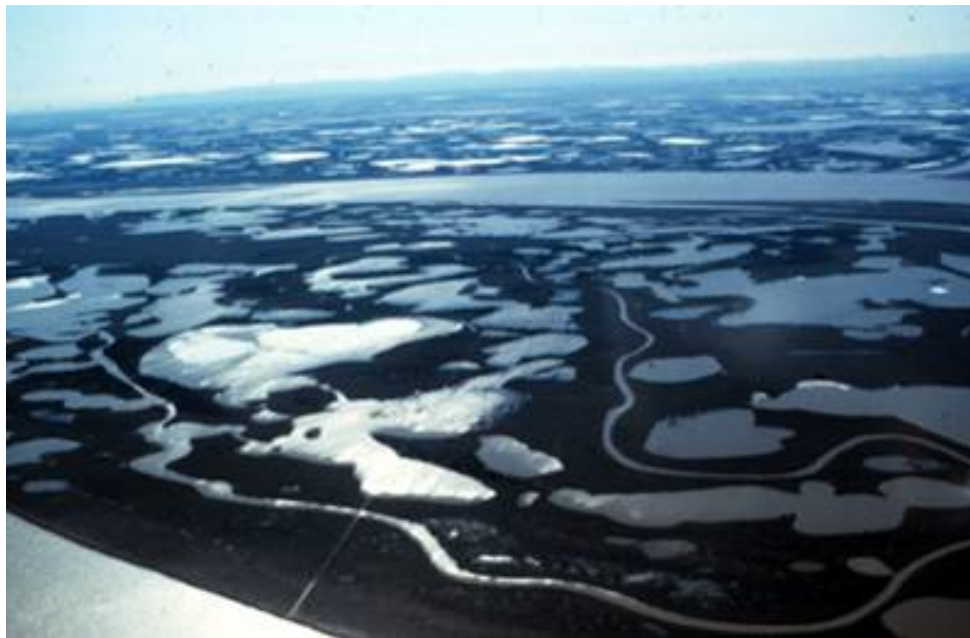
Figure 67 Thermokarst lakes in permafrost terrain

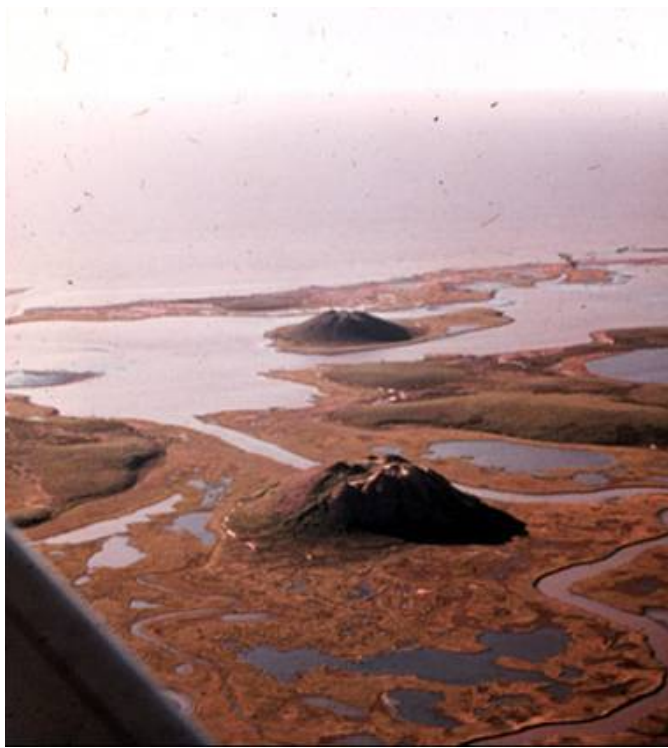
Figure 68 Pingo formations in permafrost terrain

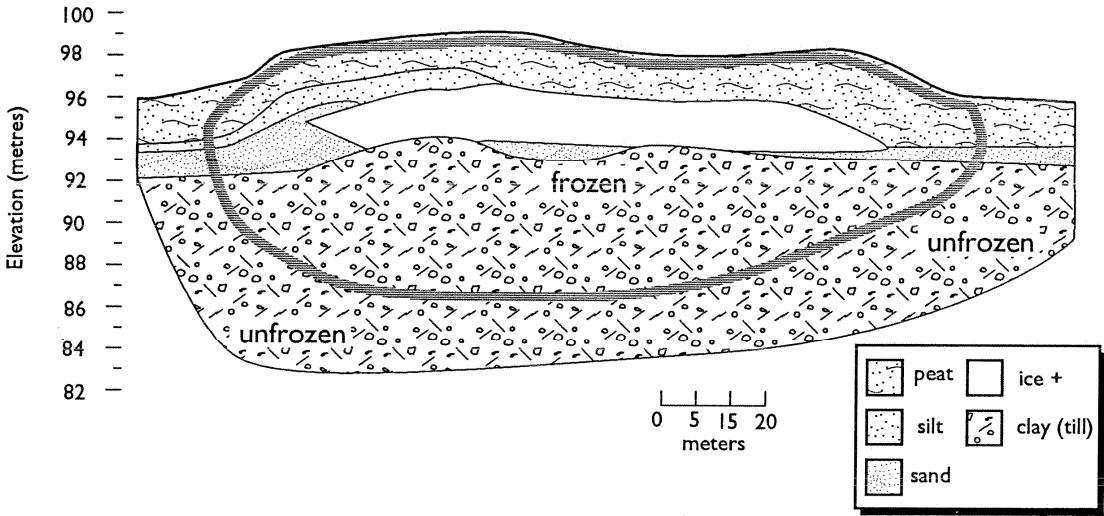
Figure 69 Cross-section through peat plateau in permafrost terrain

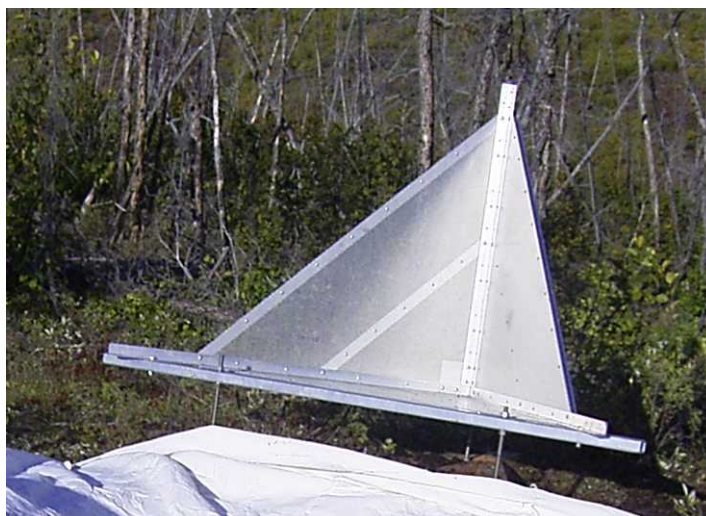
Figure 73 Example of improved reflector installation method (photo courtesy of Canadian Centre for Remote Sensing)
