VISIT TO CARMACKS COAL PROPERTIES
TANTALUS AND TANTALUS BUTTE, CARMACKS, Y.T.

A visit to the coal properties was to evaluate the risk to the public of the cave-ins as a result of the underground fire in the Tantalus Butte property, to evaluate the amount of reclamation that might be required should Dome wish to abandon the properties, and the state of the remaining equipment and buildings on the property. The attached photos and sketch indicate that the underground cave-ins can be safely protected from accident by some improvement to the north end of the access to the strike of the coal property. Some barbed wire has been strung (one strand) for a considerable length of the strike in the steeper areas at the south end of the property. I see little point in attempting to fill or fence the individual cave-ins. It is worthwhile to remove the structure over the raise at the north end of the property and to try to fill it with waste material. Similarly, the existing access road at the north end of the strike that is partially blocked-off should be made significantly more difficult for access to be gained to the area of the cave-ins and the last raise.

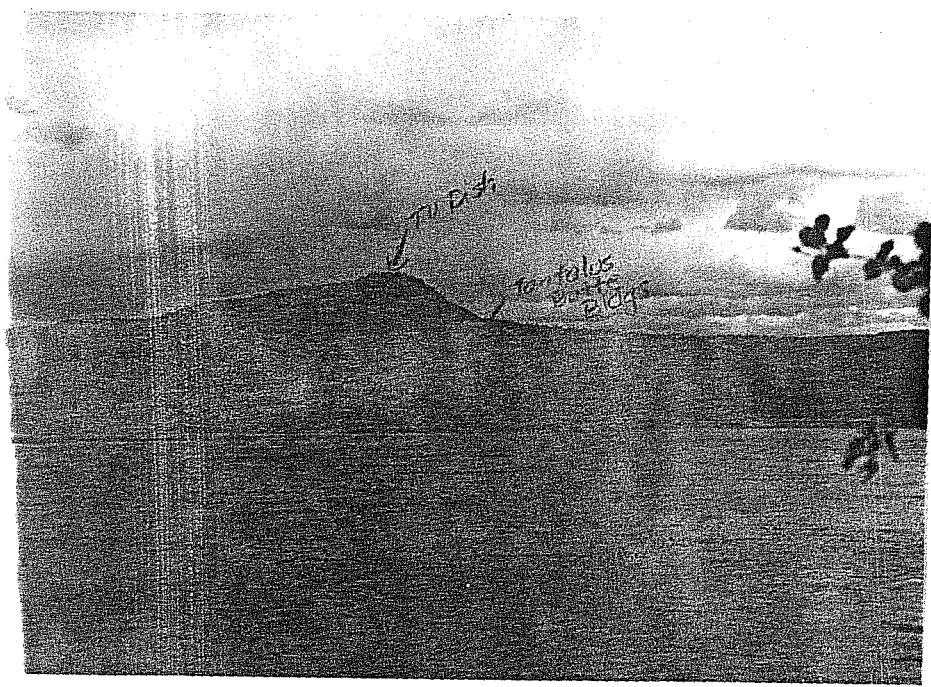
June 8, 1983
View from sign to Tantalus Butte Coal Mine north of Yukon River near Carmacks. Carmacks TV DISH is located on top of bluff.

The people that operate the television dish located at the top of the bluff should be contacted to ascertain that they are aware of the hazard of the cave-ins and that they be given a key to an improved gate to be installed below the open pit and wasterock piles at the north end of the property.

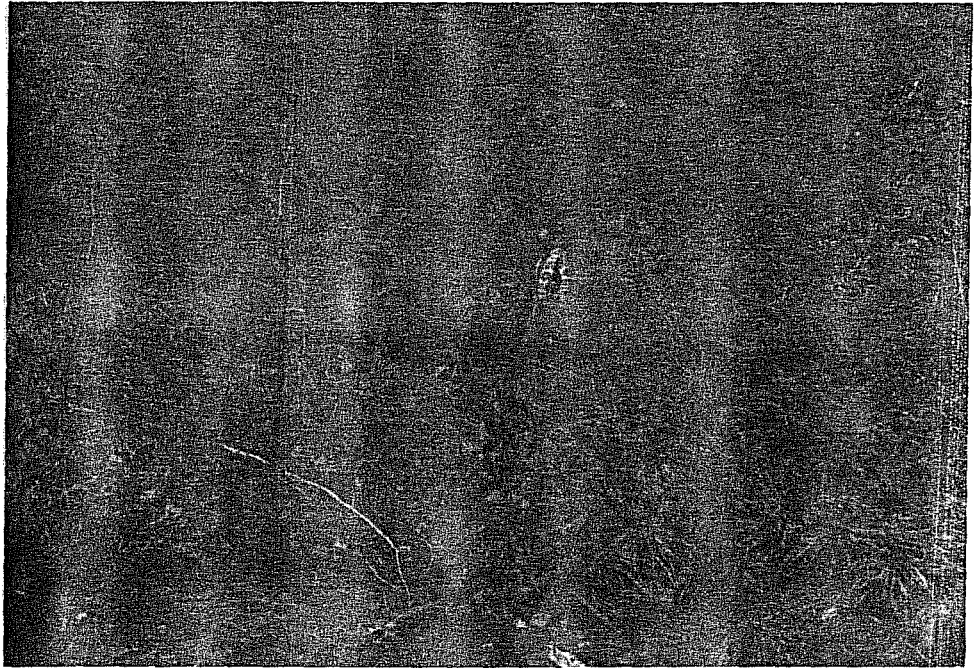
June 8, 1983
Tantalus Butte Coal Mine
Cave-in just above filled in adit.

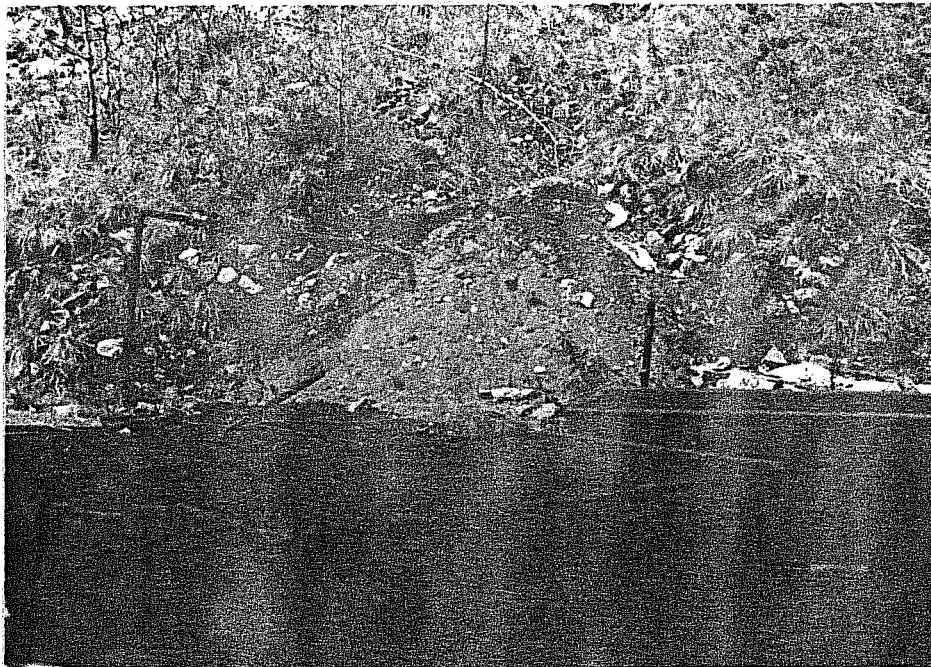
June 8, 1983
Tantalus Butte Coal Mine
Filled in adit entrance.

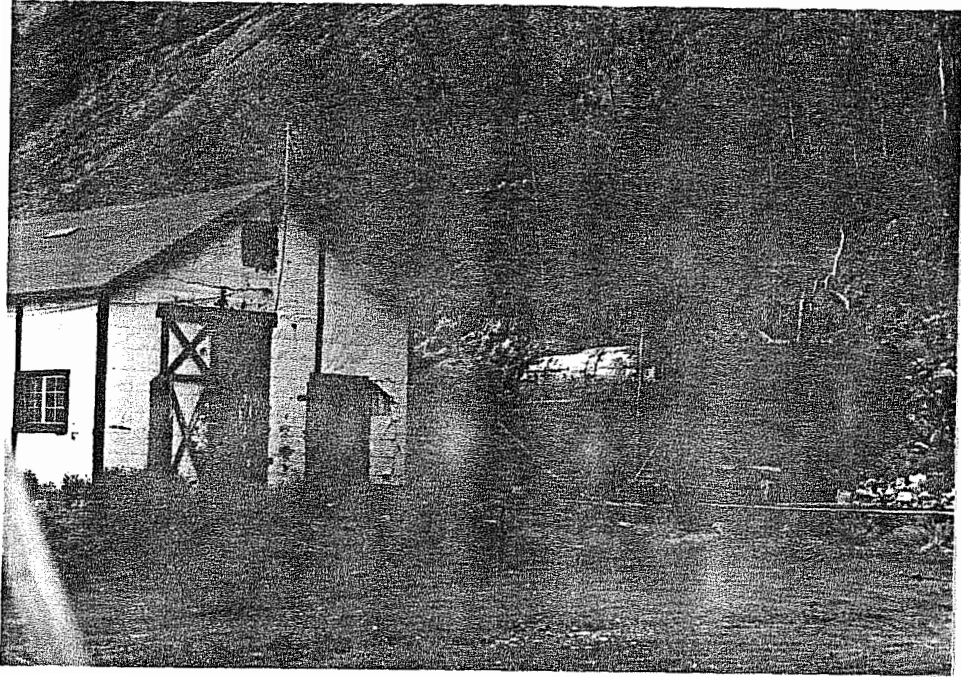
June 8, 1983
Tantalus Butte Coal Mine
Shed and tanks 100 feet to the left of the filled
in adit. Note rail lines to the shed and tippie.

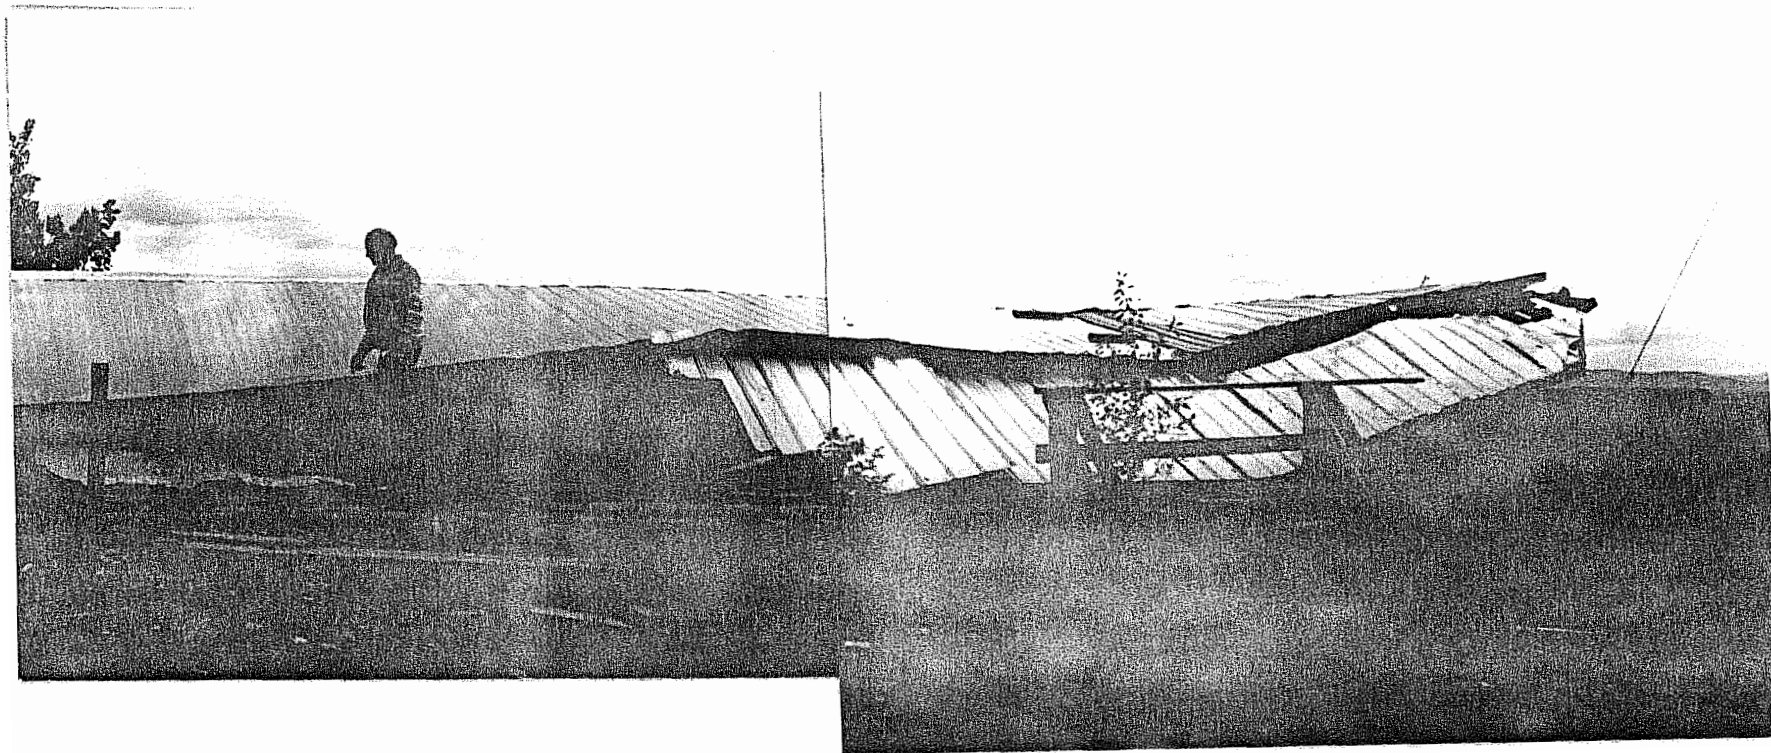
June 8, 1983
Tantalus Butte Coal Mine
Vandalized cover over rail line to tipple.

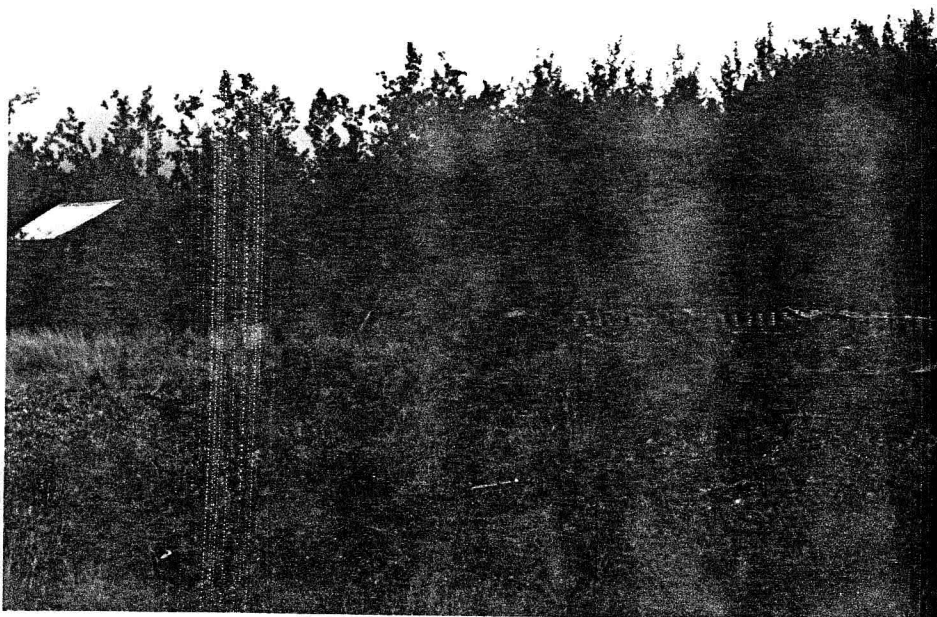
June 8, 1983
Tantalus Butte Coal Mine
Coal core shed and core
samples outside 200 feet
left of shed and tanks.

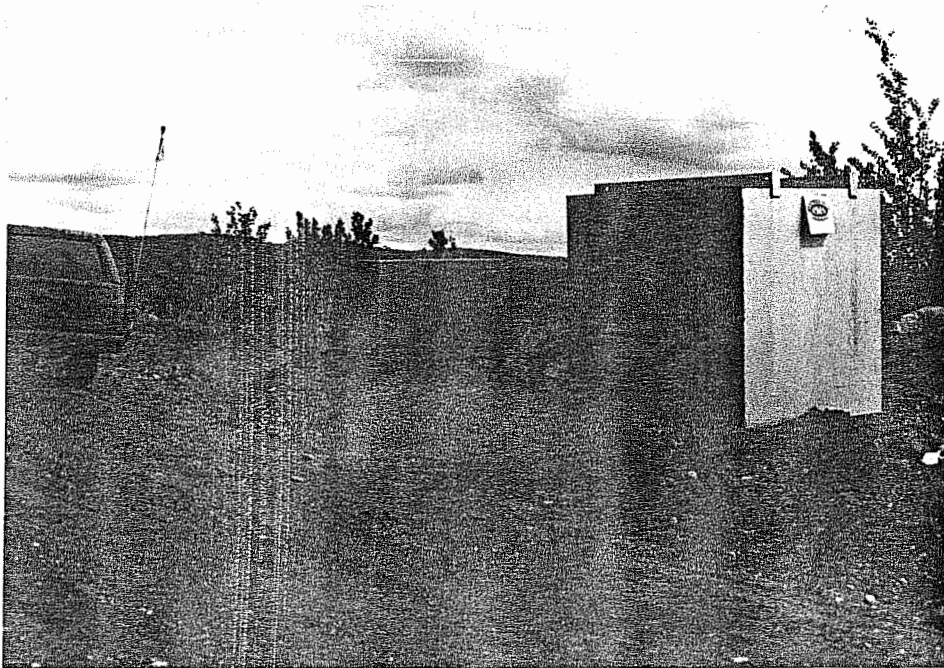
June 8, 1983
Tantalus Butte Coal Mine
Surplus & explosives
magazine on lower waste
dump from underground
operations.
Note natural revegetation.

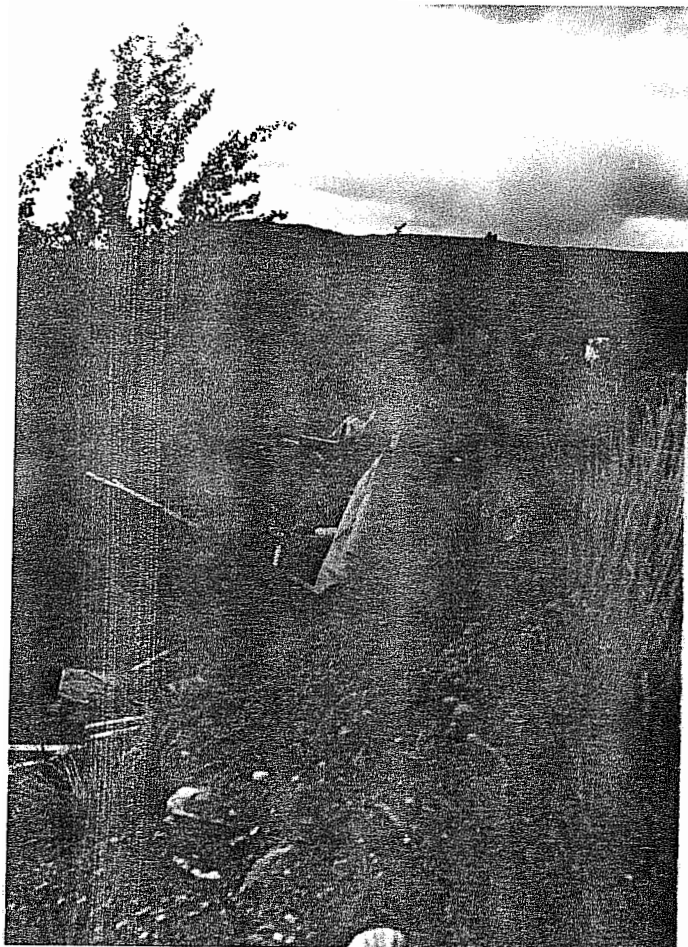
June 8, 1983
Tantalus Butte Coal Mine
Debris at edge of lower
waste dump from underground
operations.

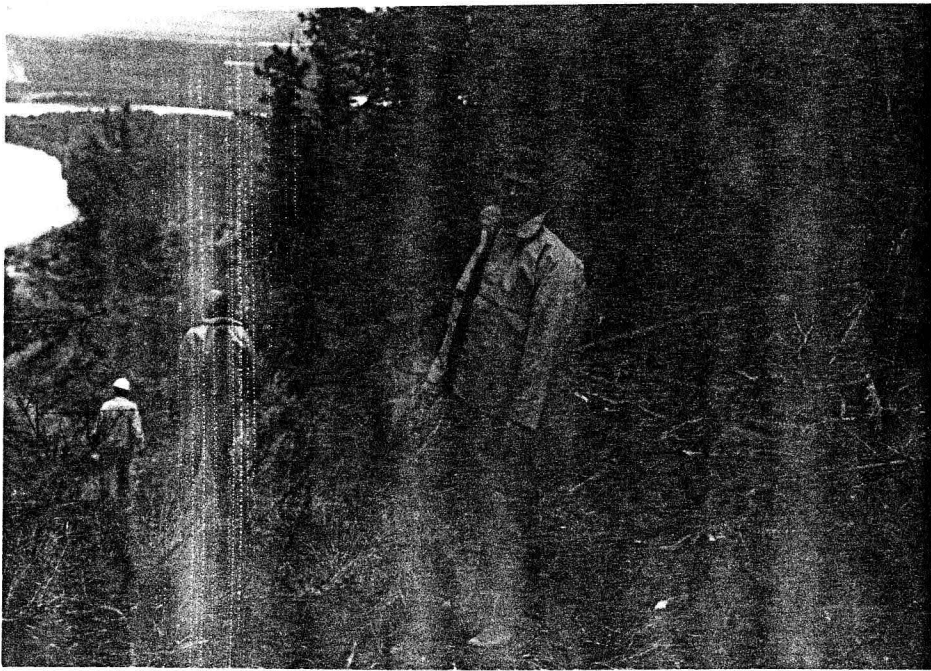
June 8, 1983
Tantalus Butte Coal Mine
Single strand of barbed wire
separating road from cave-
Ins Slope.
Cat Track made to fill in
one of early cave-ins.

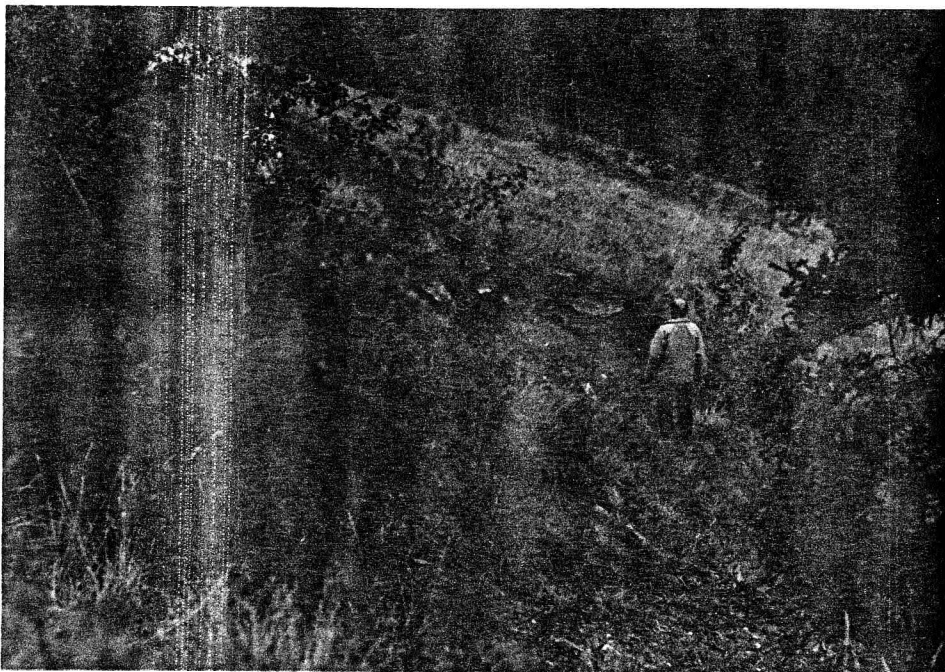
June 8, 1983
Tantalus Butte Coal Mine
Size of one of major
cave-ins.

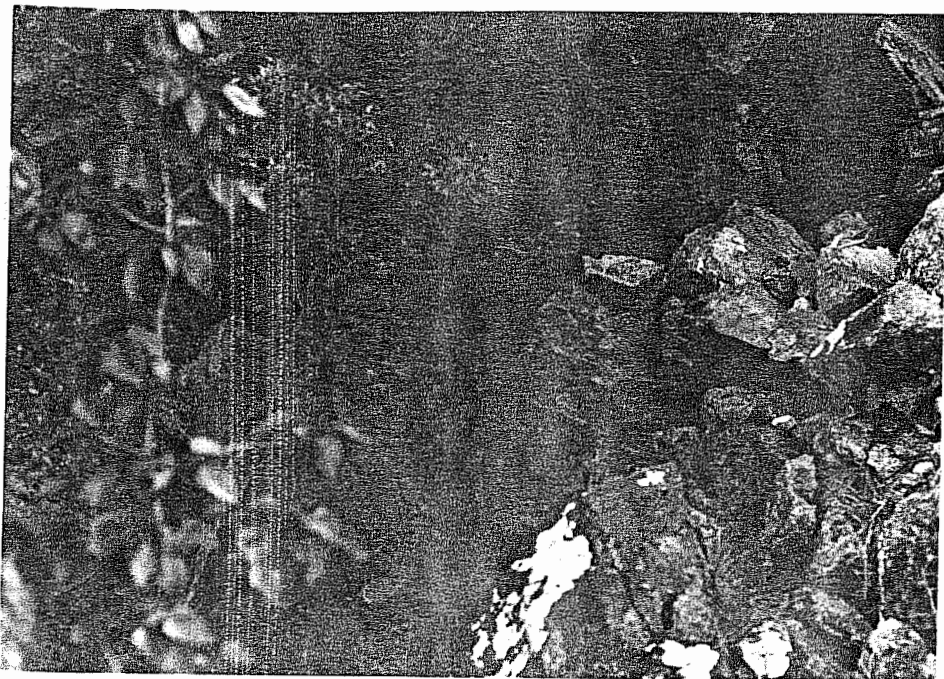
June 8, 1983
Tantalus Butte Coal Mine
One of larger cave-ins
shows deep hole to under-
ground procupine seen in
this cave-in.
Note revegetation in
cave-in.

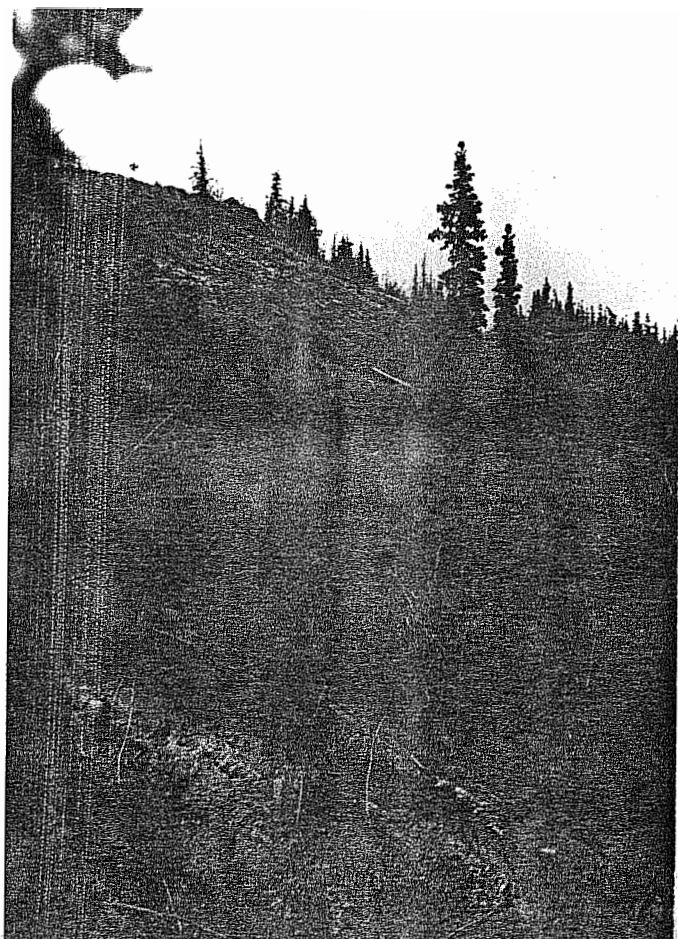
June 8, 1983
Tantalus Butte Coal Mine
View along strike of coal
vein shows 4 cave-ins
farthest one emitting
steam & gases.

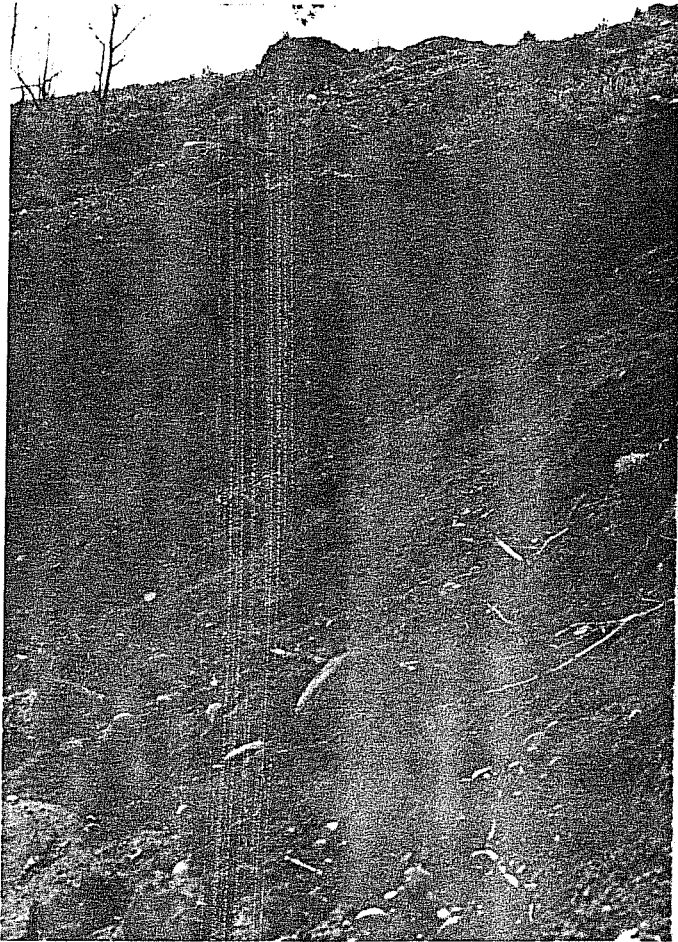
June 8, 1983
Tantalus Butte Coal Mine
One of northerly cave-ins.
Note crack and venting
gases top centre and right.
Access from north is
relatively easy.

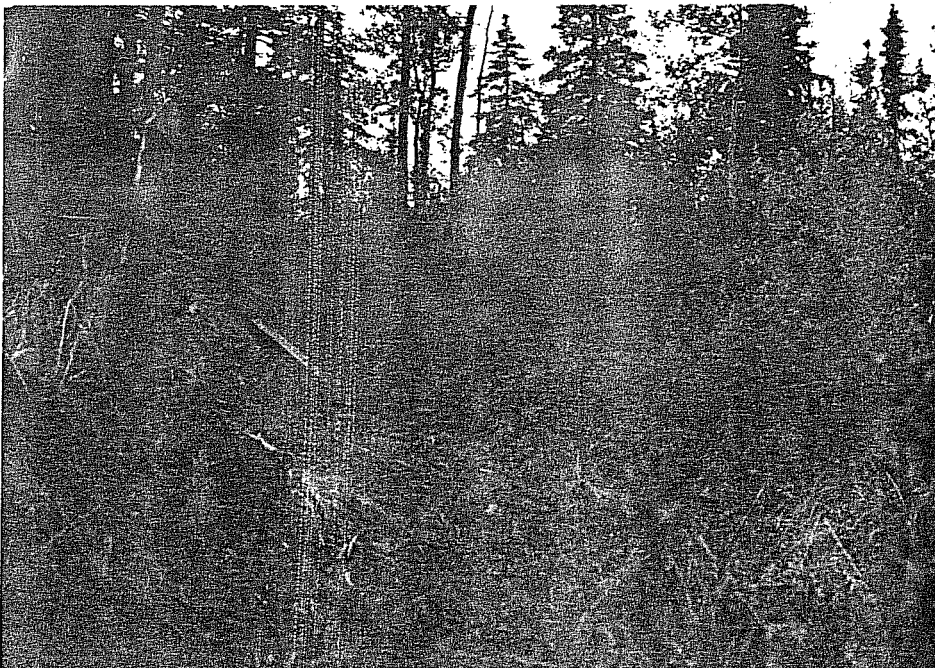
June 8, 1983
Tantalus Butte Coal Mine
One of old raises to
underground near the north
end of strike.
Raise opening has been
covered with plastic, but
should probably be removed
and filled in.
Access to this area from
north is relatively easy.

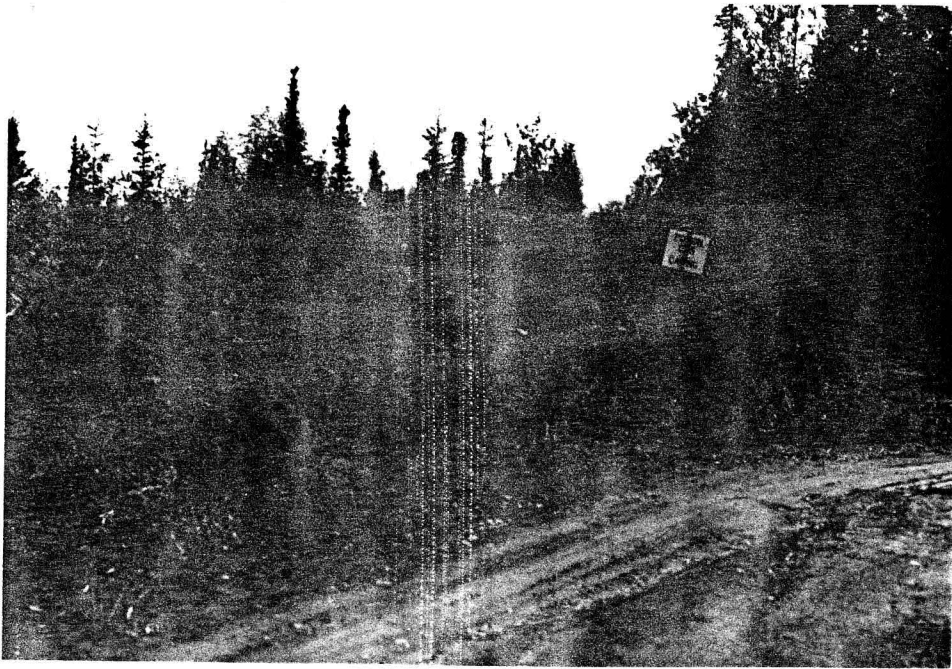
June 8, 1983
Tantalus Butte Coal Mine
Junction of road to TV DISH
(right) and access to north
end cave-ins.
This road block should be
improved.

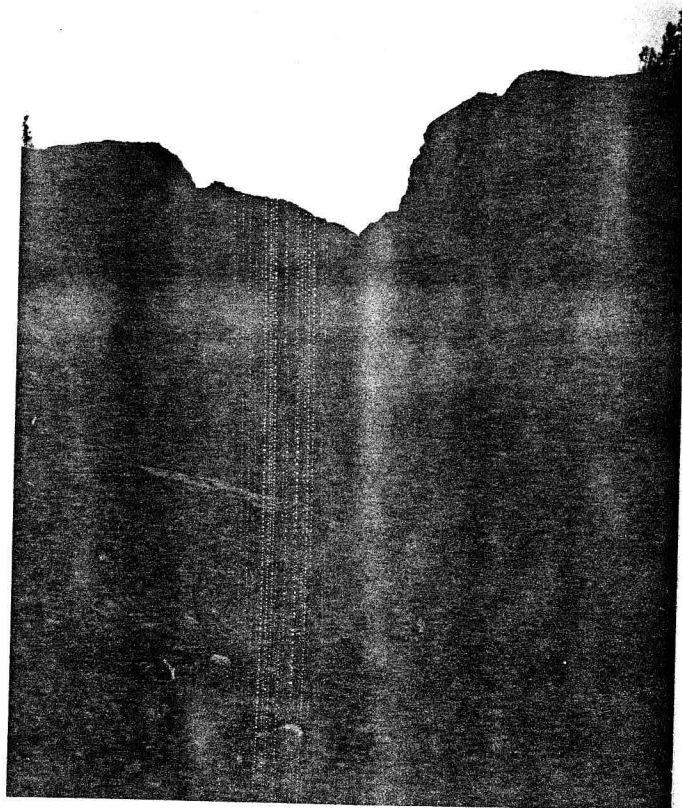
June 8, 1983
Tantalus Butte Coal Mine
North end of open pit
mining.
Note narrowness of the coal
zone.

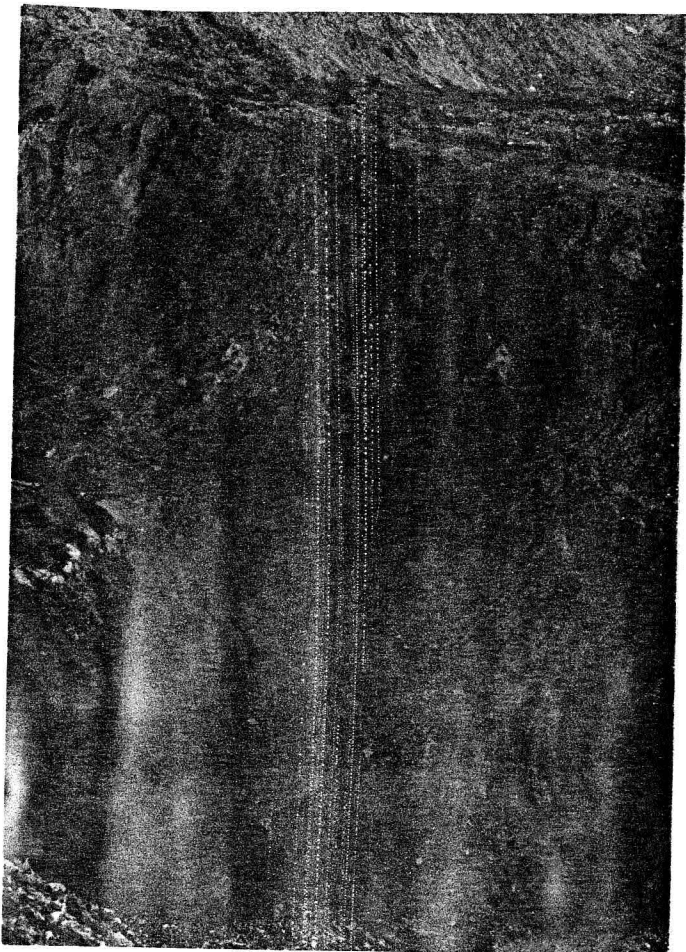
June 8, 1983
Tantalus Butte Coal Mine
Southern portion of open
pit, large waste rock areas
to east and west appear
stable and nor eroding.

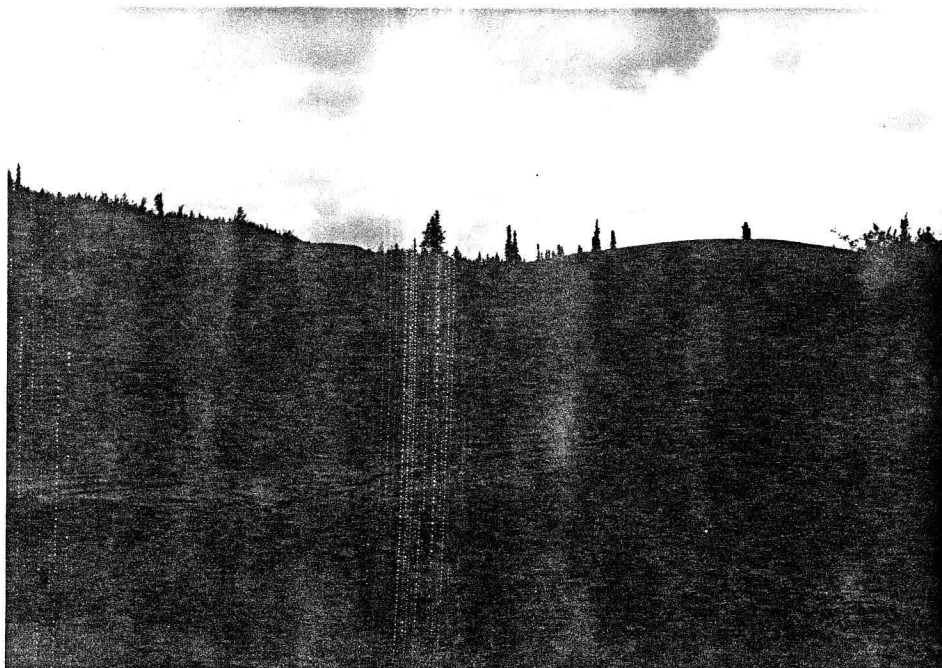
June 8, 1983
Tantalus Butte Coal Mine
Wasterock area typical of
the surface mined area.

Wasterock piles have been graded and show no erosion problems and are beginning to naturally revegetate. It would be a simple job, if required at all, to try to get some seed from indigenous plants to revegetate these slopes. Sage grows prevalently on steep slopes in the immediate area and would probably be a good species to attempt to grow. In late 1981 a report entitled "Cyprus Anvil Mining Corporation, Carmacks Coal Project Reclamation Plan" was submitted to Indian & Northern Affairs Canada (INAC). INAC issued a Land Use Permit to allow CAMC to conduct its reclamation program. The program consisted of stabilizing open pit cuts and revegetation of reclaimed waste piles. I will follow-up with INAC to find out about status of Permit and delaying work.

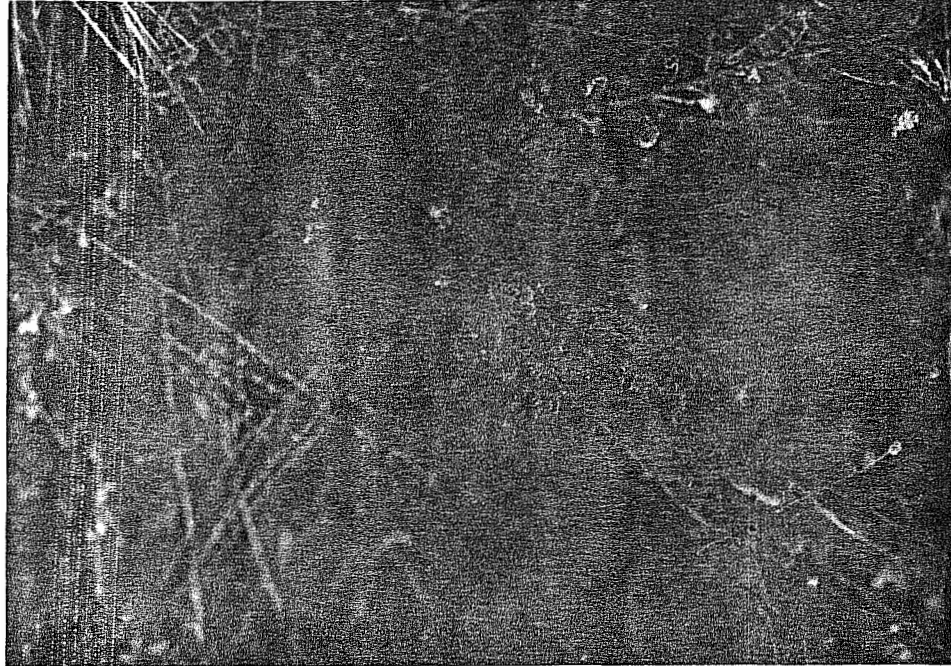
June 8, 1983
Tantalus Butte Coal Mine
Sage plant naturally grows on steep slopes and
will likely grow on wasterock pile slopes.
