A Draft Report To
 CYPRUS ANVIL MINING CORPORATION
 Concerning
 STAGE 2 GEOTECHNICAL INVESTIGATION
 For The
 PROPOSED VANGORDA RAW ORE TRANSPORT SYSTEM
 (Overland Conveyor Alternative)
 Faro Yukon territory

802-2048

Golder Associates
 Consulting Geotechnical Engineers

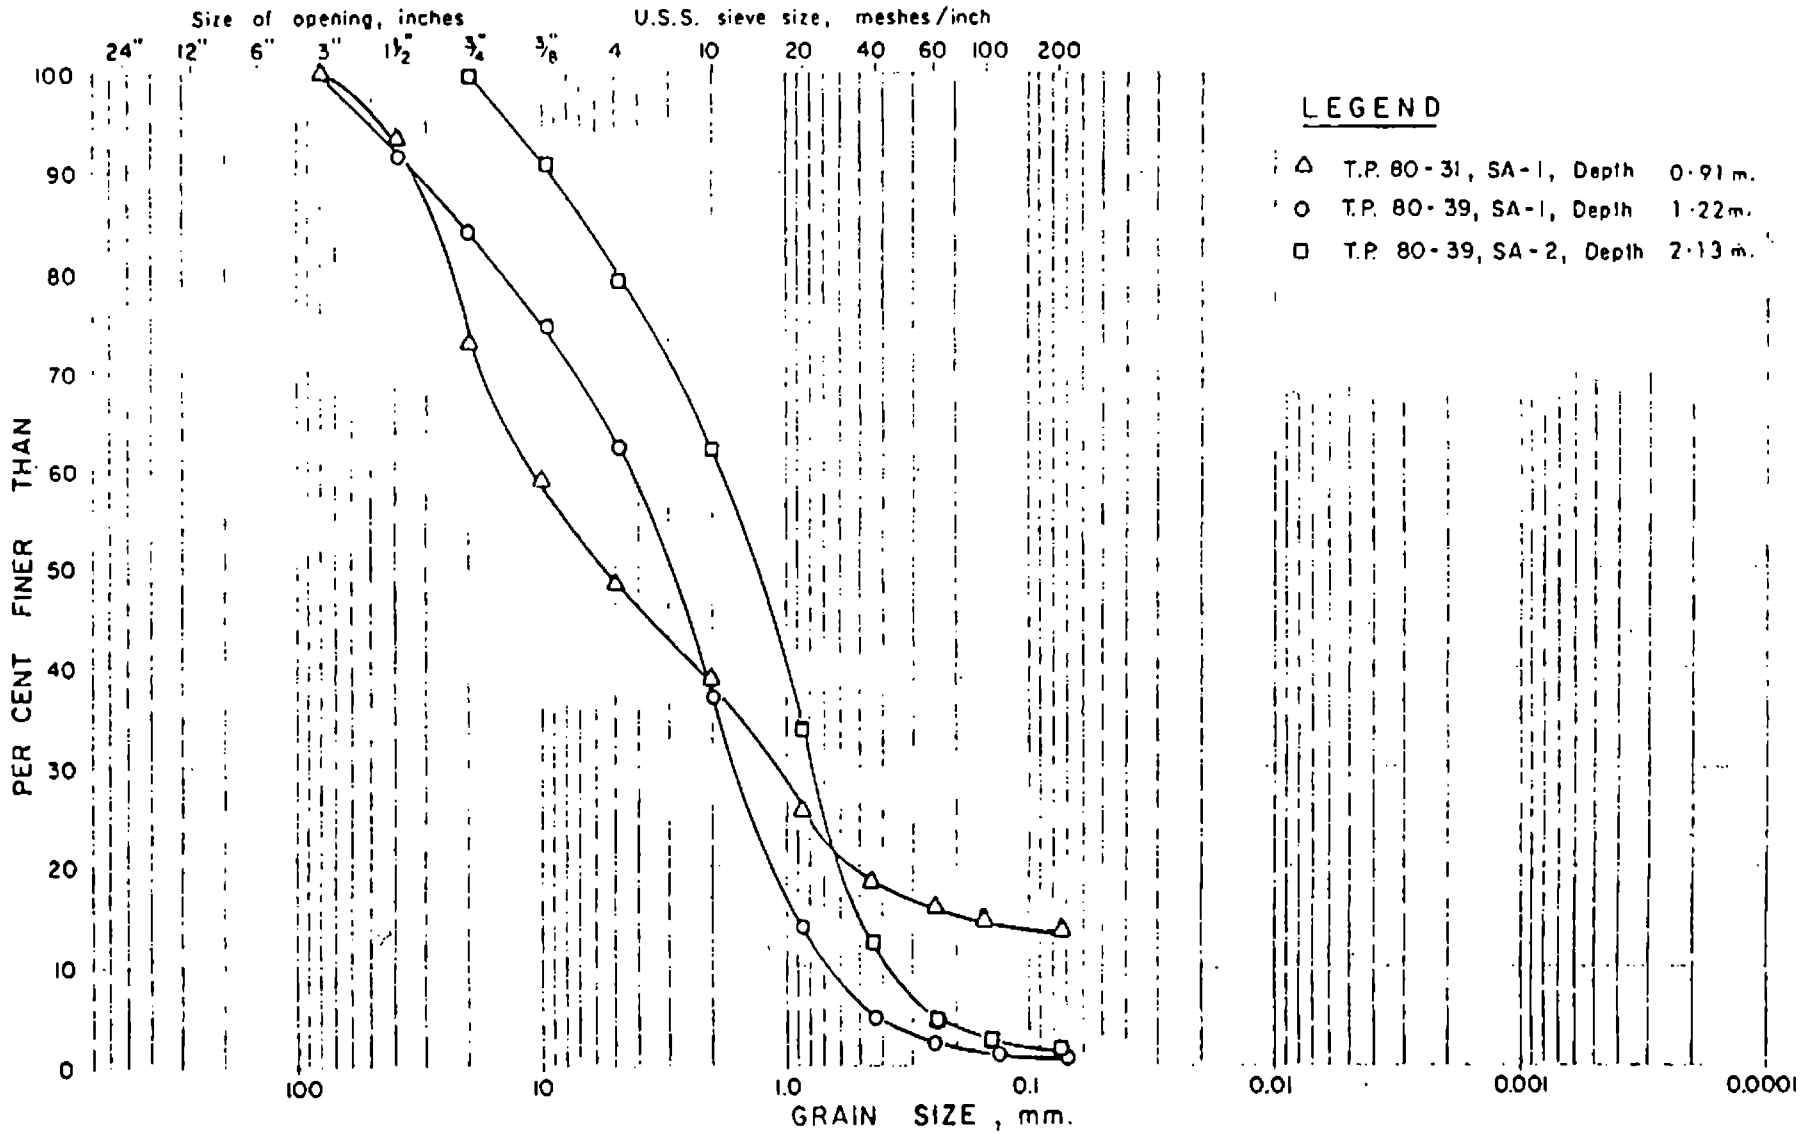
Figure 10

GRAIN SIZE DISTRIBUTION
SILTY SAND TILL

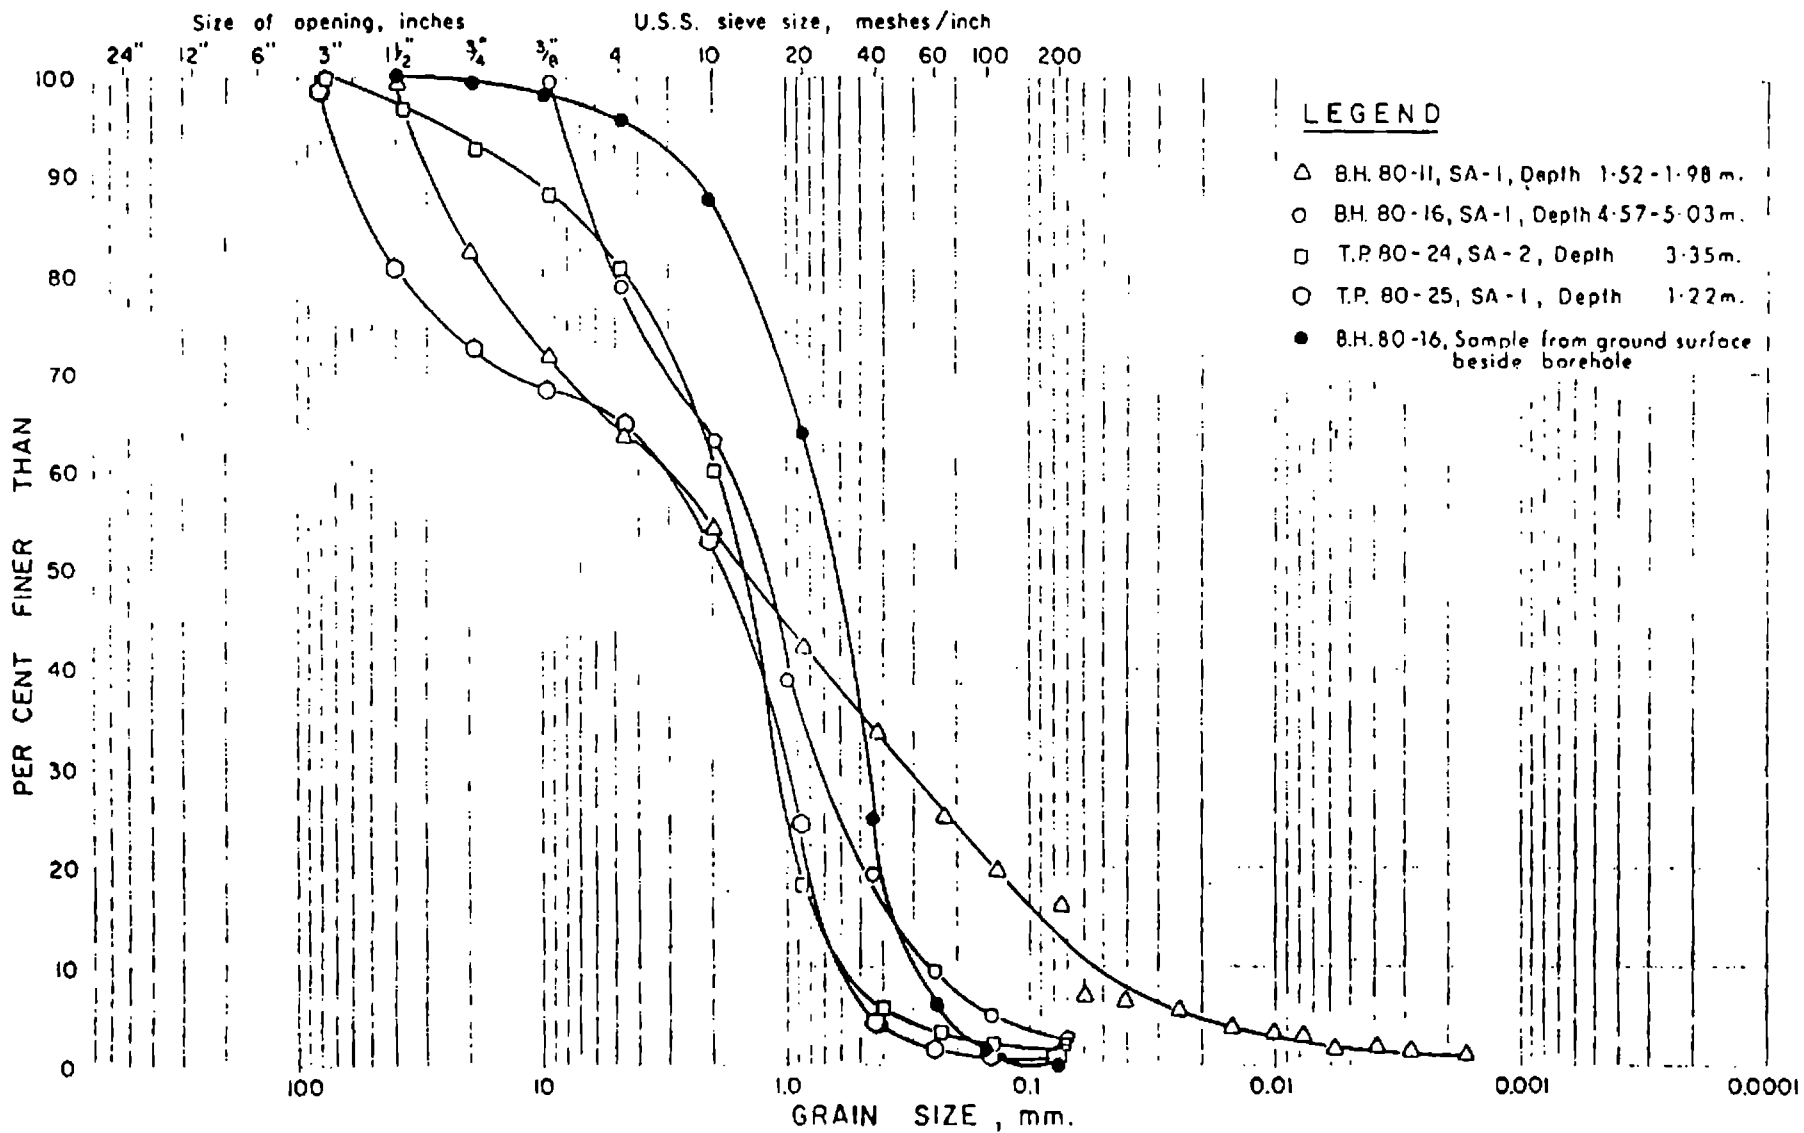
Figure 13

- △ B.H. 80-11, SA-1, Depth 1-52-1-98 m.
- B.H. 80-16, SA-1, Depth 4-57-5-03 m.
- T.P. 80-24, SA-2, Depth 3-35 m.
- T.P. 80-25, SA-1, Depth 1-22 m.
- B.H. 80-16, Sample from ground surface beside borehole

GRAIN SIZE DISTRIBUTION SAND AND GRAVEL
