Yukon Placer Database Operations Report

Field Name: Northway Mining & Exploration Inc., 1995-1999

Stream: Last Chance: a tributary of Hunker

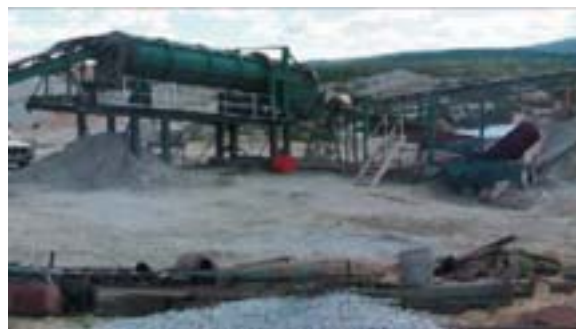
Title: Northway Mining & Exploration Ltd., Preido Hill

This operation worked on Preido Hill which is location on the right limit of Last Chance Creek at its confluence with Hunker Creek.
