# Yukon Placer Database Operations Report

Field Name: Tuck, 1983-1984, 1998-2003

Stream: Hight: a tributary of Minto

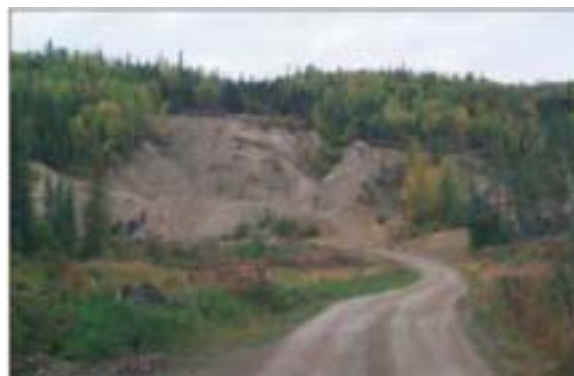
**Title:** Wilf Tuck's mining cut on Highet Creek

Deposits are present in the Highet Creek Valley, and on a low bench along the right limit of the creek. The deposits include pre-glacial gravel, glaciofluvial sand and gravel, and post-glacial gravel. During 1998-2002, approximately 80 feet of silt, some of it frozen, overlaid 16 to 18 feet of pay gravels. Very little rock was encountered and two old drifts remained exposed in the bottom of the cut.
